INITIAL SITE ASSESSMENT REPORT
for the
ENCINITAS HABITAT STEWARDSHIP PROGRAM
City of Encinitas, California

DUDEK
605 Third Street
Encinitas, California 92024
Contact: Anita Hayworth

AUGUST 2015

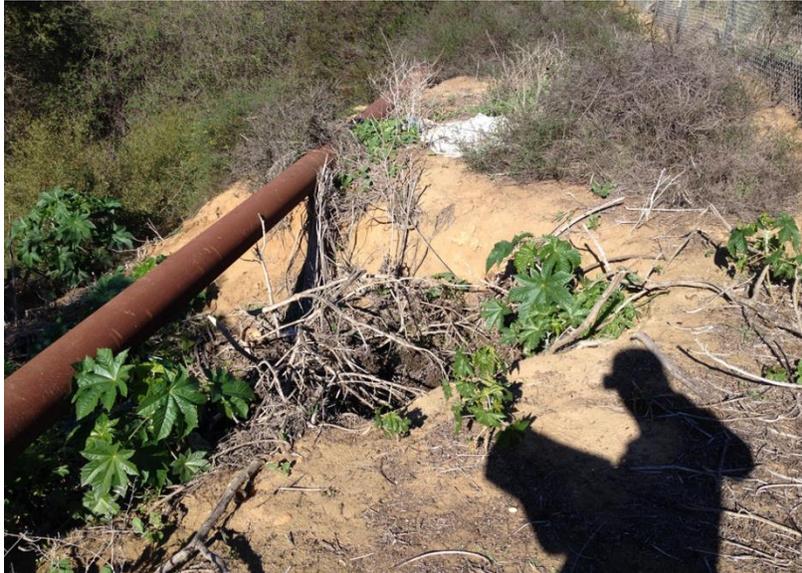
- Minor rilling scattered throughout the slopes on site.
- Two eroded gullies were observed in the southeast corner of the site. One of the eroded drainages formed at an unprotected storm drain outlet pipe. (Figure 3A; Photo 1). The cause of the other eroded gully is unknown, but appears to be from coalescing surface runoff on the slope. The eroded drainages would require substantial grading and heavy equipment work to be repaired; however, this would cause detrimental effects to the native habitat that is established in these areas. Therefore, an attempt should be made to first stabilize the erosion issue to prevent further erosion at these locations.

Photo 1: Severe erosion in southeast corner of open space boundary; photo taken looking north.

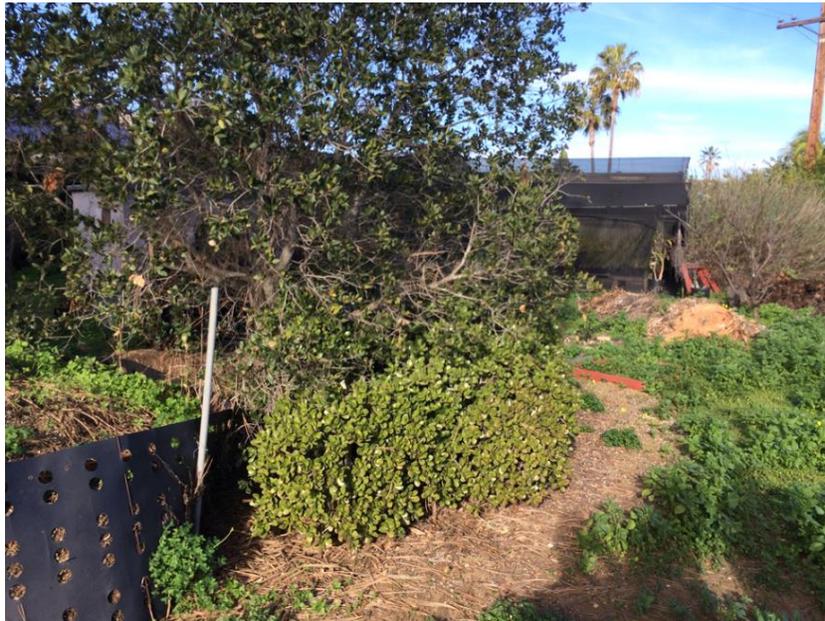
- Gap in the fencing on the southeast end of the project
- Fencing gaps along the western property line at the top of the slope (Figure 3A)
- Several trail spurs into the habitat on either side of the main trail.
- Approximately 350 feet north from the southwest edge of the open space area, a private residence has encroached into the open space (Photo 2).

Photo 2: Property boundary encroachment by resident onto open space. Photo taken facing north on western boundary.

8. Coordinate fence replacement between residences and the open space on the western edge.
9. Repair fence break in the southeast corner of the open space

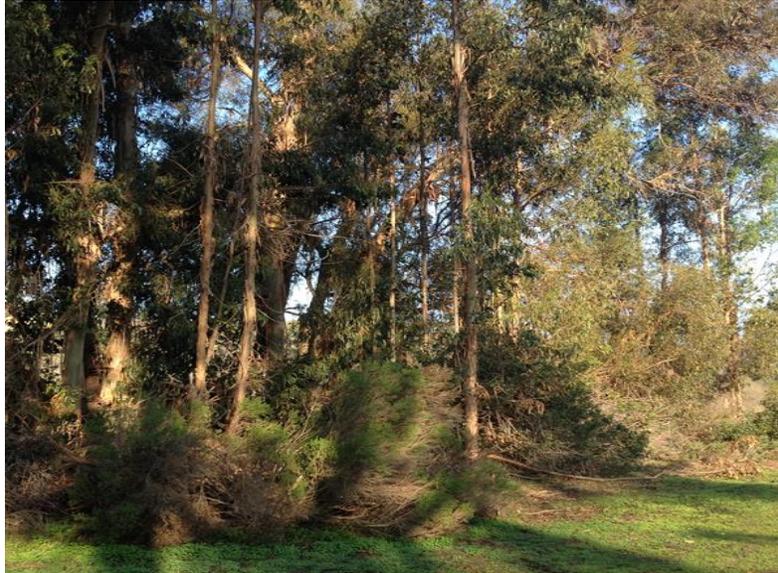
Photo 4: Eucalyptus woodland in west side of site

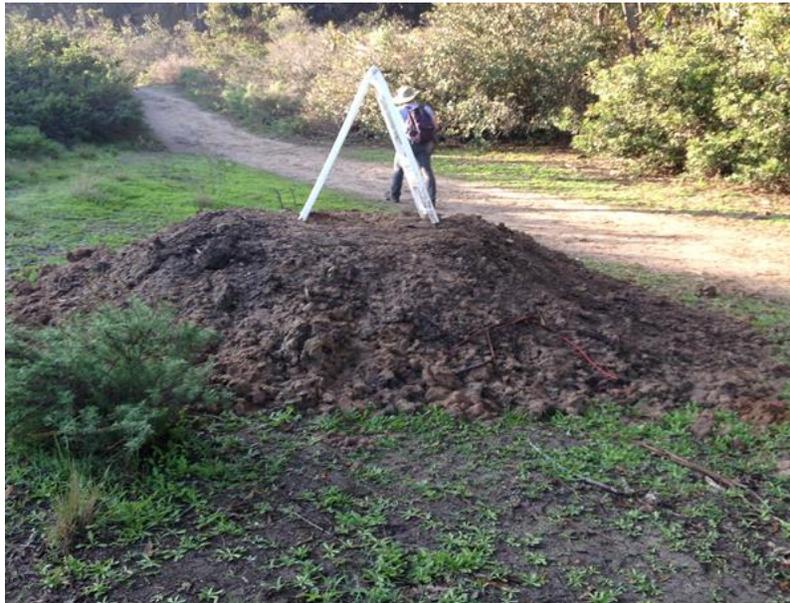
Photo 5: Dirt and asphalt mound near trail on western portion of site

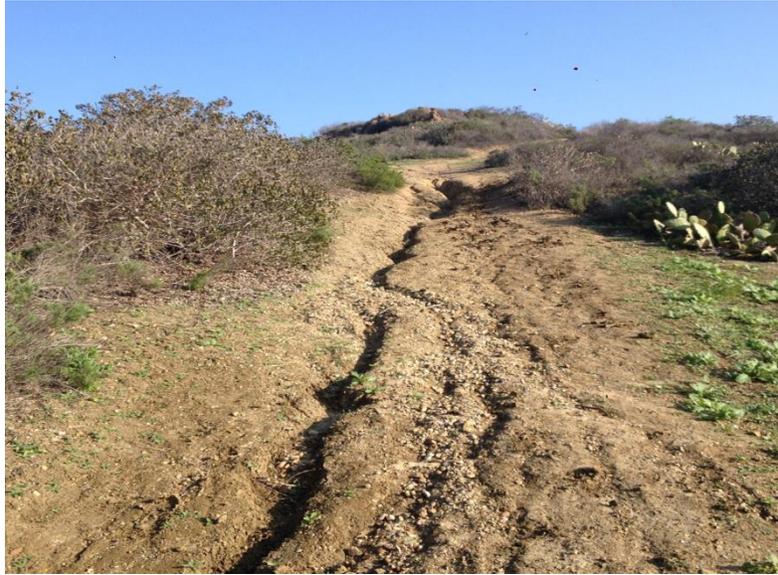
Photo 6: Erosional rilling in trail

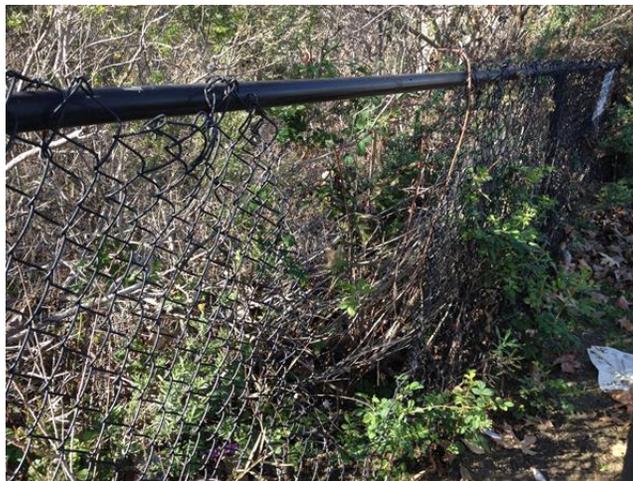
Photo 9: Tear in fence at corner of El Camino Real and Town Center drive

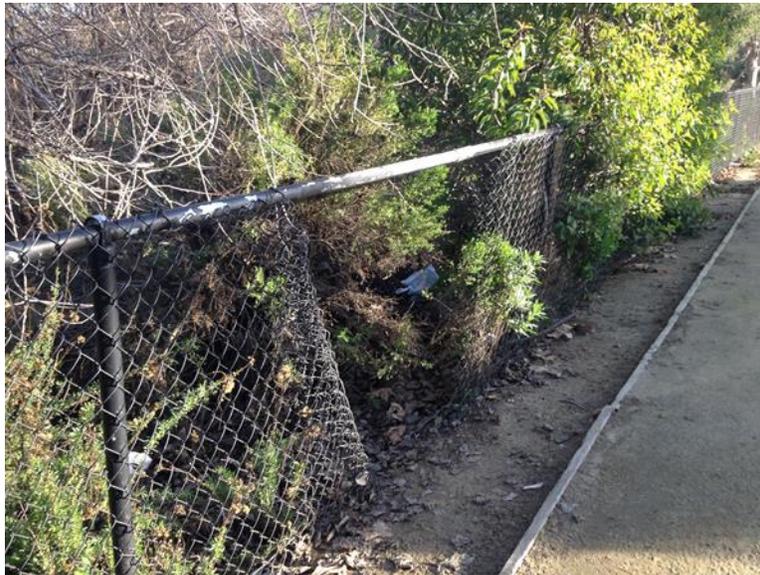
Photo 10: Tear in fence adjacent to parking lot on the western boundary of open space .

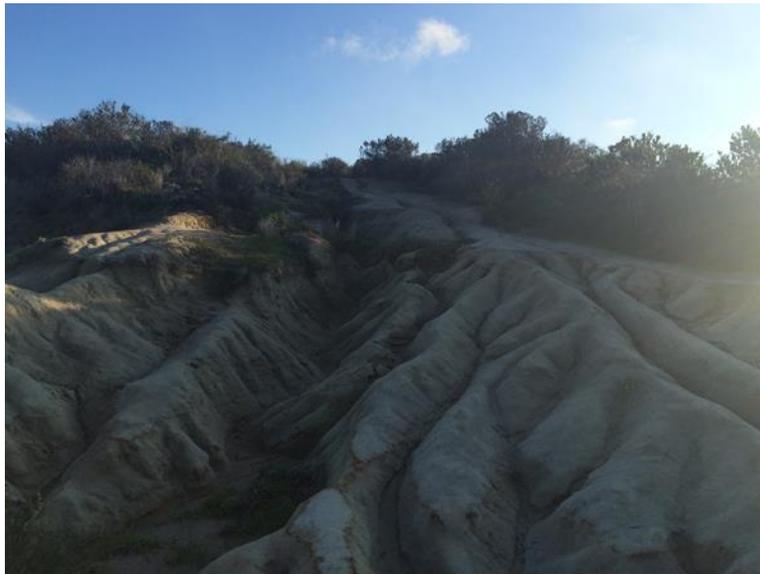
- Moderate to severe rilling in the trail along the top of the hill in the west portion of the site (Photo 11)
- Minor features around the on-site drainage that feeds into the Not a Part detention basin on the north end of the open space.

Photo 11: Severe erosion rilling along trail at top of hill

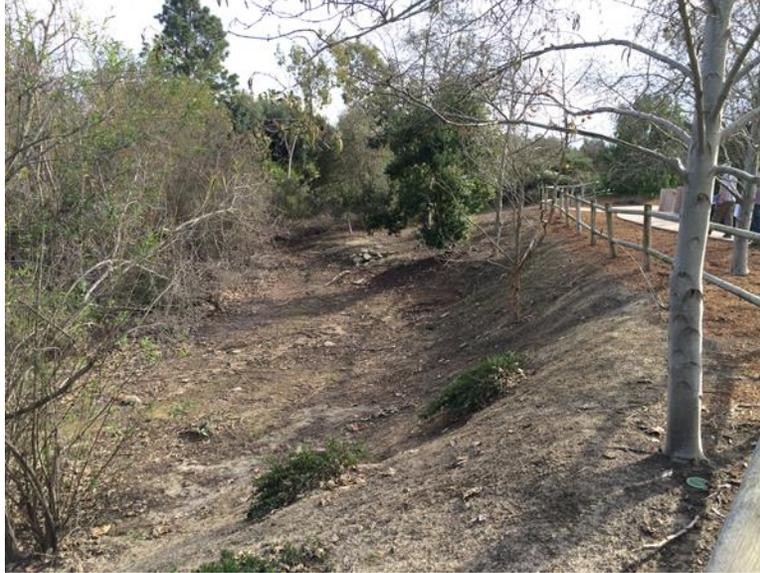
Photo 12: Area previously cleared of vegetation and now is vulnerable to erosion and invasion by exotics
