PACIFIC VIEW ELEMENTARY

Rehabilitation & Re-Use Study

August 10, 2015
90% Review Draft

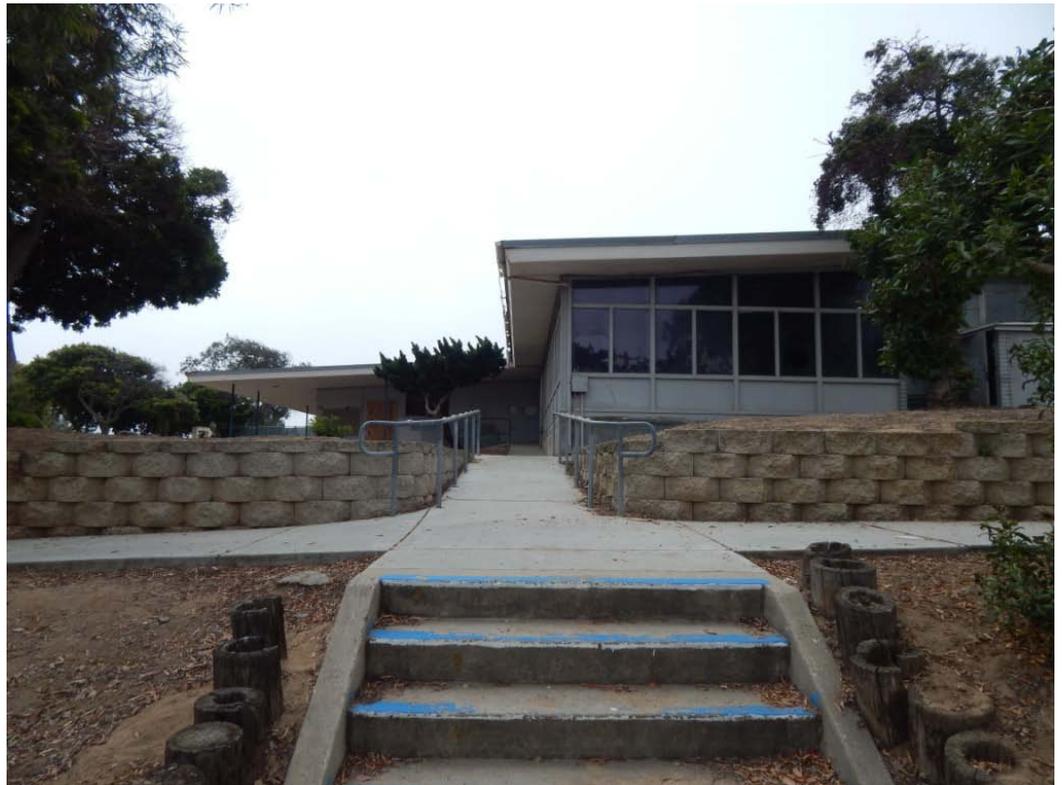
Existing Secondary Entrance (E Street)

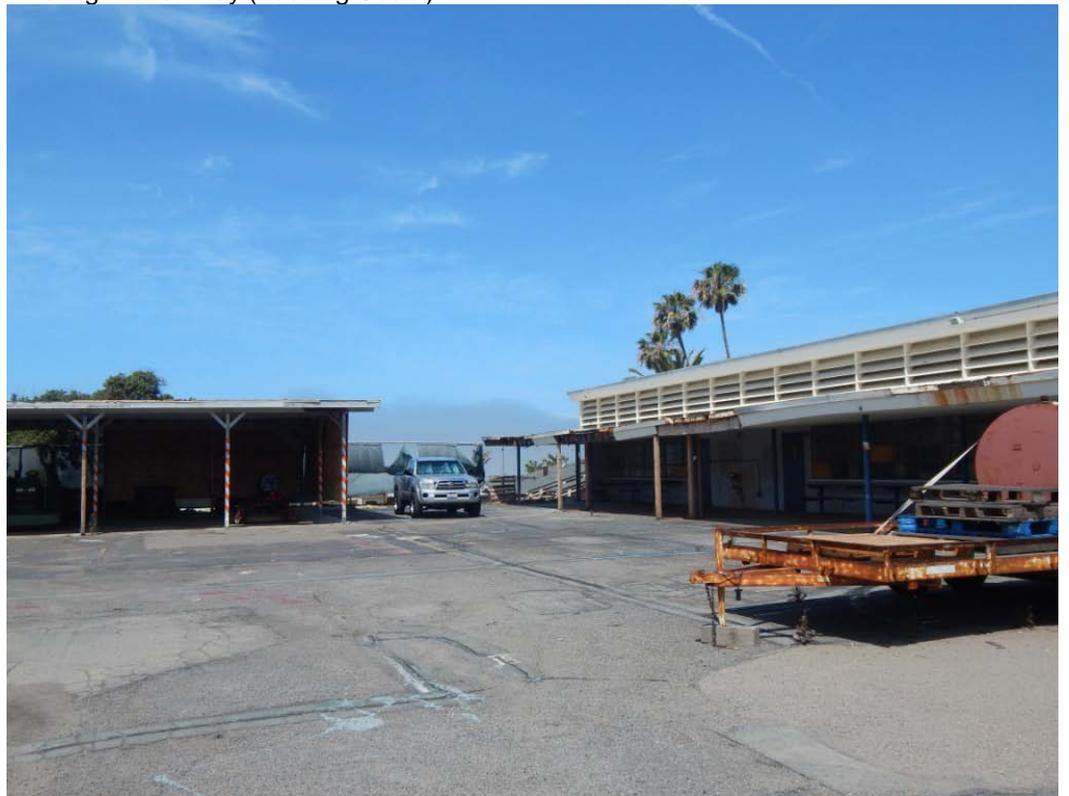
Existing Parking Area Pavement Condition (Looking West)

- **Travel ways**
Provide at least 24-feet of improved unobstructed pavement width for all travel areas with an inside turning radius of 28-feet for fire access, including providing any structural sections within unpaved areas that require fire access per the City of Encinitas requirements. It may be necessary to consult with a qualified arborist regarding impact to neighboring trees if trees are to remain (Refer to Recommended Pacific View – Option IIIA Site Plan).

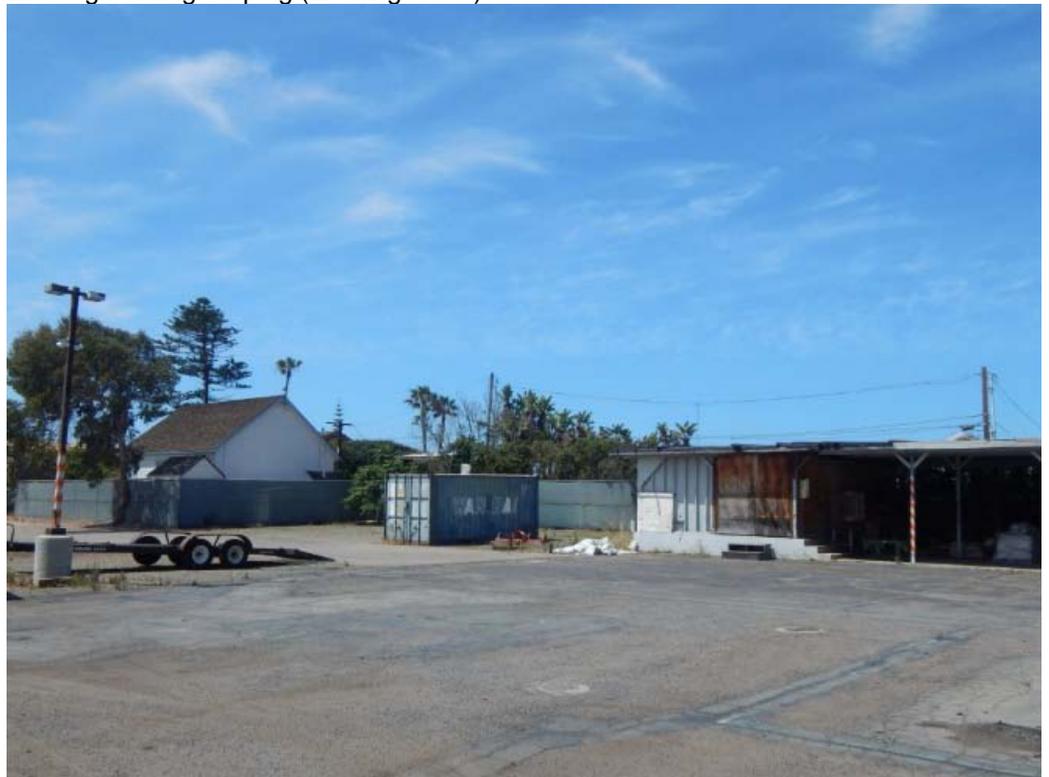
Existing Parking Area Pavement Condition (Looking South)

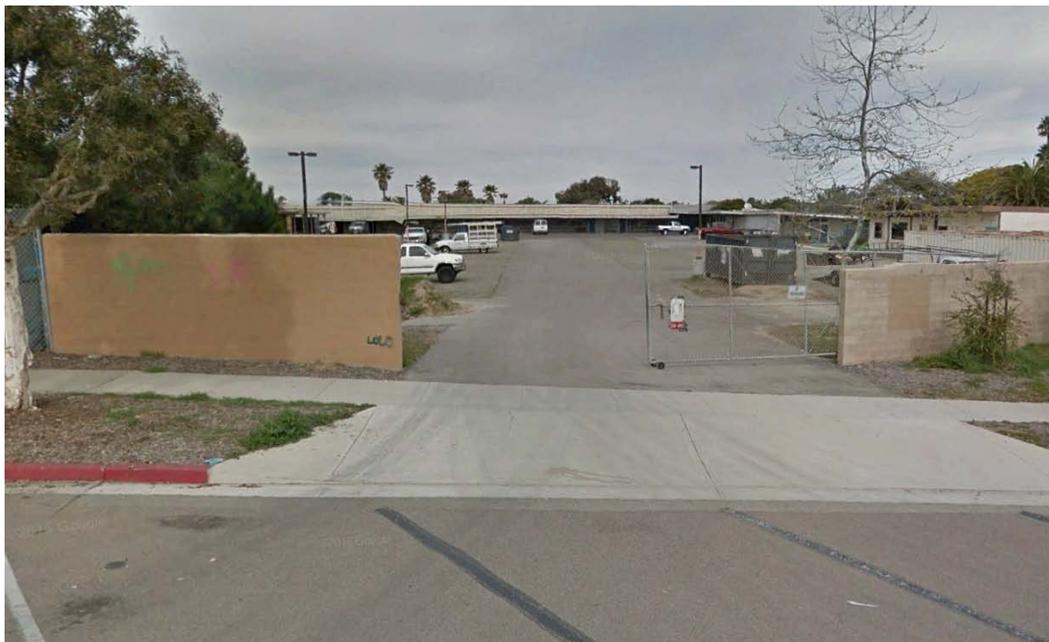
Existing Vehicular Site Entrance

- **Site Access**
Provide a new concrete driveway in accordance with the City of Encinitas design requirements. Remove and re-stripe existing diagonal striping along F Street to be reconfigured based on new site access (Refer to Recommended Pacific View – Option IIIA).

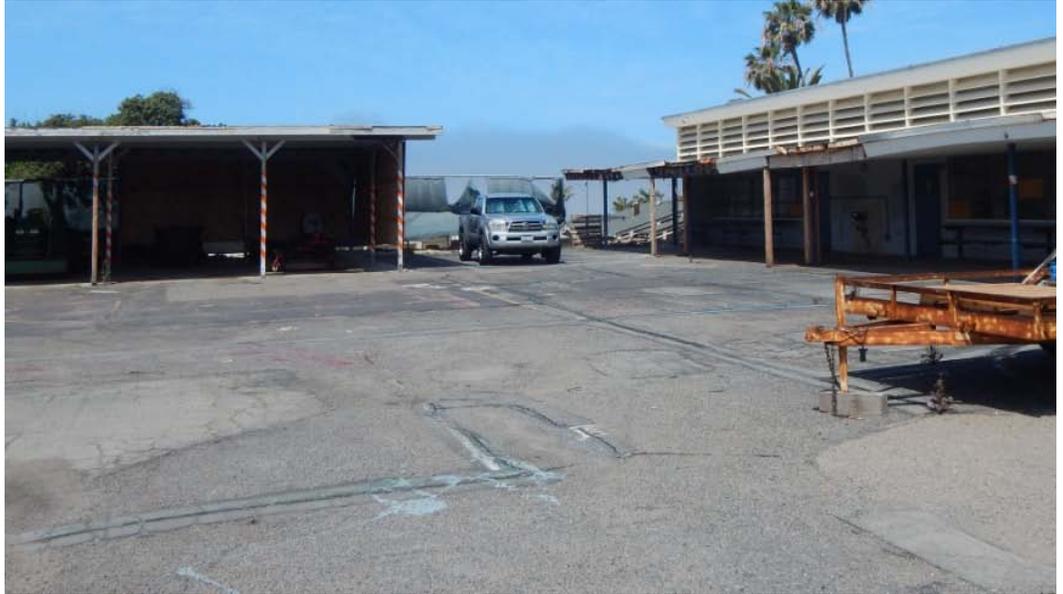
- A preliminary investigation into as-built utility drawings indicates that the original construction of the site utilities to be over 50 years old and it is anticipated that most utilities are at or near the end of their services life. During our site investigation, we observed several areas where narrow trench resurfacing had taken place within the asphalt parking area. The path of these narrow trenches roughly follows the course of aboveground utility features such as sewer cleanouts, storm drain inlets, and water valves. Based on these observations it is suspected that a portion of the existing site utilities was either replaced or repaired after the original installation. For evaluation of the existing building utilities, refer to the mechanical section of this report.

Existing Narrow Utility Trenching

- Prior to development of the site a detailed utility investigation should be performed to assess the condition and capacity of all utilities. Depending on the future use of the site it may be necessary to repair, replace, and/or upgrade the existing utility system. The city has elected to forego this investigation until an Operating Partner is selected as well as to reduce cost at this phase of the project.

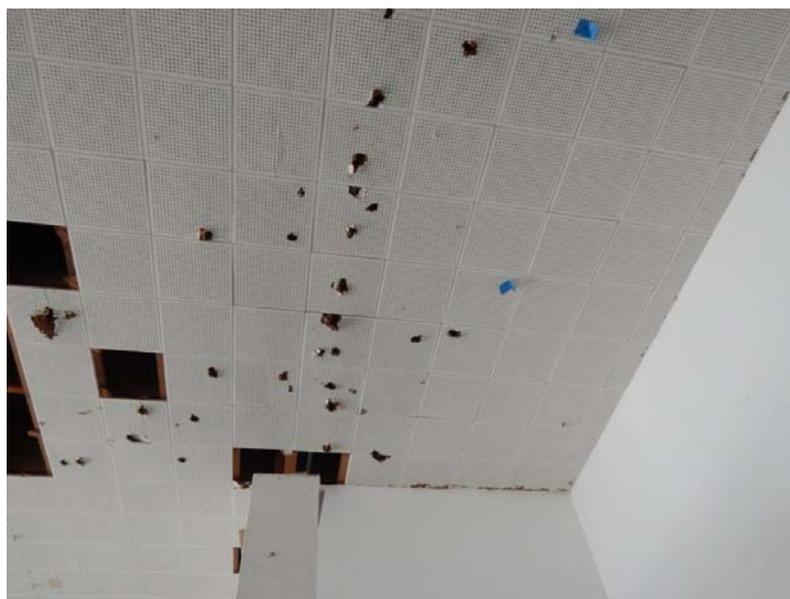
Existing stained, damaged and missing ceiling tiles

Demolish all finishes. Demolish 2x wood framed partitions and restroom partition walls, and replace, as necessary for new configuration. See Appendix B

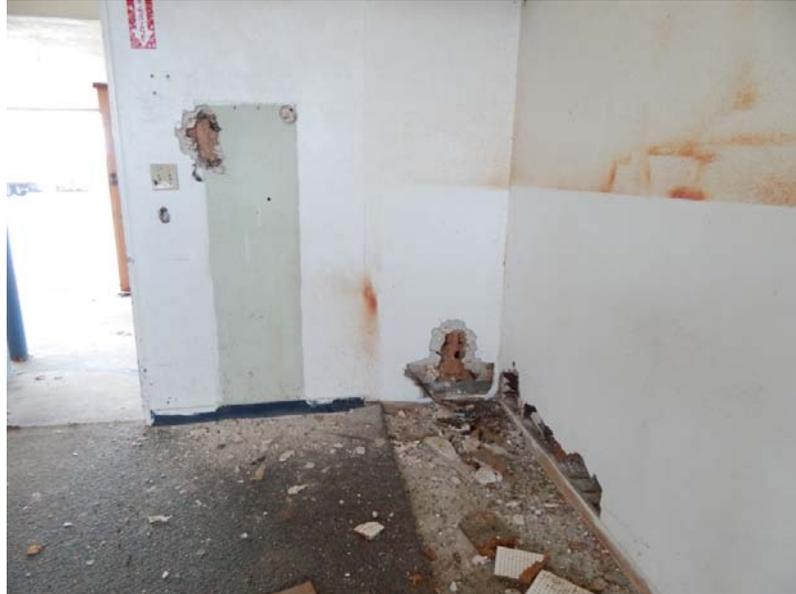
Existing stained and damaged wall finish.

Replace insulation with new batt and/or rigid insulation to achieve necessary Title 24 R-values. Replace interior wall finishes with 5/8" type X gyp. bd., taped only. Patch and repair exterior finish with stucco to match existing. See Appendix G for Asbestos report information on hazardous material locations. Demolish all floor finishes. Clean and seal existing concrete floor finish in all areas except restrooms.

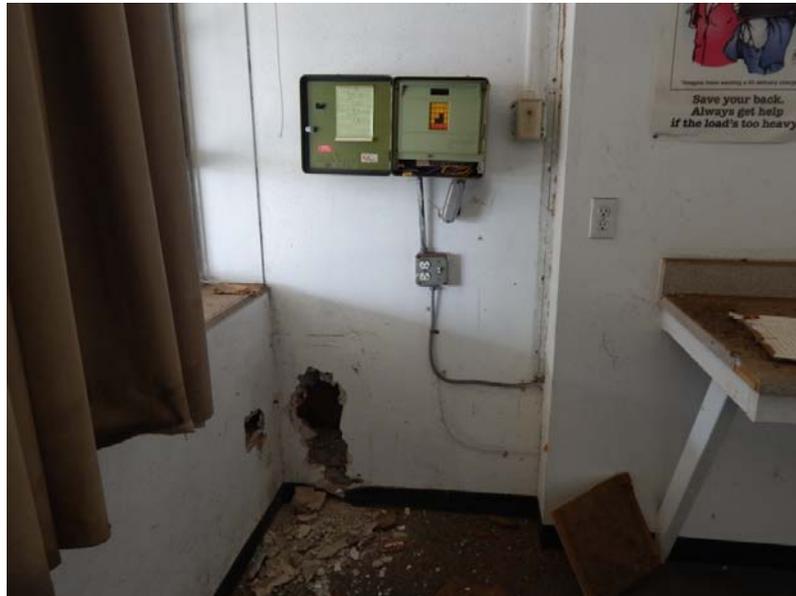
Existing stained and damaged wall finish.

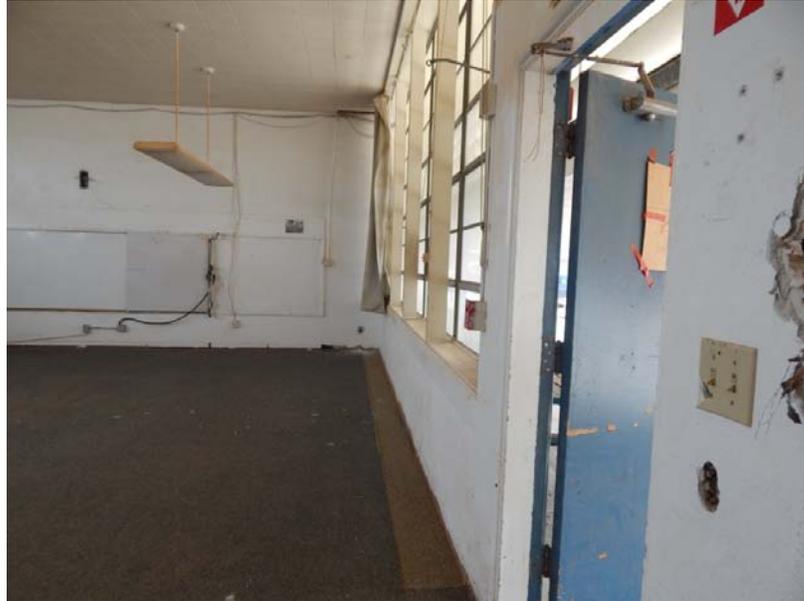
Existing stained and worn floor finish.

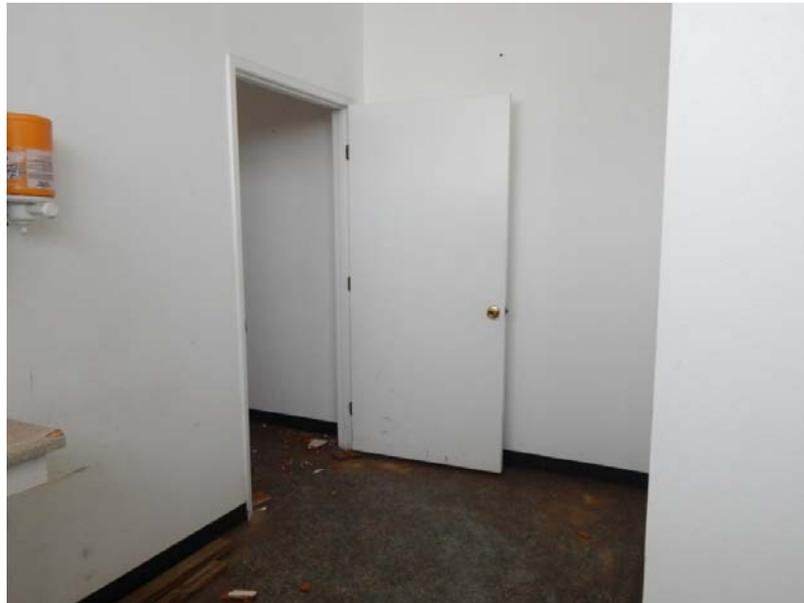
Existing stained and worn floor finish.

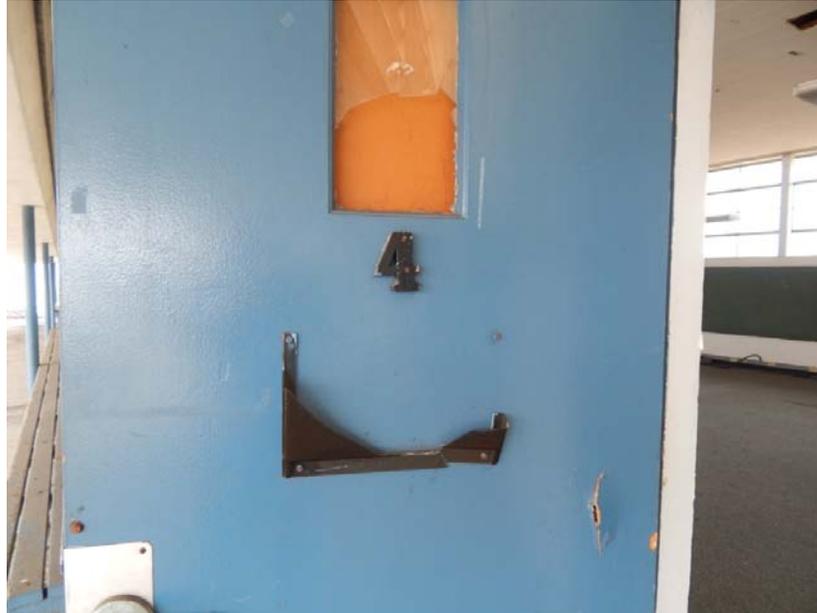
Damaged door

Remove and replace doors and frames with Hollow Metal (HM) doors and frames at exterior locations and Solid Core Wood (SC) doors with HM frames at interior locations. All doors to receive new accessible hardware sets. See appendix G for hazardous materials report for lead paint locations.

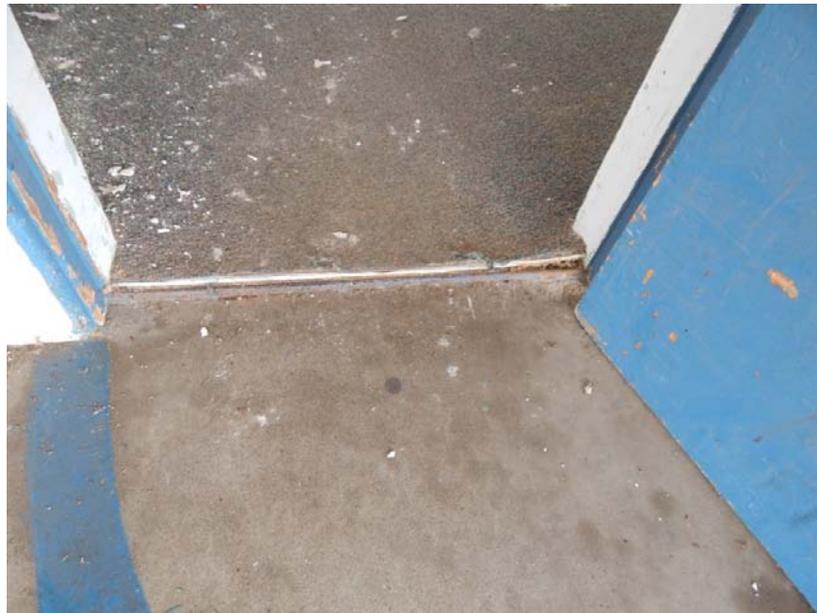
Non ADA compliant threshold

Demolish and replace exterior concrete walk to provide compliant thresholds and accessible Path of Travel (POT) to all spaces.

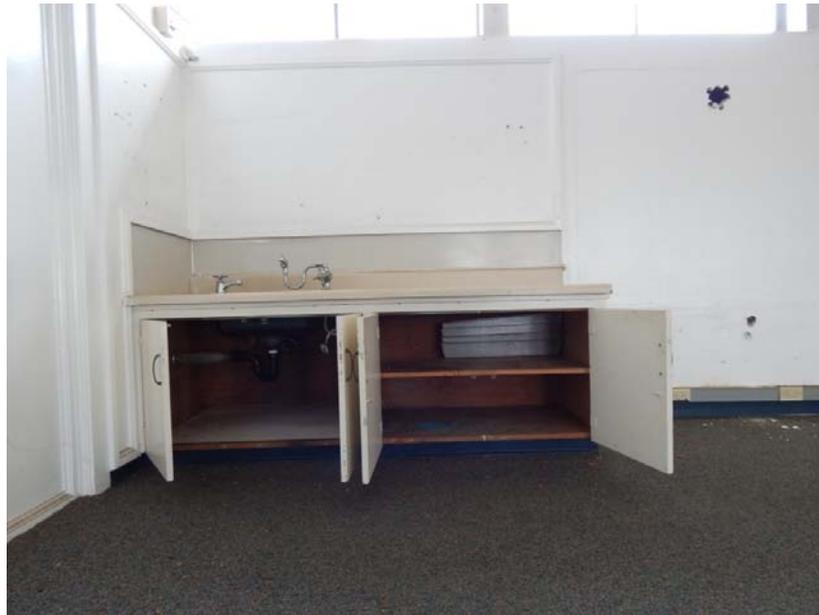
Deteriorating casework lacking ADA clearances

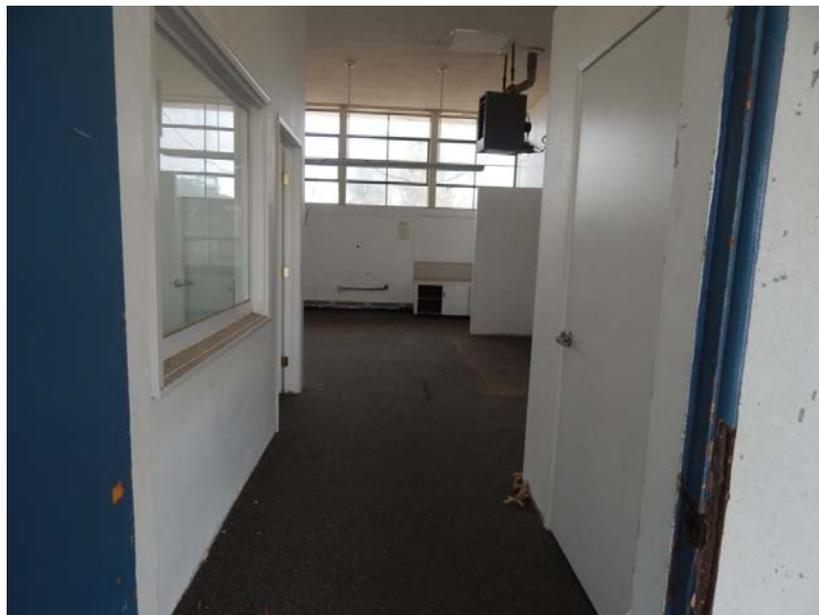
Damaged and deteriorating door frame

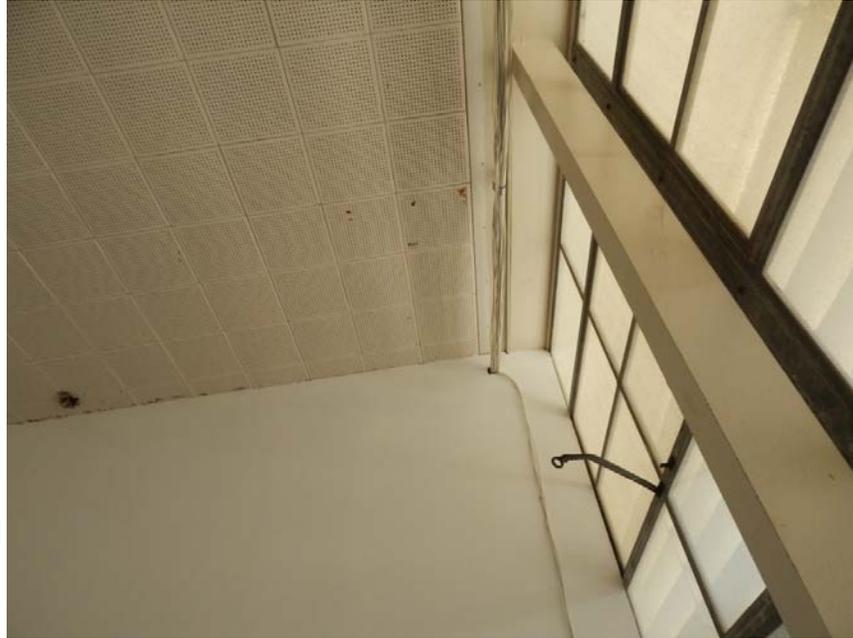
Deteriorating window frames and non ADA accessible hardware

Remove and replace windows with element resistant, energy efficient, thermally broken frames with insulated glazing.

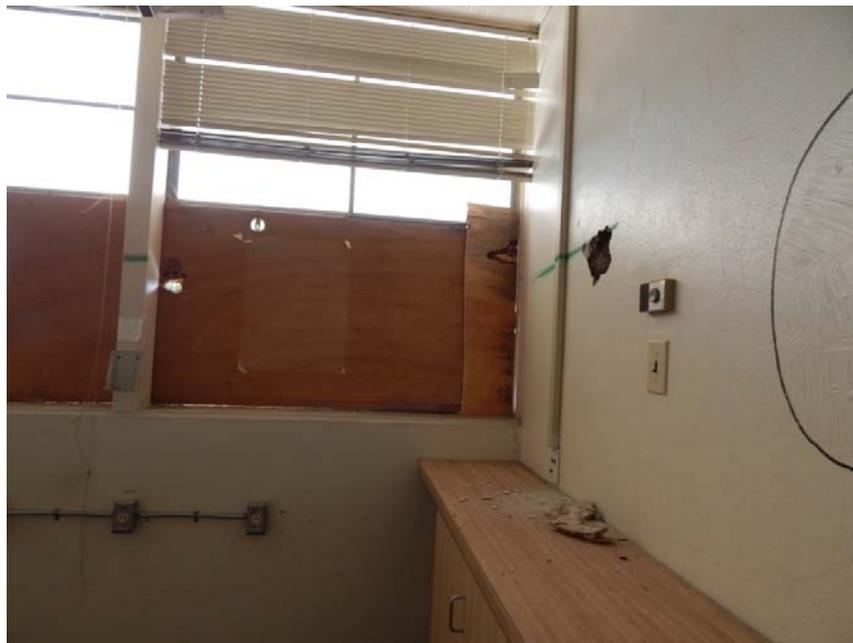
Damaged single glazing

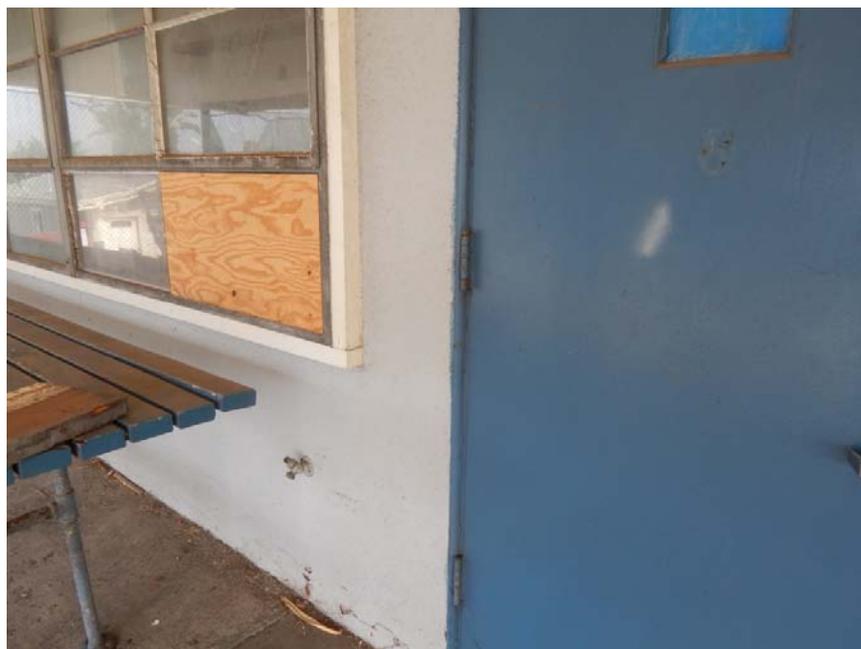
Deteriorating windows with damaged single glazing

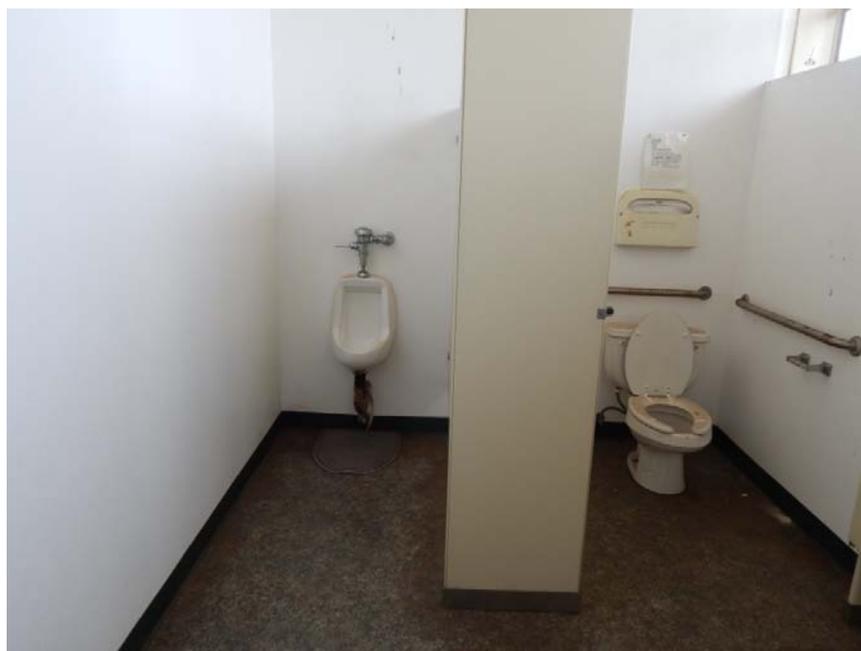
Insufficient ADA clearances at toilet facilities

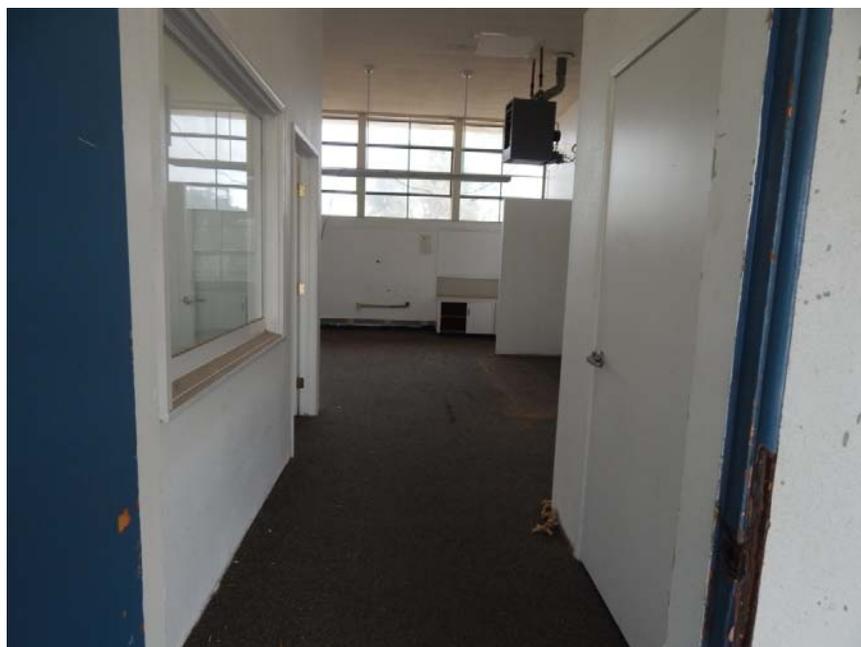
Insufficient ADA clearances for maneuvering space at doors

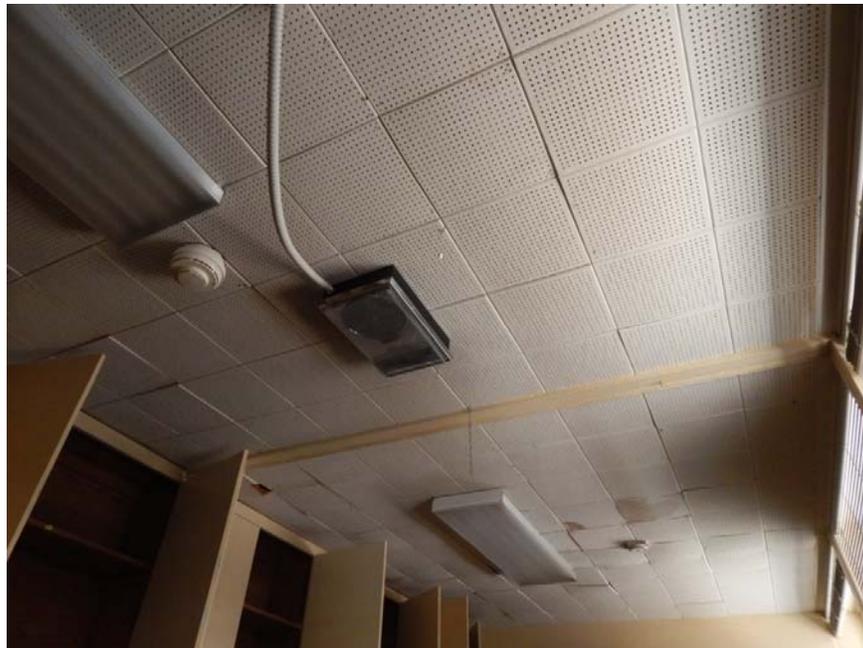
Sagging and stained ceiling tiles indicating water damage and age

Demolish all finishes. Demolish 2x wood framed partitions and restroom partition walls, and replace, as necessary for new configuration. (See Appendix B)

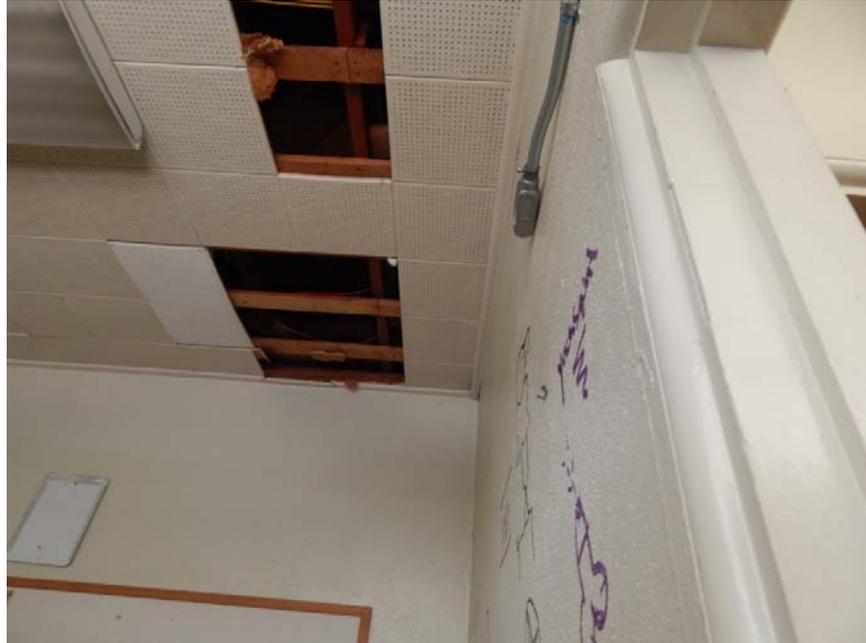
Missing and sagging ceiling tiles

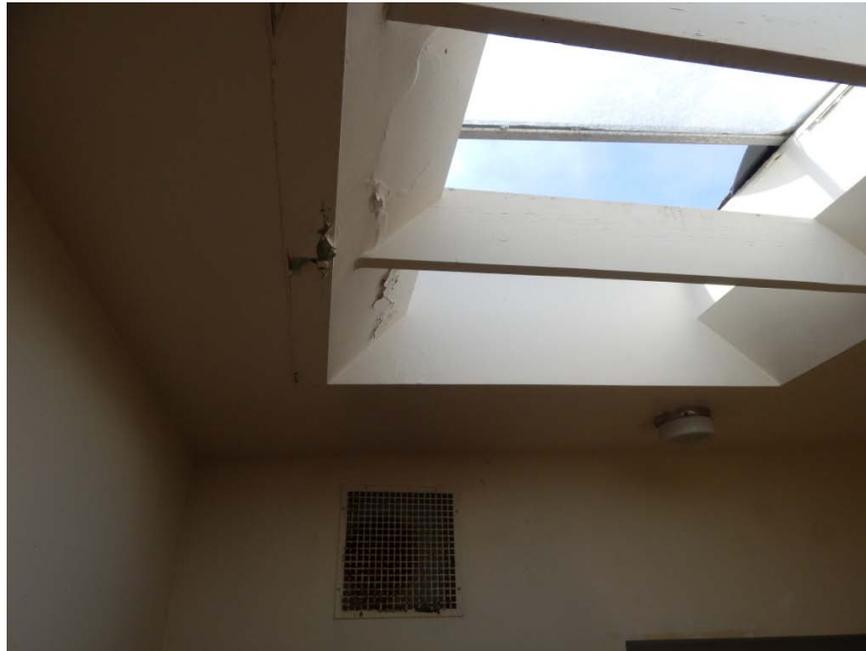
Water damaged ceiling finish

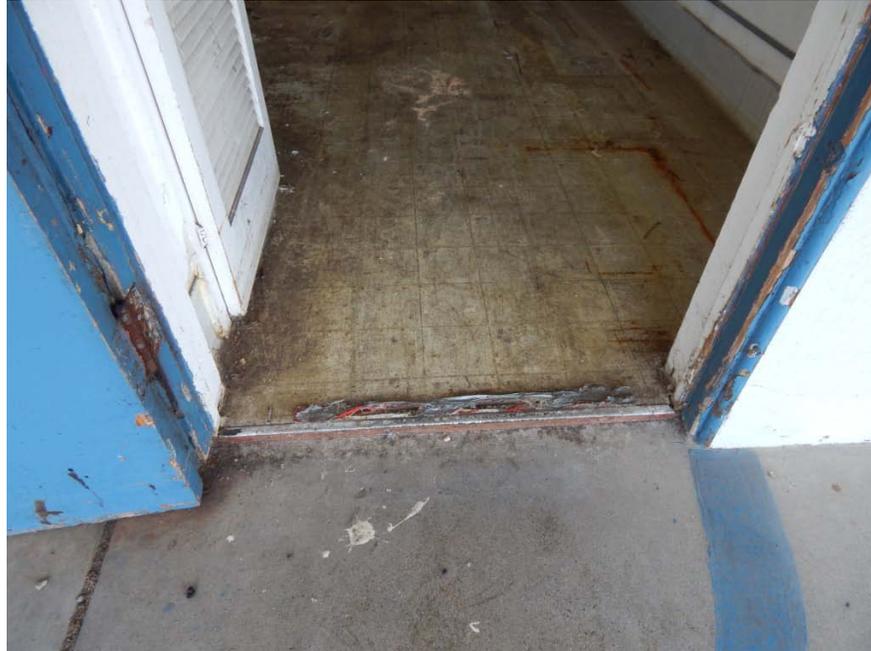
Stained and damaged tile flooring and damaged and deteriorating door and door frame

Remove and replace doors and frames with Hollow Metal (HM) doors and frames at exterior locations and Solid Core Wood (SC) doors with HM frames at interior locations. All doors to receive new accessible hardware sets. See Appendix G for hazardous materials report for lead paint locations.

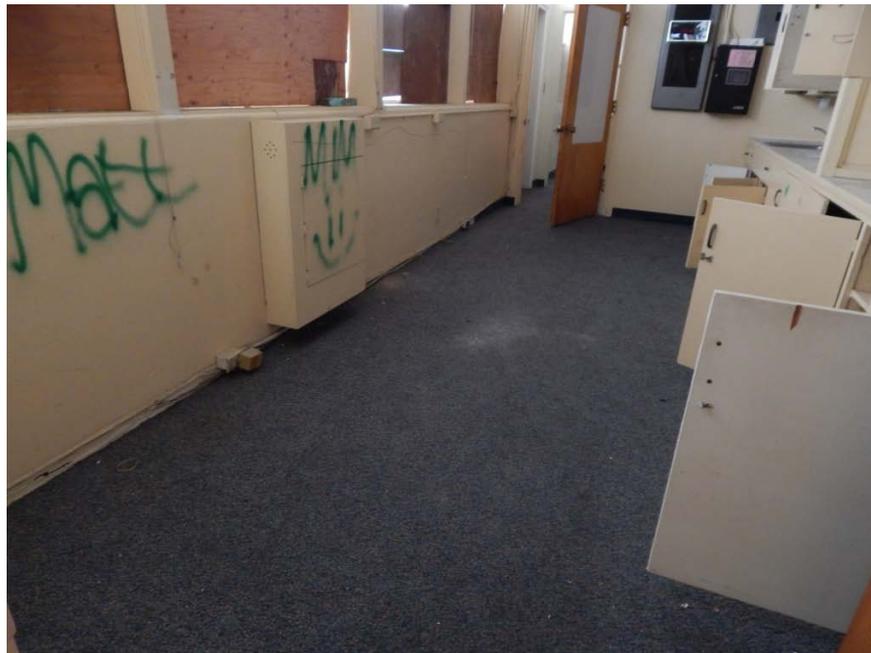
Stained and worn carpeting

Replace insulation with new batt and/or rigid insulation to achieve necessary Title 24 R-values. Replace interior wall finishes with 5/8" type X gyp. bd., taped only. Patch and repair exterior finish with stucco to match existing. See Appendix G for Asbestos report information on hazardous material locations. Demolish all floor finishes. Clean and seal existing concrete floor finish in all areas except restrooms.

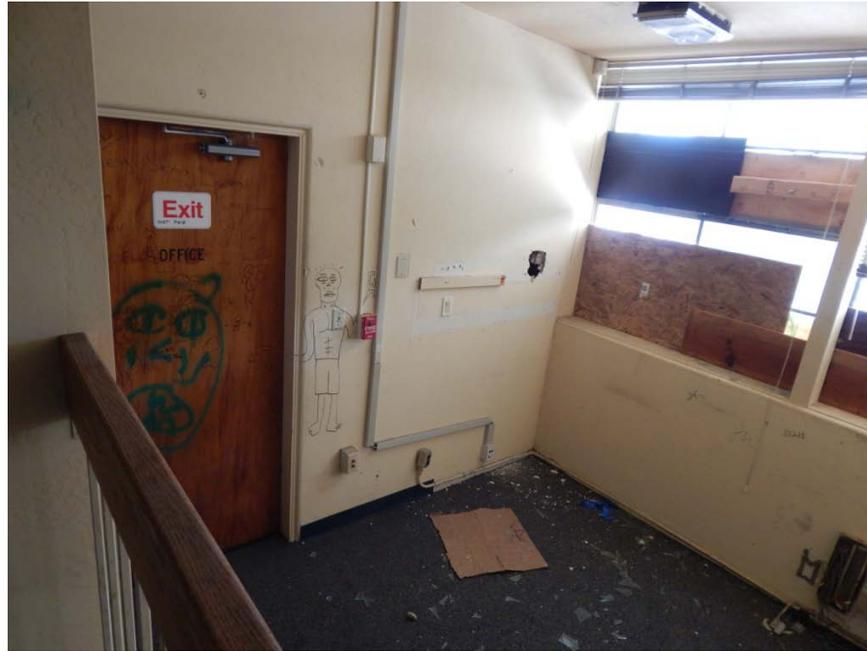
Damaged wall finish

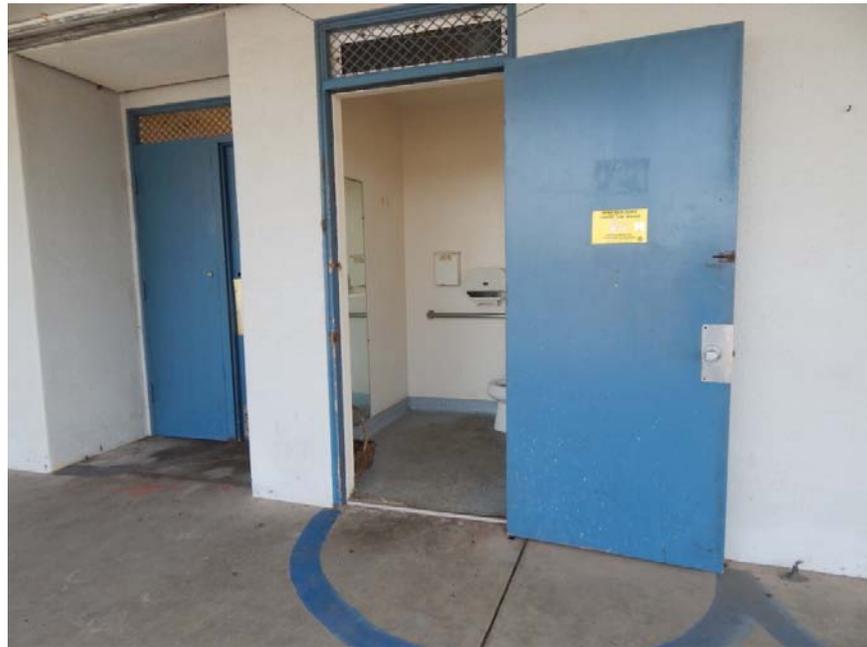
Threshold exceeds 1/4" max. ht. for ADA and hardware is damaged

Demolish and replace exterior concrete walk to provide compliant thresholds and accessible Path of Travel (POT) to all spaces including ramps from the upper level to the lower level.

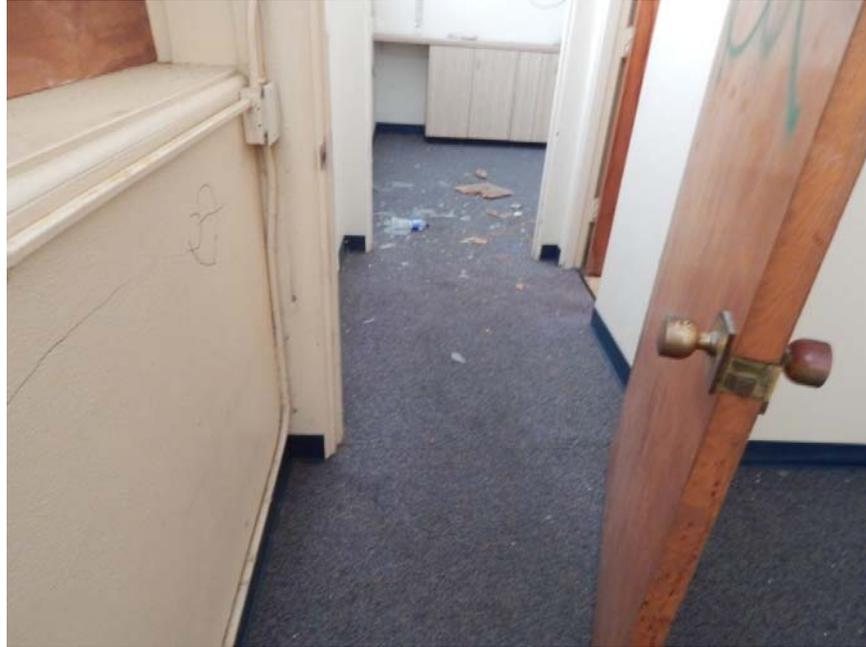
Grasping and twisting operation of hardware not ADA compliant

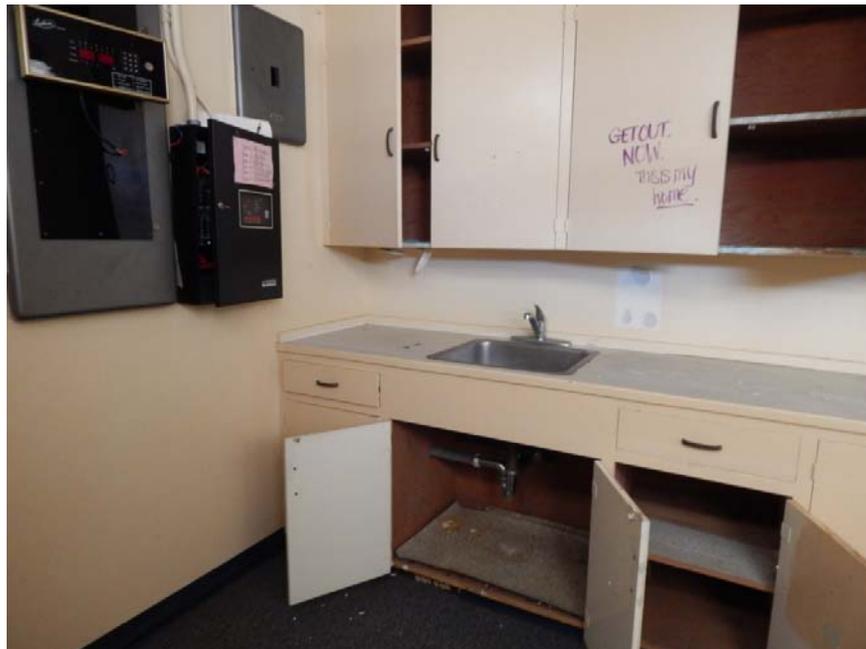
Damaged casework and insufficient ADA clearances

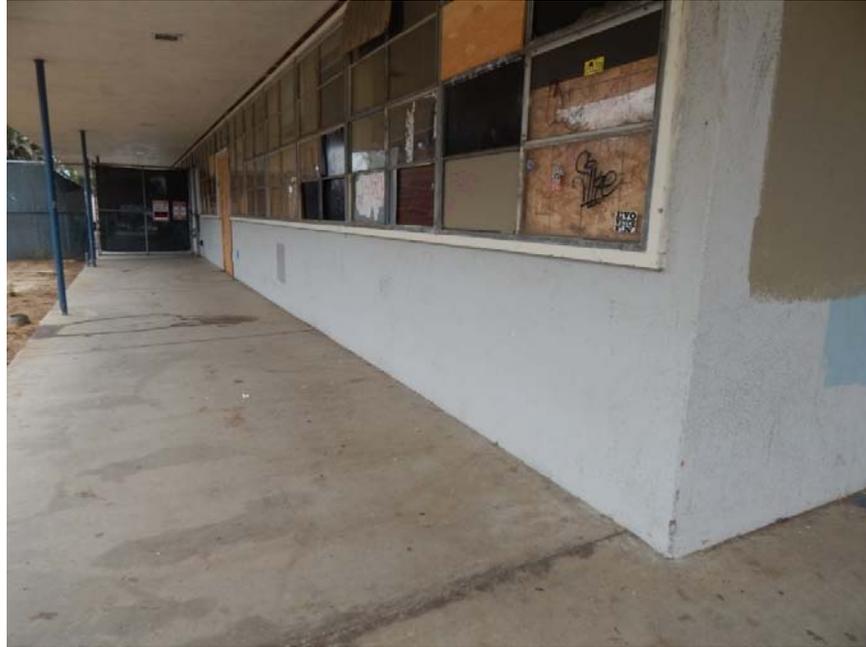
Deteriorating window frames and broken single glazing

Remove and replace windows with element resistant, energy efficient, thermally broken frames with insulated glazing.

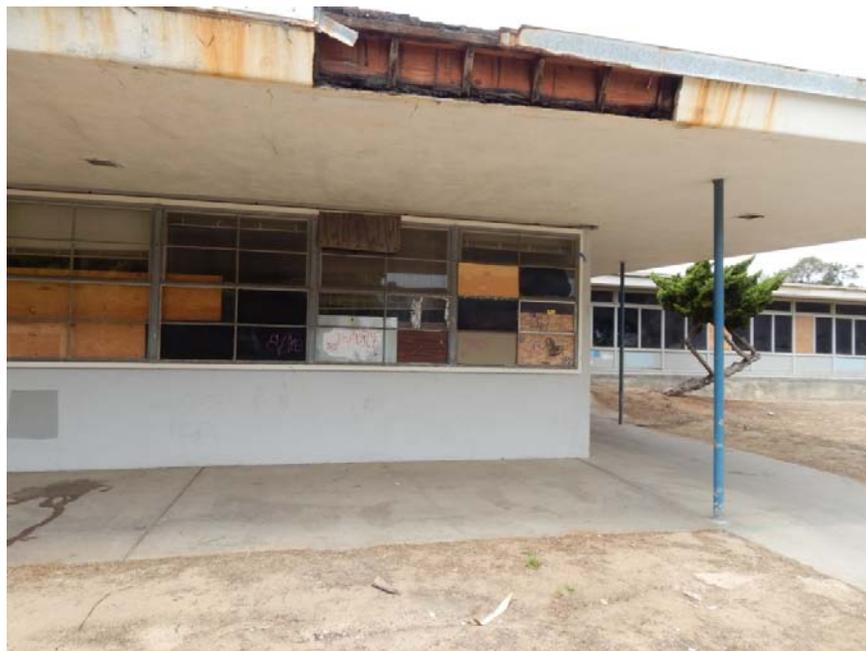
Deteriorating window frames, broken single glazing and rotting canopy structure

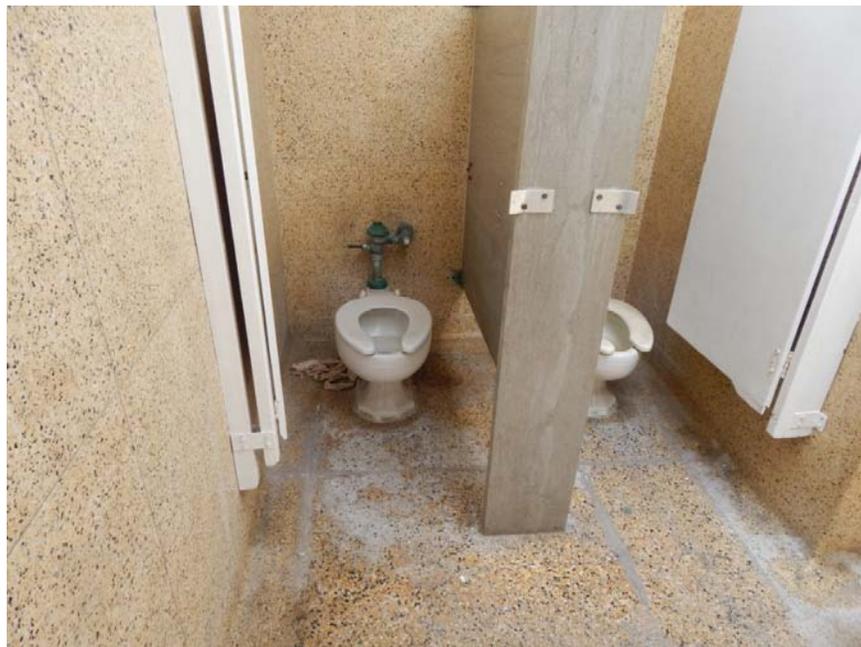
Missing ADA required clearances and accessories at toilet facilities

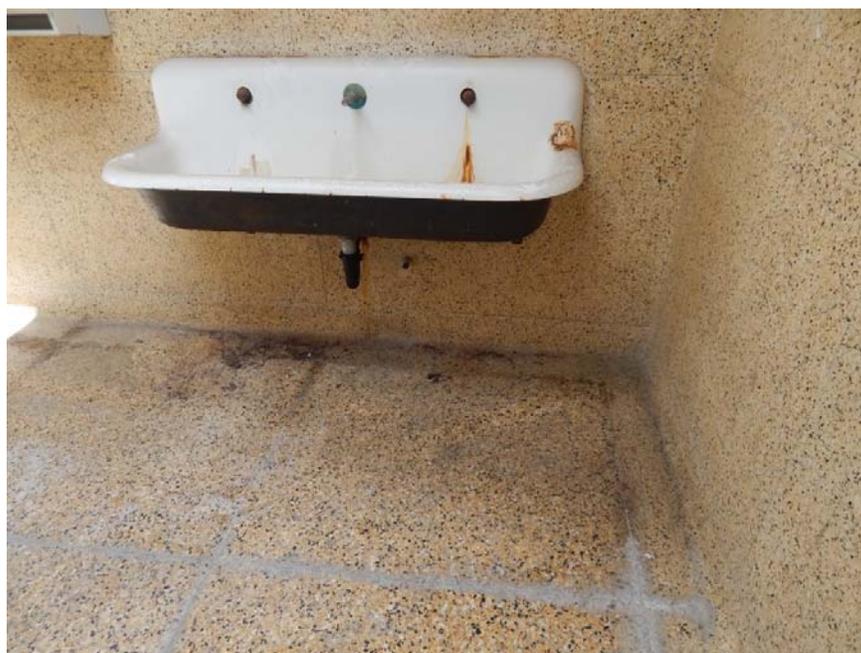
Insufficient ADA clearances and non-compliant faucets at sinks

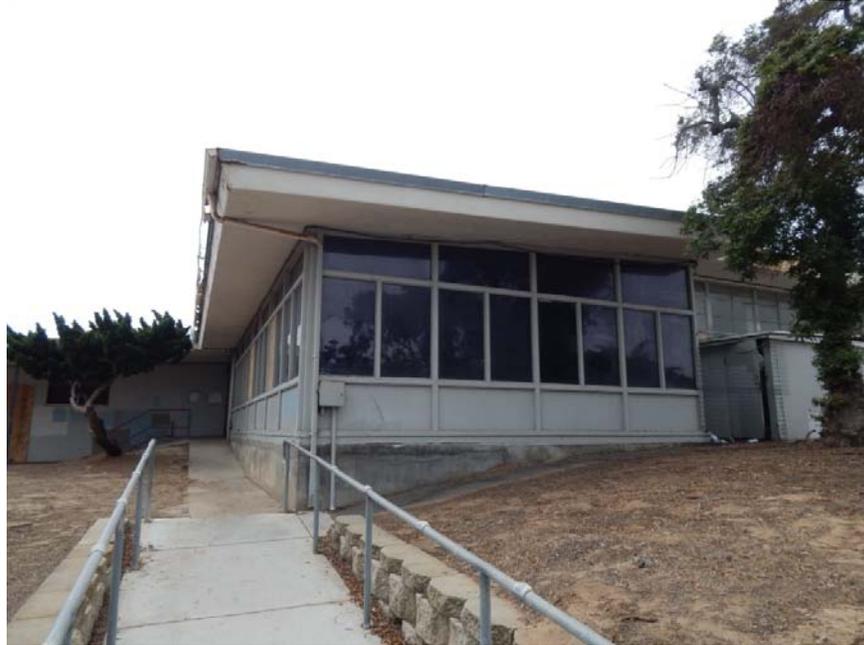
Ramp exceeds max. slope and lacks proper handrails per ADA

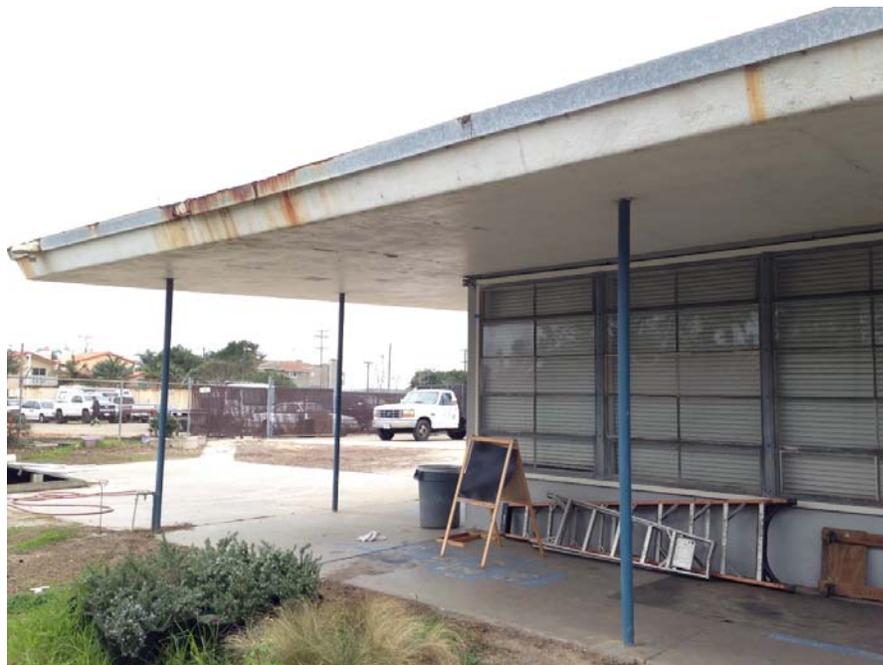
Figure 10. Typical water damage and corrosion observed at the canopies and overhangs.

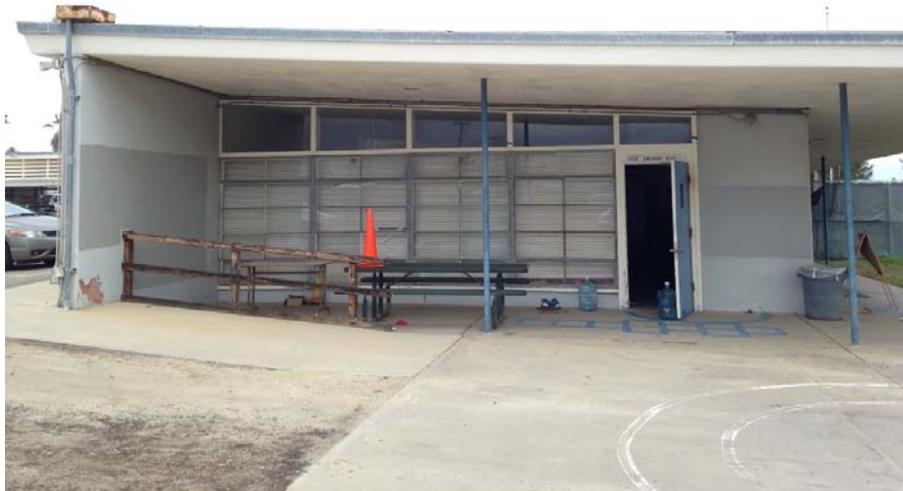
Figure 11. South wall of the East Building with 4'-10" shear wall segment potentially requiring retrofit.

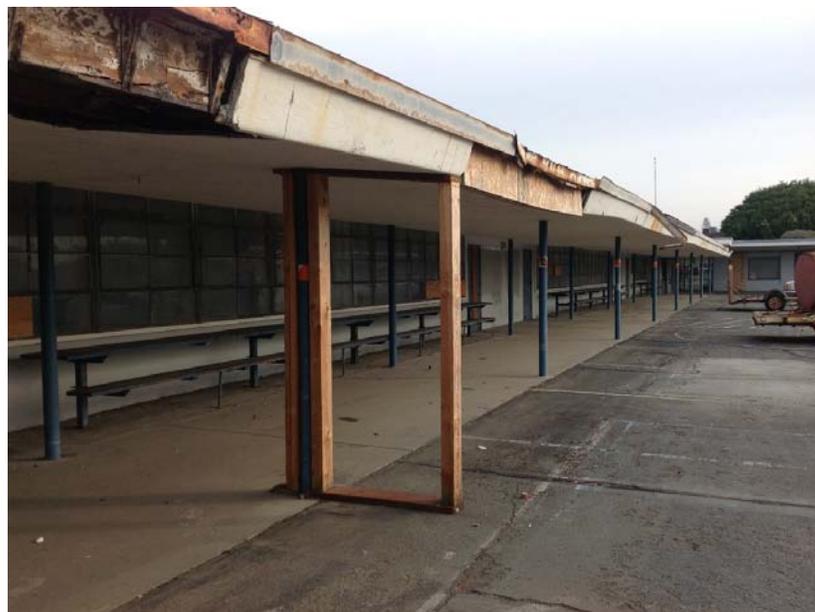
Figure 12. Condition of the exterior canopy at the North Building. Demolition is recommended.

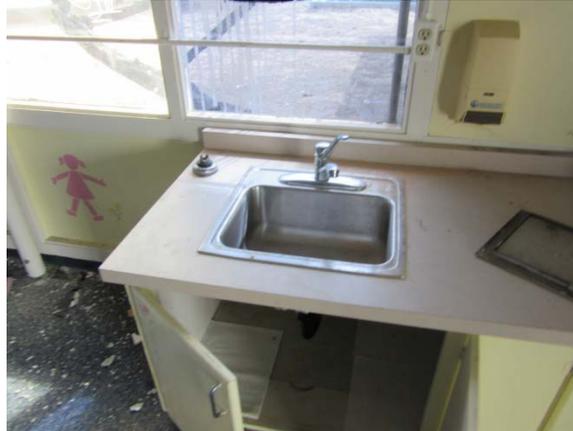
Sink in Classroom

Classroom - This room has a stainless steel sink with hot and cold water, and drain, waste and vent piping. The sink looks to be in relatively good condition (age estimated at 15 years or less). It is assumed the piping is from the original construction. The sink faucet was cycled with water coming from the hot and cold side. The water drained correctly from the sink bowl. See Existing Observations Floor Plan for Plumbing, Heating, and Ventilation for location of fixture (Keynote - Bubble 1).

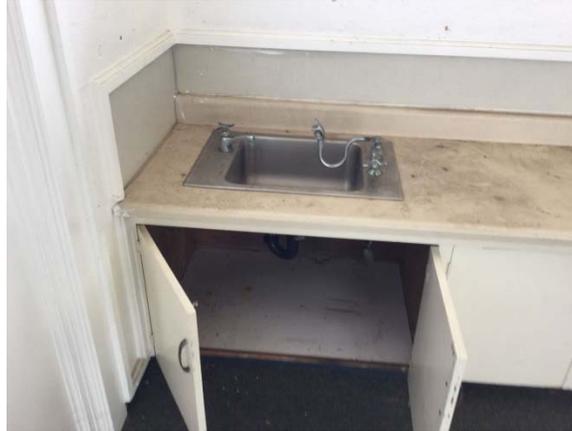
Sink with Drinking Fountain

Classroom 3 - This room has a stainless steel sink with drinking fountain, cold water, and drain, waste and vent piping. The sink looks to be in fair condition (age estimated at 25 years or more). It is assumed the piping is from the original construction. The drinking fountain looks to of similar age as the sink. The sink faucet and drinking fountain were not cycled. The integrity of the drain piping under the sink was suspect. See Existing Observations Floor Plan for Plumbing, Heating, and Ventilation for location of fixture (Keynote - Bubble 4).
