PACIFIC VIEW ELEMENTARY

Rehabilitation & Re-Use Study

August 10, 2015
90% Review Draft

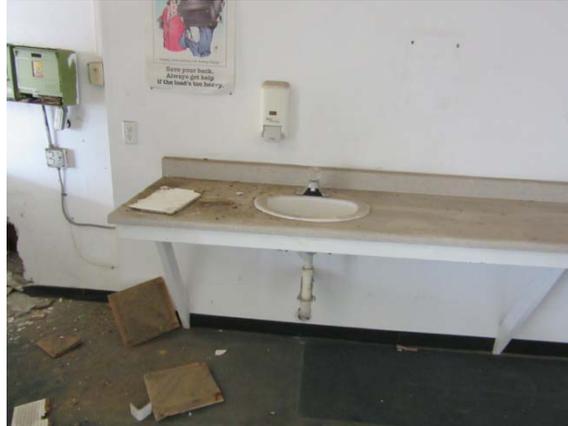
Typical Sink in Classroom Area (West End Keynote - Bubble 5)

Classroom 6 - This room is separated into a number of rooms. The front half is a classroom. The classroom has a sink at each end with hot and cold water piping, and drain, waste and vent piping. The sinks look to be in poor condition (age estimated at 25 years or more). It is assumed the piping is from the original construction. The sink faucets were cycled with water coming from the hot and cold side. The water drained correctly from the sink bowls. See Existing Observations Floor Plan for Plumbing, Heating, and Ventilation for location of fixtures (Keynote - Bubble 5 and 6).

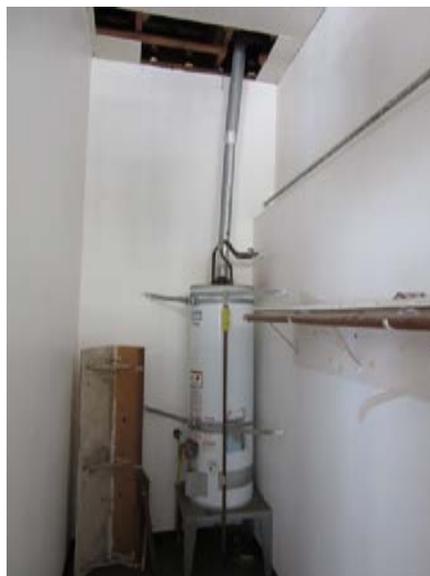
Hot Water Heater

Water Heater Room (In Classroom 6) - Another room in this space contains a natural gas fired hot water heater. The water heater has a 30 gallon capacity and was manufactured in March of 2004. The heater looks to be in good condition, but is nearing the end of its useful life. See Existing Observations Floor Plan for Plumbing, Heating, and Ventilation for location of the water heater (Keynote - Bubble 7).

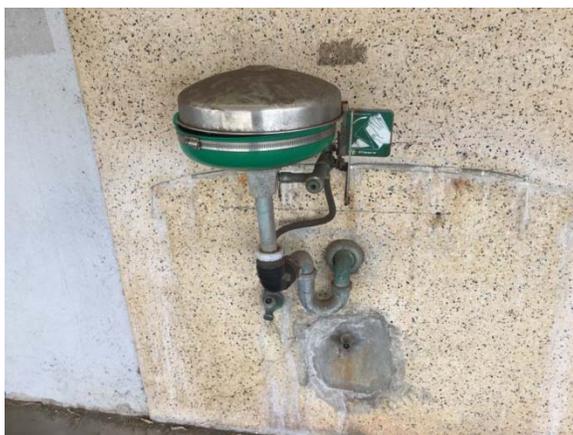
Emergency Eye Wash - An emergency eye wash is located outside Classroom 6. It looks to be in poor condition. It could not be cycled to determine water flow or proper drainage. See Existing Observations Floor Plan for Plumbing, Heating, and Ventilation for location of fixture (Keynote - Bubble 10).

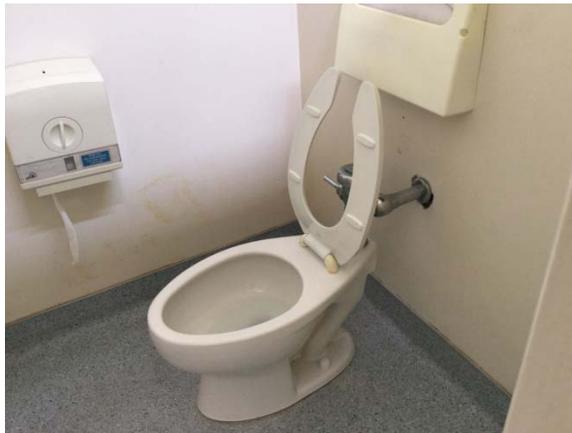
Water Closet

Women's Restroom Classroom 7 - This room contains a water closet. The water closet looks to be in fair condition (age at least 25 years old). It is assumed the piping is from the original construction. The water closet was flushed with water draining correctly from the water closet bowl. See Existing Observations Floor Plan for Plumbing, Heating, and Ventilation for location of fixture (Keynote - Bubble 14).

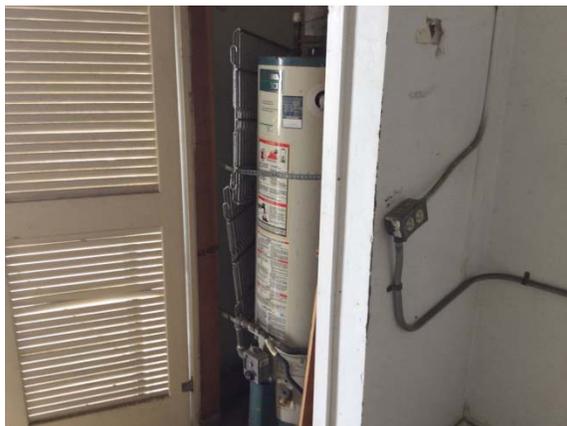
Water Heater Closet (Closet in STO/JAN Room) - The closet houses a natural gas fired 30 gallon hot water heater that provides hot water to this building. The heater was manufactured in 1991. This unit is well beyond its useful life. See Existing Observations Floor Plan for Plumbing, Heating, and Ventilation for location of fixture (Keynote - Bubble 15).

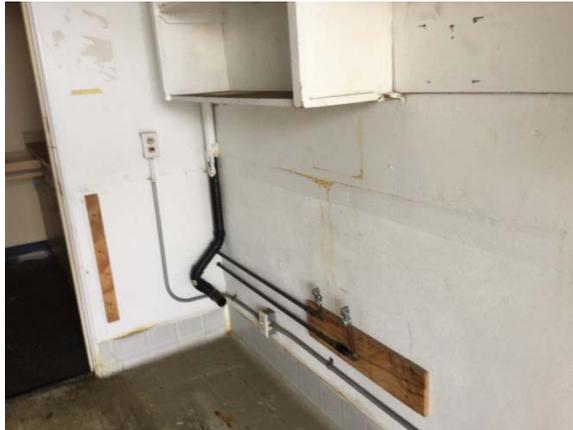
Removed Fixture

STO/JAN Room - At the south east corner of this room there are indications a plumbing fixture has been removed. Hot and cold water piping, vent piping, and waste piping have been capped off. It is assumed this piping is from the original construction. See Existing Observations Floor Plan for Plumbing, Heating, and Ventilation for location of fixture (Keynote-Bubble 16).

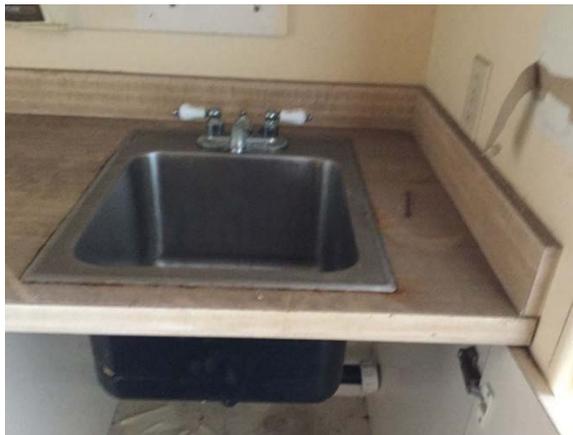
Sink

STO/JAN Room - This room has a kitchen sink and faucet. The sink and faucet look to be in fair condition (age estimated at 25 years or more). It is assumed the piping is from the original construction. The sink faucet was cycled with water coming from the hot and cold side. The water drained correctly from the sink bowl. See Existing Observations Floor Plan for Plumbing, Heating, and Ventilation for location of fixture (Keynote - Bubble 17).

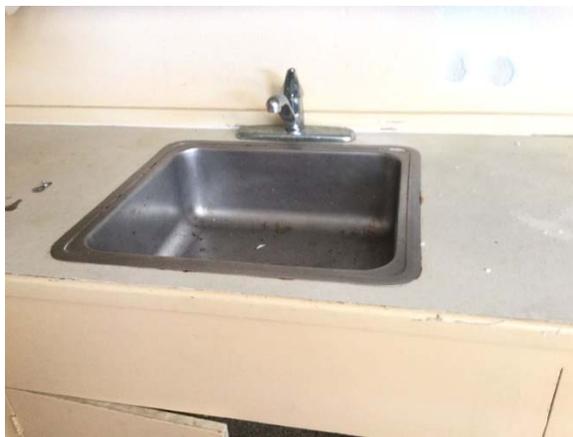
Sink

Office - (South of Office at Northeast Corner of the Building) - This room has a kitchen sink and faucet. The sink and faucet look to be in poor condition (age estimated at 30 years or more). It is assumed the piping is from the original construction. The sink faucet was cycled with water coming from the hot and cold side. The water drained correctly from the sink bowl. See Existing Observations Floor Plan for Plumbing, Heating, and Ventilation for location of fixture (Keynote - Bubble 18).

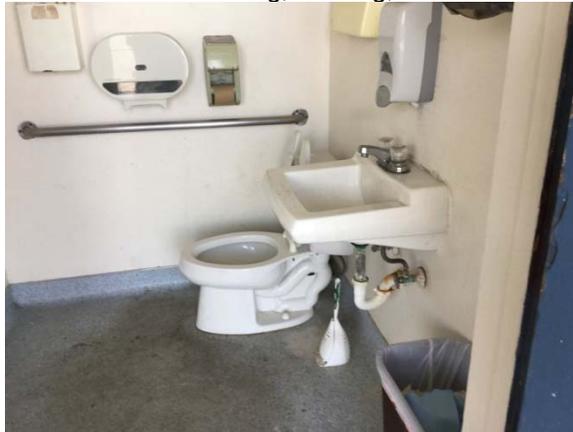
Faculty Restroom Water Closet and Lavatory Sink

Faculty Restroom - The restroom contains a flush tank water closet and wall mounted lavatory sink, hot and cold water piping, and drain, waste and vent piping. The sink and water closet look to be in poor condition (age estimated at 35 years or more). It is assumed the piping is from the original construction. The sink faucet was cycled with water coming from the hot and cold side. The water drained correctly from the sink bowl. The water closet was flushed with water draining correctly from the water closet bowl. See Existing Observations Floor Plan for Plumbing, Heating, and Ventilation for location of fixture (Keynote - Bubble 20).

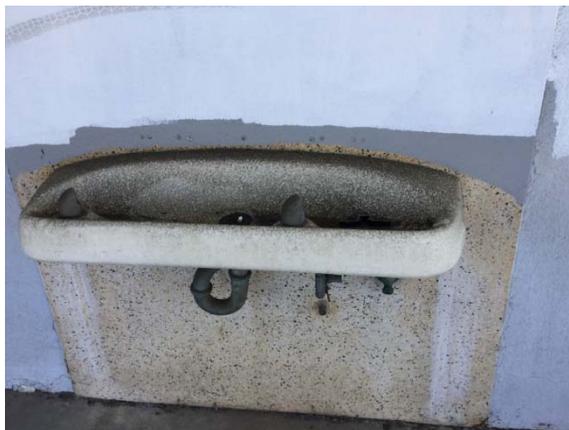
Typical Drinking Fountain

Drinking Fountains - There is a drinking fountain located on the east and west side of the building. They are both in very poor condition (original construction). Both units were not operational. See Existing Observations Floor Plan for Plumbing, Heating, and Ventilation for location of fixture (Keynote - Bubble 23).

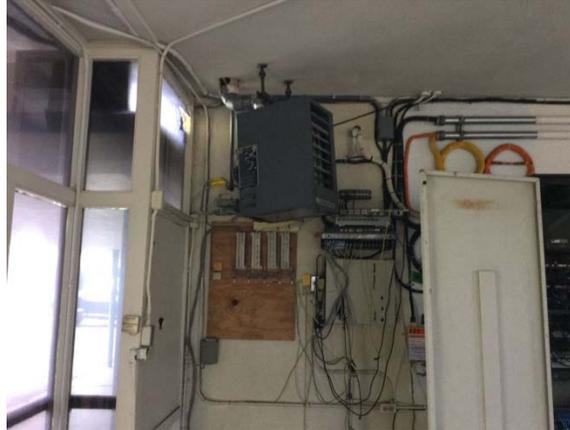
Classroom Unit Heater

Classroom (East end of building) - This room has a ceiling hung natural gas fired 45,000 btu/hr unit heater. The heater was manufactured in 1988. The unit was not cycled to determine operability. At 27 years old the unit is beyond it useful life. See Existing Observations Floor Plan for Plumbing, Heating, and Ventilation for location of heating unit (Keynote - Square 1).

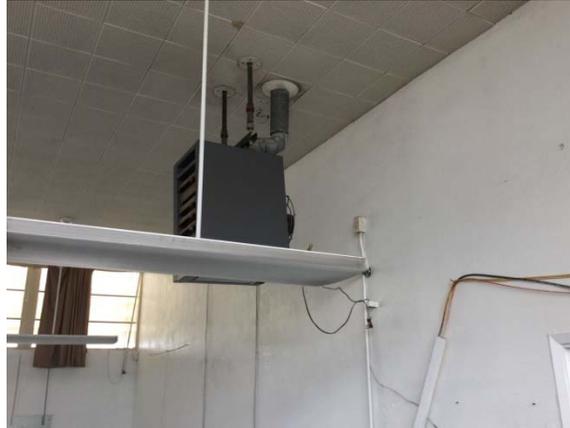
Classroom 1 Unit Heater

Classroom 1 (Including Offices 3 & 4) - This room has a ceiling hung natural gas fired unit heater estimated (nameplate not visible) at 45,000 btu/hr (similar size as unit heater in previous classroom). It is assumed this heater is the same vintage as the previous classroom, which was manufactured in 1988. The unit was not cycled to determine operability. At 27 years old the unit is beyond it useful life. See Existing Observations Floor Plan for Plumbing, Heating, and Ventilation for location of heating unit (Keynote - Square 2).

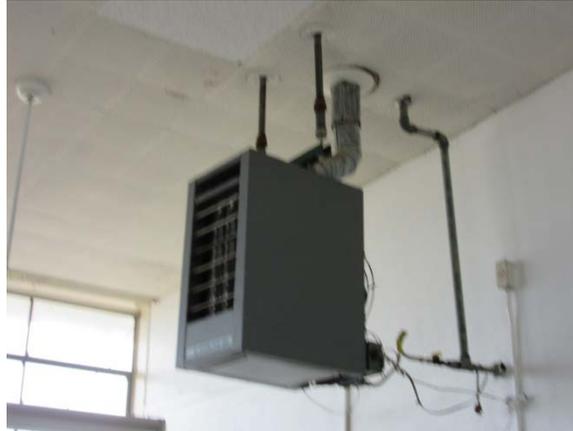
Unit Heater Classroom 2

Classroom 2(Including Offices 1 & 2) - This room has a ceiling hung natural gas fired 45,000 btu/hr unit heater. The heater was manufactured in 1989. The unit was not cycled to determine operability. At 26 years old the unit is beyond it useful life. See Existing Observations Floor Plan for Plumbing, Heating, and Ventilation for location of heating unit (Keynote - Square 3).

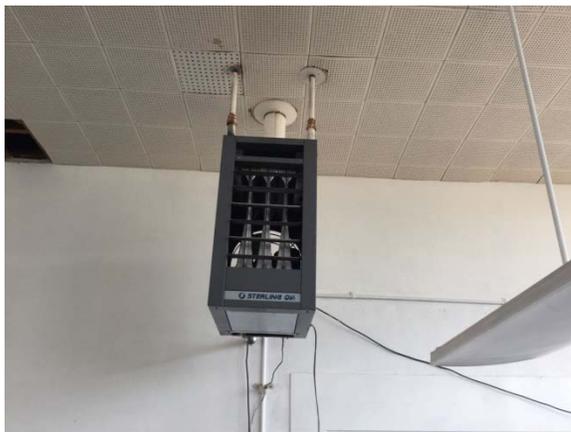
Classroom 3 Unit Heater

Classroom 3 - This room has a ceiling hung natural gas fired 45,000 btu/hr unit heater. The heater was manufactured in 1989. The unit was not cycled to determine operability. At 26 years old the unit is beyond it useful life. See Existing Observations Floor Plan for Plumbing, Heating, and Ventilation for location of heating unit (Keynote - Square 4).

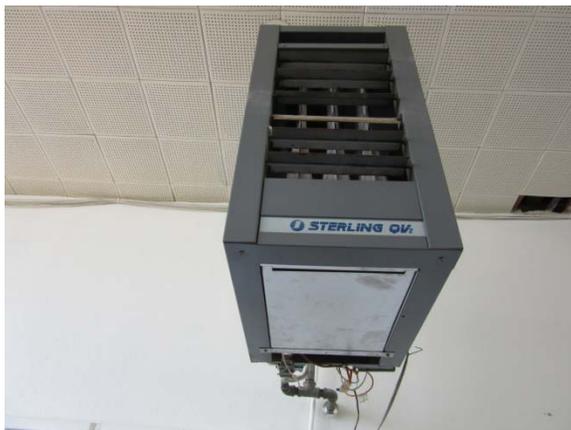
Classroom 4 Unit Heater

Classroom 4 - This room has a ceiling hung natural gas fired 36,450 btu/hr unit heater. The heater was manufactured in 1989. The unit was not cycled to determine operability. At 26 years old the unit is beyond it useful life. See Existing Observations Floor Plan for Plumbing, Heating, and Ventilation for location of heating unit (Keynote - Square 5).

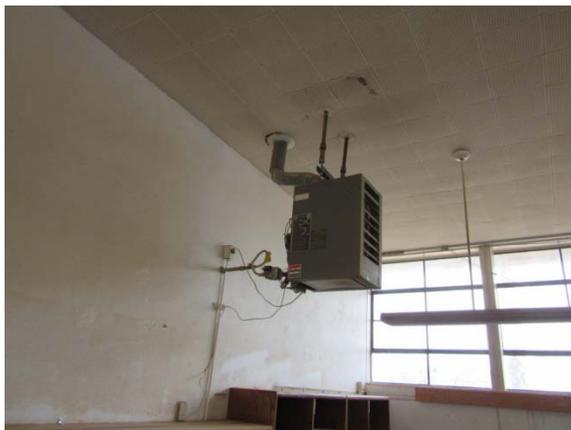
Unit Heater Classroom 5

Classroom 5 - This room has a ceiling hung natural gas fired 45,000 btu/hr unit heater. The heater was manufactured in 1989. The unit was not cycled to determine operability. At 26 years old the unit is beyond it useful life. See Existing Observations Floor Plan for Plumbing, Heating, and Ventilation for location of heating unit (Keynote - Square 6).

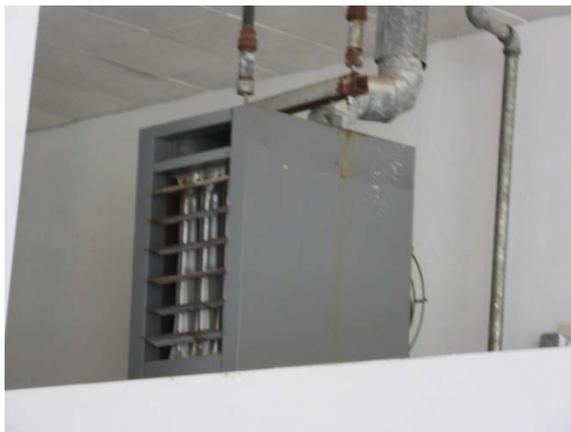
Unit Heater above Water Heater Closet in Classroom 6

Classroom 6 - This room is separated into a number of rooms. The classroom has a ceiling hung (over the water heater closet) natural gas fired unit heater estimated (nameplate not visible) at 45,000 btu/hr (similar size as unit heater in Classroom 1). It is assumed this heater is the same vintage as that unit, which was manufactured in 1988. The unit was not cycled to determine operability. At 27 years old the unit is beyond it useful life. See Existing Observations Floor Plan for Plumbing, Heating, and Ventilation for location of heating unit (Keynote - Square 7).

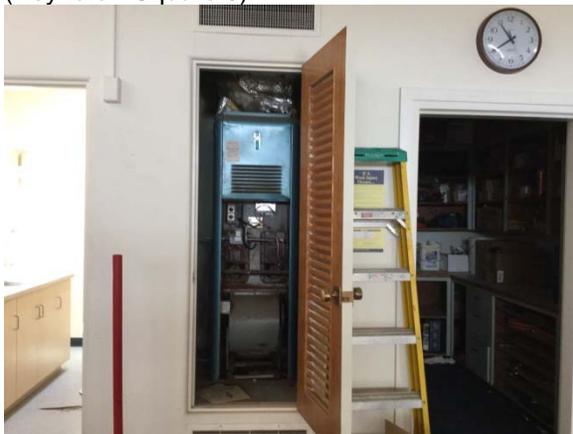
Classroom 7 Forced Air Furnace

Classroom 7 - This room is separated into a number of rooms. The south end was a classroom. It is presently used by the Encinitas Union School District maintenance department. The classroom is heated by a natural gas fired forced air furnace (84,000 btu/hr). The supply exhaust is located above the unit and the return intake is located below the unit. The unit looks very old. The serial number does not coincide with units from 1972 to the present, it is well beyond its useful life. The unit was not cycled to determine its operability. See Existing Observations Floor Plan for Plumbing, Heating, and Ventilation for location of heating unit (Keynote - Square 8).

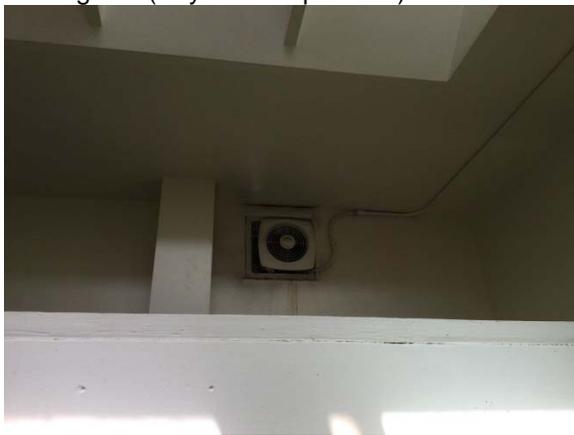
Exhaust Fan above Men's and Women's Restroom

Men's Restroom Classroom 7 Staff Area - There is an exhaust fan located above the Men's and Women's restroom. This unit provides ventilation for the Men's and Women's staff restroom. Nameplate date on the unit was not visible. Age is estimated to be 30 years or more. See Existing Observations Floor Plan for Plumbing, Heating, and Ventilation for location of heating unit (Keynote - Square 10).

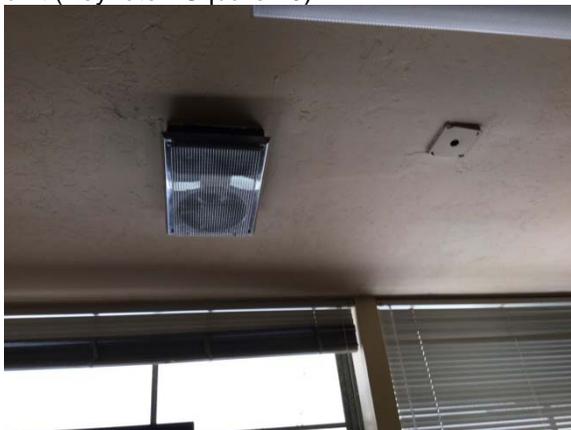
Electric Heater

Office Northeast Corner of Building - This area has a ceiling mounted electric heater with wall mounted control switch. Age (looks more than 20 years old) and capacity unknown. See Existing Observations Floor Plan for Plumbing, Heating, and Ventilation for location of heating unit (Keynote - Square 13).

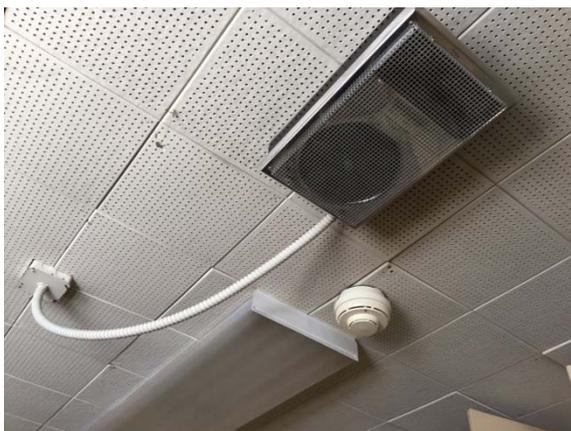
Electric Heater

Staff - Area South of Office at Northeast Corner of the Building - This area has a ceiling mounted electric heater with wall mounted control switch. Age (looks more than 20 years old) and capacity unknown. See Existing Observations Floor Plan for Plumbing, Heating, and Ventilation for location of heating unit (Keynote - Square 14).

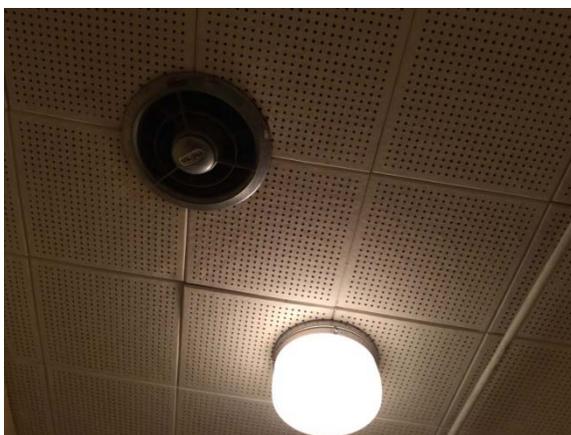
Exhaust Fan

Private Restroom South of Area South of Office at Northeast Corner of the Building - The restroom contains an exhaust fan mounted in the ceiling. Age (looks more than 20 years old) and capacity unknown. It is assumed exhaust exits above the roof. See Existing Observations Floor Plan for Plumbing, Heating, and Ventilation for location of heating unit (Keynote - Square 15).

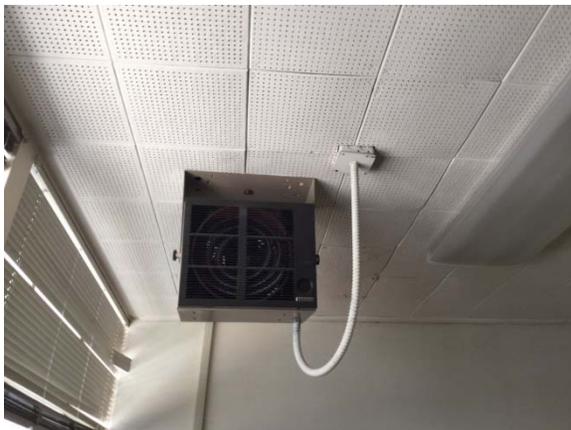
Electric Unit Heater

Office South of Private Restroom Above - This office has a ceiling mounted electric unit heater. Age (looks more than 20 years old) and capacity unknown. See Existing Observations Floor Plan for Plumbing, Heating, and Ventilation for location of heating unit (Keynote - Square 16).

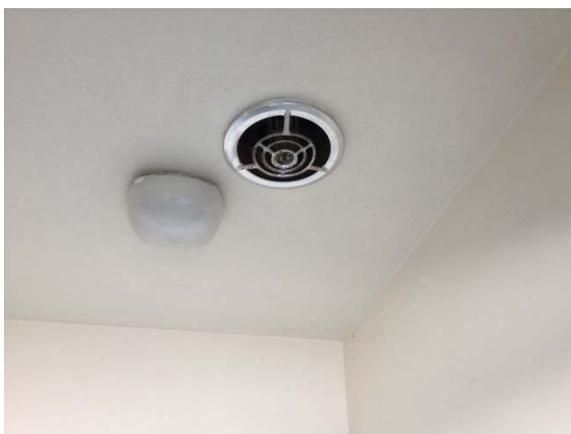
Exhaust Fan

Faculty Restroom - The restroom contains an exhaust fan mounted in the ceiling. Age (looks more than 20 years old) and capacity unknown. It is assumed exhaust exits above the roof. See Existing Observations Floor Plan for Plumbing, Heating, and Ventilation for location of heating unit (Keynote - Square 17).

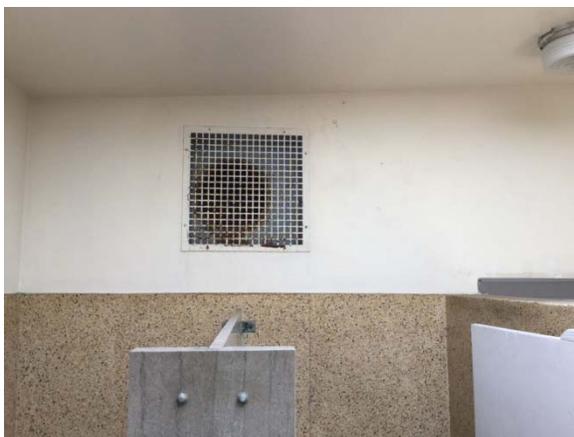
Boy's Restroom Exhaust Grille

Boy's Restroom - The restroom does not have a heating source. The room is exhausted from a grille located in the south wall above the water closets and urinals. The grille is connected to a duct that goes to the roof. It is assumed the duct is connected to an exhaust fan on the roof. Roof access was not available. Based on the condition of the grille and duct visible behind the grille the exhaust fan is probably 30 or more years old. See Existing Observations Floor Plan for Plumbing, Heating, and Ventilation for location of heating unit (Keynote - Square 18).

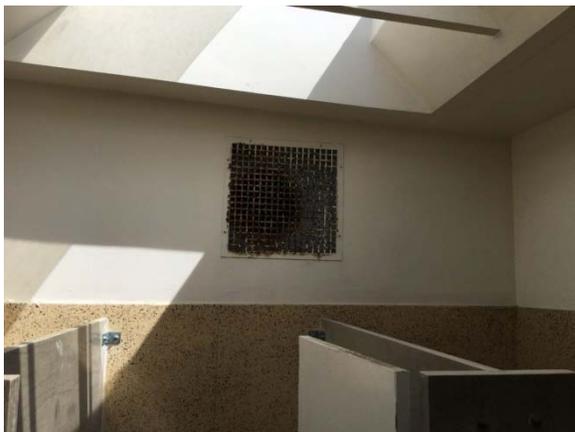
Girl's Restroom Exhaust Grille

Girl's Restroom - The restroom does not have a heating source. The room is exhausted from a grille located in the south wall above the water closets and urinals. The grille is connected to a duct that goes to the roof. It is assume the duct is connected to an exhaust fan on the roof. Roof access was not available. Based on the condition of the grille and duct visible behind the grille the exhaust fan is probably 30 or more years old. See Existing Observations Floor Plan for Plumbing, Heating, and Ventilation for location of heating unit (Keynote - Square 19).
