# City of Encinitas

## Assessment of Torrey Pine Tree

### Near 1206 Summit Avenue

### Asset I.D. # 13164 ETREE

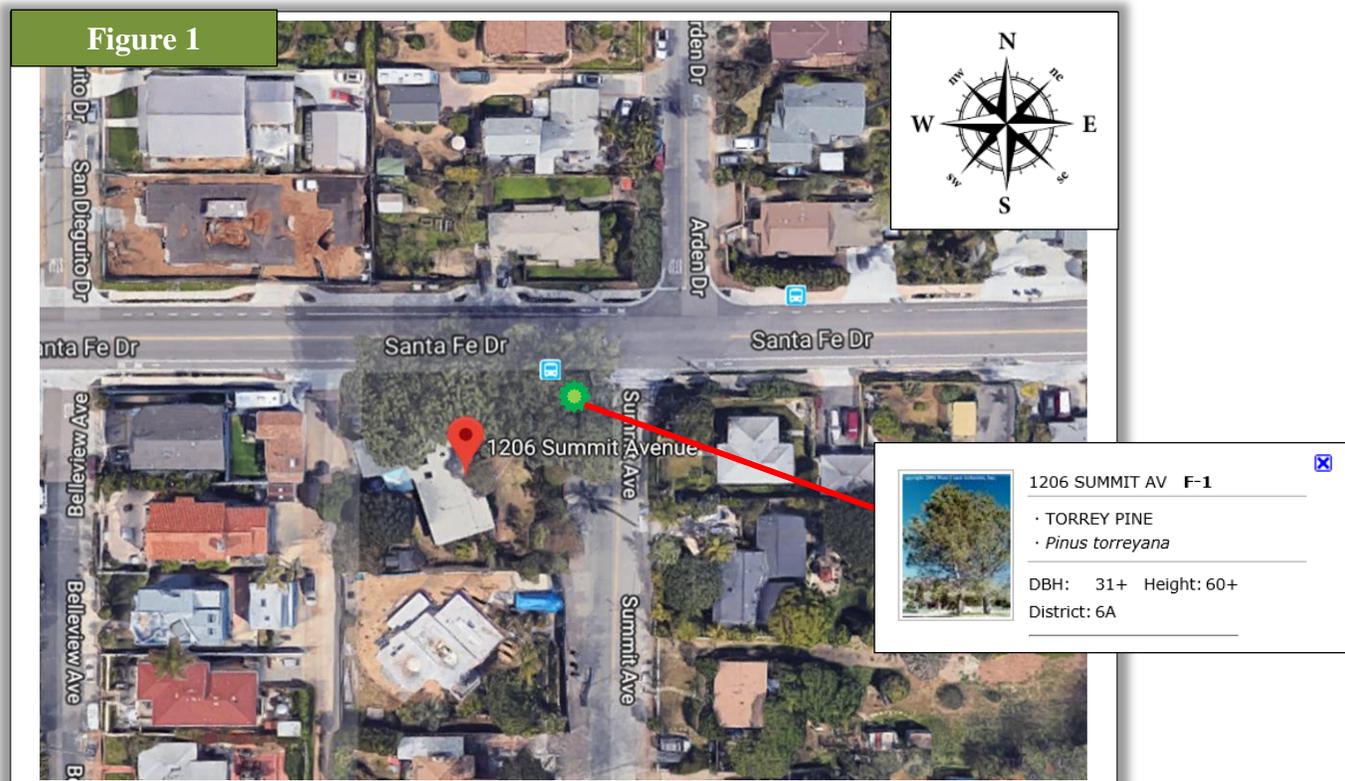
In June of 2019, West Coast Arborists, Inc., (WCA) was contacted by the City of Encinitas in regard to the assessment of a torrey pine (*Pinus torreyana*) tree located on the north-east corner of 1206 Summit Avenue. In ArborAccess (WCA’s tree inventory database), the tree is inventoried as 1206 SUMMIT AV F-1 (see Figure 1 below).

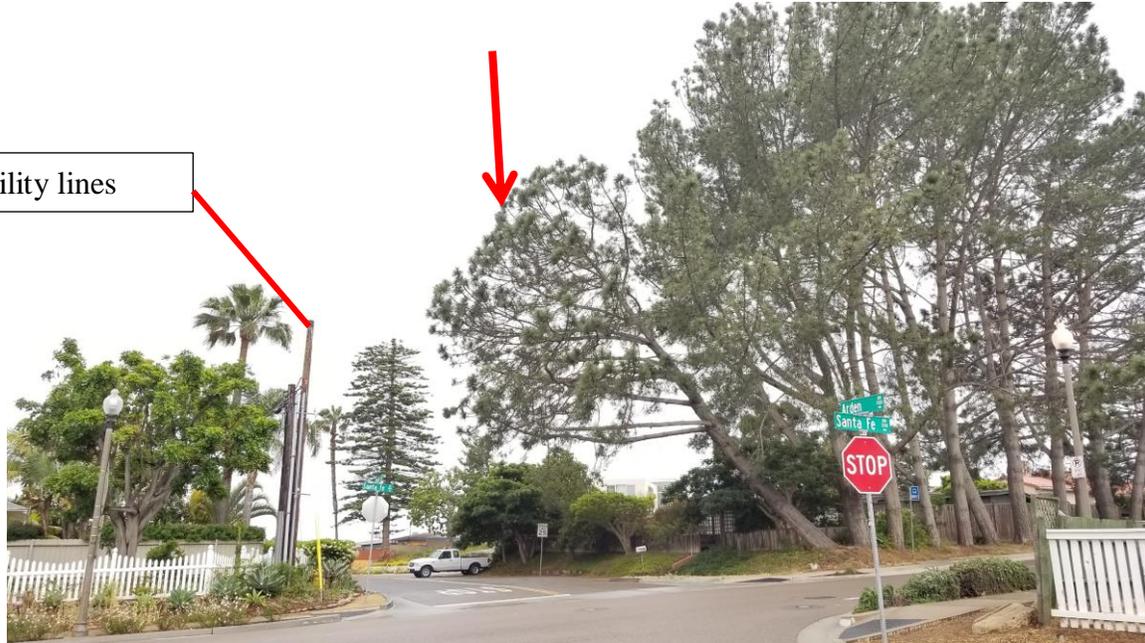
Photo #1

- The tree (red arrow) was located on the north-east side of 1206 Summit Avenue within a monolithic style planting area within the City’s ROW. There were several other mature torrey pine trees on the west side of the tree.
- The tree had a DSH<sup>1</sup> measurement of 31 inches and a height of about 75 feet.
- Judging by the color and density of the foliage, the tree was in fair- good health for the species and time of year.
- The tree had an approximate 45-degree lean/ canopy imbalance towards the east over Summit Avenue. There were very little branches/ foliar growth opposite to the tree’s lean (west side). According to an established resident, this lean has been there for as long as they recall (decades).
- There were some utility lines approximately 65 feet to the east of the tree.

**Pruning/ Monitoring for Preservation** – With the use of a laser, the tree was measured as having a height of 75 feet, and a distance of 65 feet from the utility lines (main target of concern). If tree preservation is desired, WCA recommends performing and maintaining a canopy reduction of at least 11 feet with the use of **reduction pruning** techniques. This will reduce the overall risk from moderate to low by eliminating the utility line’s potential for impact and reducing the likelihood of failure from possible to improbable.

**Removal** – A primary goal in assessing and managing the urban forest is to strike a balance between the risk that a tree poses, and the benefits that individuals and communities derive from trees. All trees have a limited life span which is often shortened due to numerous stresses in an urban environment. Removal of the tree should be considered if the City/ community does not view the tree’s benefits as outweighing the fiscal and logistical burdens associated with preservation. This decision would completely eliminate the associated risks and allow space for the adjacent tree to grow.

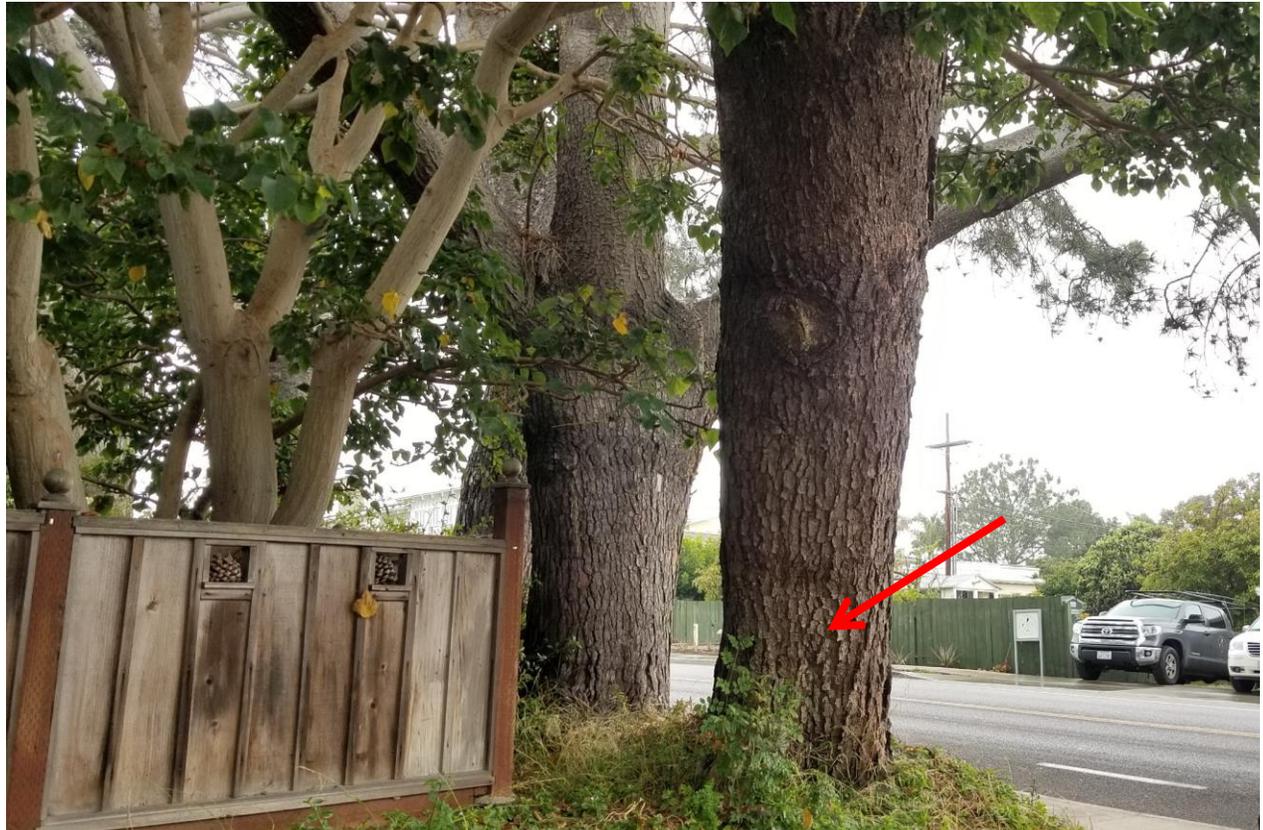
Photo #2

The tree's lean appeared to be an ordinary **trophic response** to its surroundings and it has not failed in recent storm/ wind events; however, there remained several conditions of concern including: an approximate 45-degree lean, a history of sidewalk repairs/ possible root pruning on the tension side of the lean, minimal growth in response to the lean, a buried root collar, and signs of possible basal decay. Considering these defects, the tree was assessed as having a *possible* basal/ root failure within the next two years. This failure would most likely occur towards the south-east in the direction of the lean.

- The tree's trunk (red arrow) showed minimal signs of growth in response to the tree's lean/loading. Notice how it tapers in towards the base of the tree.

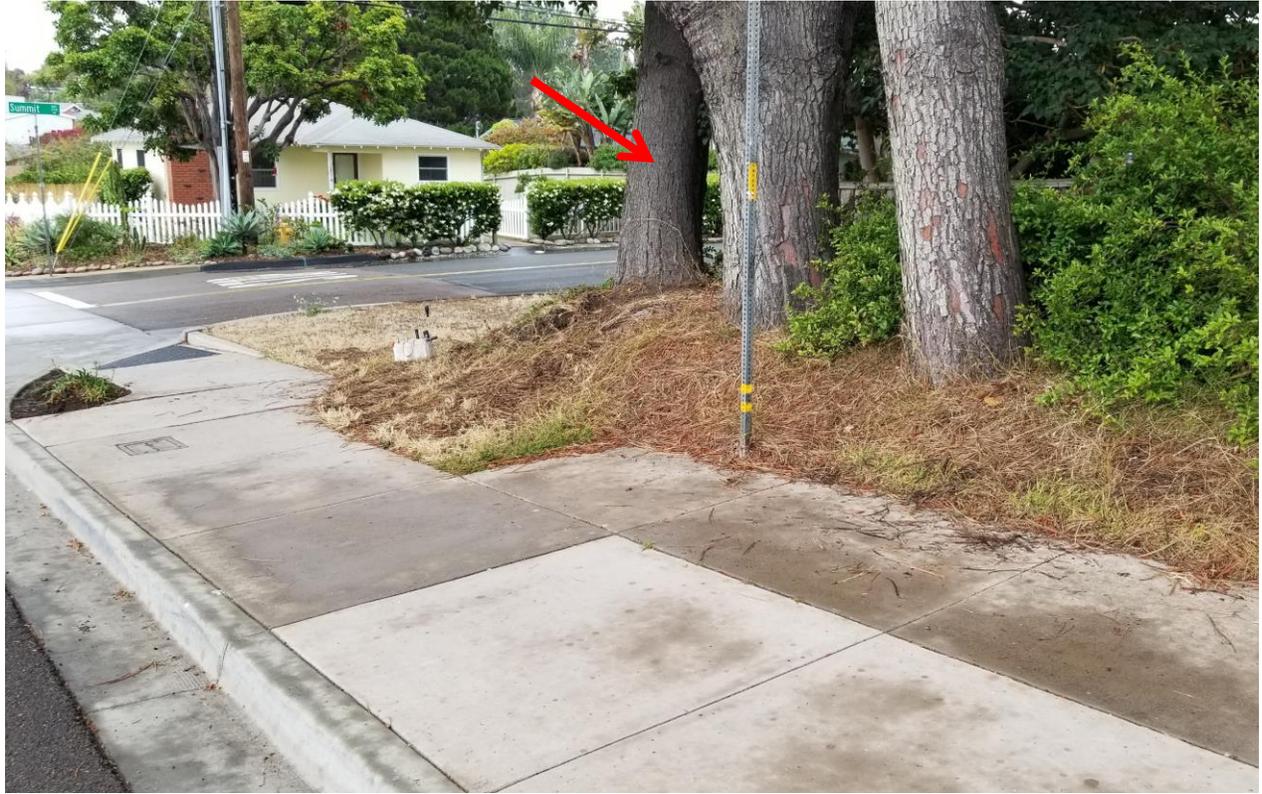
Photo #3

- The sidewalk adjacent to the tree (red arrow) had a lighter tone indicating it was replaced in the relatively recent past. The closest measured section of sidewalk was 104 inches from the tree's trunk.

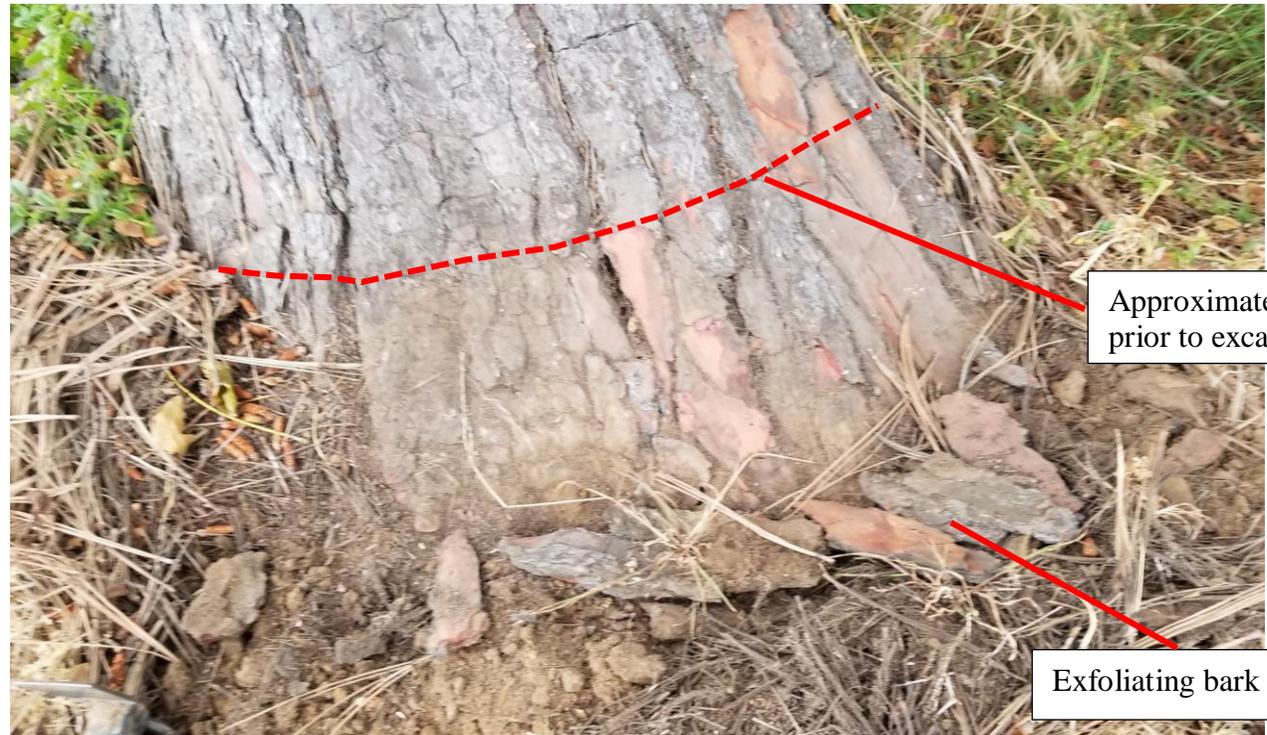
Photo #4

- Sounding the base of the tree's trunk with a nylon mallet gave indications of a possible basal decay on the north-west side of the tree. Some loose bark on the trunk may have influenced the resonating sound.
- The tree's root collar was not visible, a light root collar excavation was not deep enough to expose it.

If a more in-depth analysis of the tree’s root/ trunk structure is desired, WCA can perform a **Level 3 Advanced Assessment** using air spading or tomography equipment upon the City’s request. If monitoring of the lean is desired, a survey nail can be installed on the underside of the tree’s lean to periodically measure with an electronic distance meter (EMD) or a simple plumb bob.
