Street Tree Removal

Monterey Cypress – 465 Neptune

Street Tree Removal Evaluation

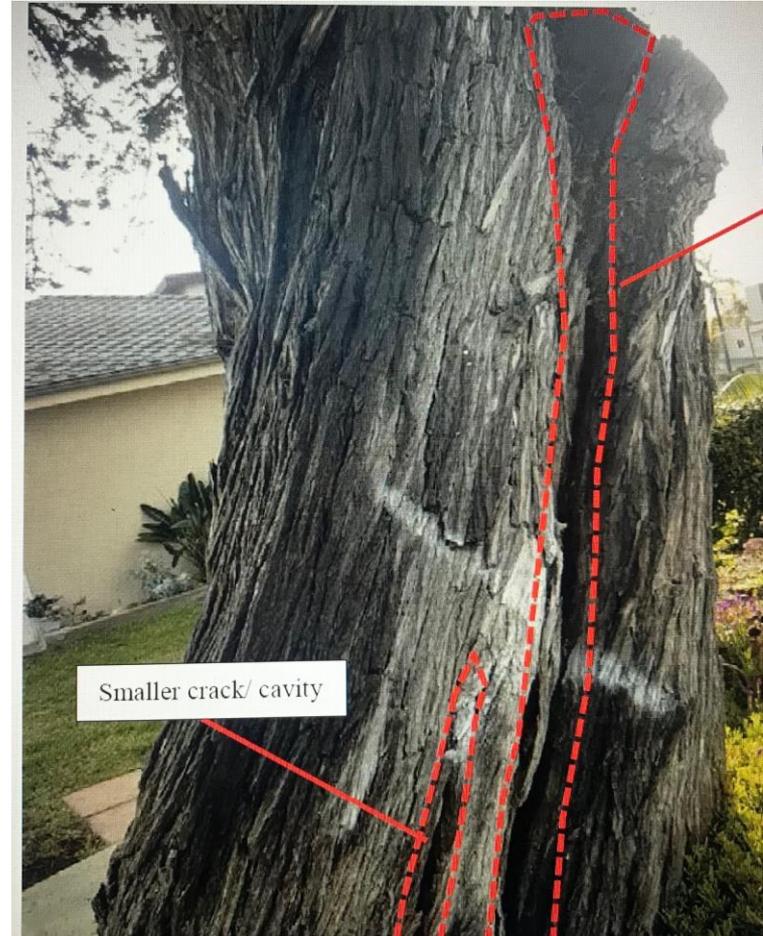
Street Tree Removal Evaluation

6. Due to concerns related to the structural integrity of the tree, the City arborist performed a LV3 evaluation using Sonic Tomography.
7. Tree was found to have high levels of internal damaged and/or decay, and presented a imminent risk to the community and adjacent homeowner.
8. UFAC was notified of the pending removal.
9. Tree was removed.

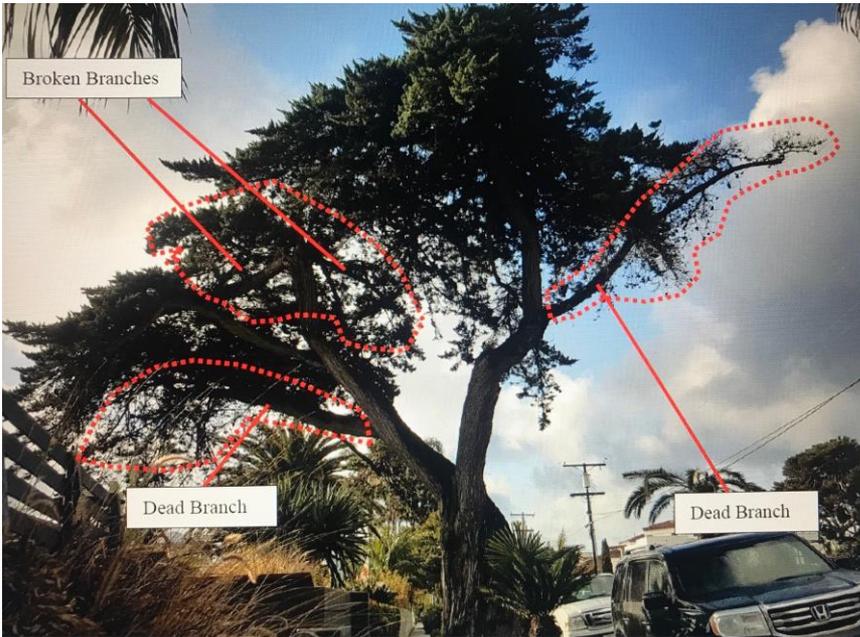
Initial Evaluation

1. Tree was found to be in fair to good health, with the exception of two dead branches.
2. Signs of structural decline
 - a) Two 1- to 3- inch wide cracks that extend at least 1- foot into the tree
 - b) Presence of basal decay
 - c) Termite damage
 - d) When sounded with a mallet the tree has a deep hollow resonating sound
3. Due to the observed defects the tree was considered a risk to the community and adjacent home. Tree was recommended for removal.
4. Request that WCA to verify the findings.

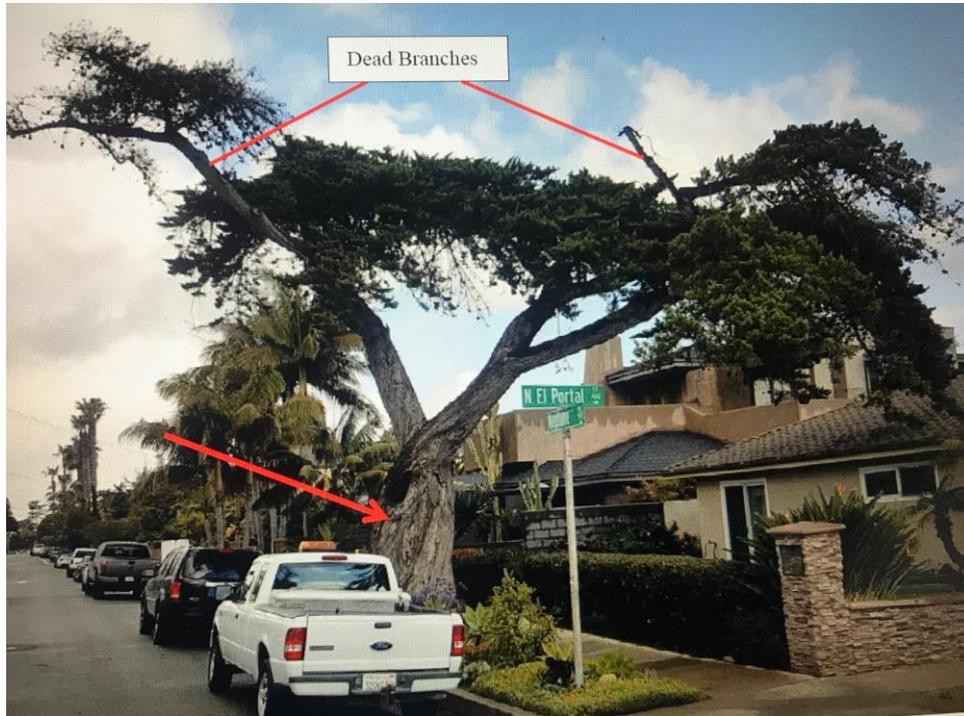
WCA Evaluation

1. WCA performed a LV-3 risk assessment using a Resistograph.
2. During the evaluation WCA found the following:
 - a) Tree has co-dominant stems a unbalanced canopy.
 - b) Two branch failures.
 - c) Old wounds with termite damage
 - d) Dull hollow sound when sounded.
 - e) Two cracks/cavities running vertically along the west side of the tree.
 - f) High level of interspersed decay with the trunk.

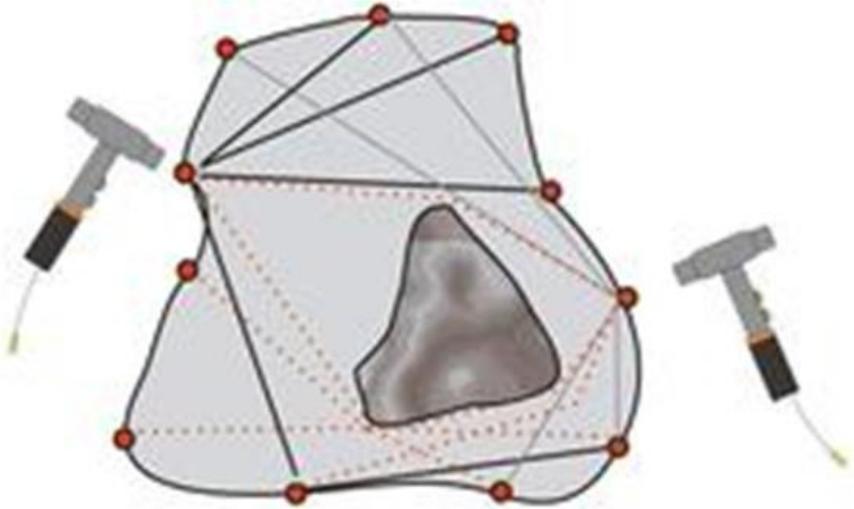
LV3 – City Evaluation

1. Conducted a structural analysis of the tree's trunk with the use of sonic tomography.
2. Sonic tomography detects decay, cavities, and fractures in trees by accurately measuring the velocity of sound waves as they pass through wood.
3. Differences in velocity help determine areas of healthy wood and areas of damaged wood, which has less elasticity and density than healthy wood

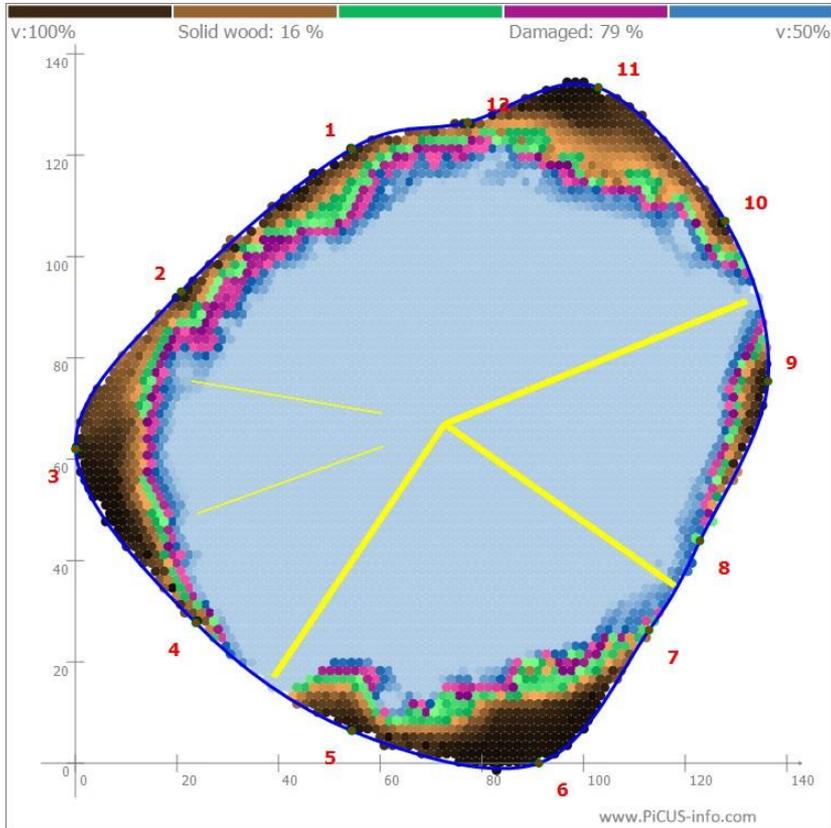
LV3 – City Evaluation

4. The tomogram shows the relative and apparent ability of the wood to transmit acoustic waves.
 5. Provides an output and visual representation that displays different colors based on properties.
- Dark Browns – Areas of healthy wood, where the fastest velocities occur.
 - Green – Varies, but describes the distance between healthy and damaged wood, and can be indicative of early fungus infection.
 - Violets and Blues – Damaged wood.
 - Yellow Lines – Cracks
