City of Encinitas

Level 3 Assessment of Blue Gum Tree

Near 1009 2nd Street
Asset I.D. # 5919TREE

OCTOBER 10, 2018

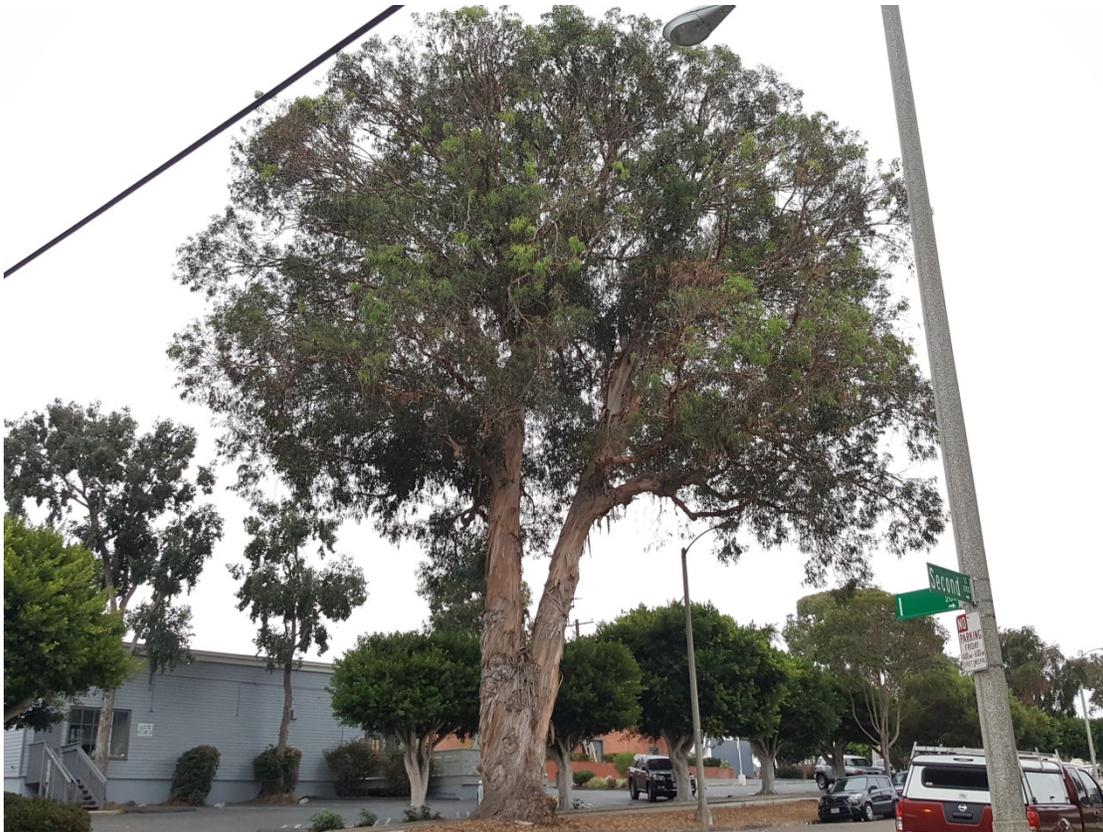
Photo #1

- The tree's canopy structure was poor; the tree had a slight lean towards the south, and the canopy was built on two large codominant stems with a bark inclusion between them. The tree's **live crown ratio (LCR)** was about 50%.

- The tree was located on the west side of 1009 2nd Street within a parkway.
- The tree had a DSH¹ measurement of 64 inches and a height of about 100 feet.
- Judging by the color and density of the foliage, the tree was in fair health for the species and time of year. There was some branch dieback and signs of basal decay (old conks/mycelium)
- The tree's canopy structure was poor; the tree had a slight lean towards the south, and the canopy was built on two large codominant stems with a bark inclusion between them. The tree's live crown ratio (LCR) was about 50%.

Removal – I recommend removing the tree because of its poor structure, the high risk it is presenting, and the present fungal disease that will continue to deteriorate the tree’s health and structure. This decision would completely eliminate the associated risks, and make space for a new tree(s) to help maintain a healthy and diverse urban forest.

Mitigation Pruning/ Monitoring – If preservation is essential, I recommend performing a crown reduction of approximately 30 percent (roughly 30 feet), with a concentration on the south side of the tree to improve canopy balance. This crown reduction will lessen the mechanical forces applied on the tree’s defects of concern and should reduce the risk level to an overall low. I also recommend having the cable support system inspected during the pruning and replaced if necessary.

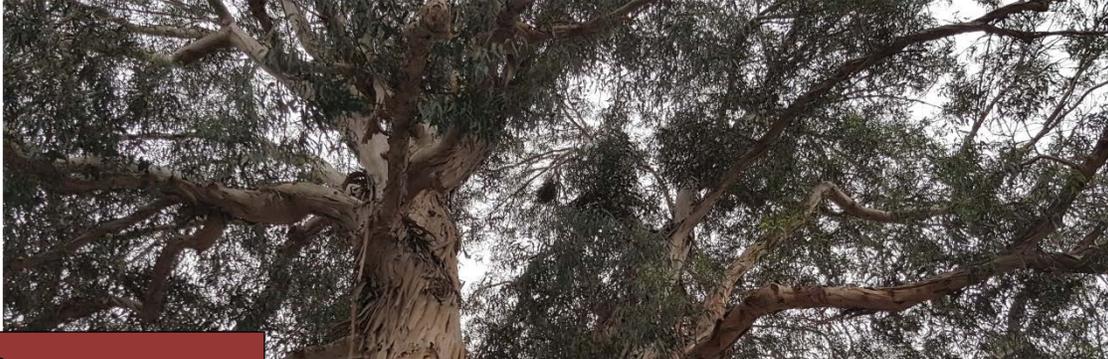
Photo #2

- There was a metal cable installed between the two codominant stems with included bark at about 45 feet above grade.

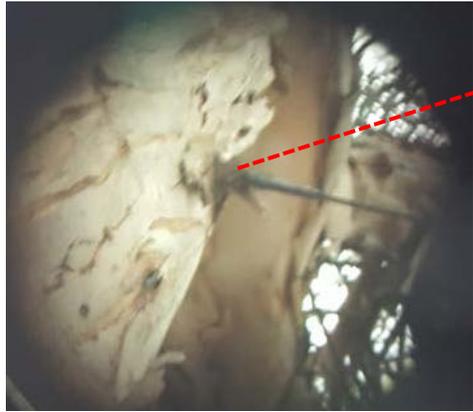
Close-up of cable

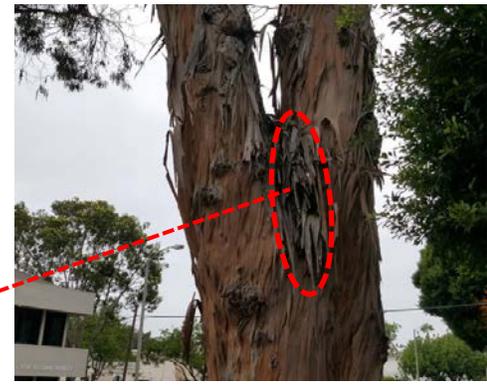
Close-up of bark inclusion

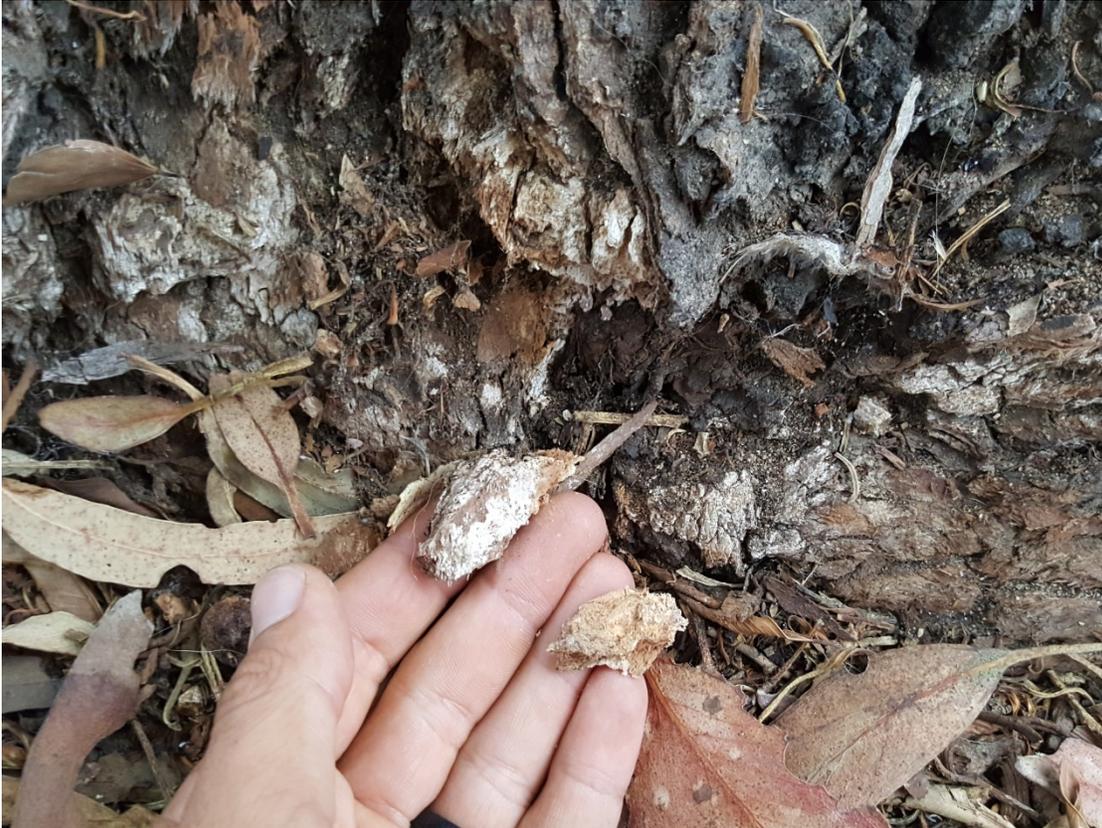
Photo #3

After completing the advanced trunk assessment, the defect of greatest concern was the indication of asymmetrical basal decay that likely extended further down into the structurally important roots. This decay can significantly compromise the strength and elasticity of the wood which can lead to failures; especially when you add other factors and loads such as: an unknown history of root pruning/ damages from hardscape repairs, the tree's slight lean opposite to areas with more concentrated decay, seasonal Santa Ana winds, and the tree's large and dense canopy for wind forces to act upon. The *likelihood of failure* because of basal/ root decay was assessed as **probable** within the next 2 years if no mitigation is taken.

- Sounding wood for signs of decay was not very effective because of the large amount of exfoliating bark common on this species of Eucalyptus. Sounding around the root collar resulted in a dull resonance in several locations indicating some decay.
- There were remnants of old fungal fruiting bodies/ mycelium at the base of the trunk (see white masses in hand).

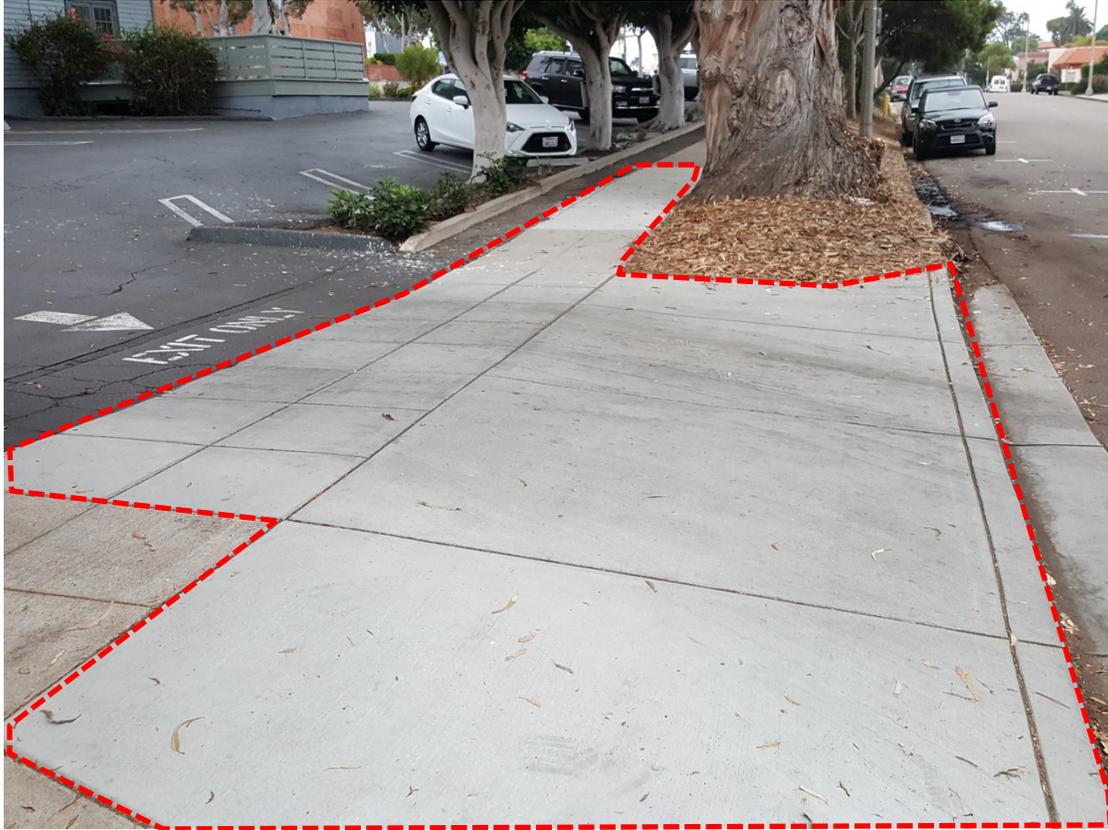
Photo #3

- The sidewalk adjacent to the tree (red dotted area) had a light tone indicating it was likely replaced less than 10 years ago.
