INITIAL SITE ASSESSMENT REPORT
for the
ENCINITAS HABITAT STEWARDSHIP PROGRAM
City of Encinitas, California

DUDEK
605 Third Street
Encinitas, California 92024
Contact: Anita Hayworth

APRIL 2019

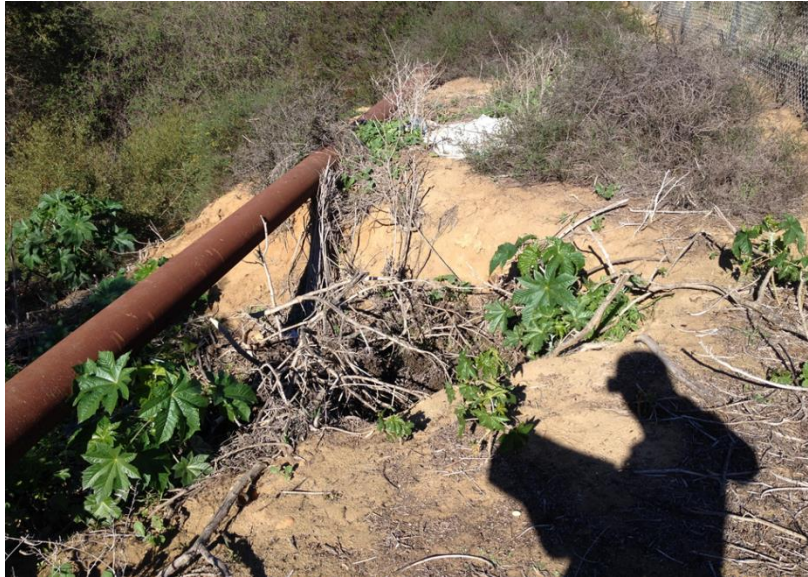
Photo 1: Severe erosion in southeast corner of open space boundary; photo taken looking north.

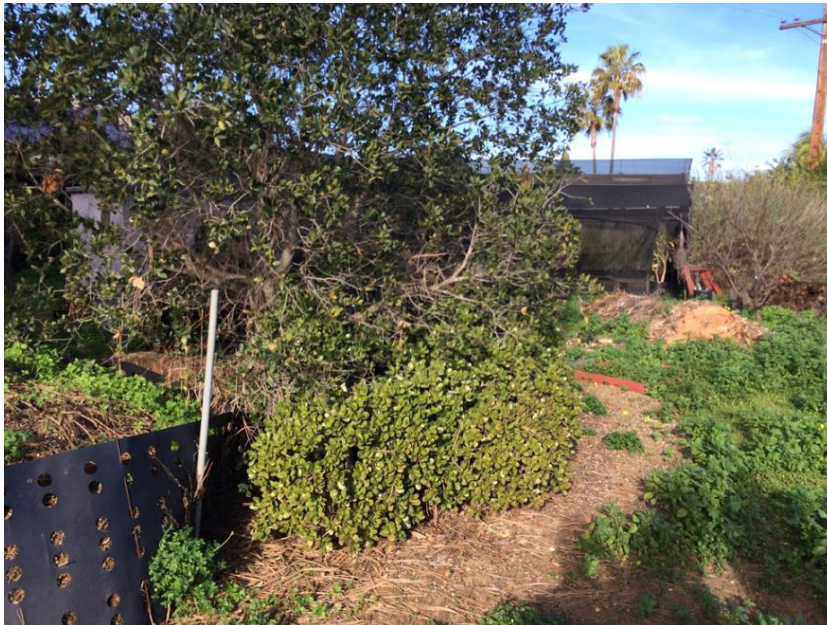
Photo 2: Property boundary encroachment by resident onto open space. Photo taken facing north on western boundary.

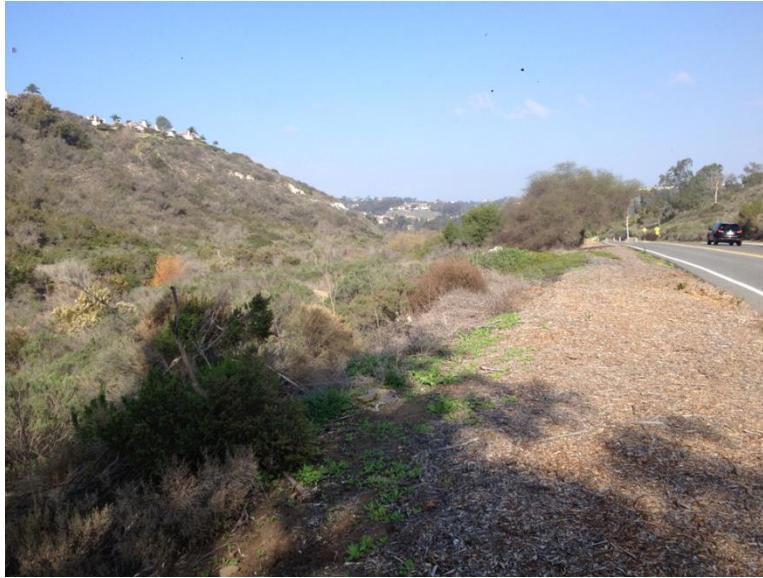
Photo 3: Looking north along Saxony Road from about halfway up the open space

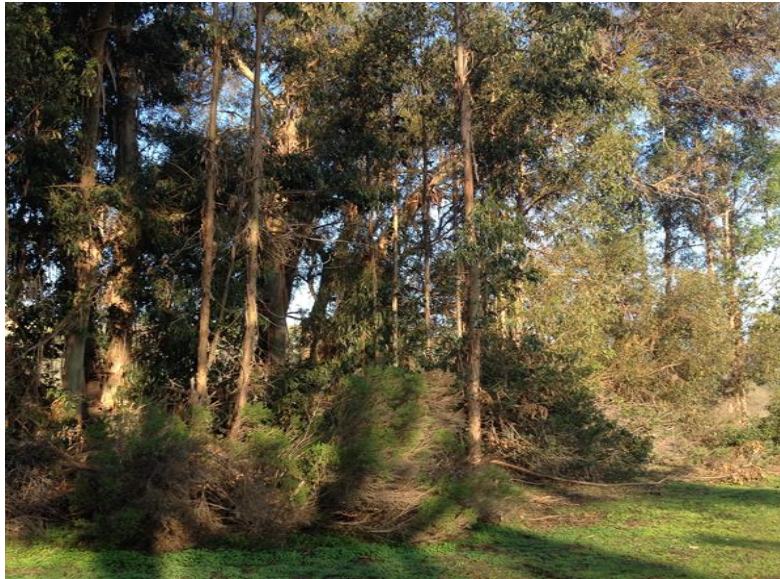
Photo 4: Eucalyptus woodland in west side of site

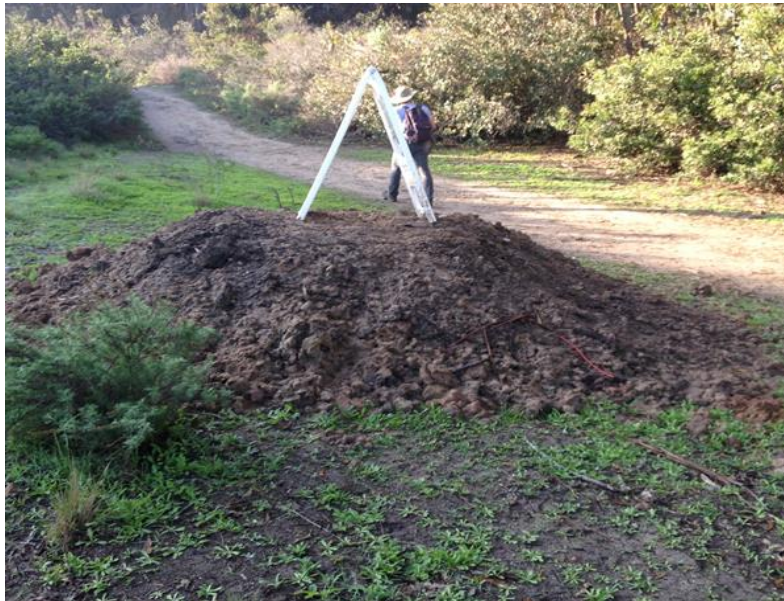
Photo 5: Dirt and asphalt mound near trail on western portion of site

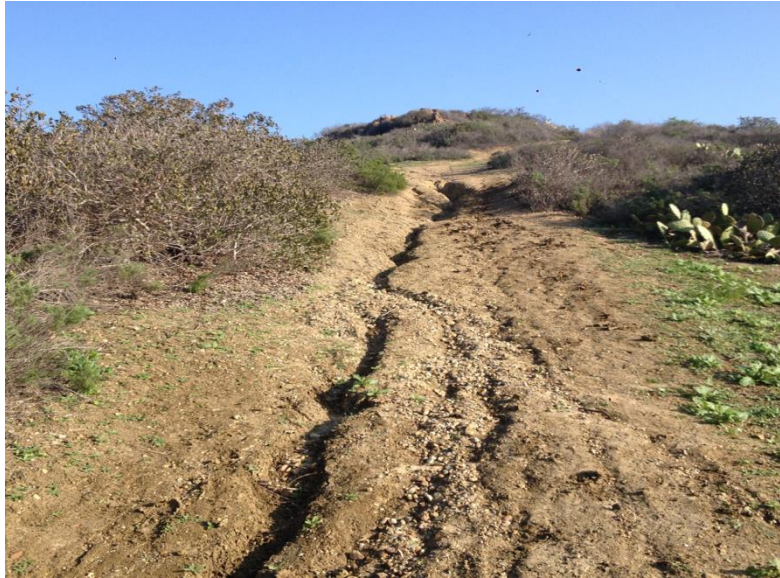
Photo 6: Erosional rilling in trail

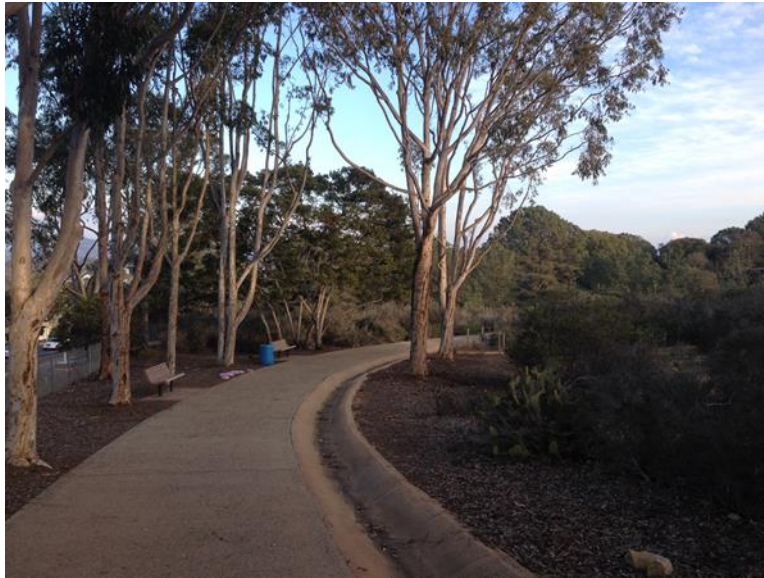
Photo 7: Looking east from the western border along concrete trail near majority of Eucalyptus trees on site.

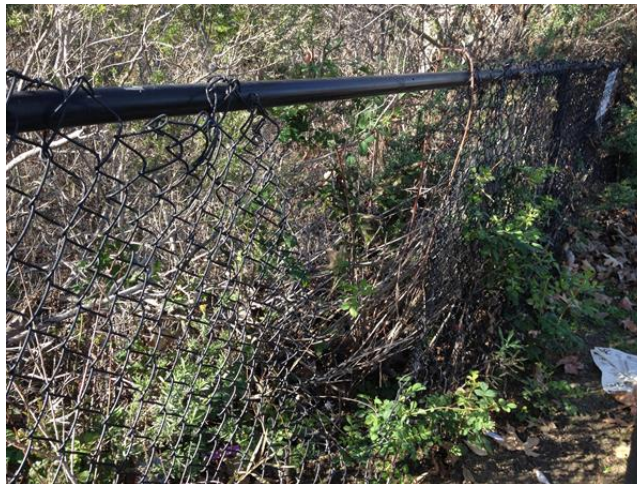
Photo 9: Tear in fence at corner of El Camino Real and Town Center drive

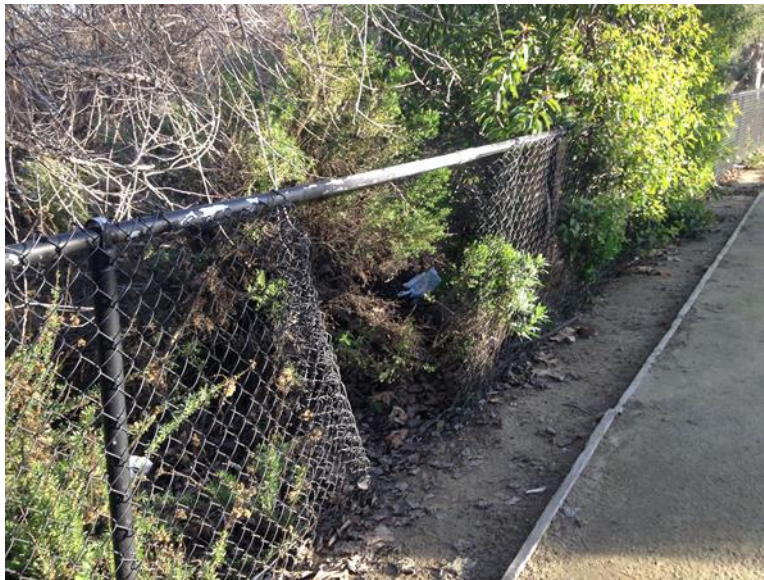
Photo 10: Tear in fence adjacent to parking lot on the western boundary of open space .

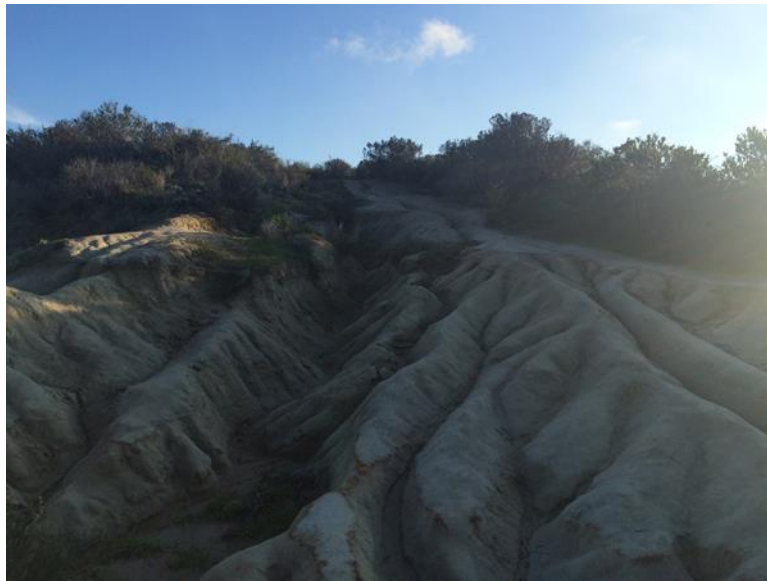
- Moderate to severe rilling in the trail along the top of the hill in the west portion of the site (Photo 11)
- Minor features around the on-site drainage that feeds into the Not a Part detention basin on the north end of the open space.

Photo 11: Severe erosion rilling along trail at top of hill

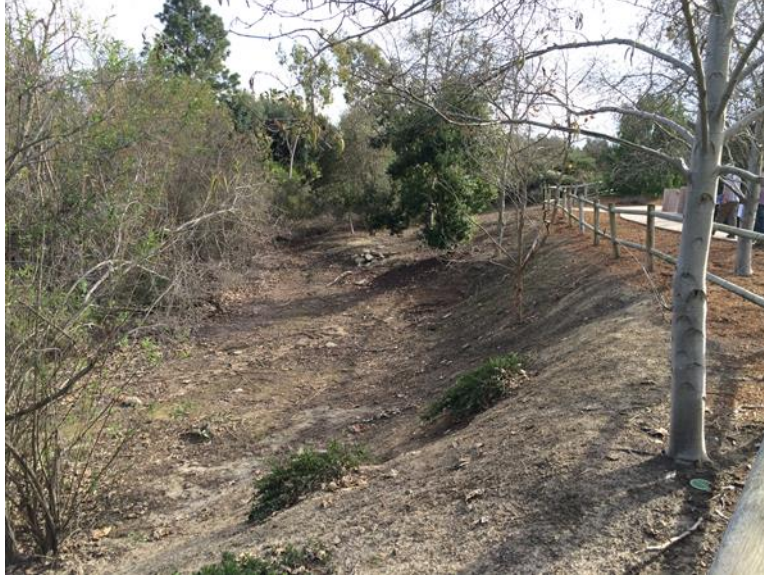
Photo 12: Area previously cleared of vegetation and now is vulnerable to erosion and invasion by exotics
