RE: Fenway N Hwy 101 Mixed Use Project

The following is in response to my April 16th, 2021 site inspection of the Fenway N Highway 101 Mixed Use Project. This inspection was performed at your request to review the on-site trees at this location and document the species and their condition.

Fenway N Hwy 101 Mixed Use Project Inventory

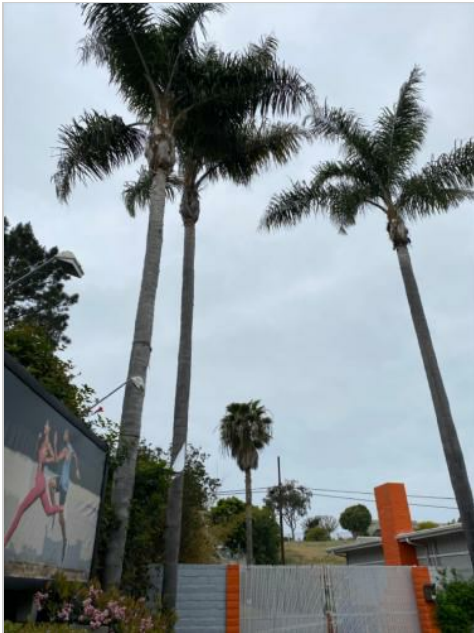
Syagrus romanzoffiana ID# 1
Queen Palm
Height: 46'-60" DBH: 13"-18"
Health: 60% - Fair

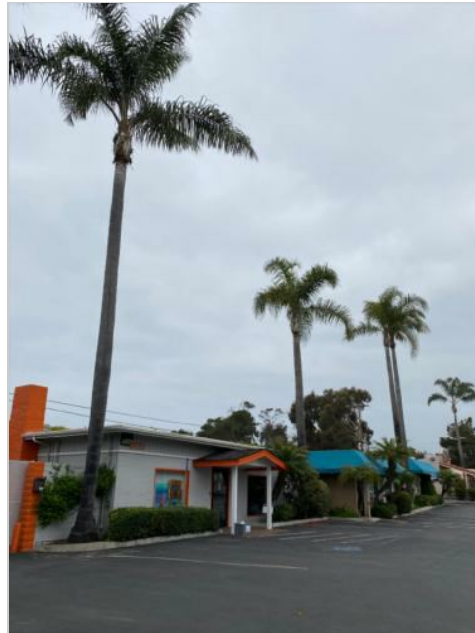
Syagrus romanzoffiana ID# 1
Queen Palm
Height: 46'-60" DBH: 13"-18"
Health: 60% - Fair

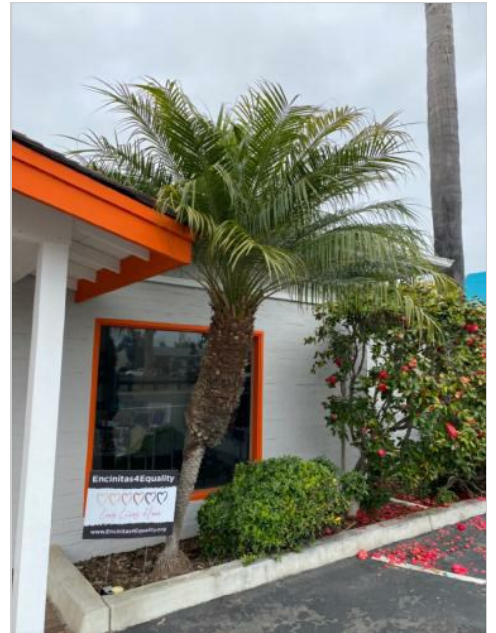
Phoenix roebelenii ID# 4
Pygmy Date Palm
Height: 1'-15" DBH: 7"-12"
Health: 60% - Fair

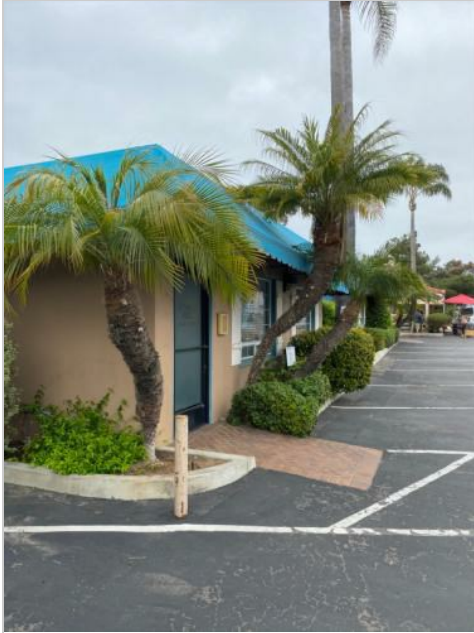
Phoenix roebelenii ID# 4
Pygmy Date Palm
Height: 1'-15' DBH: 7"-12"
Health: 60% - Fair

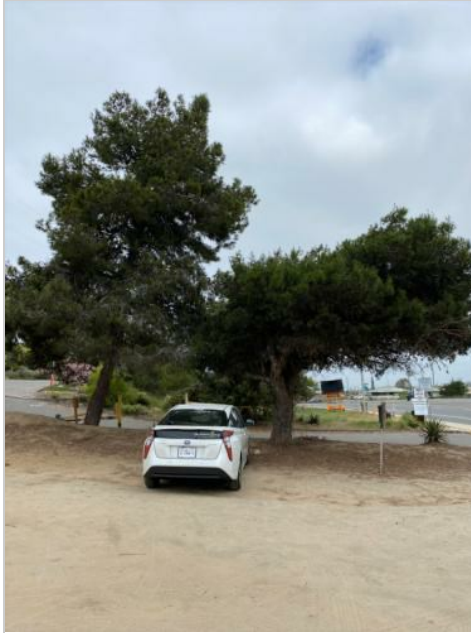
Pinus spp. ID# 11
Pine Species
Height: 31'-45' DBH: 19"-24"
Health: 40% - Poor

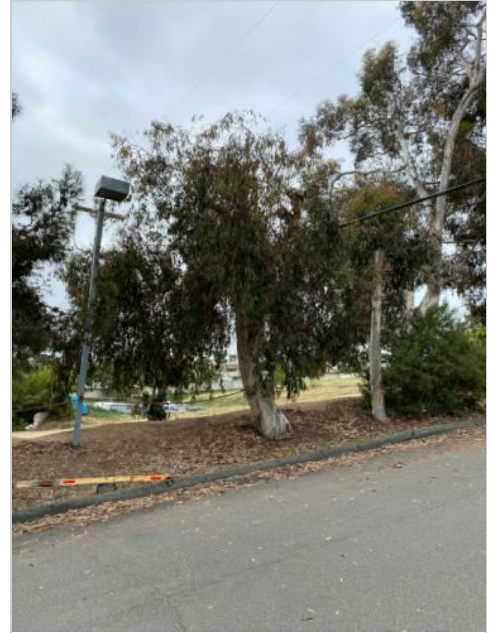
Eucalyptus spp. ID# 13
Eucalyptus Species
Height: 46'-60' DBH: 19"-24"
Health: 40% - Poor

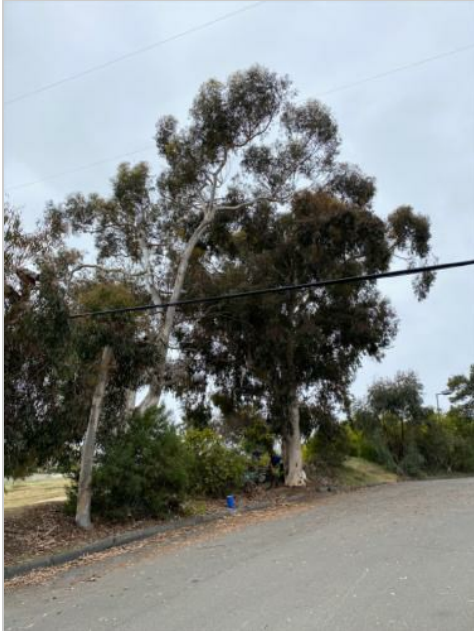
Eucalyptus spp. ID# 13
Eucalyptus Species
Height: 46'-60" DBH: 19"-24"
Health: 40% - Poor

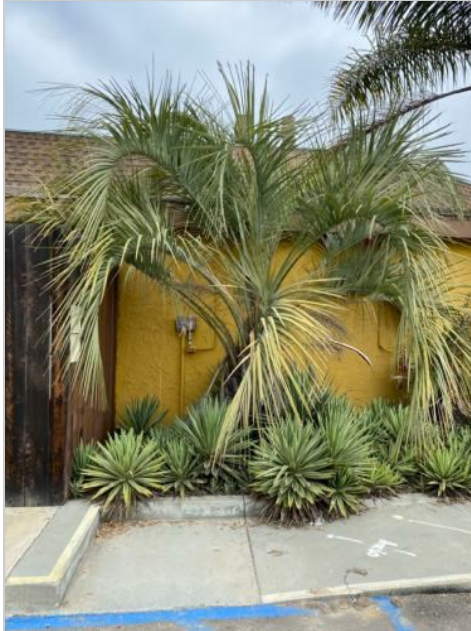
Butia capitata ID# 27
Pindo Palm
Height: 1'-15' DBH: 13"-18"
Health: 60% - Fair

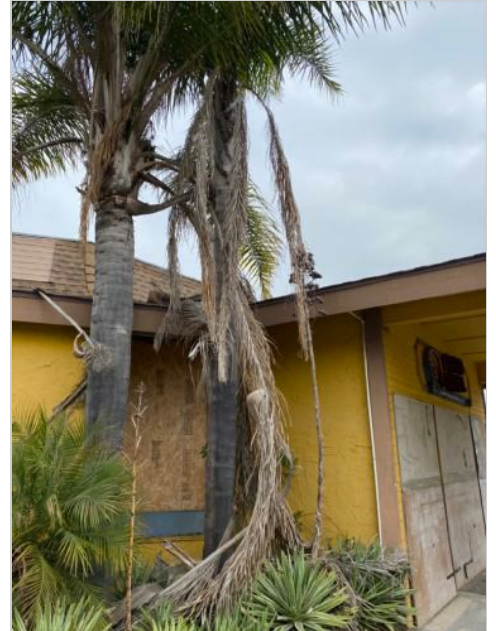
Syagrus romanzoffiana ID# 29
Queen Palm
Height: 16'-30' DBH: 13"-18"
Health: 0% - Dead

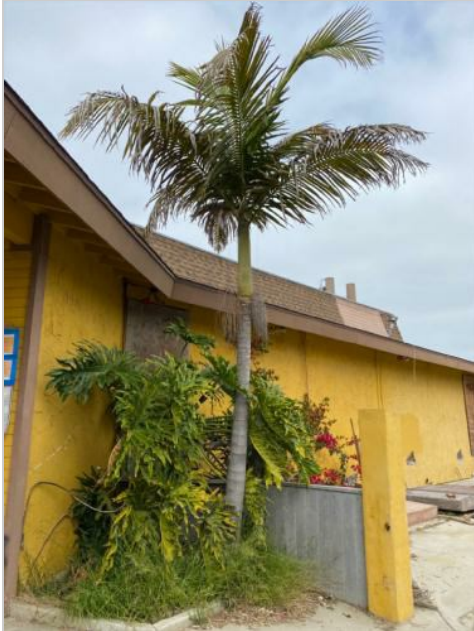
Archontophoenix cunninghamiana ID# 32
King Palm
Height: 16'-30' DBH: 7"-12"
Health: 40% - Poor

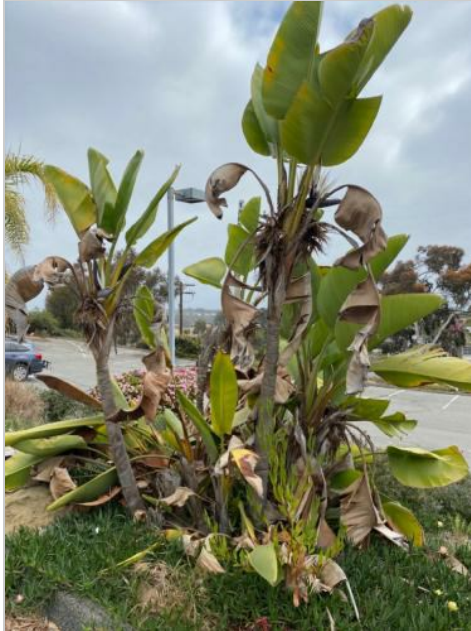
Strelitzia reginae ID# 34
Giant Bird Of Paradise
Height: 1'-15' DBH: 13"-18"
Health: 40% - Poor

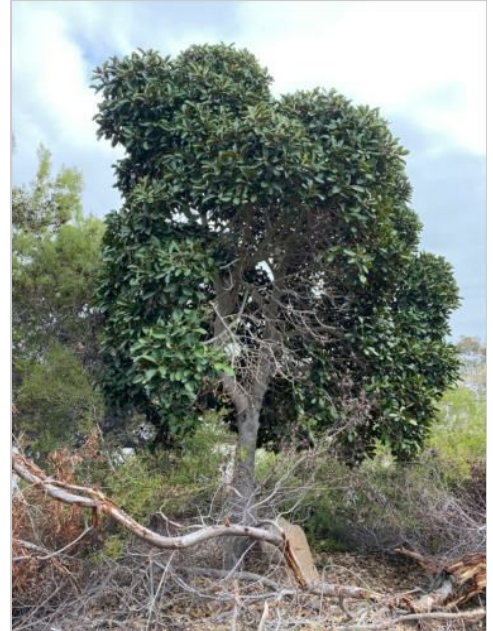
Ficus rubiginosa ID# 39
Rusty Fig
Height: 16'-30' DBH: 7"-12"
Health: 60% - Fair

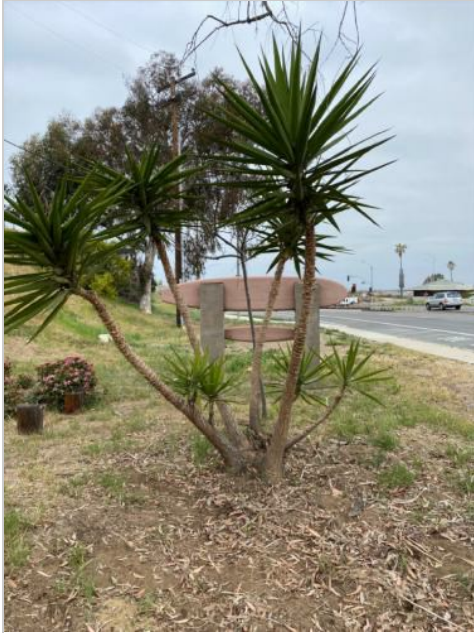
Yucca gloriosa ID# 44
Spanish Dagger
Height: 1'-15' DBH: 7"-12"
Health: 60% - Fair

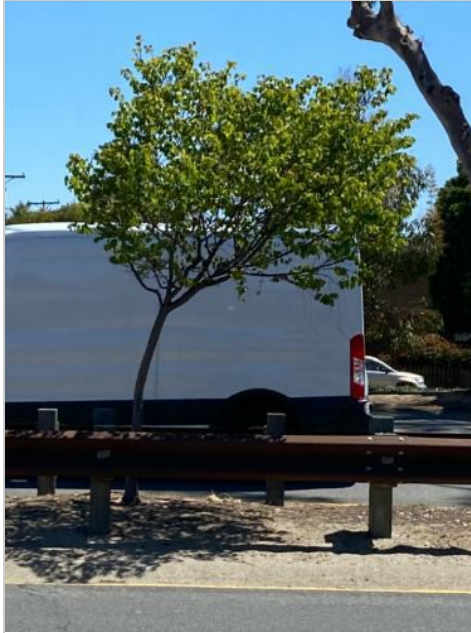
Cercis occidentalis ID# 48
Western Redbud
Height: 1'-15' DBH: 1"-6"
Health: 60% - Fair

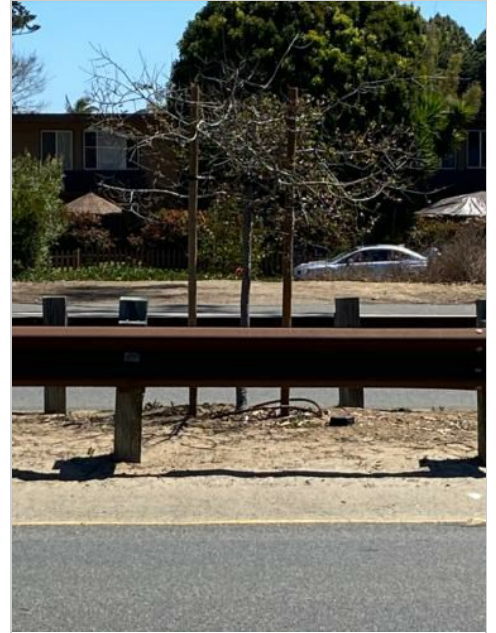
Quercus agrifolia ID# 50
Coast Live Oak
Height: 1'-15' DBH: 1"-6"
Health: 20% - Critical

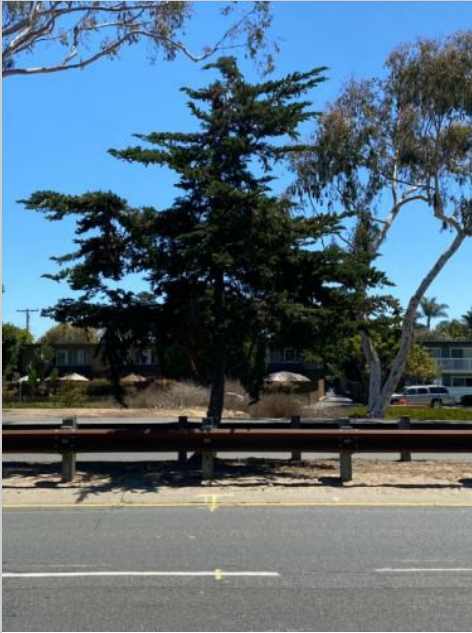
Hesperocyparis macrocarpa ID# 51
Monterey Cypress
Height: 16'-30' DBH: 7"-12"
Health: 60% - Fair

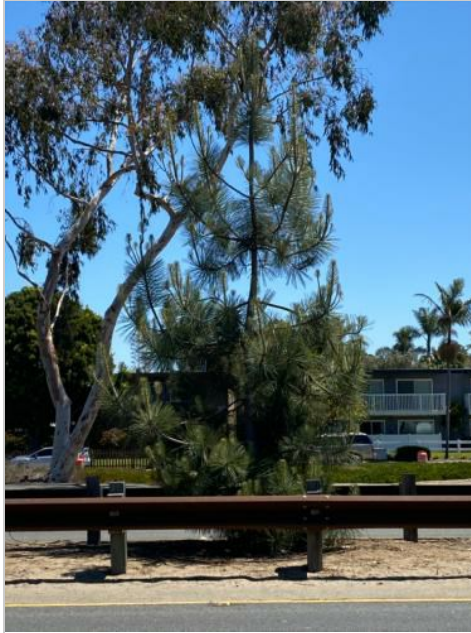
Pinus torreyana ID# 52
Torrey Pine
Height: 16'-30' DBH: 7"-12"
Health: 80% - Good

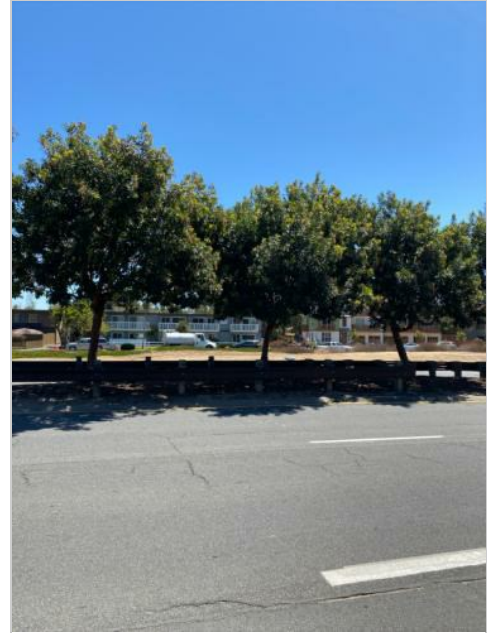
Arbutus cv. Marina ID# 53
Marina Strawberry Tree
Height: 16'-30' DBH: 7"-12"
Health: 80% - Good
