# **APPENDIX C-2 ARBORIST REPORT**

**RE: Fenway N Hwy 101 Mixed Use Project**

The following is in response to my April 16th, 2021 site inspection of the Fenway N Highway 101 Mixed Use Project. This inspection was performed at your request to review the on-site trees at this location and document the species and their condition.

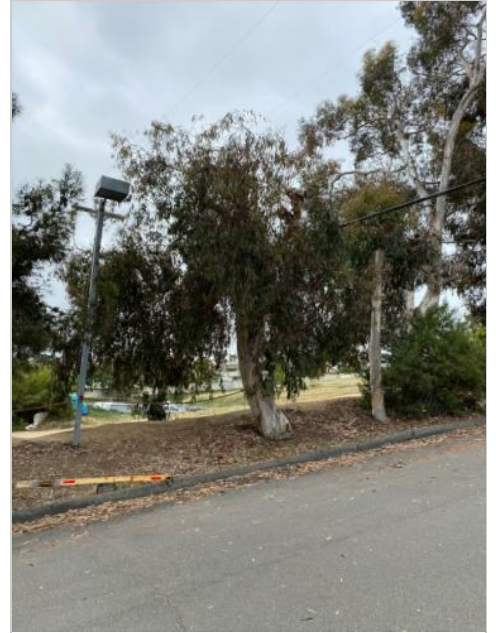
| Fenway N Hwy 101 Mixed Use Project | | | | | | | |
|---|--|---|---|---|---|--|--|
| 13 | Eucalyptus species ( <i>Eucalyptus spp.</i> ) | 45-60' | 18-24" | Poor | Deferred maintenance, poor structure | | |

*Eucalyptus spp.* ID# 13  
Eucalyptus Species  
Height: 46'-60' DBH: 19"-24"  
Health: 40% - Poor

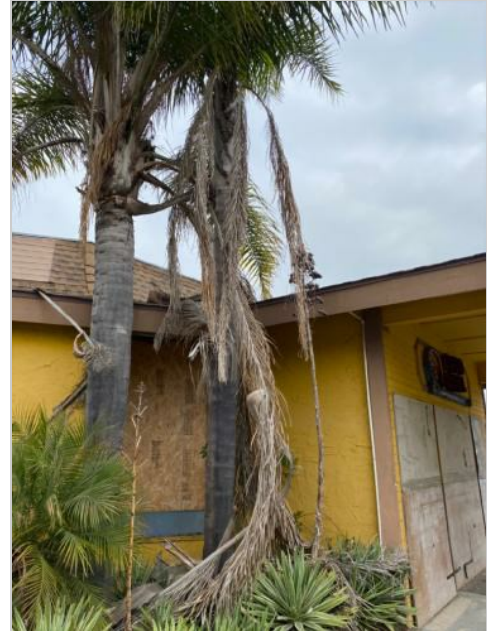
| Fenway N Hwy 101 Mixed Use Project | | | | | | | |
|---|--|---|---|---|---|--|--|
| 29 | Queen Palm ( <i>Syagrus romanzoffianum</i> ) | 15-30' | 12-18" | Dead | Deferred maintenance, poor structure | | |

*Syagrus romanzoffiana* ID# 29  
Queen Palm  
Height: 16'-30' DBH: 13"-18"  
Health: 0% - Dead

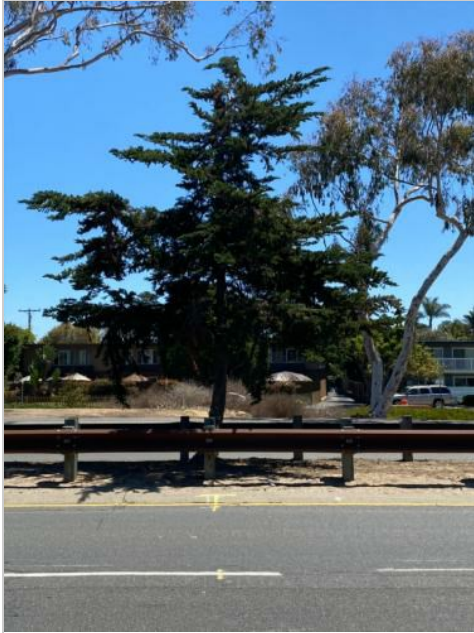
| Fenway N Hwy 101 Mixed Use Project | | | | | | | |
|---|--|---|---|---|---|--|--|
| 51 | Monterey Cypress ( <i>Cupressus macrocarpa</i> ) | 15-30' | 6-12" | Good | Regular maintenance | | |

*Hesperocyparis macrocarpa* ID# 51  
Monterey Cypress  
Height: 16'-30' DBH: 7"-12"  
Health: 60% - Fair
