City of Encinitas

4.4.17 Assessment of Ficus Tree At 364 Second Street (Side-2)

John Ugrob
Utility & Maintenance Supervisor
Street/ NPDES Division
City of Encinitas

APRIL 4, 2017

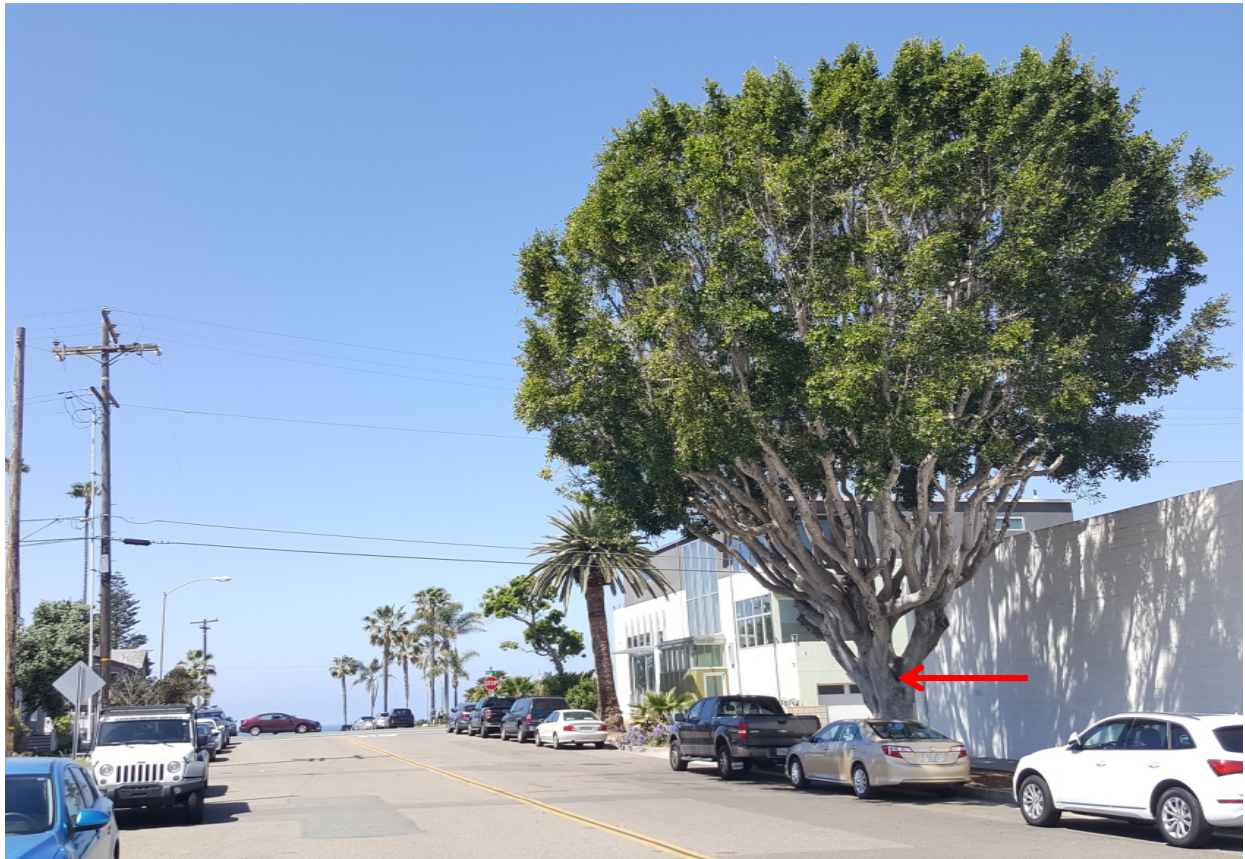
- The tree was growing in an 8.5 foot wide parkway on the north side of C St. between 2nd and 3rd St. (see Photo #1 in Appendix A).
- The tree had a DSH² measurement of inches 36 inches and a height of about 55 feet (measured with a TruPulse laser).

- Judging by the color and density of the foliage, the tree appeared to be in fair health for the species and time of year. The tree had a moderate **live crown ratio** of approximately 50% which is common for street trees necessitating raised crowns for vehicle clearance (see Photo #1 in Appendix A).

- The tree (red arrow) was growing in an 8.5 foot wide parkway on the north side of C St. between 2nd and 3rd St.
- Judging by the color and density of the foliage, the tree appeared to be in fair health for the species and time of year. The tree had a moderate **live crown ratio** of approximately 50% which is common for street trees necessitating raised crowns for vehicle clearance.
- There were some powerlines within the target zone of the tree its west side.

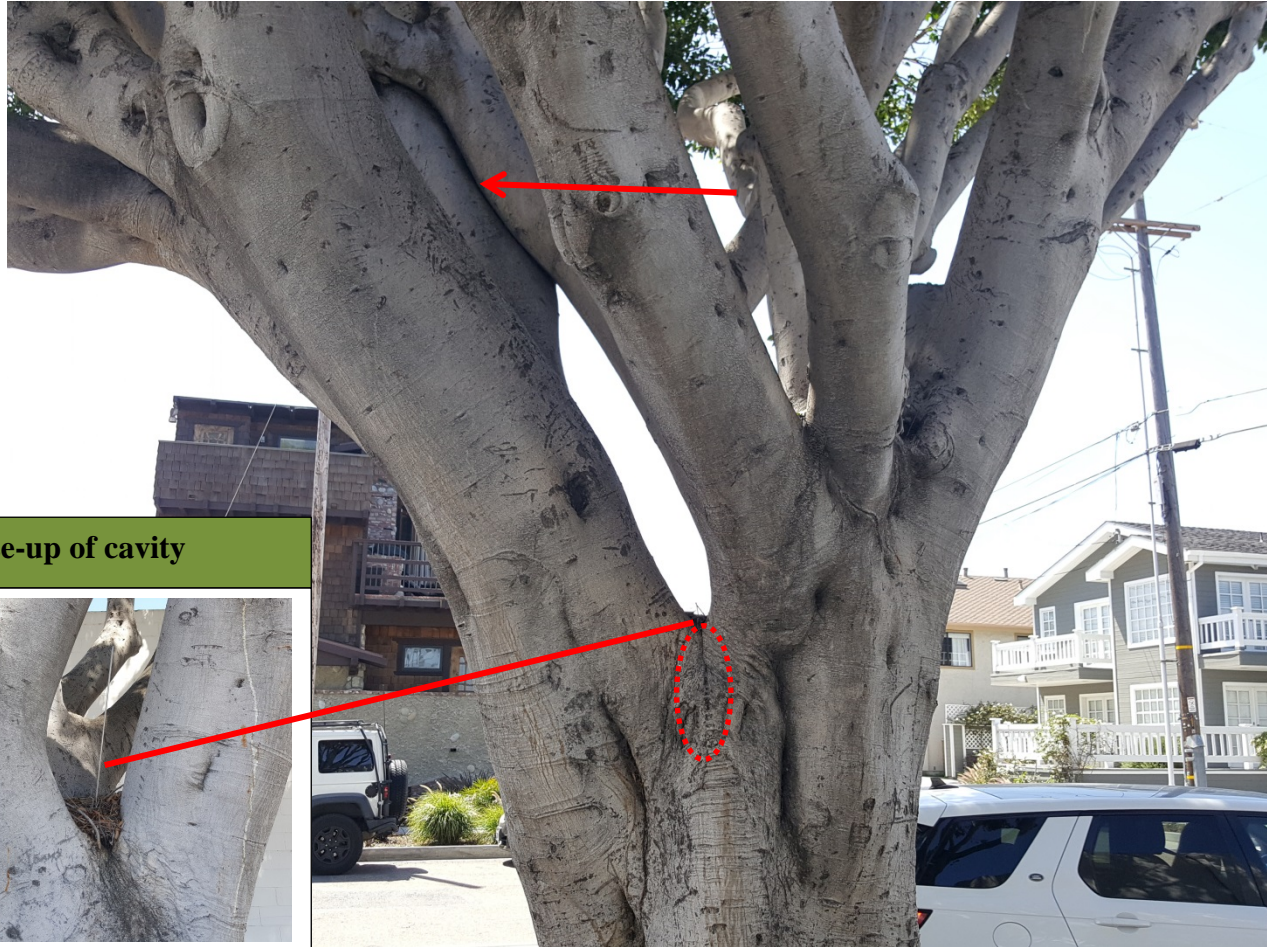
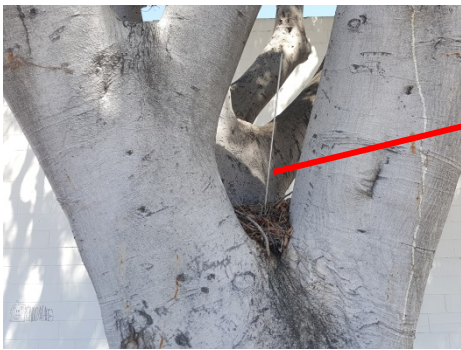
- There were some powerlines within the target zone of the tree its west side (see Photo #1 in Appendix A).
- The tree had multiple overextended **codominant stems** and scaffold branches which are indicative of poor tree structure. Some of these stems had included bark (see Photo #2 in Appendix A).

- There was a debris filled cavity between the multiple stems. Probing it indicated a depth of approximately 12 inches (see Photo #2 in Appendix A).
- There appeared to be a fair amount of growth in response to the structural defects (see Photo #2 in Appendix A).

The defects of greatest concern for the subject tree were the significant root pruning combined with overextended stems/ scaffold branches. The *likelihood of a failure* within the next year was assessed as **possible** for the subject tree because of these defects. This potential failure event would be most likely to occur during abnormal or extreme weather conditions.

- The tree had multiple overextended **codominant stems** and scaffold branches which are indicative of poor tree structure. Some of these stems had included bark (see **red dotted oval**).
- There was a debris filled cavity between the multiple stems (see **red line** and close up box on the left). Probing it indicated a depth of approximately 12 inches.
- There appeared to be a fair amount of growth in response to the structural defects.

Risk and Mitigation – After performing a **Level 2 Basic Assessment**⁴, the subject tree was assessed to have an overall moderate risk rating. In regards to mitigating these risks, I recommend applying and maintaining an approximate 25% crown reduction with the structure and canopy balance of the tree in mind (see Appendix B and Figure 3 below). This recommended pruning should be done in compliance to ANSI A300 Arboricultural Standards and will need to be applied over multiple spaced out pruning doses to minimize health impacts on the tree. This is also done to allow time for interior growth to further develop and broaden the options for new branches to prune back to. Pruning techniques such as **reduction pruning**, and **removal pruning cuts** should be used (not topping) to achieve this overall squattier appearance and are further explained in Appendix B. The end outcome should be a reduction of **mechanical stress** from overextended loads and an improvement in wind penetration. A residual risk of “Low” should be achieved after implementing these recommended pruning strategies.

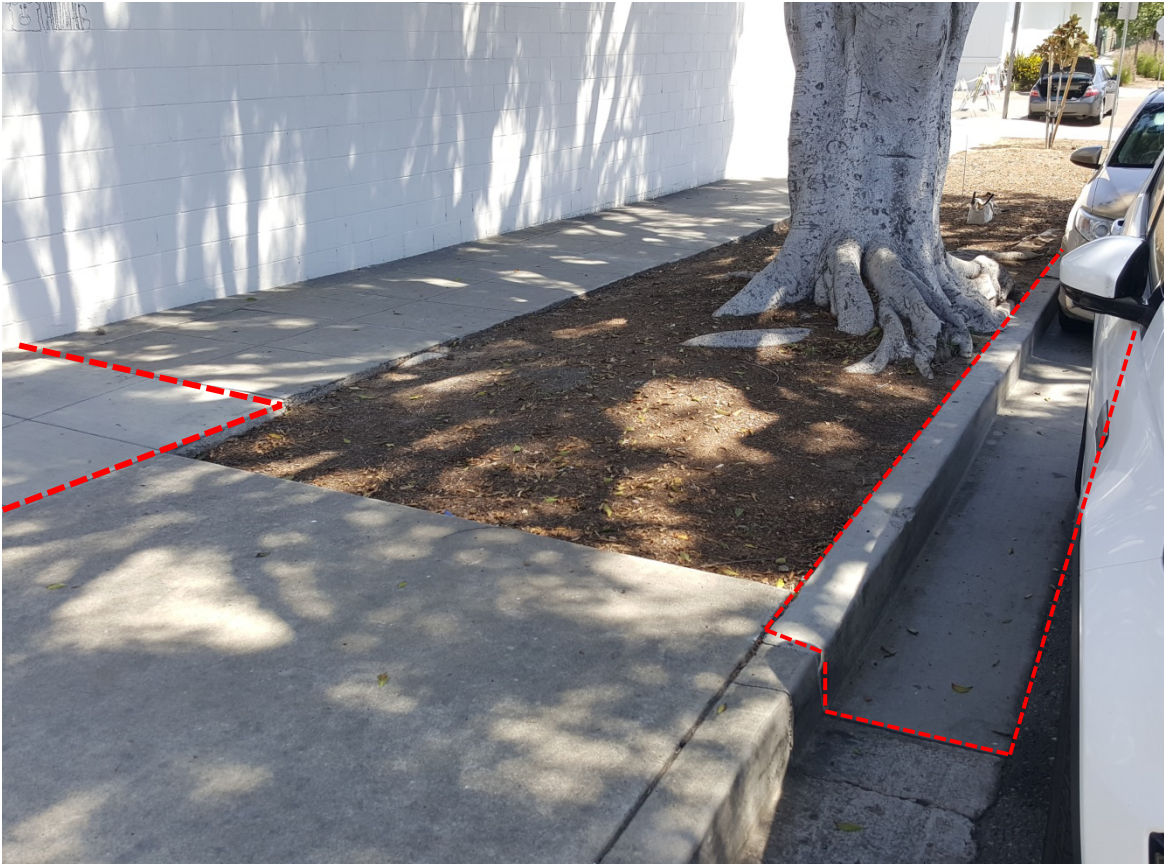
Photo #3

- Judging by the lighter tones, it appeared that a section of sidewalk and curb face had been replaced (see red dotted areas).

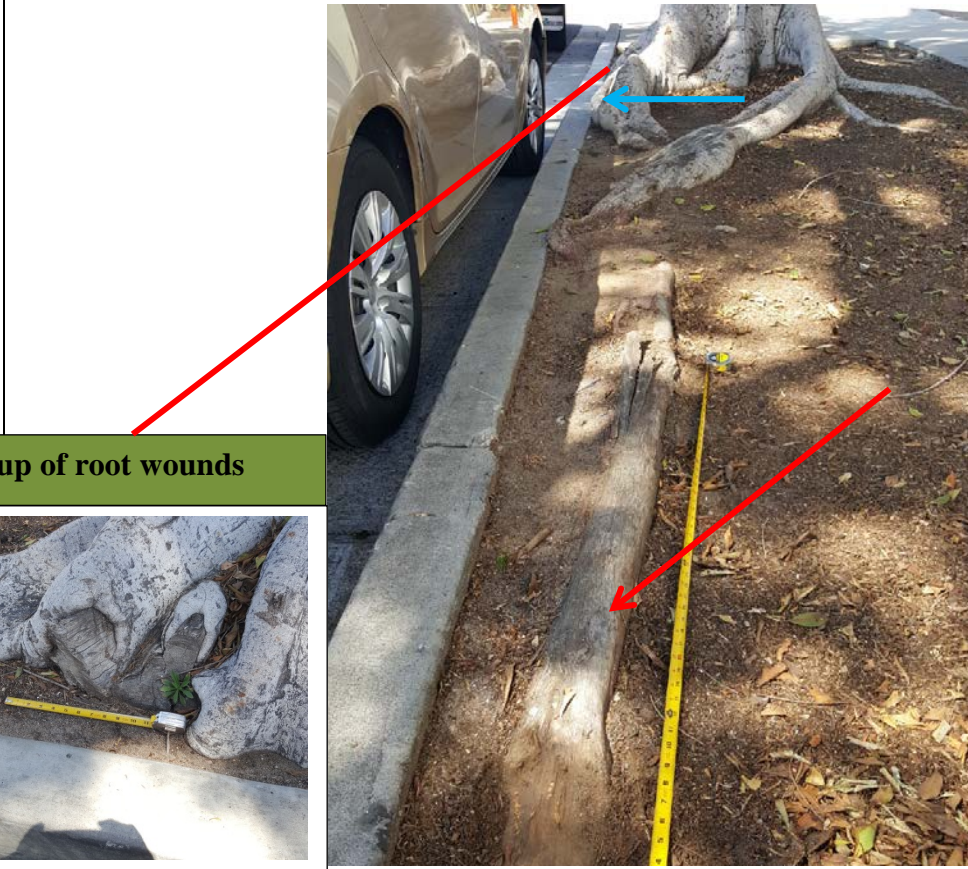
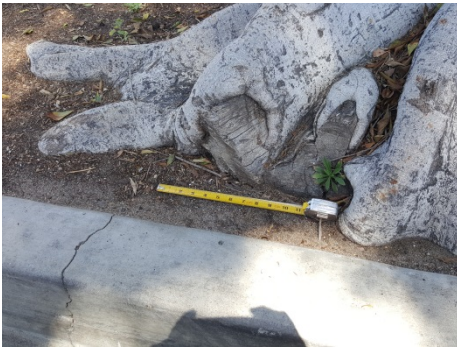
- Judging by the lighter tones, it appeared that a section of sidewalk and curb face had been replaced. Some of the buttress roots were showing a **contact stress response** to growing next to the curb face. This phenomenon occurs when trees grow in close contact with infrastructure. Trunk and root tissues mold, and grow over the infrastructure element providing a level of structural support. There may be an increase in failure potential if the infrastructure element is removed or replaced (see Photo #3 in Appendix A).
- There were multiple root injuries on the south side of the tree adjacent to the curb face (see Photo #4 in Appendix A).
- There was a root on the east side of the tree that did not appear to have remaining living tissues (see Photo #4 in Appendix A).

- There were multiple root injuries on the south side of the tree adjacent to the curb face (see red line and close up box).
- There was a root on the east side of the tree that did not appear to have remaining living tissues (see red arrow).
- One of the buttress roots was showing a **contact stress response** to growing next to the curb face (see blue arrow). This phenomenon occurs when trees grow in close contact with infrastructure. Trunk and root tissues mold, and grow over the infrastructure element providing a level of structural support. There may be an increase in failure potential if the infrastructure element is removed or replaced.

Root Pruning: Root pruning (such as observed on this tree) is an injurious practice that can significantly damage trees and affect their structural strength and health. If future conflicts between roots and infrastructure occur, I recommend looking into alternative mitigation strategies such as **elevated root bridging**, or meandering sidewalks to minimize damage to roots. If root pruning cuts must be made, I recommend doing so selectively under the supervision of a Certified Arborist and as far away from the trunk as possible using sharp tools to avoid tearing and crushing of roots. It is with the health and safety of the community that I present these recommendations.

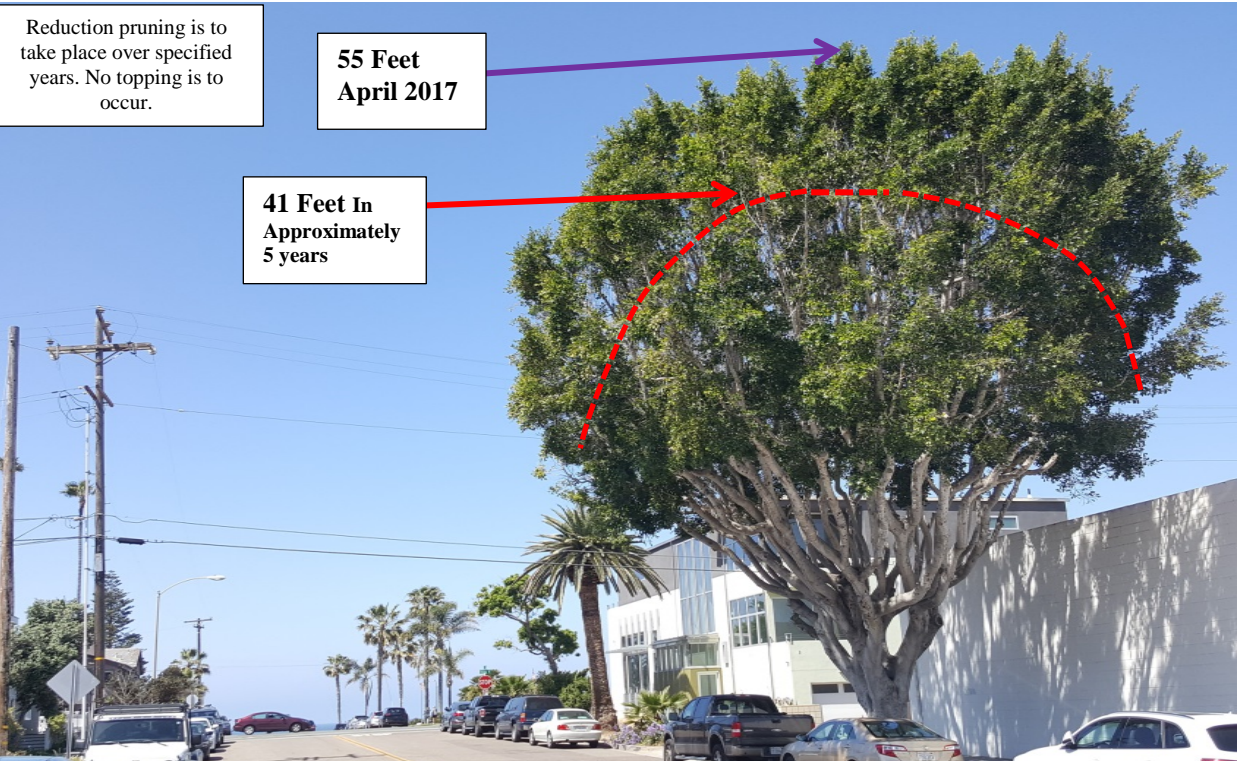
Crown Reduction Pruning Goal

This tree had a measured height of 55 feet (see purple arrow). The proposed goal is to achieve a 25% (13.75 feet) **crown reduction through a multi-year pruning plan (up to five years)** leaving the tree with a height of approximately 41 feet (see red dotted line and arrow) after the final pruning dose.

Reduction pruning is to take place over specified years. No topping is to occur.
