City of Encinitas

4.4.17 Assessment of Ficus Tree At 402 Second Street (Front-2)

APRIL 4, 2017

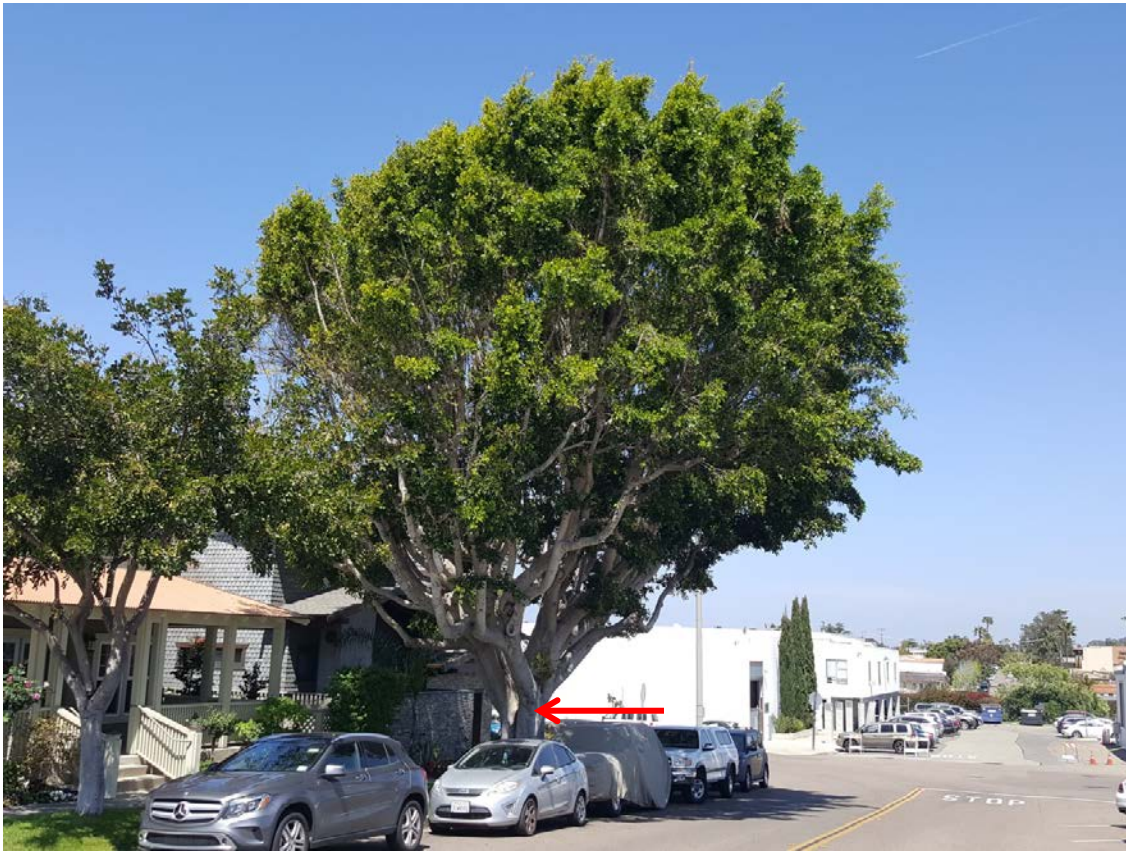
- The tree was growing in an 8.5 foot wide parkway on the west side of 2nd St. and in front of the 402 address (see Figure 1, as well as Photo #1 in Appendix A).

- Judging by the color and density of the foliage, the tree appeared to be in fair to good health for the species and time of year (see Photo #1 in Appendix A).

- The tree (red arrow) was growing in an 8.5 foot parkway on the east side of 2nd St. in front of the 402 residence.
- Judging by the color and density of the foliage, the tree appeared to be in fair to good health for the species and time of year.
- The tree had multiple overextended **codominant stems** and scaffold branches which are indicative of poor tree structure.

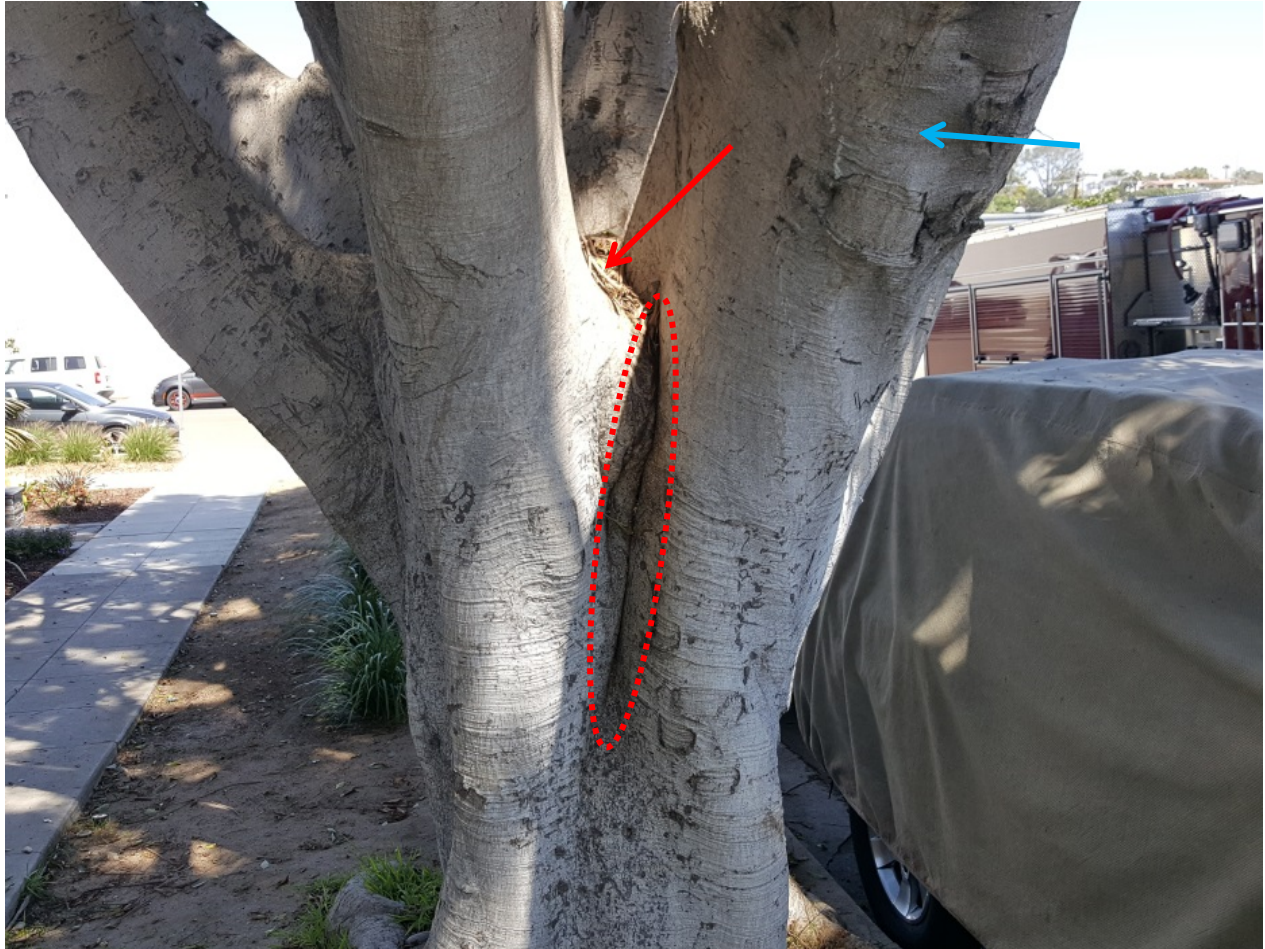
- The tree had a DSH² measurement of 43 inches and a height of about 50 feet (measured with a TruPulse laser).
- The tree had multiple overextended **codominant stems** and scaffold branches which are indicative of poor tree structure (see Photos #1 and #2 in Appendix A).

- The tree had multiple codominant stems and scaffold branches with included bark. The largest bark inclusion observed had debris filled cavity with a depth of approximately 12 inches (see Photos #1 and #2 in Appendix A).

The part of greatest concern was the stem on the south-east side of the tree (see Photo #2 in Appendix A) because of its overextended horizontal growth, and the large amount of included bark with a significant debris filled cavity at its union. These defects were assessed to give the stem a **probable** *likelihood of failure*. This potential failure event would be most likely to occur during abnormal or extreme weather conditions.

- The tree had multiple codominant stems and scaffold branches with included bark. The largest bark inclusion observed (**red dotted oval**) had debris filled cavity with a depth of approximately 12 inches (see **red arrow**).
- The main part of concern was the large stem in the right side of the photo (**blue arrow**).

1. Remove the tree and replace it with a with a healthy site adequate species.
2. Applying **reduction pruning**, and **removal pruning cut** techniques (not **topping**) to reduce the overall canopy height and spread by about 25% (see Figure 3 and Appendix B). This recommended pruning should be done in compliance to ANSI A300 Arboricultural Standards and will need to be applied over multiple spaced out pruning doses (up to five years) to minimize health impacts on the tree. This is also recommended to allow time for interior growth to further develop and broaden the options for new branches to prune back to. The end outcome should be a reduction of **mechanical stress** from overextended loads. The first pruning dose should address reducing the overextended stem of concern to immediately reduce the trees' overall risk.

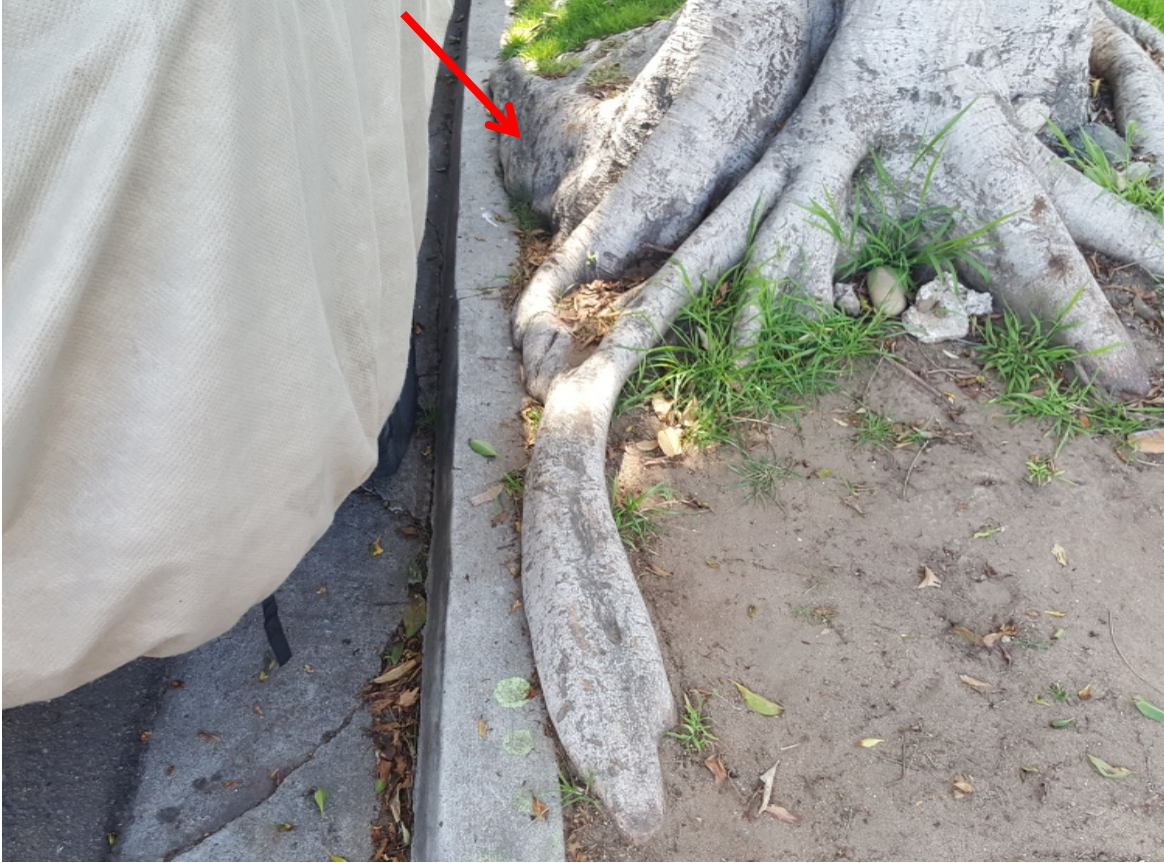
- Some of the larger buttress roots were showing a **contact stress response** to growing next to the curb face. This phenomenon occurs when trees grow in close contact with infrastructure. Trunk and root tissues mold, and grow over the infrastructure element providing a level of structural support. There may be an increase in failure potential if the infrastructure element is removed or replaced (see Photo #3 in Appendix A).

- Some of the larger buttress roots were showing a **contact stress response** to growing next to the curb face (see **red arrow**). This phenomenon occurs when trees grow in close contact with infrastructure. Trunk and root tissues mold, and grow over the infrastructure element providing a level of structural support. There may be an increase in failure potential if the infrastructure element is removed or replaced.
