City of Encinitas

3.22.17 Assessment of Ficus Tree At 510 Second Street (Front-1)

MARCH 22, 2017

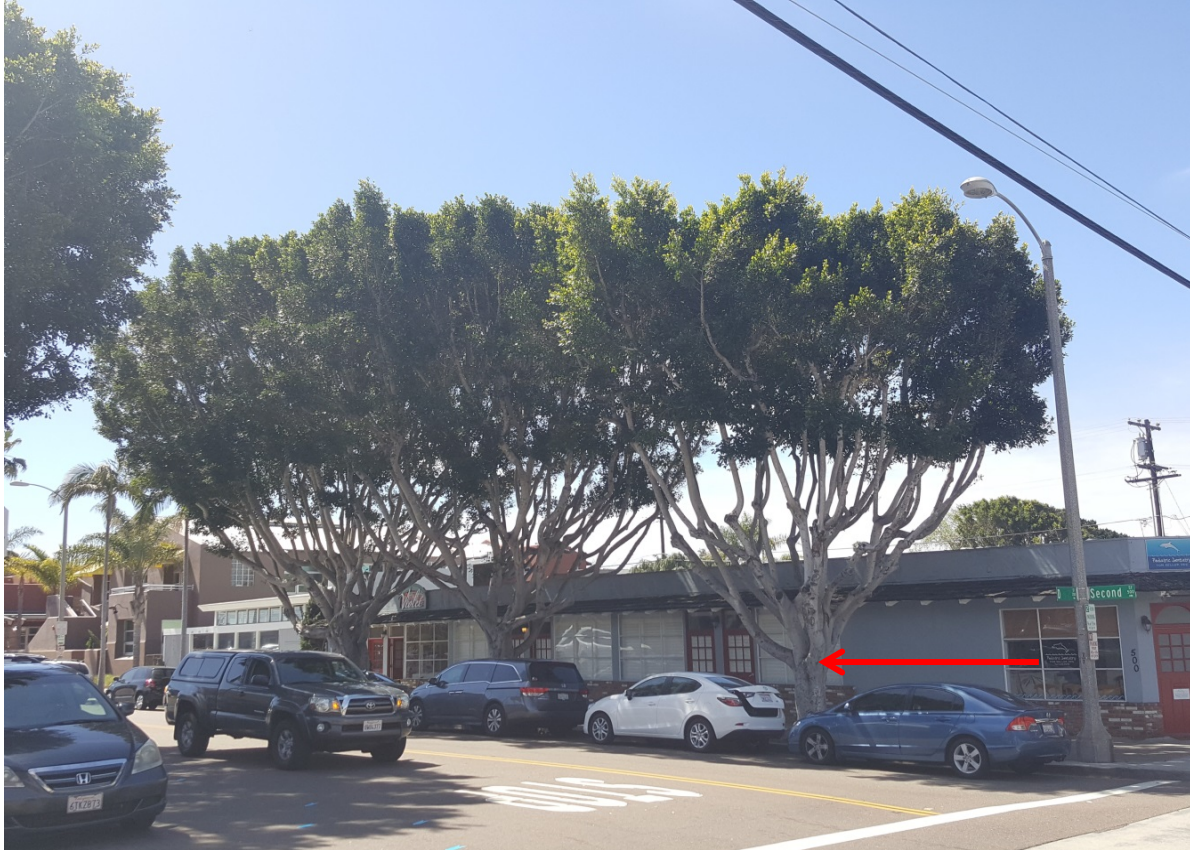
- The tree was growing in a 7 foot wide tree well on the west side of 2nd St. and in front of the 510 business address (see Figure 1, as well as Photo #1 in Appendix A).

- Judging by the color and density of the foliage, the tree appeared to be in fair health for the species and time of year. The tree had a moderate **live crown ratio** of approximately 40% which is common for street trees necessitating crown raising for vehicle clearance (see Photo #1 in Appendix A).

- The tree had a DSH² measurement of 29 inches and a height of about 40 feet (measured with a TruPulse laser).
- There were some powerlines on the north side of the tree which appeared to be outside of the **target zone** (see Photo #1 in Appendix A).

- The tree was growing in a 7 foot wide tree well on the west side of 2nd St. and in front of the 510 business address.
- Judging by the color and density of the foliage, the tree appeared to be in fair health for the species and time of year. There was a moderate **live crown ratio** of approximately 40% which is common for street trees necessitating raised crowns for vehicle clearance.

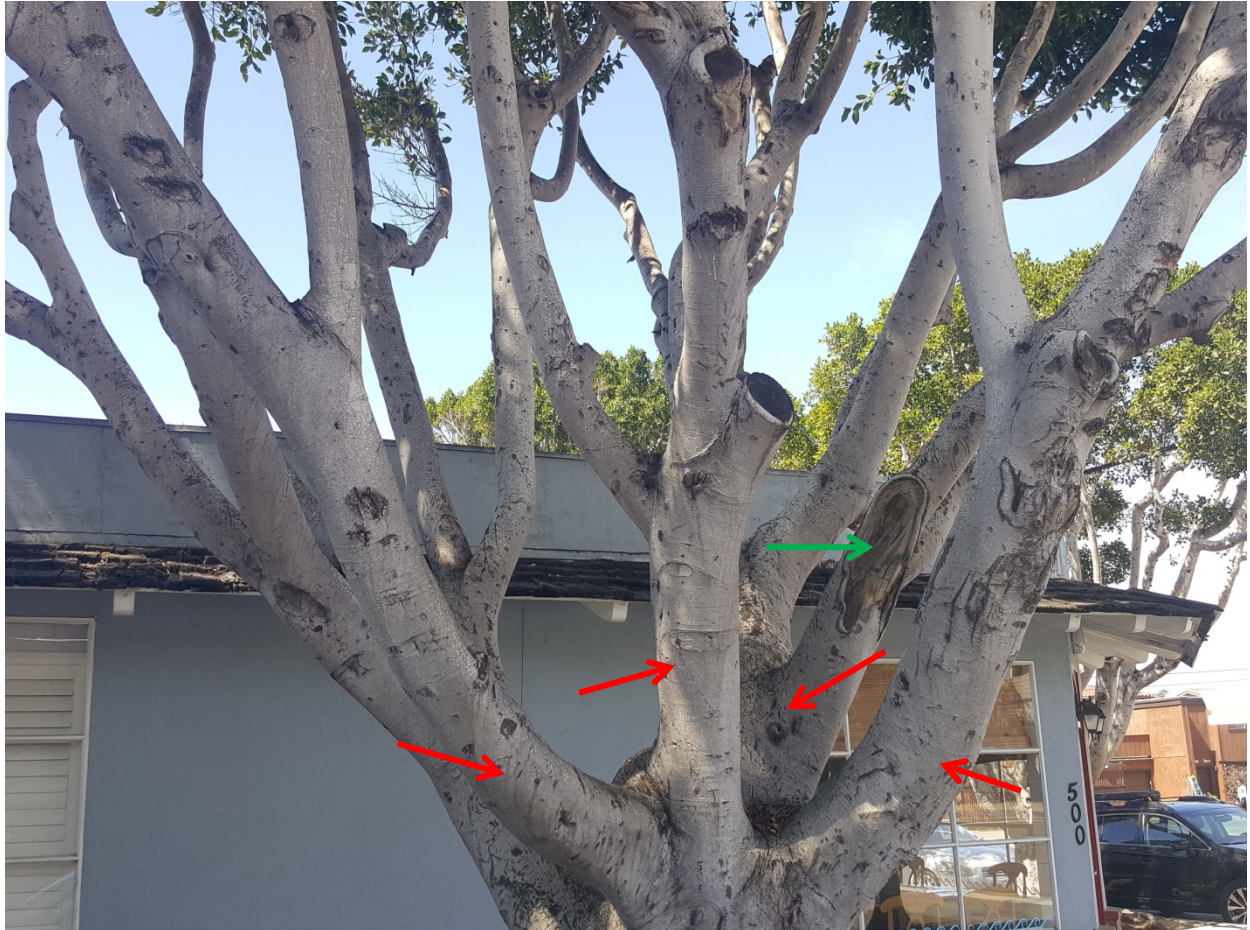
- The tree had multiple **codominant stems** and branches which are indicative of poor structure yet common to this species (see Photo #2 in Appendix A).

- There was evidence of an old stem failure on the west side of the tree which was likely caused by either a vehicle impact, or weakly attached overextended growth (see Photo #2 in Appendix A).

- The tree had multiple **codominant stems** and branches (**red arrows**) which are indicative of poor structure yet common to this species.
- There was evidence of an old stem failure on the west side of the tree (**green arrow**) which was likely caused by either a vehicle impact or weakly attached overextended growth.

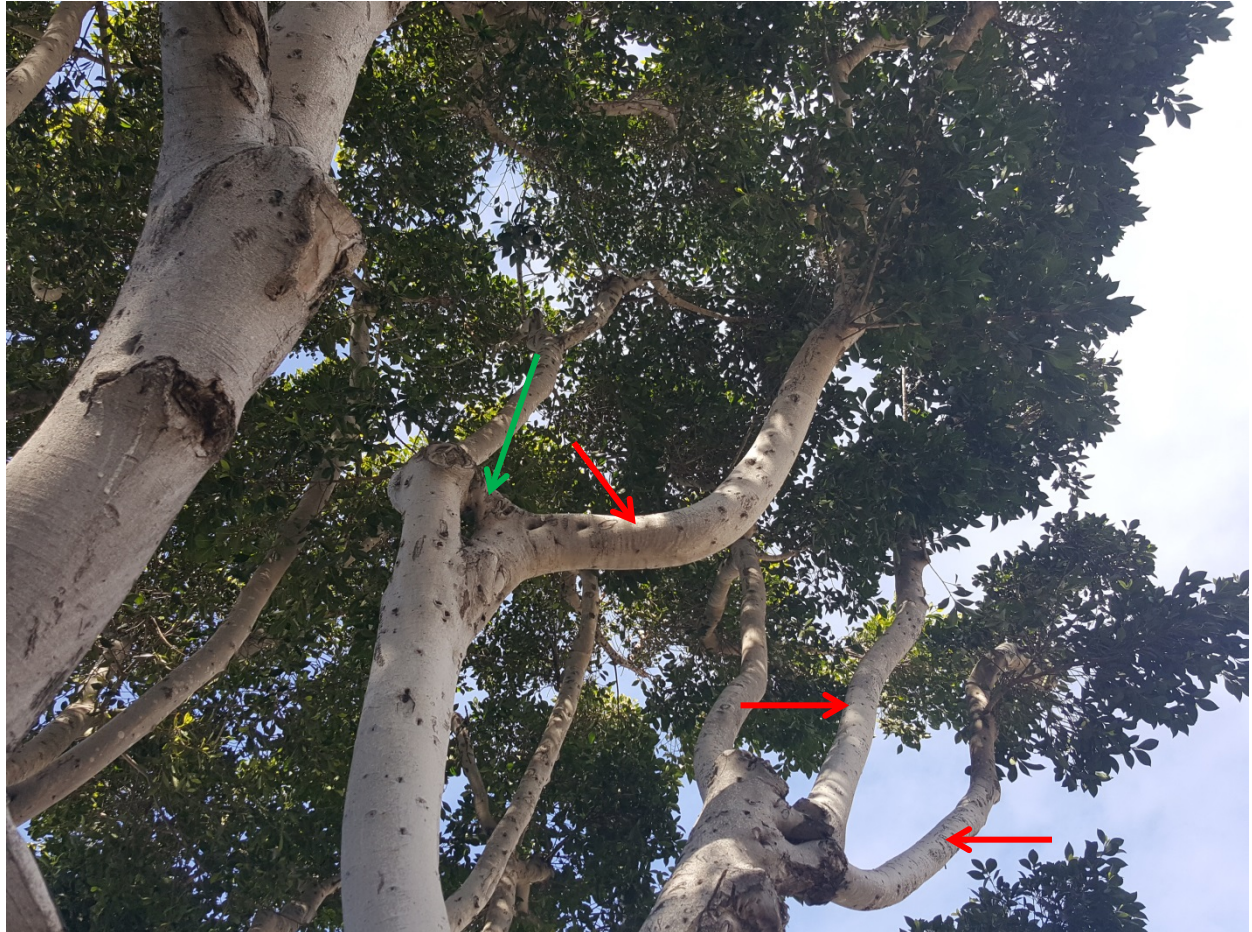
- Some of the branches had evidence of some included bark and poorly developed branch unions (see Photo #3 in Appendix A).

The most likely and relevant failure would be to one of the roughly 4-6 inch diameter and 10-15 foot long braches on the west side because of their overextended growth and evidence of poorly developed branch unions. This failure would be most likely to occur during abnormal or extreme weather conditions.

Some of the branches (examples indicated by **red arrows**) had evidence of some included bark and poorly developed branch unions. There was a fair amount of responsive growth including grafting to other branches (**green arrow**) located around most of these poorly structured branch unions.

After analyzing site observations and running them individually through the tree risk assessment matrices (Figure 2), it was concluded that the subject tree is currently presenting an overall low risk and mitigation is not necessary at this time. If the City of Encinitas would like to further decrease the overall associated risks then I recommend reducing or removing the branches pointed out in Appendix A, Photo #3 as well as maintaining the tree near its current height and retaining interior foliage. This should be achieved using pruning techniques which are further explained in Figure 3 below as well as Appendix B .

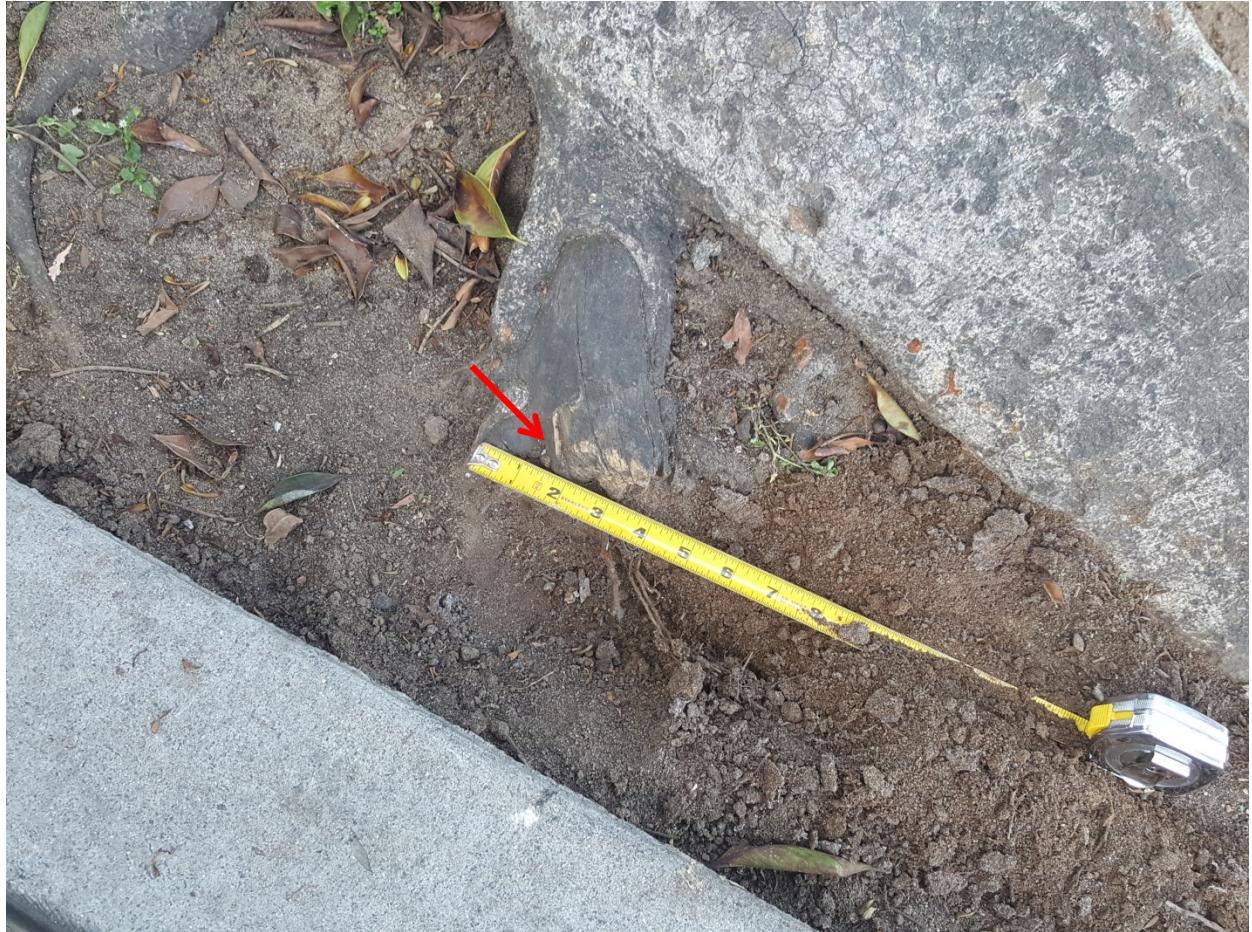
- There was evidence of some older root pruning that occurred near tree's base, likely to perform hardscape repairs. The percentage of overall root mass that was observed to be injured did not appear great enough to compromise structural stability (see Photo #4 in Appendix A).
- There was evidence of hardscape repairs such as slab replacements and sidewalk grinding to mitigate trip hazards around the tree (see Photo #5 in Appendix A).

There was evidence of some older root pruning that occurred near tree's base (red arrow), likely to perform hardscape repairs. The percentage of overall root mass that was observed to be injured did not appear great enough to compromise structural stability.

If conflicts between roots and infrastructure arise in the future, I recommend consulting with an ISA Certified Arborist to aid in finding the most efficient long term solution with minimal impacts to the tree. It is with the health and safety of the community in mind for which I present these recommendations.

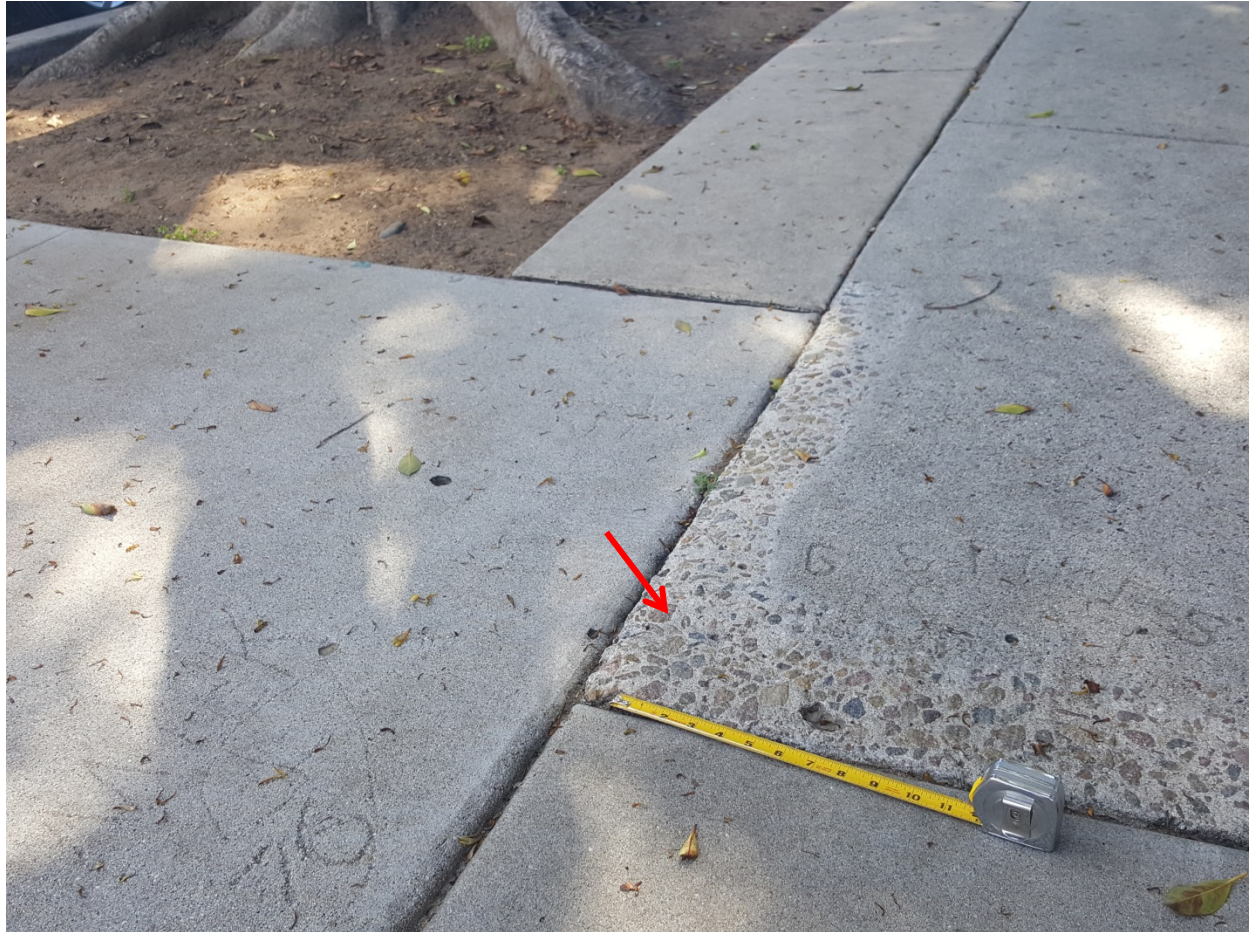
Photo #5

There was evidence of hardscape repairs such as slab replacements and sidewalk grinding (red arrow) to mitigate trip hazards around the tree.
