City of Encinitas

3.3.17 Assessment of Ficus Tree Near 510 Second Street

MARCH 3, 2017

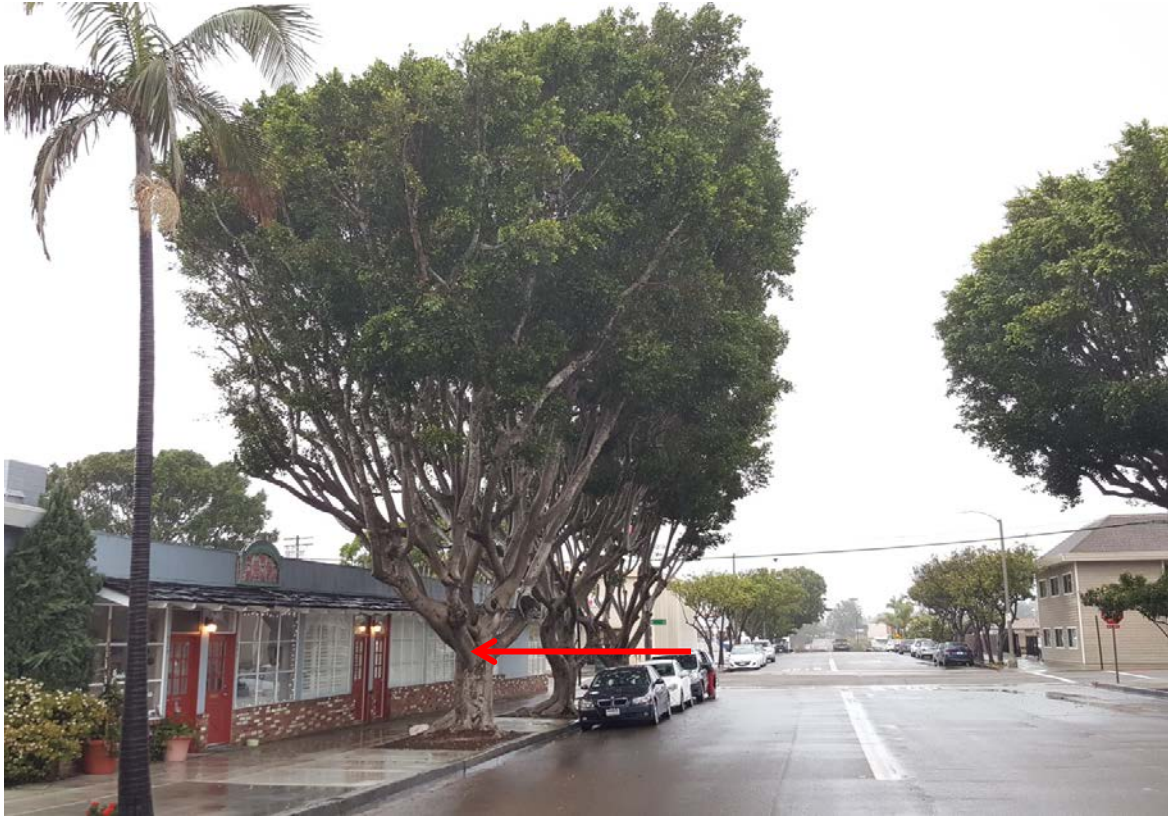
- The tree was growing in a 7 foot wide tree well on the west side of 2nd St. and in front of the 510 business address (see Figure 1, as well as Photo #1 in Appendix A).

- Judging by the color and density of the foliage, the tree appeared to be in fair health for the species and time of year. There was a moderate **live crown ratio** of approximately 50% which is common for street trees necessitating crown raising for vehicle clearance (see Photo #1 in Appendix A).

- The tree (**red arrow**) was growing in a 7 foot wide tree well on the west side of 2nd St. in front of the 510 business address.
- Judging by the color and density of the foliage, the tree appeared to be in fair health for the species and time of year. There was a moderate **live crown ratio** of approximately 50% which is common for street trees necessitating raised crowns for vehicle clearance.

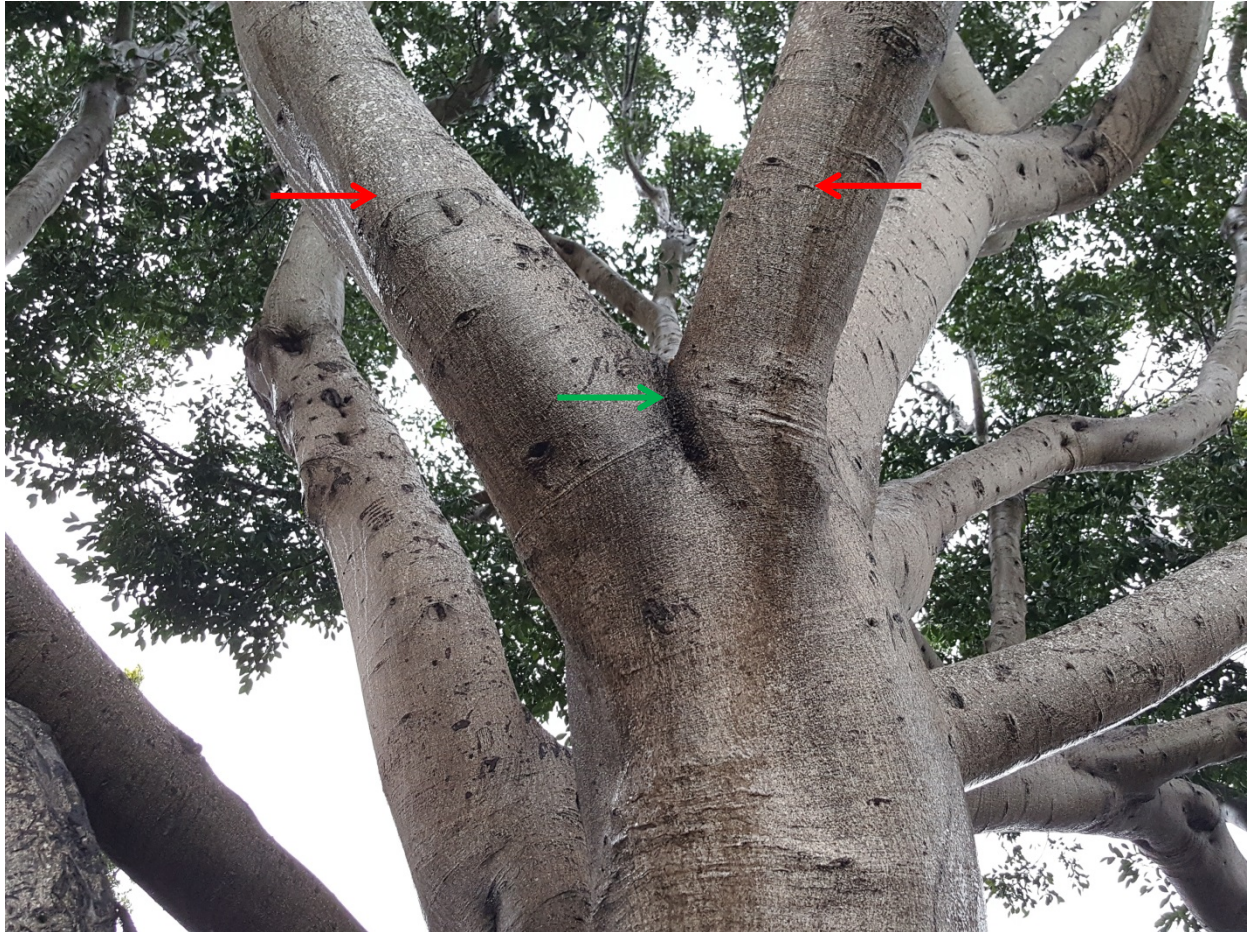
- The tree had a DSH² measurement of 32 inches and a height of about 45 feet (measured with a TruPulse laser).
- The tree had multiple **codominant stems** with some **included bark** which is indicative of poor tree structure. There was a fair amount of **responsive growth** located around most of these poorly structured branch unions (see Photo #2 in Appendix A).

The tree had multiple **codominant stems** (red arrows) with some **included bark** (green arrow) which is indicative of poor tree structure. There was a fair amount of **responsive growth** located around most of these poorly structured branch unions (see red arrow).

Risk: In order to help decrease associated risks to an overall low for the subject tree, I recommend performing an approximate 25% **crown reduction**⁶ (see Appendix B as well a Figure 3 below) to reduce the mechanical stress being applied on weakened roots and branch unions. This crown reduction should be done in compliance to ANSI A300 Arboricultural Standards and will need to be applied over multiple spaced out pruning doses (taking up to 5 years) to minimize health impacts on the tree. This is also recommended to allow time for interior growth to further develop and broaden the options for new branches to prune back to. Pruning techniques such as **reduction pruning**, and **removal pruning cuts** should be used (not topping) to achieve this overall squattier appearance and are further explained in Figure 3 and Appendix B.

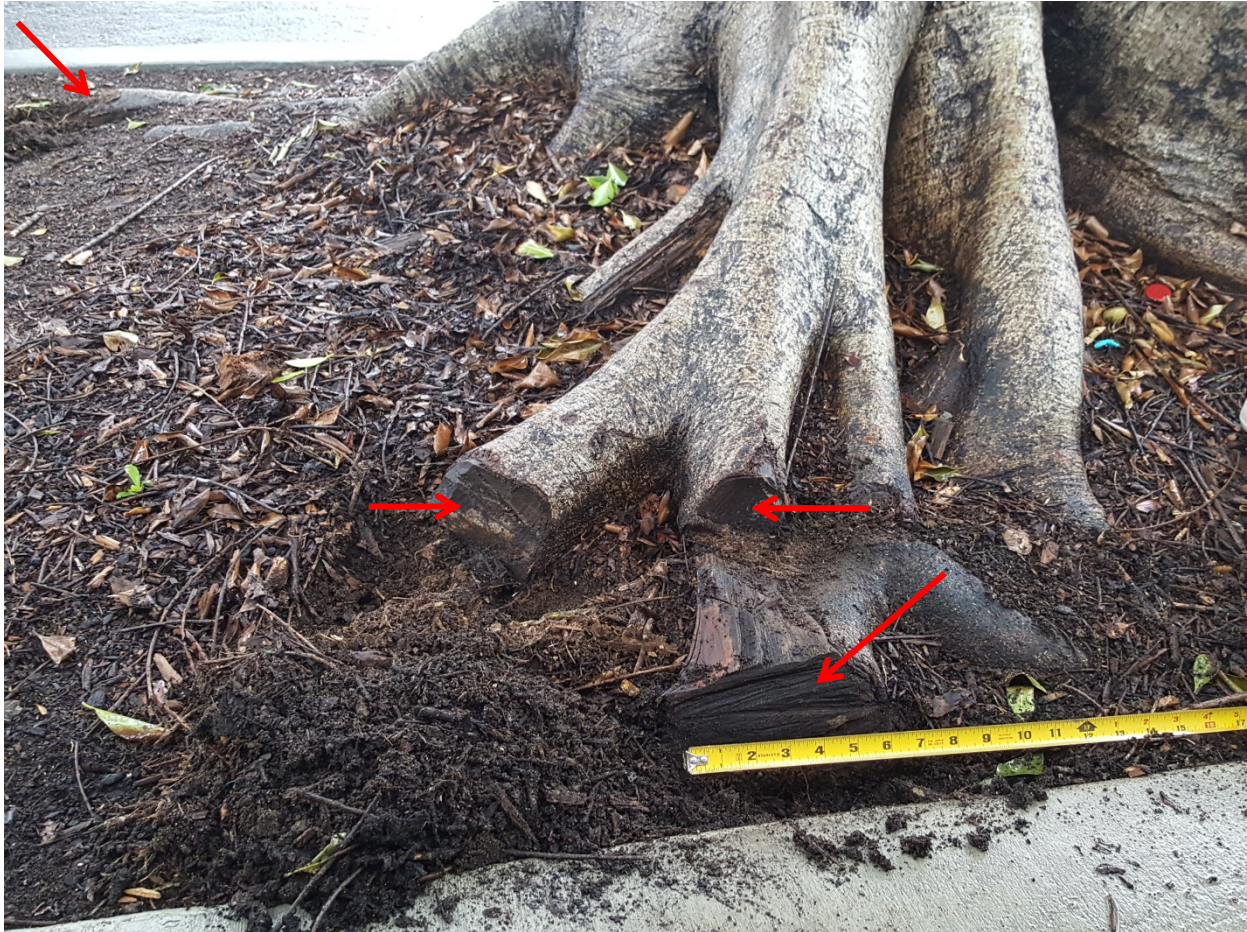
- There was evidence of root pruning to at least 4 **buttress roots** near west and north sides of the tree's base. The largest of these root injuries was about 7 inches in diameter. Some of these roots had a hollow resonance to them while sounding them with a mallet (see Photo #3 in Appendix A).

The subject tree had evidence of root pruning to at least 4 **buttress roots**⁴ on its north-west side within a proximity to the trunk where studies have shown⁵ to negatively impact tree and stability. However, the subject tree had not failed, nor was it showing indicators of a developing failure (such as soil cracks, heaving, or lean) after the abnormally extreme weather conditions experienced throughout this recent winter. Taking both of these factors into account, the *likelihood of failure* for this tree within the next year has been assessed as **possible** with the most likely and relevant failure being uprooting of the entire tree towards 2nd St. (Opposite to where the root pruning occurred). This failure would be most likely to occur during abnormal or extreme weather conditions.

There was evidence of root pruning to at least 4 **buttress roots** near west and north sides of the tree's base (see **red arrows**). The largest of these root injuries was about 7 inches in diameter. Some of these roots had a hollow resonance to them while sounding them with a mallet.

Root Pruning: Root pruning (such as observed on this tree) is an injurious practice that can significantly damage trees and affect their structural strength and health. If future conflicts between roots and infrastructure occur, I recommend looking into alternative mitigation strategies such as **elevated root bridging** to minimize the pruning of roots. It is with the health and safety of the community for which I present all of these recommendations.

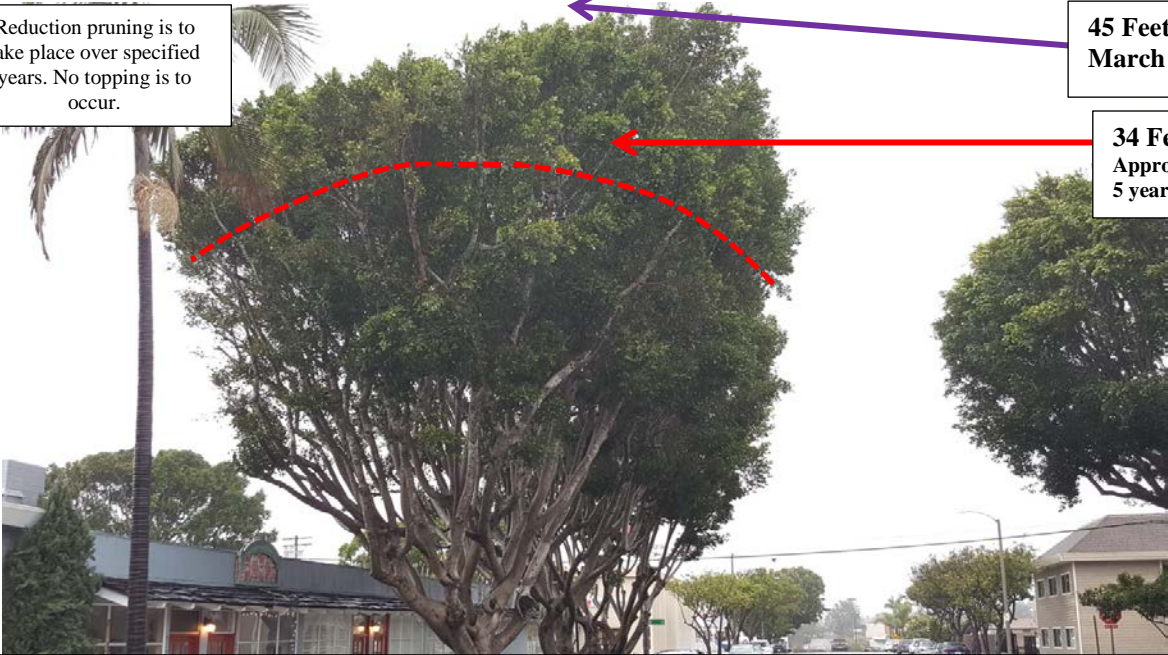
Crown Reduction Pruning Goal

This tree had a measured height of 45 feet (see purple arrow). The proposed goal is to achieve a 25% (11.25 feet) **crown reduction through a multi-year pruning plan (taking up to five years)** leaving the tree with a height of approximately 34 feet (see red dotted line and arrow) after the final pruning dose.

Reduction pruning is to take place over specified years. No topping is to occur.
