City of Encinitas

4.6.17 Assessment of Ficus Tree Near 510 Second St.

APRIL 6, 2017

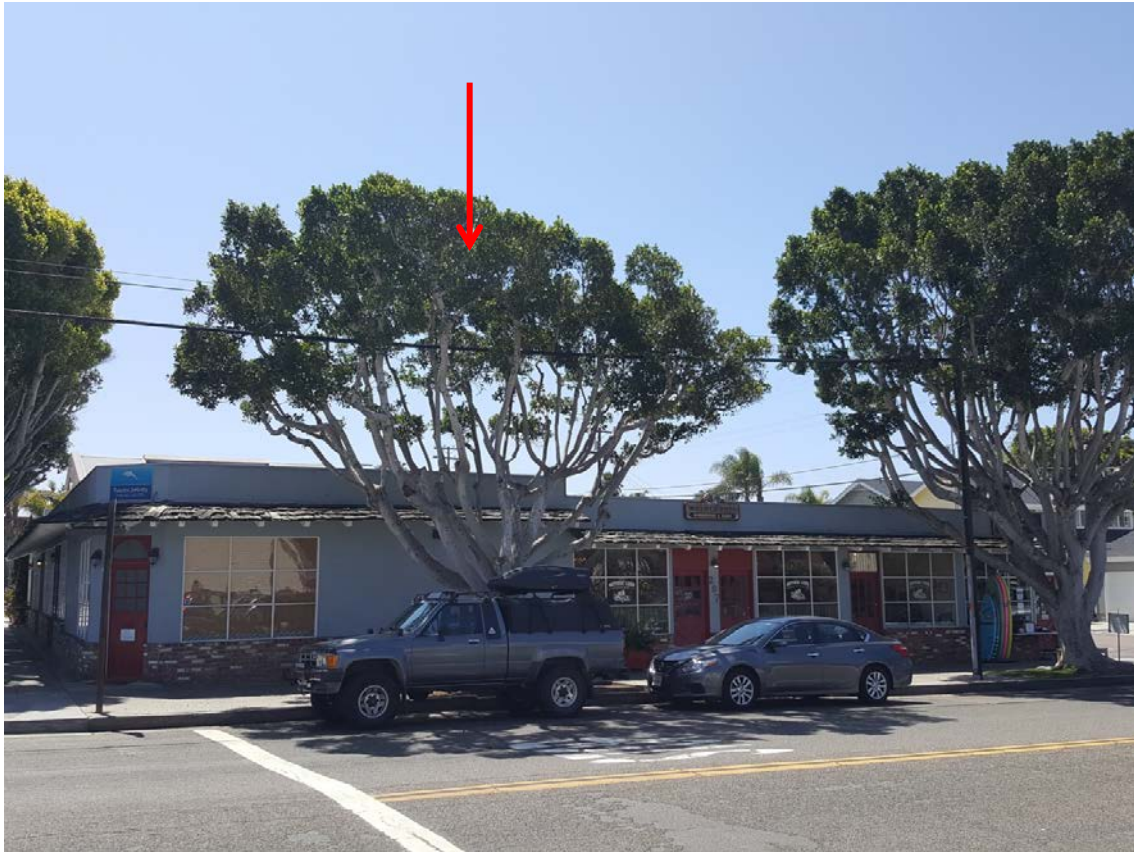
- The tree was growing in a 7.5 foot wide tree well on the south side of the 200 block on D St. (see Photo #1 in Appendix A).
- Judging by the color and density of the foliage, the tree appeared to be in fair to poor health for the species and time of year. The tree had a low **live crown ratio** of approximately 40% which is common for street trees necessitating raised crowns for vehicle/ building clearance.

- The tree had multiple **codominant stems** and branches which are indicative of poor structure yet common to this species (see Photo #1 in Appendix A).

- There were some powerlines running through the canopy of the tree.
- The tree had a DSH² measurement of 25 inches and a height of about 30 feet (measured with a TruPulse laser).

- The tree (**red arrow**) was growing in a 7.5 foot wide tree well on the south side of the 200 block on D St.
- Judging by the color and density of the foliage, the tree appeared to be in fair to poor health for the species and time of year. The tree had a low **live crown ratio** of approximately 40% which is common for street trees necessitating raised crowns for vehicle/ building clearance.
- The tree had multiple **codominant stems** and branches which are indicative of poor structure yet common to this species.
- There were some powerlines running through the canopy of the tree.

1. I recommend maintaining the tree close to its current height using **reduction pruning** techniques (not topping) which are further explained in Appendix B. Retaining as much interior foliage as possible will also be important for both tree health, and to develop proper branch taper.
2. In regards to improving the health of the tree, I recommend applying 2-4 inches of coarse organic mulch around the drip line of the tree (within the tree well) as well as providing deep and infrequent irrigation.
3. If future conflicts between roots and infrastructure arise, I recommend looking into alternative mitigation techniques such as root bridging or concrete grinding.

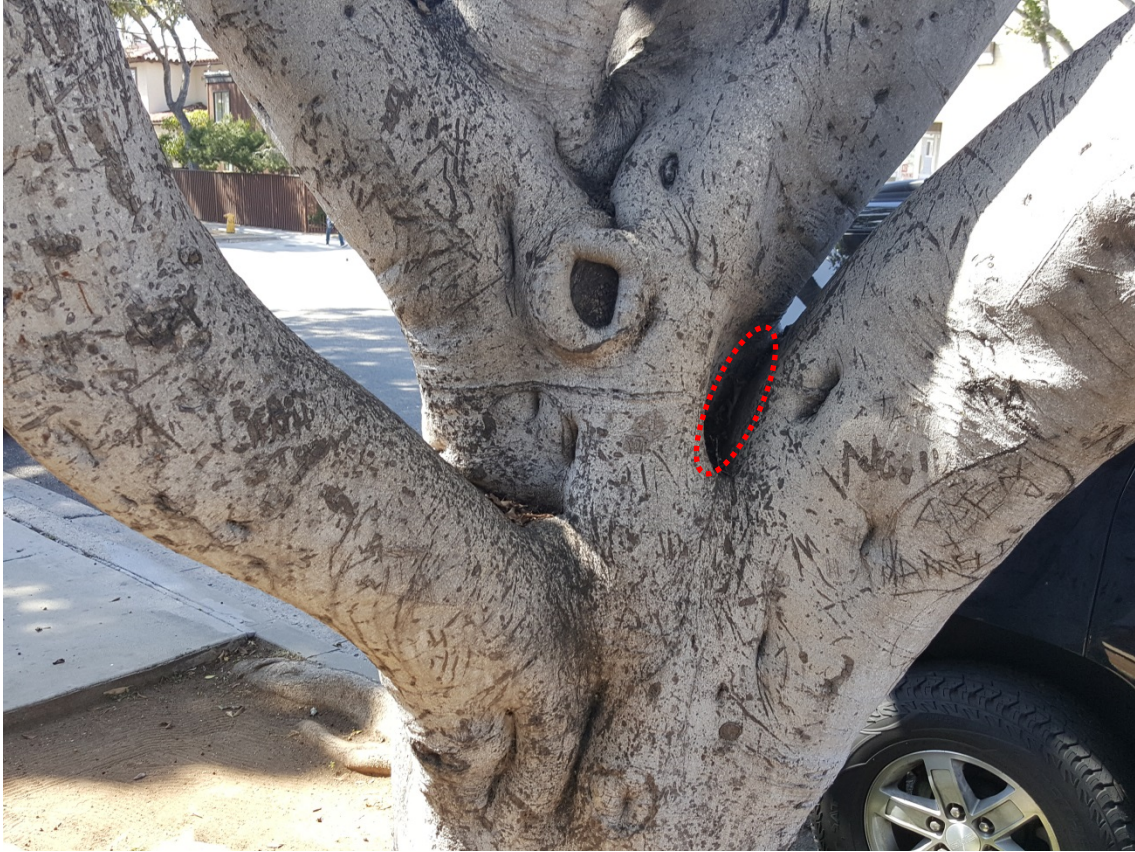
- There included bark observed between two of the codominant stems (see Photo #2 in Appendix A).
- One of the larger buttress roots was showing a **contact stress response** to growing next to the curb face. This phenomenon occurs when trees grow in close contact with infrastructure. Trunk and root tissues mold, and grow over the infrastructure element providing a level of structural support. There may be an increase in failure potential if the infrastructure element is removed or replaced (see Photo #3 in Appendix A).

- There included bark observed between two of the codominant stems (see red dotted oval).

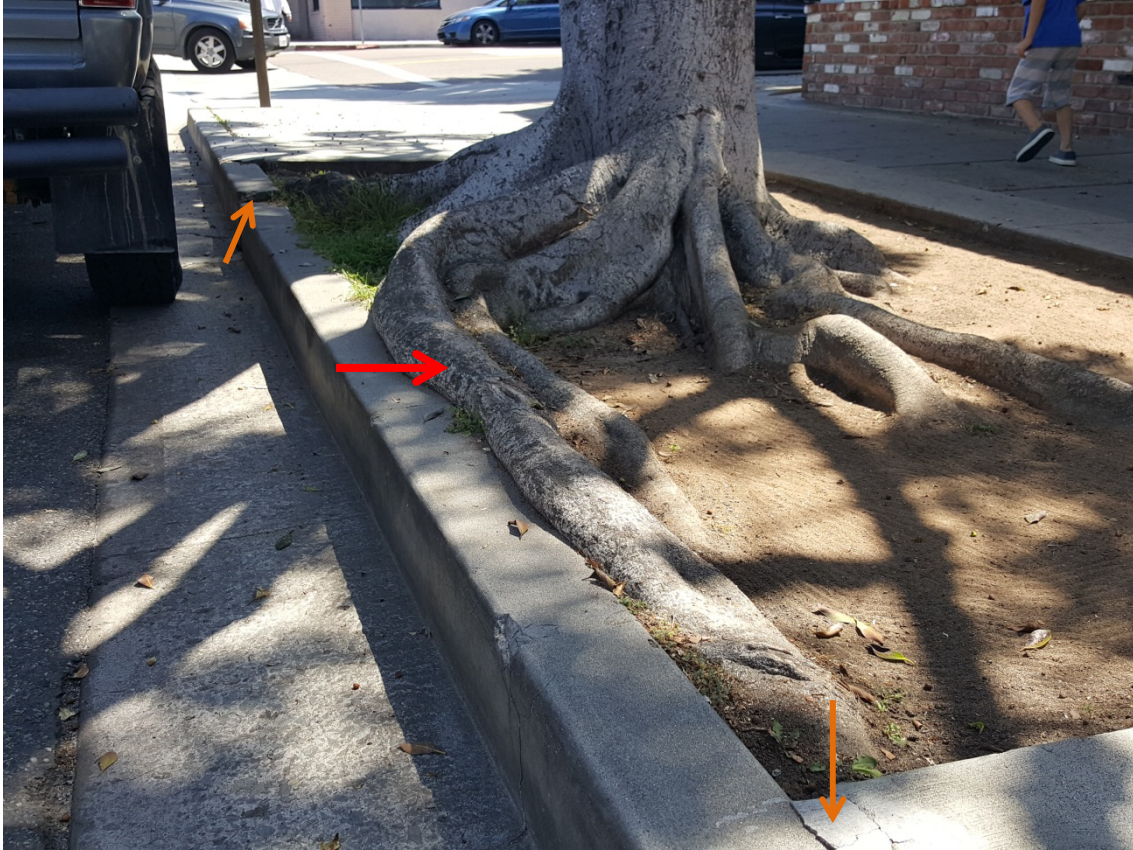
- There was evidence of some deflections and repairs around the curb face and sidewalk (see Photo #3 in Appendix A).

- One of the larger buttress roots was showing a **contact stress response** to growing next to the curb face (see **red arrow**). This phenomenon occurs when trees grow in close contact with infrastructure. Trunk and root tissues mold, and grow over the infrastructure element providing a level of structural support. There may be an increase in failure potential if the infrastructure element is removed or replaced.
- There was evidence of some deflections and repairs around the curb face and sidewalk (see **orange arrows**).
