City of Encinitas

3.23.17 Assessment of Ficus Tree At 580 Second Street (Front-1)

Gene Bordson
Certified Arborist # WE-10777A
Qualified Applicator License# 140768
Qualified Tree Risk Assessor

MARCH 23, 2017

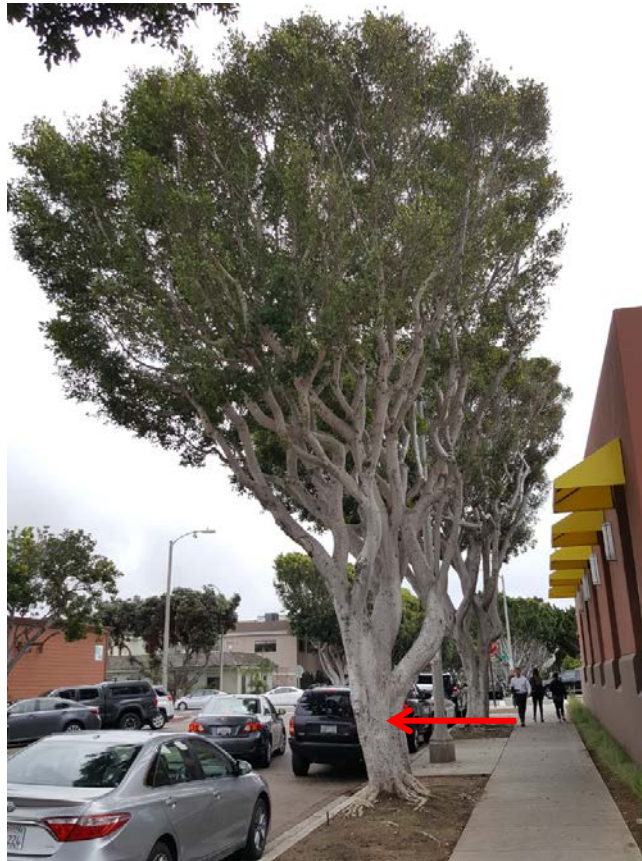
- The tree was growing in a 6 foot wide tree well on the west side of 2nd St. and in front of the 580 business address (see Figure 1, as well as Photo #1 in Appendix A).

- Judging by the color and density of the foliage, the tree appeared to be in fair health for the species and time of year. The tree had a moderate **live crown ratio** of approximately 50% which is common for street trees necessitating crown raising for vehicle clearance (see Photo #1 in Appendix A).

- The tree had a DSH² measurement of 29 inches and a height of about 45 feet (measured with a TruPulse laser).
- The tree had multiple **codominant stems** and scaffold branches which are indicative of poor tree structure (see Photo #1 in Appendix A).

- The canopy was a little unbalanced towards the east because of the pruning for building clearance (see Photo #1 in Appendix A).
- On the east side of the tree, there was an old injury from a stem failure which was likely associated with overextended growth with included bark and or a vehicle impact(see Photo #2 in Appendix A).

- The tree (red arrow) was growing in a 6 foot wide tree well on the west side of 2nd St. in front of the 580 business address.
- Judging by the color and density of the foliage, the tree appeared to be in fair health for the species and time of year. The tree had a moderate **live crown ratio** of approximately 50% which is common for street trees necessitating raised crowns for vehicle clearance.
- The tree had multiple **codominant stems** and scaffold branches which are indicative of poor tree structure
- The canopy was a little unbalanced towards the east because of past pruning for building clearance.

Risk: In order to help decrease associated risks to an overall low for the subject tree, I recommend performing an approximate 25% **canopy reduction**⁴ (see Appendix B as well as Figure 3 below). This canopy reduction will decrease the mechanical stress applied to the root system because of the increased wind penetration and reduced leverage effects from overextended growth. This work performed should be done in compliance to ANSI A300 Arboricultural Standards and will need to be applied over multiple spaced out pruning doses (taking up to five years) to minimize health impacts on the tree. This is also recommended to allow time for interior growth to further develop and broaden the options for new branches to prune back to. Pruning techniques such as **reduction pruning**, and **removal pruning cuts** should be used (not topping) to achieve this overall squattier appearance and are further explained in Appendix B.

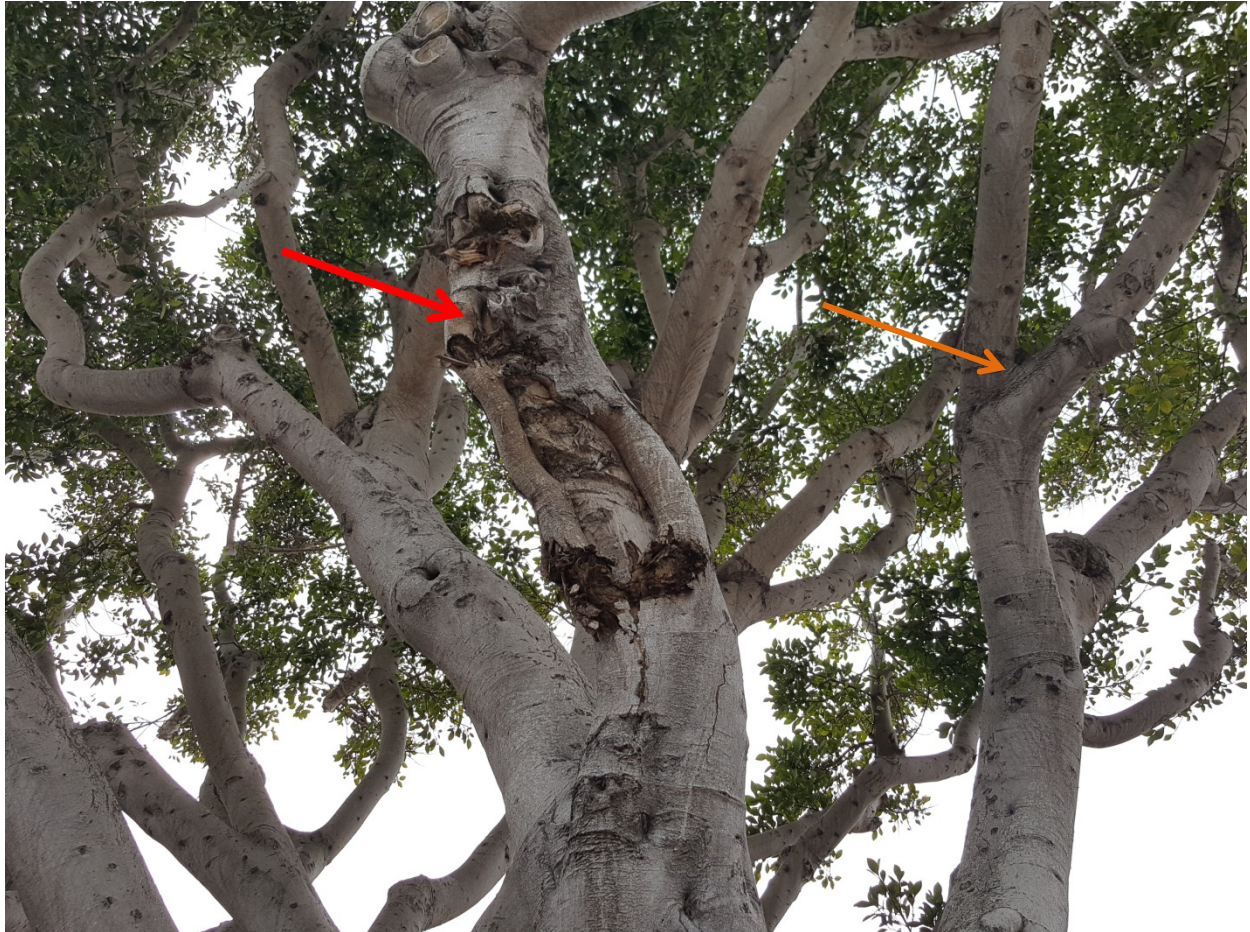
Photo #2

- On the east side of the tree, there was an old injury from a stem failure (red arrow) which was likely associated with overextended growth with included bark and or a vehicle impact.
- There were a few codominant branches observed to have a bit of included bark (orange arrow).

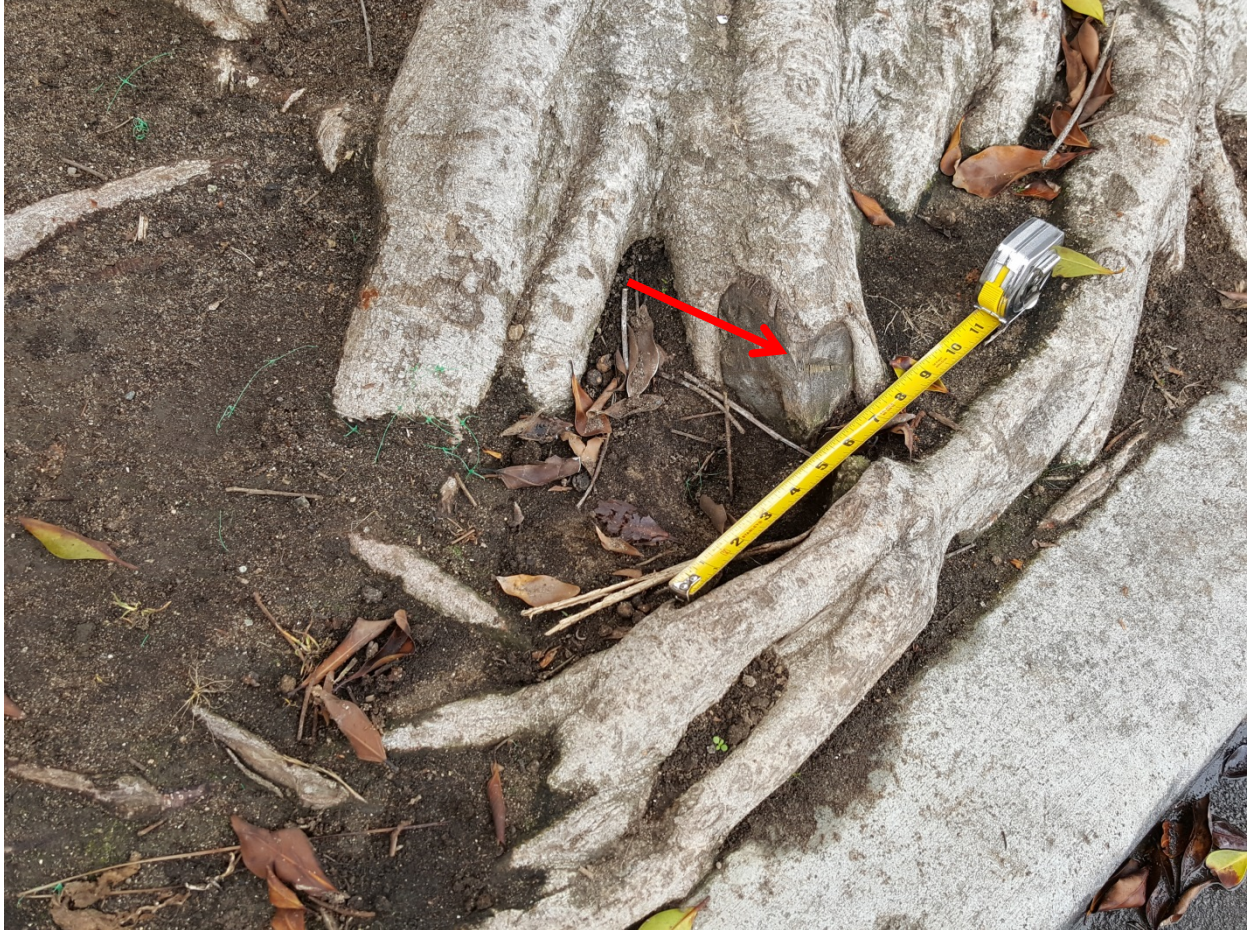
Photo #3

There was one 4-5 inch pruning wound observed on the east side of the tree near the curb face (see red arrow).

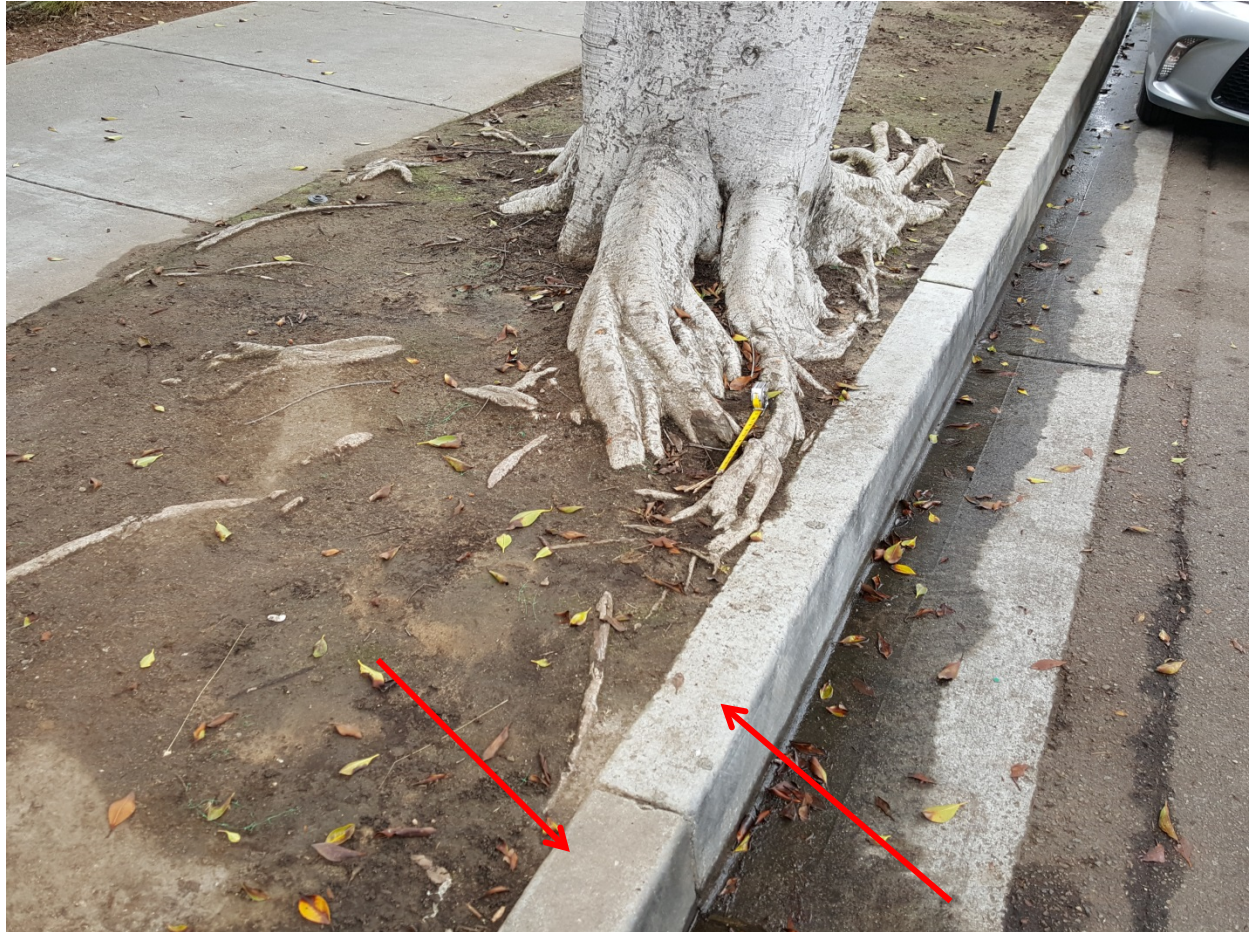
- Judging by the lighter color of the curb face in front of the tree, it appeared that a large section of curb face was replaced on the east side of the tree. It is likely yet unknown if additional subterranean root pruning occurred during this hardscape repair (see Photo #4 in Appendix A).

The *likelihood of a failure* within the next year has been assessed as **possible** for the subject tree. The most likely and relevant failure would be uprooting of the entire tree (windthrow, root failure) because of observed root pruning, slightly unbalanced canopy, and the possibility that additional root injuries occurred when replacing the curb face. The tree did not fail throughout this recent year's abnormal winter weather conditions but failure is still possible due to these factors. This potential failure event would be most likely to occur during abnormal or extreme weather conditions.

Judging by the lighter color of the curb face in front of the tree, it appeared that a large section of curb face was replaced on the east side of the tree (see **red arrows**). It is likely yet unknown if additional subterranean root pruning occurred during this hardscape repair.

Root Pruning: Root pruning (such as observed on this tree) is an injurious practice that can significantly damage trees and affect their structural strength and health. If future conflicts between roots and infrastructure occur, I recommend looking into alternative mitigation strategies such as **elevated root bridging**, or meandering sidewalks to minimize damage to roots.
