City of Encinitas

3.23.17 Assessment of Ficus Tree At 580 Second Street (Front-2)

MARCH 23, 2017

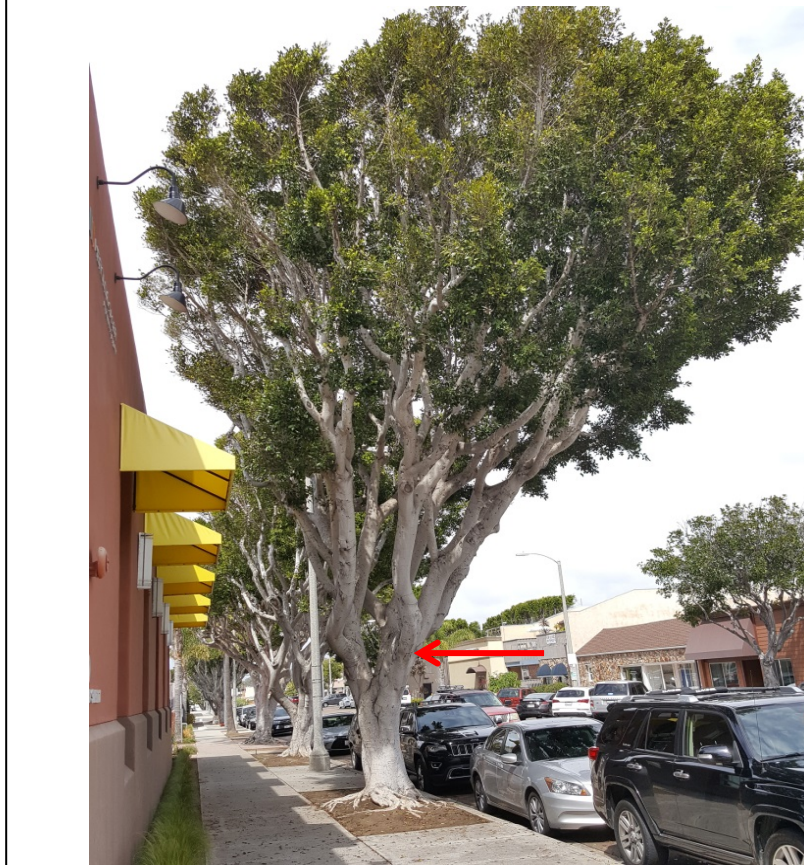
- The tree was growing in a 6 foot wide tree well on the west side of 2nd St. and in front of the 580 business address (see Figure 1, as well as Photo #1 in Appendix A).

- Judging by the color and density of the foliage, the tree appeared to be in fair health for the species and time of year. The tree had a moderate **live crown ratio** of approximately 50% which is common for street trees necessitating crown raising for vehicle clearance (see Photo #1 in Appendix A).

- The tree had a DSH² measurement of 30 inches and a height of about 45 feet (measured with a TruPulse laser).
- The tree had multiple **codominant stems** and scaffold branches which are indicative of poor tree structure (see Photo #1 in Appendix A).

- The canopy was a little unbalanced towards the east because of the pruning for building clearance (see Photo #1 in Appendix A).
- On the east side of the tree, there was an old injury from a stem failure which was likely associated with overextended growth with included bark and or a vehicle impact (see Photo #2 in Appendix A).

- The tree (red arrow) was growing in a 6 foot wide tree well on the west side of 2nd St. in front of the 580 business address.
- Judging by the color and density of the foliage, the tree appeared to be in fair health for the species and time of year. The tree had a moderate **live crown ratio** of approximately 50% which is common for street trees necessitating raised crowns for vehicle clearance.
- The tree had multiple **codominant stems** and scaffold branches which are indicative of poor tree structure.
- The canopy was a little unbalanced towards the east because of past pruning for building clearance.

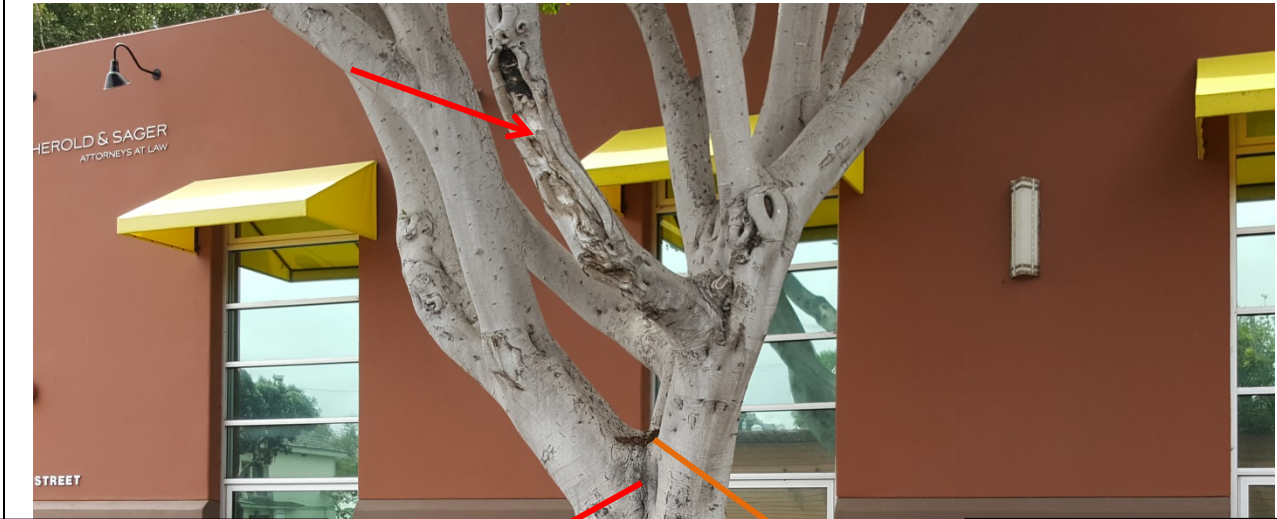
- On the east side of the tree, there was an old injury from a stem failure which was likely associated with overextended growth with included bark and or a vehicle impact (see Photo #2 in Appendix A).

- There were a few overextended stems and branches observed to have some included bark. One large codominant also had a shallow debris filled cavity (see Photo #2 in Appendix A).

The *likelihood of a failure* within the next year has been assessed as **possible** for the subject tree. The most likely and relevant failure would be to an overextended stem or scaffold branch with included bark on the east side of the tree. This potential failure event would be most likely to occur during abnormal or extreme weather conditions.

- On the east side of the tree, there was an old injury from a stem failure (**red arrow**) which was likely associated with overextended growth with included bark and or a vehicle impact.
- There were a few overextended stems and branches observed to have some included bark (see **red line** and close-up box on the left). One large stem shown above also had a shallow debris filled cavity (see **orange line** and close-up box on the right).

The subject tree has a poorly developed structure and is currently posing an overall moderate risk to the community. In order to decrease associated risks while retaining its health and unique character, I have two recommendations:

1. Perform and approximate 20% **crown reduction** (see Appendix B as well as Figure 3 below).
2. An initial focus on reducing the length of overextended horizontal growth around the tree.

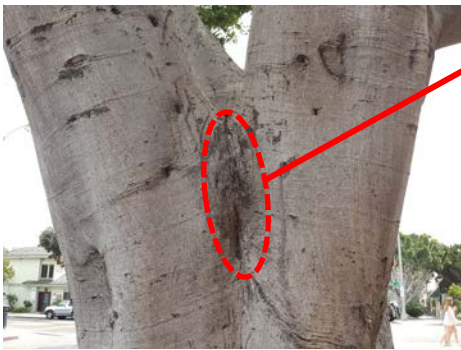
Close-up of included bark

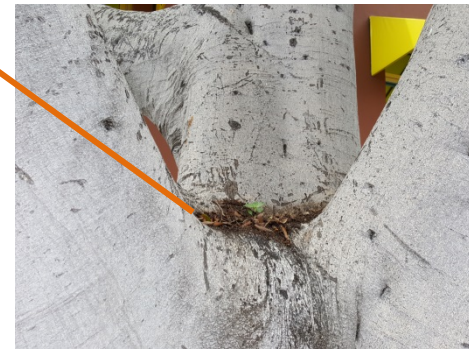
Close-up of shallow debris filled cavity
