City of Encinitas

4.8.17 Assessment of Ficus Tree At 580 2nd Street (Side-2)

APRIL 8, 2017

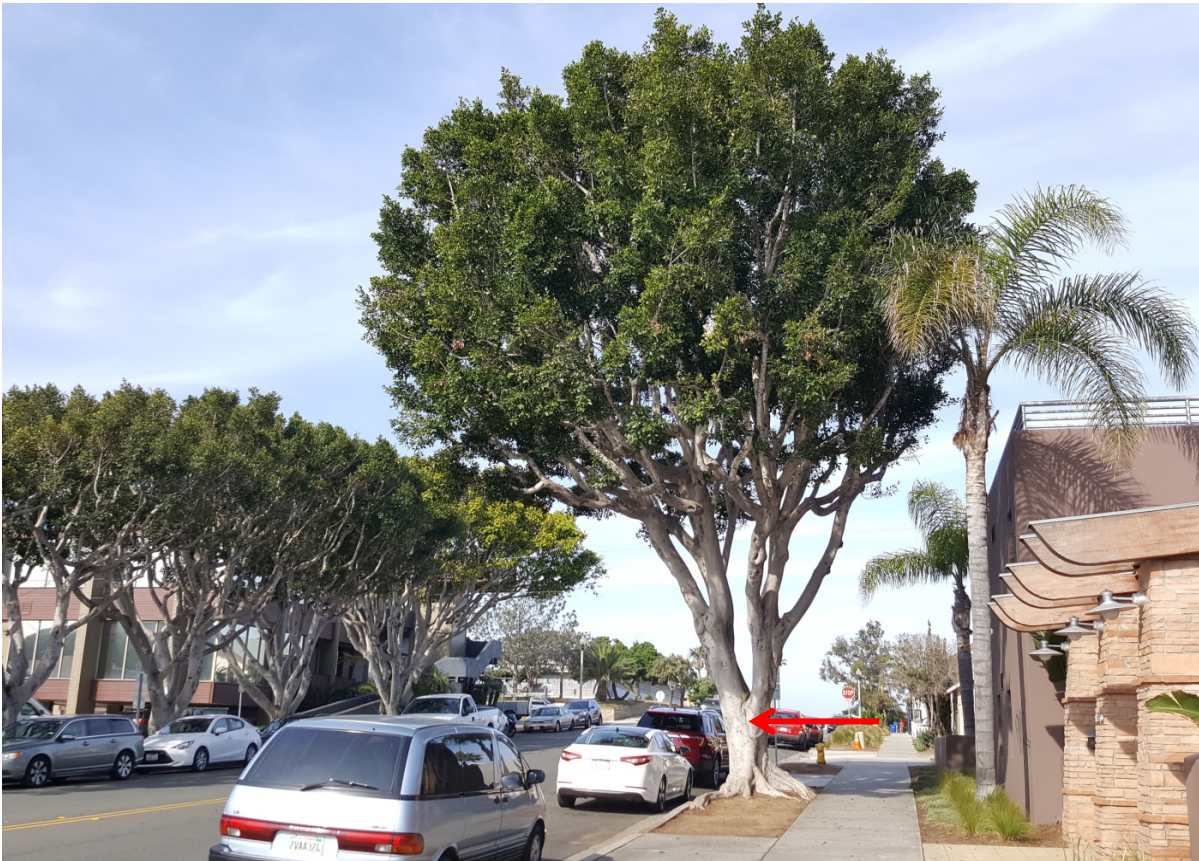
- The tree was growing in a tree well on the north side of E St. (see Photo #1 in Appendix A).
- Judging by the color and density of the foliage, the tree appeared to be in fair health for the species and time of year. The tree had a moderate **live crown ratio** of approximately 50% which is common for street trees necessitating raised crowns for vehicle and building clearance (see Photo #1 in Appendix A).

- The tree had a DSH² measurement of 34 inches and a height of about 45 feet (measured with a TruPulse laser).
- The tree had multiple codominant stems and overextended scaffold branches which are indicative of poor structure yet fairly common among this species (see Photo #1 in Appendix A).

The defect of greatest concern for the subject tree was the overextended stems/ scaffold branches with included bark. The *likelihood of this failure* within the next year was assessed as **possible** for the subject tree. Failure events would be most likely to occur during abnormal or extreme weather conditions.

- The tree (red arrow) was growing in a tree well on the North side of E St.
- Judging by the color and density of the foliage, the tree appeared to be in fair health for the species and time of year. The tree had a moderate **live crown ratio** of approximately 50% which is common for street trees necessitating raised crowns for vehicle and building clearance.
- The tree had multiple codominant stems and overextended scaffold branches which are indicative of poor structure yet fairly common among this species.

Risk and Mitigation – After performing a **Level 2 Basic Assessment**⁴, the subject tree was assessed to have an overall moderate risk rating. In regards to mitigating these risks, I recommend applying and maintaining an approximate 20% overall crown reduction (retaining interior growth) with the structure and canopy balance of the tree in mind (see Appendix B as well as Figure 3 below). This recommended pruning should be done in compliance to ANSI A300 Arboricultural Standards and will need to be applied over multiple spaced out pruning doses (up to five years) to minimize health impacts on the tree. This is also recommended to allow time for interior growth to further develop and broaden the options for new branches to prune back to. Pruning techniques such as **reduction pruning**, and **removal pruning cuts** should be used (not topping) to achieve this overall squattier appearance and are further explained in Appendix B. The end outcome should be a reduction of **mechanical stress** from overextended loads. A residual risk of “Low” should be achieved after implementing these recommended pruning strategies. It is with the health and safety of the community that I present these recommendations.

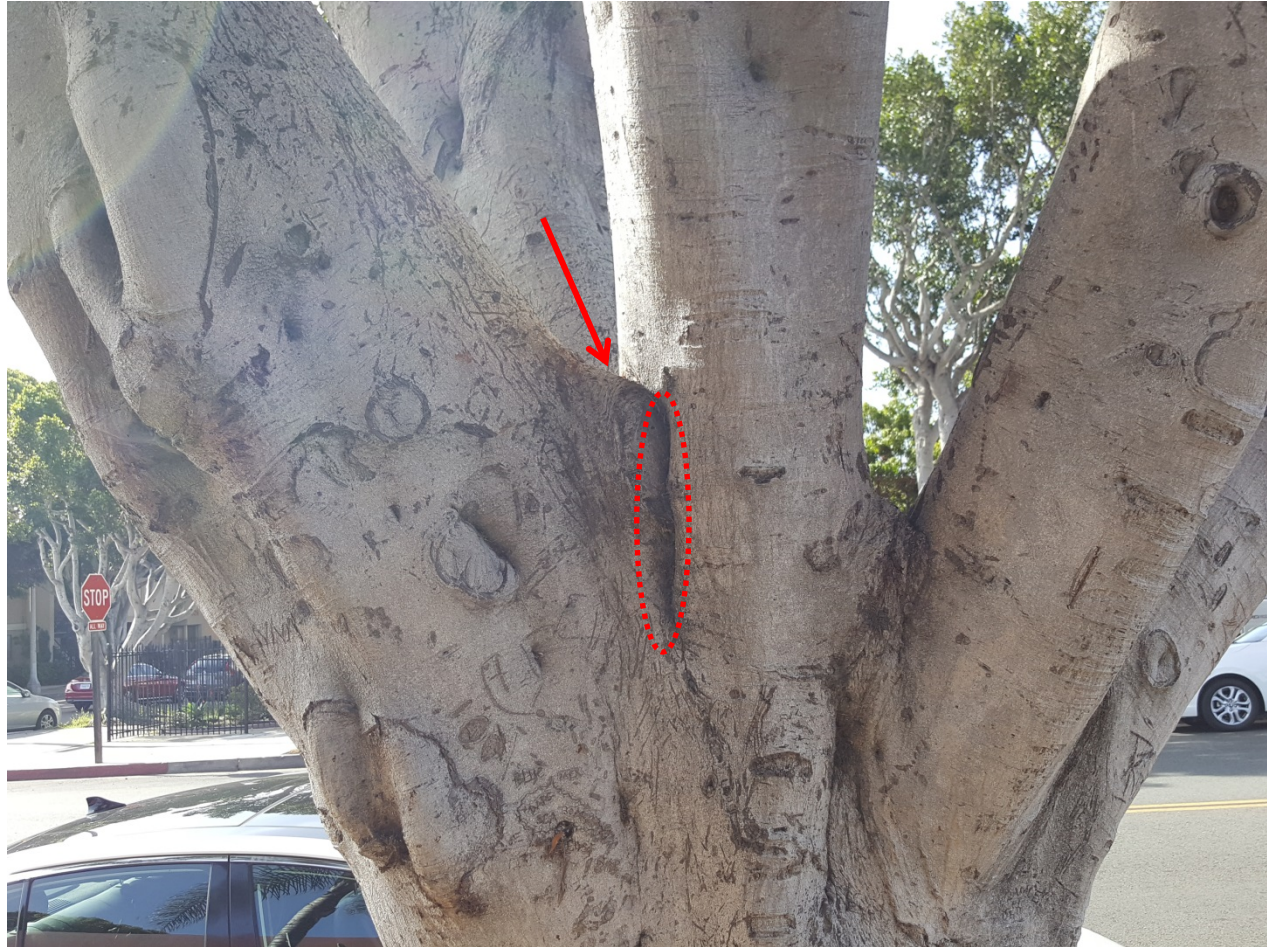
- Some of the stems and scaffold branches had presence of included bark as well as a small debris cavity between the branch unions (see Photo #2 in Appendix A).

- Some of the stems and scaffold branches had presence of included bark (red dotted oval) as well as a shallow debris cavity between the branch unions (red arrow).

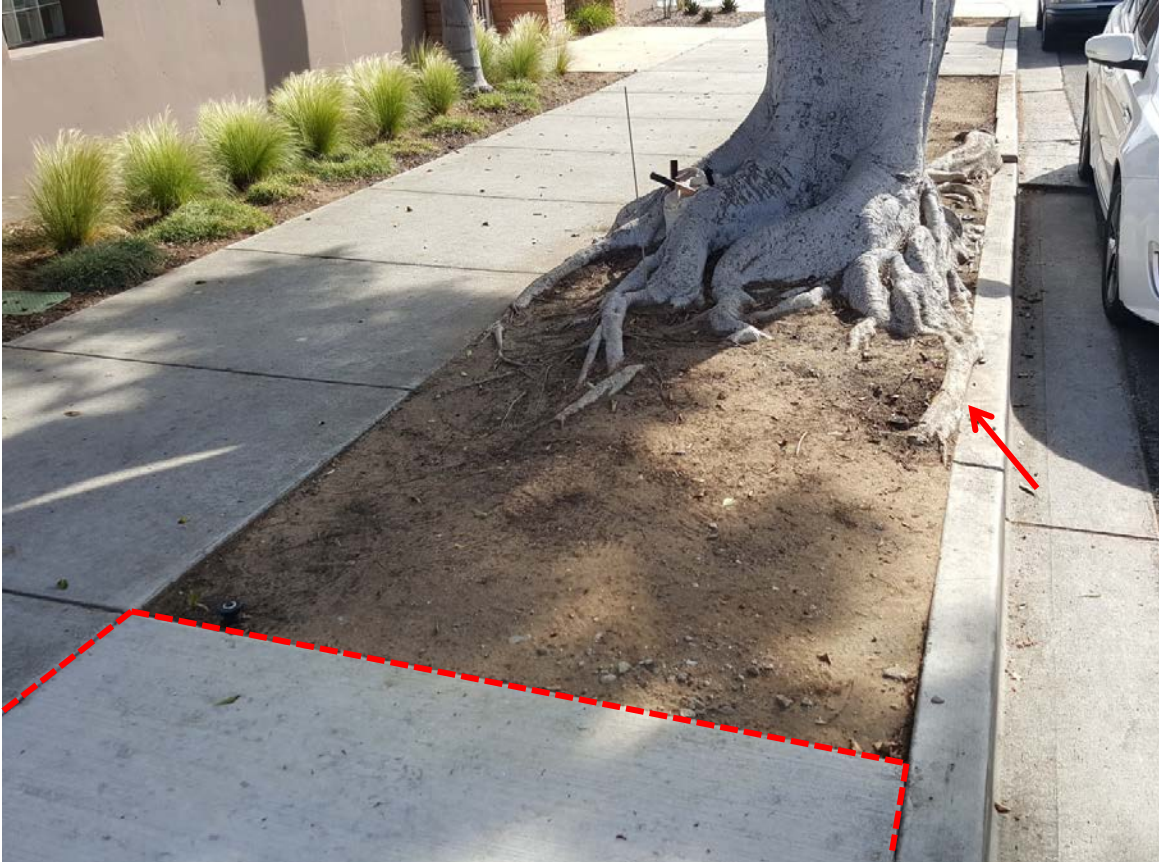
- Judging by the lighter tone of concrete, it appeared that a section of sidewalk had been replaced around the tree (see Photo #3 in Appendix A).
- Some of the buttress roots were showing a **contact stress response** to growing next to the curb face. This phenomenon occurs when trees grow in close contact with infrastructure. Trunk and root tissues mold, and grow over the infrastructure element providing a level of structural support. There may be an increase in failure potential if the infrastructure element is removed or replaced. There also appeared to be some older damage to the living tissues on the top of the root (see Photo #3 in Appendix A).

- Judging by the lighter tone of concrete, it appeared that a section of sidewalk had been replaced around the tree (see **red dotted area**).
- Some of the buttress roots were showing a **contact stress response** to growing next to the curb face (see **red arrow**). This phenomenon occurs when trees grow in close contact with infrastructure. Trunk and root tissues mold, and grow over the infrastructure element providing a level of structural support. There may be an increase in failure potential if the infrastructure element is removed or replaced. There also appeared to be some older damage to the living tissues on the top of the root.
