City of Encinitas

4.8.17 Assessment of Ficus Tree At 610 2nd Street (Side-1)

Gene Bordson
Certified Arborist # WE-10777A
Qualified Applicator License# 140768
Qualified Tree Risk Assessor

APRIL 8, 2017

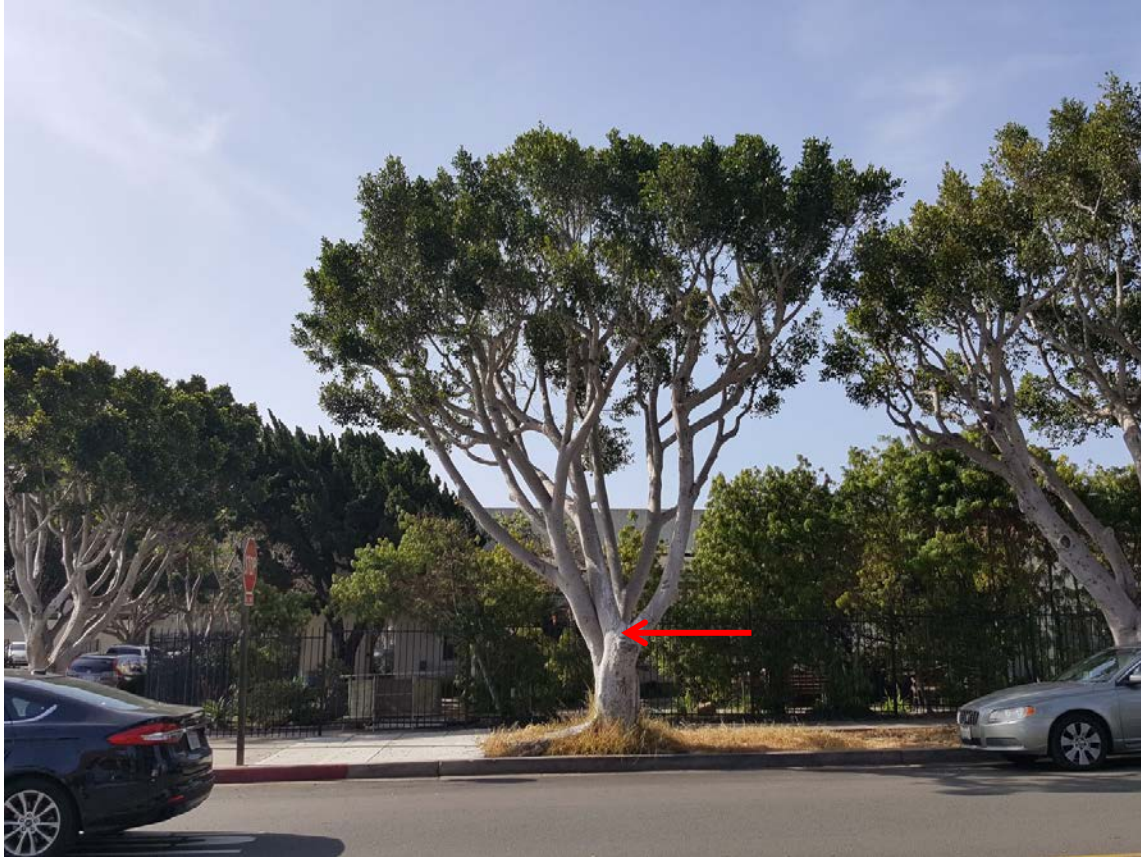
- The tree was growing in a tree well on the south side of E St. (see Photo #1 in Appendix A).
- Judging by the color and density of the foliage, the tree appeared to be in fair health for the species and time of year. The tree had a moderate **live crown ratio** of approximately 50% which is common for street trees necessitating raised crowns for vehicle and building clearance (see Photo #1 in Appendix A).

- The tree had a DSH² measurement of 25 inches and a height of about 28 feet (measured with a TruPulse laser).
- The tree had multiple codominant stems and scaffold branches which are indicative of poor structure yet fairly common among this species (see Photo #1 in Appendix A).

- The tree (red arrow) was growing in a tree well on the south side of E St.
- Judging by the color and density of the foliage, the tree appeared to be in fair health for the species and time of year. The tree had a moderate **live crown ratio** of approximately 50% which is common for street trees necessitating raised crowns for vehicle and building clearance.
- The tree had multiple codominant stems and scaffold branches which are indicative of poor structure yet fairly common among this species.

1. I recommend maintaining the tree close to its current height using **reduction pruning** techniques (not topping) which are further explained in Appendix B. Retaining as much interior foliage as possible will also be important for both tree health, and to develop proper branch taper.
2. I recommend applying 2-4 inches of coarse organic mulch around the drip line of the tree (within the tree well) as well as providing deep and infrequent irrigation.
3. If future conflicts between roots and infrastructure arise, I recommend looking into alternative mitigation techniques such as root bridging or concrete grinding.

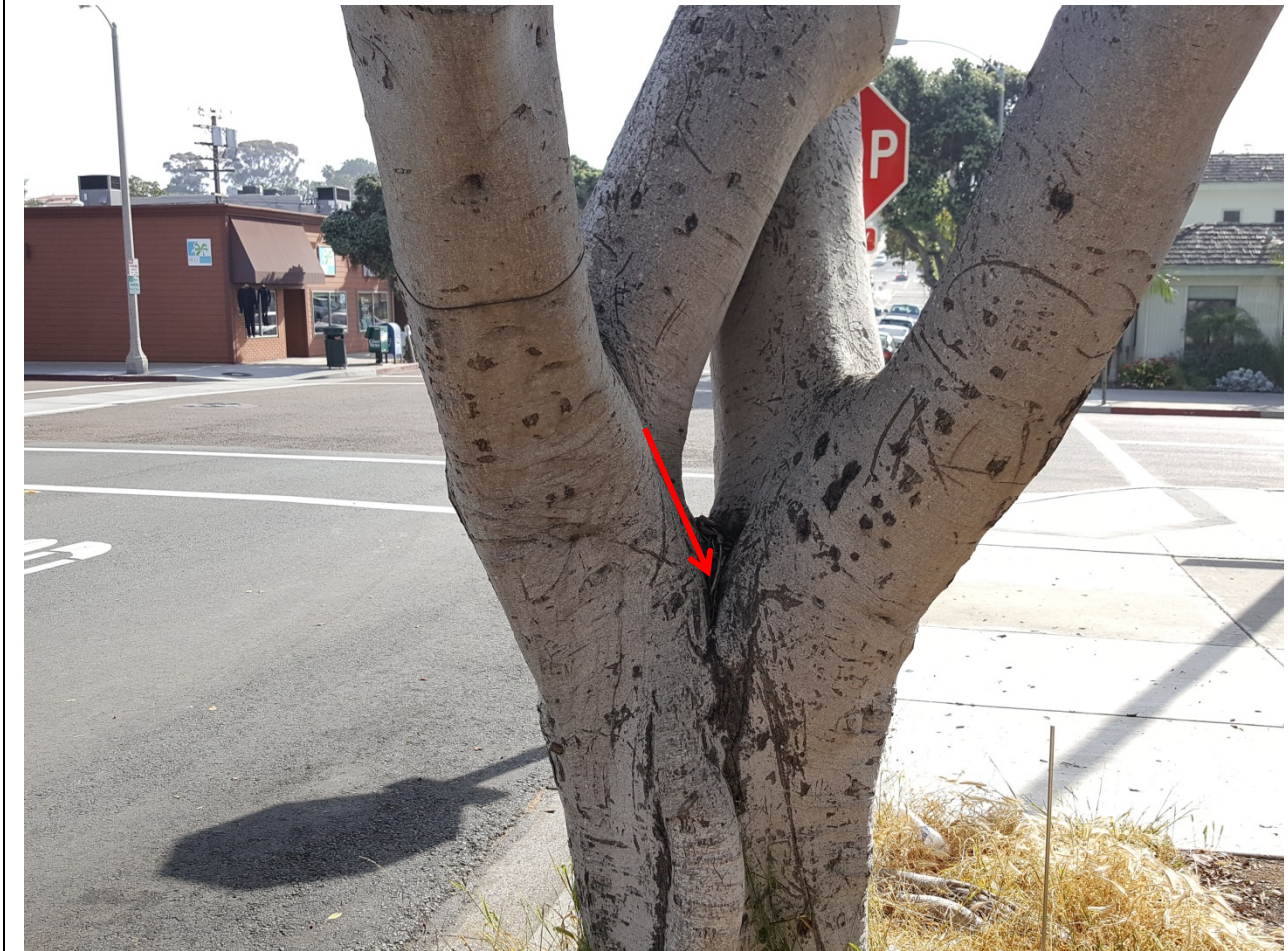
- Some of the stems and scaffold branches had presence of included bark as well as a shallow debris cavity between the unions (see Photo #2 in Appendix A).

The defect of greatest concern for the subject tree was the codominant stems/ scaffold with included bark and a small cavity. The *likelihood of this failure* within the next year was assessed as **improbable** because the stems/ scaffold branches were not overextended or experiencing significant loads from the foliage. The tree had also not experienced any failures during this recent winter's heavy storms. Failure events would be most likely to occur during abnormal or extreme weather conditions.

- Some of the stems and scaffold branches had presence of included bark as well as a shallow debris cavity between the unions (red arrow).

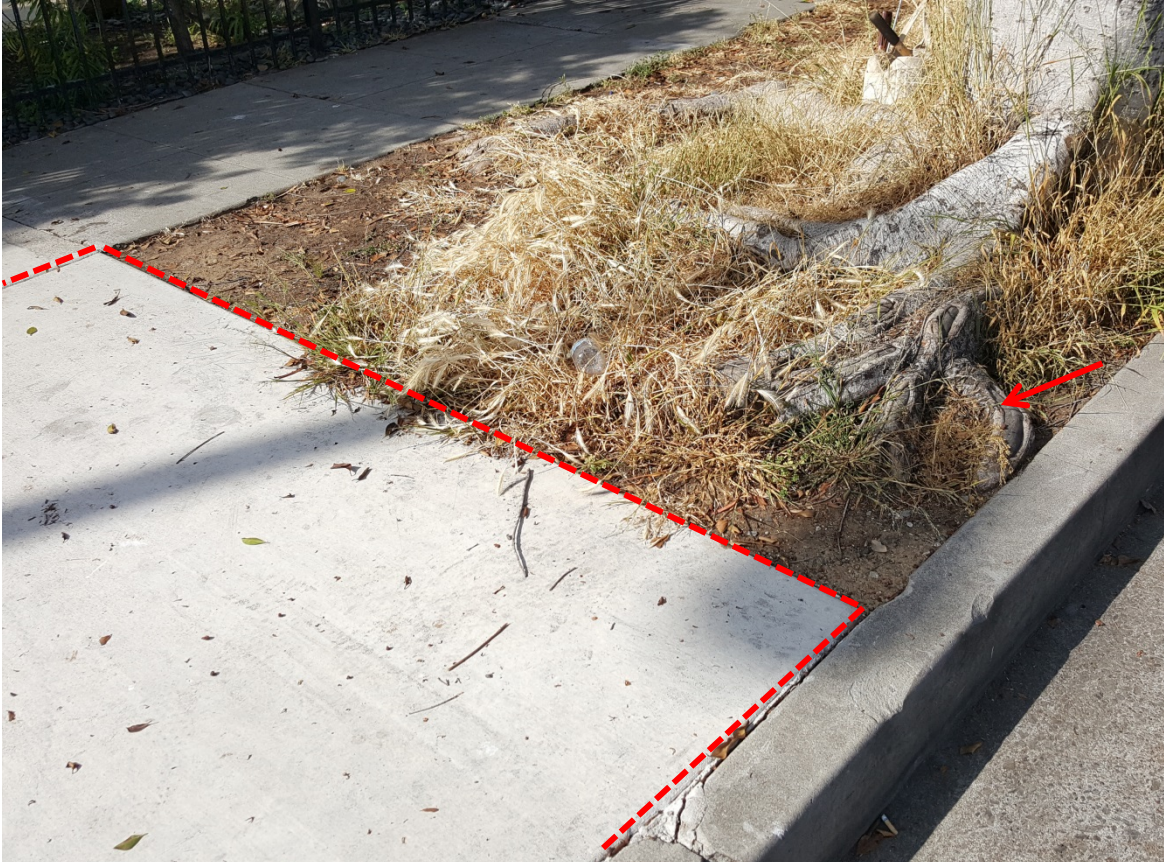
- Judging by the lighter tone of concrete, it appeared that an area of sidewalk had been replaced around the tree (see Photo #3 in Appendix A).
- There appeared to be some damage to the living tissues on the top of some surface roots (see Photo #3 in Appendix A).

- Judging by the lighter tone of concrete, it appeared that an area of sidewalk had been replaced around the tree (see **red dotted area**).
- There appeared to be some damage to the living tissues on the top of some surface roots (**red arrow**).
