City of Encinitas

4.8.17 Assessment of Ficus Tree At 610 2nd Street (Side-3)

APRIL 8, 2017

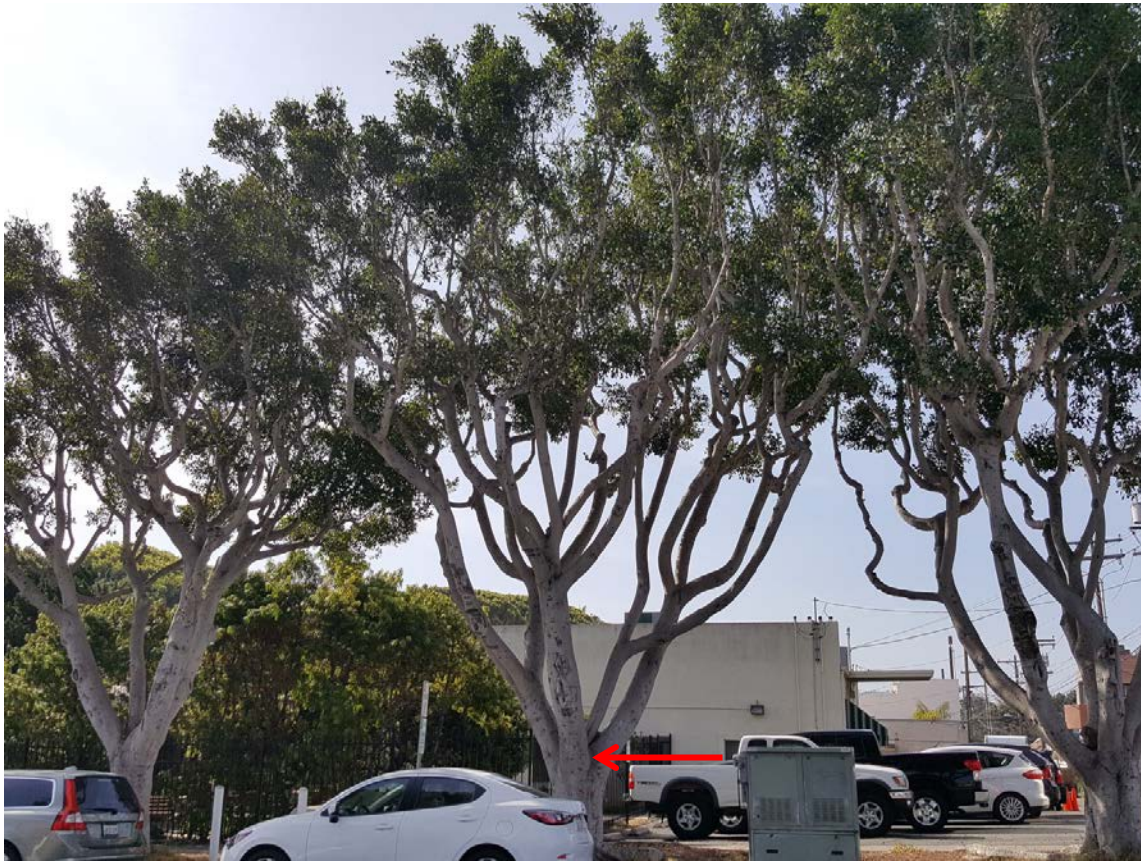
- The tree was growing in a tree well on the south side of E St. (see Photo #1 in Appendix A).
- Judging by the color and density of the foliage, the tree appeared to be in fair health for the species and time of year. The tree had a moderate **live crown ratio** of approximately 50% which is common for street trees necessitating raised crowns for vehicle and building clearance (see Photo #1 in Appendix A).

- The tree had a DSH² measurement of 30 inches and a height of about 38 feet (measured with a TruPulse laser).
- The tree had multiple codominant stems and scaffold branches which are indicative of poor structure yet fairly common among this species (see Photo #1 in Appendix A).

- The tree (red arrow) was growing in a tree well on the south side of E St.
- Judging by the color and density of the foliage, the tree appeared to be in fair health for the species and time of year. The tree had a moderate **live crown ratio** of approximately 50% which is common for street trees necessitating raised crowns for vehicle and building clearance.
- The tree had multiple codominant stems and overextended scaffold branches which are indicative of poor structure yet fairly common among this species.

1. I recommend maintaining the tree close to its current height using **reduction pruning** techniques (not topping) which are further explained in Appendix B. Retaining as much interior foliage as possible will also be important for both tree health, and to develop proper branch taper.
2. I recommend applying 2-4 inches of coarse organic mulch around the drip line of the tree (within the tree well) as well as providing deep and infrequent irrigation.
3. If future conflicts between roots and infrastructure arise, I recommend looking into alternative mitigation techniques such as root bridging or concrete grinding.

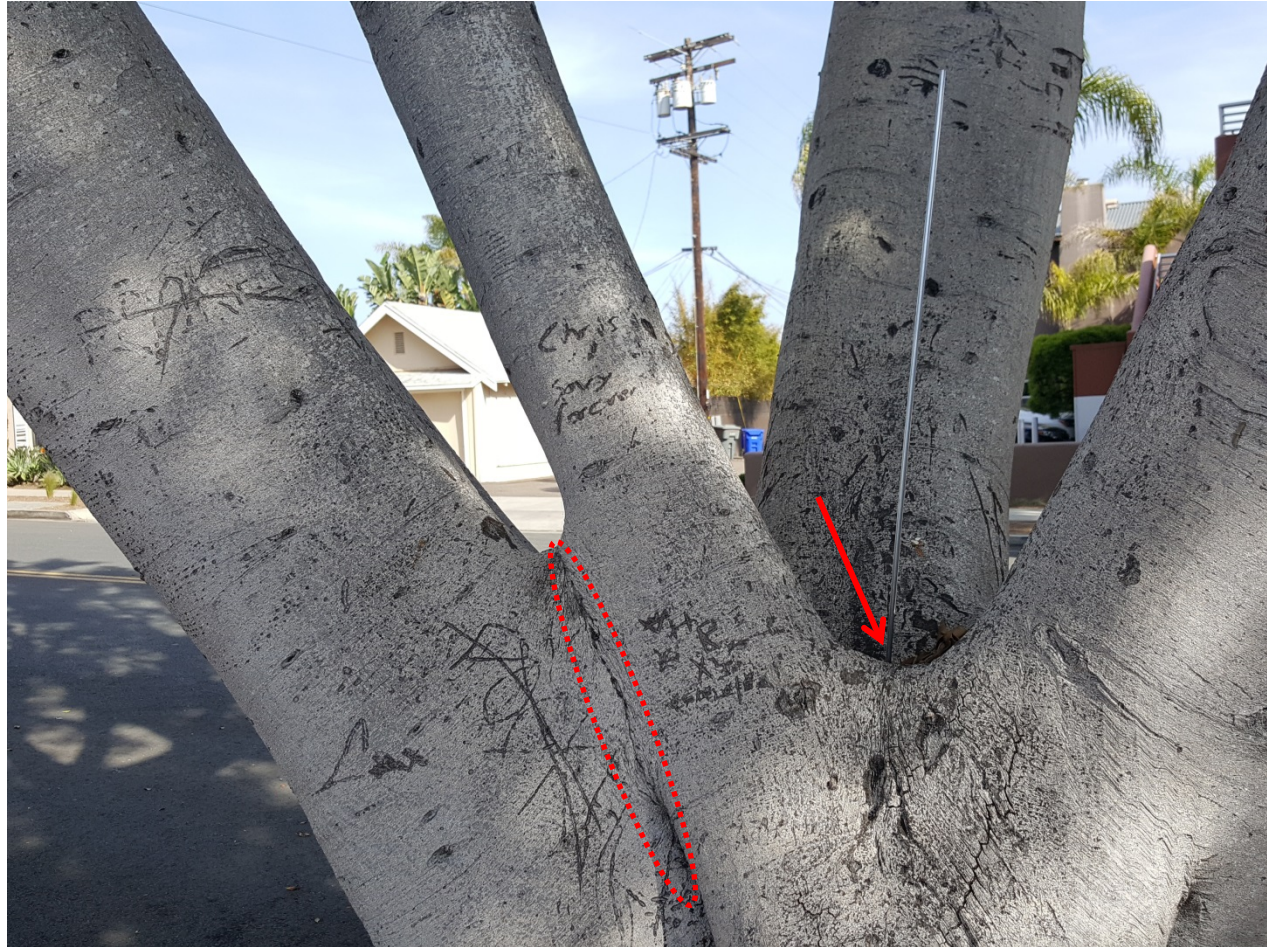
- Some of the stems and scaffold branches had presence of included bark as well as a shallow debris cavity between the unions. There appeared to be a fair amount of **responsive growth** around these defects (see Photo #2 in Appendix A).

The defect of greatest concern for the subject tree was the codominant stems/ scaffold branches with included bark and a small cavity. The *likelihood of this failure* within the next year was assessed as **improbable** because the stems/ scaffold branches were not very overextended and the tree was showing adequate responsive growth to the defects. The tree had also not experienced any failures during this recent winter's heavy storms. Failure events would be most likely to occur during abnormal or extreme weather conditions.

- Some of the stems and scaffold branches had presence of included bark (red dotted oval) as well as a shallow debris cavity between the branch unions (red arrow). There appeared to be a fair amount of responsive growth surrounding these defects.

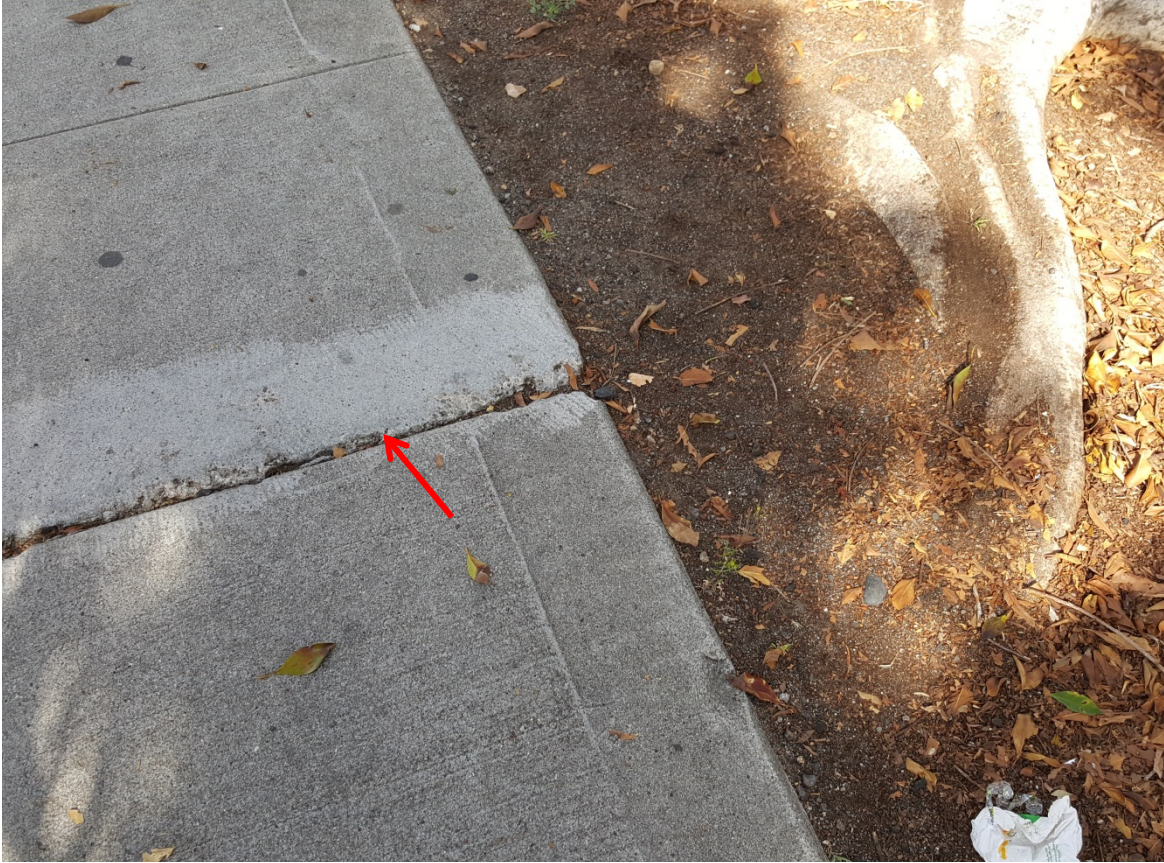
- There was evidence of concrete grinding/ shaving to reduce deflections likely a result of the tree's root growth (see Photo #3 in Appendix A).
- Vehicles appeared to use this area frequently throughout the day.

- There was evidence of concrete grinding/ shaving to reduce deflections likely a result of the tree's root growth (red arrow).
