City of Encinitas

4.10.17 Assessment of Ficus Tree At 610 2nd Street (Side-5)

Gene Bordson
Certified Arborist # WE-10777A
Qualified Applicator License# 140768
Qualified Tree Risk Assessor

APRIL 10, 2017

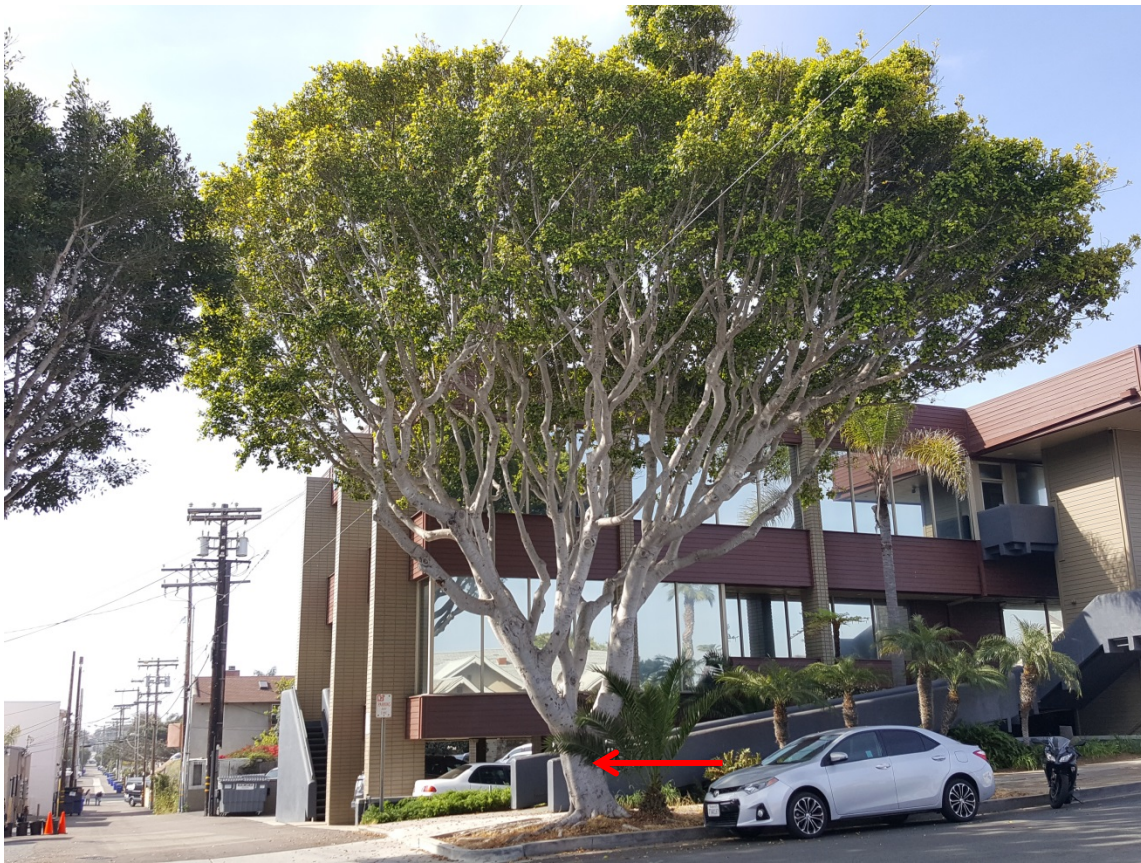
- The tree was growing in a tree well on the south side of E St (see Photo #1 in Appendix A).
- Judging by the color and density of the foliage, the tree appeared to be in fair health for the species and time of year. The tree had a moderate **live crown ratio** of approximately 50% which is common for street trees necessitating raised crowns for vehicle and building clearance (see Photo #1 in Appendix A).

- The tree had a DSH² measurement of 27 inches and a height of about 45 feet (measured with a TruPulse laser).
- The tree had multiple codominant stems and overextended scaffold branches which are indicative of poor structure yet fairly common among this species (see Photo #1 in Appendix A).

- There were powerlines running through the trees' canopy (see Photo #1 in Appendix A).
- Some of the stems and scaffold branches had presence of included bark as well as a small debris cavity between the branch unions (see Photo #2 in Appendix A).

- The tree (**red arrow**) was growing in a tree well on the south side of E St.
- Judging by the color and density of the foliage, the tree appeared to be in fair health for the species and time of year. The tree had a moderate **live crown ratio** of approximately 50% which is common for street trees necessitating raised crowns for vehicle and building clearance.
- The tree had multiple codominant stems and overextended scaffold branches which are indicative of poor structure yet fairly common among this species.
- There were powerlines running through the trees' canopy.

Risk and Mitigation – After performing a **Level 2 Basic Assessment**⁴, the subject tree was assessed to have an overall moderate risk rating. In regards to mitigating these risks, I recommend applying and maintaining an approximate 20% overall crown reduction (retaining interior growth) with the structure and canopy balance of the tree in mind (see Appendix A as well as Figure 3 below). This recommended pruning should be done in compliance to ANSI A300 Arboricultural Standards and will need to be applied over multiple spaced out pruning doses (taking up to 5 years) to minimize health impacts on the tree. This is also recommended to allow time for interior growth to further develop and broaden the options for new branches to prune back to. Pruning techniques such as **reduction pruning**, and **removal pruning cuts** should be used (not topping) to achieve this overall squattier appearance and are further explained in Appendix B. The end outcome should be a reduction of **mechanical stress** from overextended loads. A residual risk of “Low” should be achieved after implementing these recommended pruning strategies. It is with the health and safety of the community that I present these recommendations.

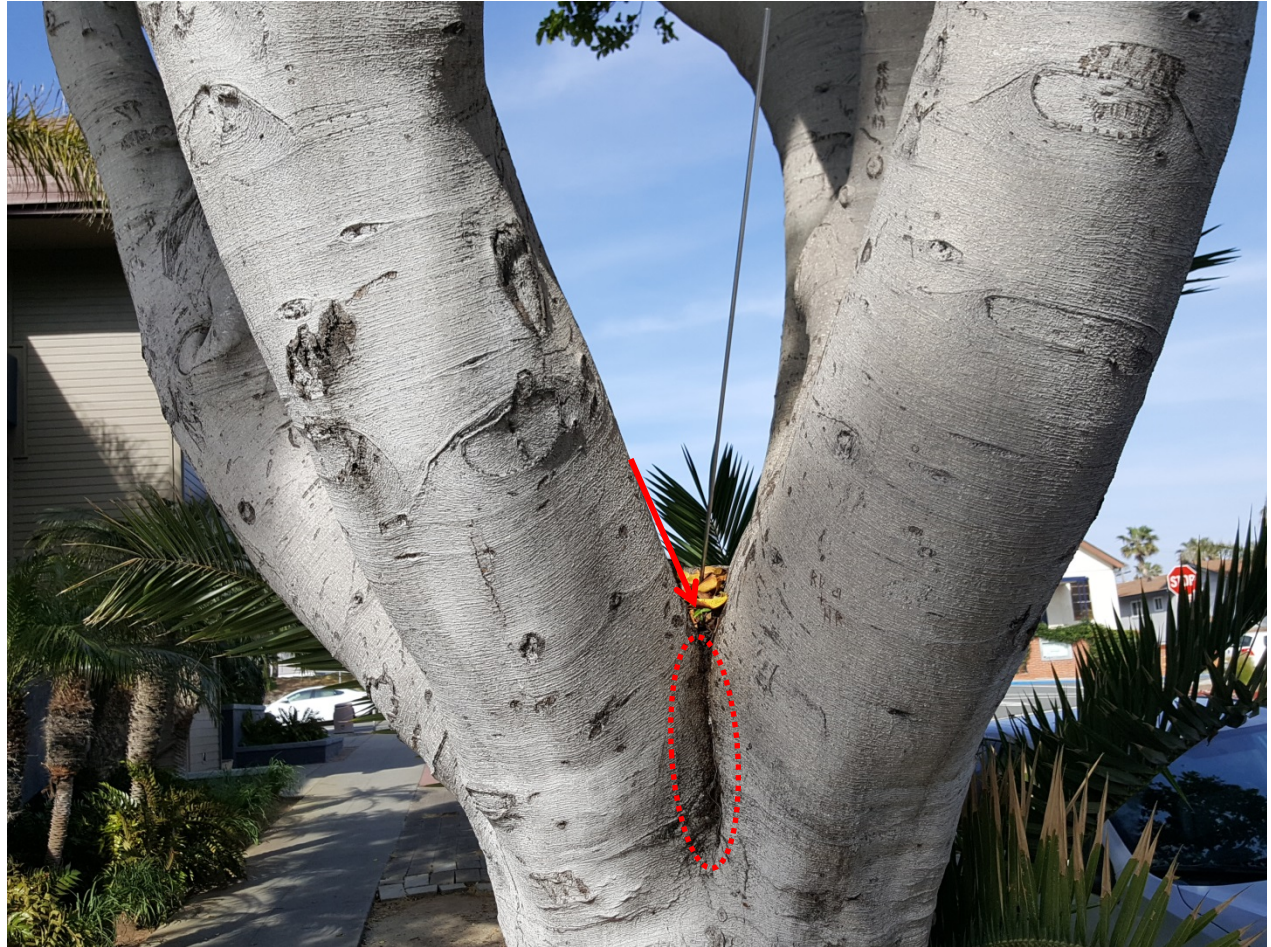
Photo #2

The defects of greatest concern for the subject tree were the significant root injuries as well as the overextended stems/ scaffold branches with significant presence of included bark. The *likelihood of a root or stem/ scaffold branch failure* within the next year was assessed as **possible** for the subject tree. A failure event would be most likely to occur during abnormal or extreme weather conditions.

- Some of the stems and scaffold branches had presence of included bark (red dotted oval) as well as a shallow debris cavity between the branch unions (red arrow).

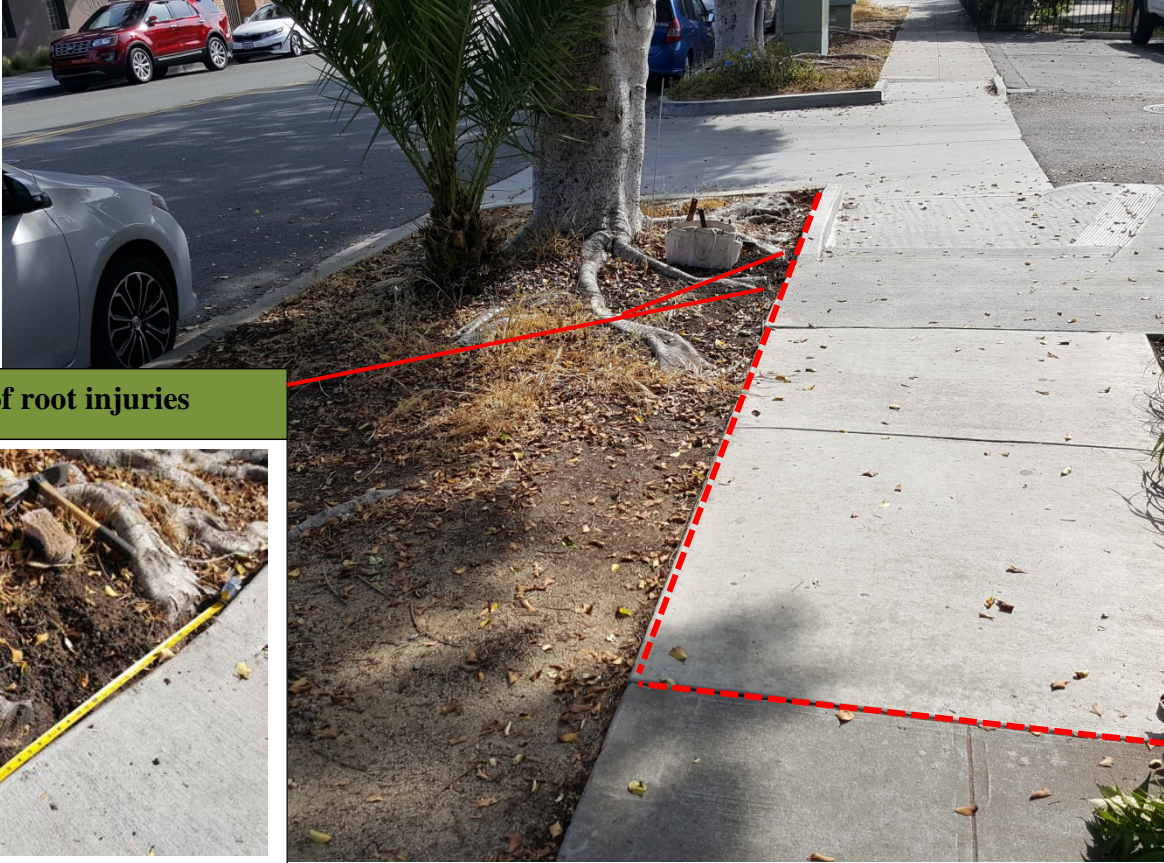
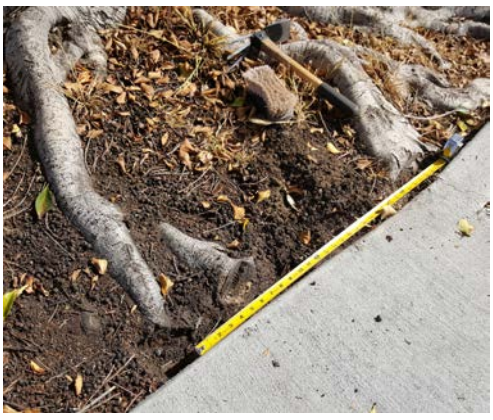
- Judging by the lighter tone of concrete, it appeared that an area of sidewalk had been replaced around the tree (see Photo #3 in Appendix A).
- There were some significant root injuries on the south side of the tree near the hardscape repairs (see Photo #3 in Appendix A).

- Judging by the lighter tone of concrete, it appeared that an area of sidewalk had been replaced around the tree (see **red dotted area**).
- There were some significant root injuries on the south side of the tree near the hardscape repairs (see close up box on the left).
