# City of Encinitas

## 3.24.17 Assessment of Ficus Tree At 621 Second Street (Front-2)

MARCH 24, 2017

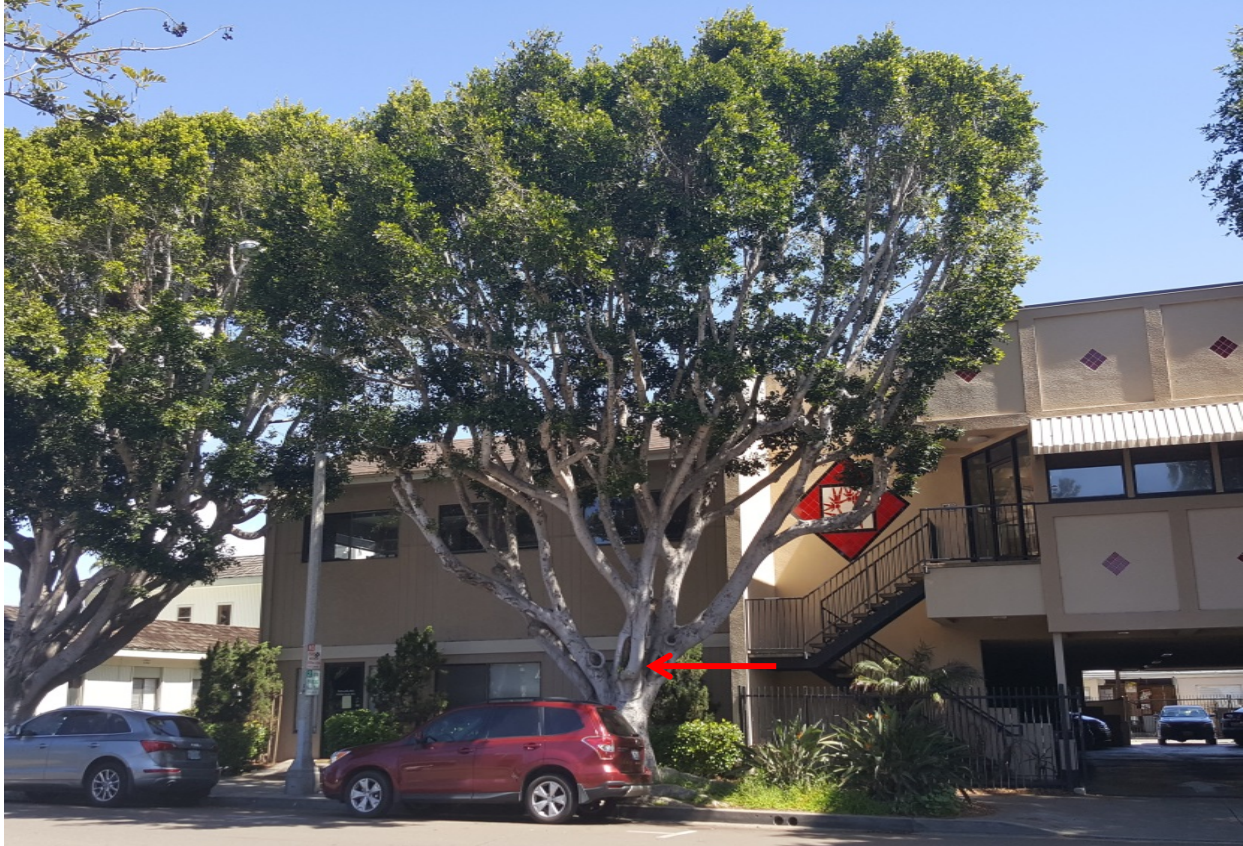
- The tree was growing in a 8.5 foot wide tree well on the east side of 2<sup>nd</sup> St. and in front of the 621 business address (see Figure 1, as well as Photo #1 in Appendix A).

- Judging by the color and density of the foliage, the tree appeared to be in fair health for the species and time of year. The tree had a moderate **live crown ratio** of approximately 50% which is common for street trees necessitating crown raising for vehicle clearance (see Photo #1 in Appendix A).

- The tree had a DSH<sup>2</sup> measurement of 30 inches and a height of about 50 feet (measured with a TruPulse laser).
- The tree had multiple **codominant stems** and scaffold branches which are indicative of poor tree structure (see Photo #1 in Appendix A).

- The tree (**red arrow**) was growing in an 8.5 foot wide tree well on the east side of 2<sup>nd</sup> St. in front of the 621 business address.
- Judging by the color and density of the foliage, the tree appeared to be in fair health for the species and time of year. The tree had a moderate **live crown ratio** of approximately 50% which is common for street trees necessitating raised crowns for vehicle clearance.
- The tree had multiple **codominant stems** and scaffold branches which are indicative of poor tree structure.

**Risk and Mitigation** – After performing a **Level 2 Basic Assessment**<sup>4</sup>, the subject tree was assessed to have an overall moderate risk rating. In regards to mitigating these risks, I recommend applying an approximate 25% overall crown reduction with the structure and canopy balance of the tree in mind (see Appendix B as well as Figure 3 below). This recommended pruning should be done in compliance to ANSI A300 Arboricultural Standards and will need to be applied over multiple spaced out pruning doses (taking up to 5 years) to minimize health impacts on the tree. This is also recommended to allow time for interior growth to further develop and broaden the options for new branches to prune back to. Pruning techniques such as **reduction pruning**, and **removal pruning cuts** should be used (not topping) to achieve this overall squattier appearance and are further explained in Appendix B. The end outcome should be a reduction of **mechanical stress** from overextended loads. A residual risk of “Low” should be achieved after implementing these recommended pruning strategies.

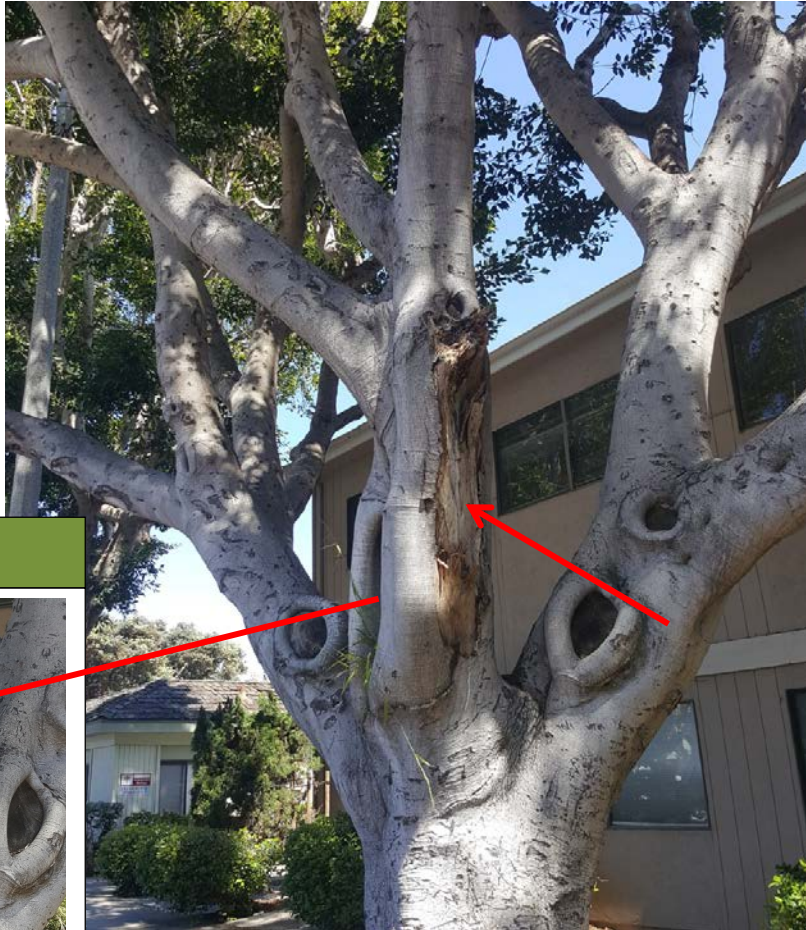
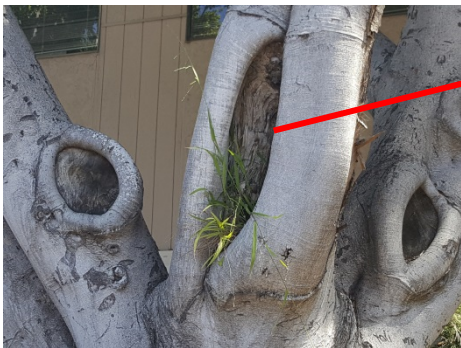
- On the south side of the tree, there was an old injury from a scaffold branch failure which was likely associated with overextended growth with included bark and or a vehicle impact (see Photo #2 in Appendix A).

- There was a cavity with grass growing from it on the west side of the tree (see Photo #2 in Appendix A).
- There was a fair amount of responsive growth around observed tree defects (see Photo #2 in Appendix A).

- On the south side of the tree, there was an old injury from a scaffold branch failure (red arrow) which was likely associated with overextended growth with included bark and or a vehicle impact.
- There was a cavity with grass growing from it on the west side of the tree (see red line and close-up box on left).
- There was a fair amount of responsive growth around observed tree defects.

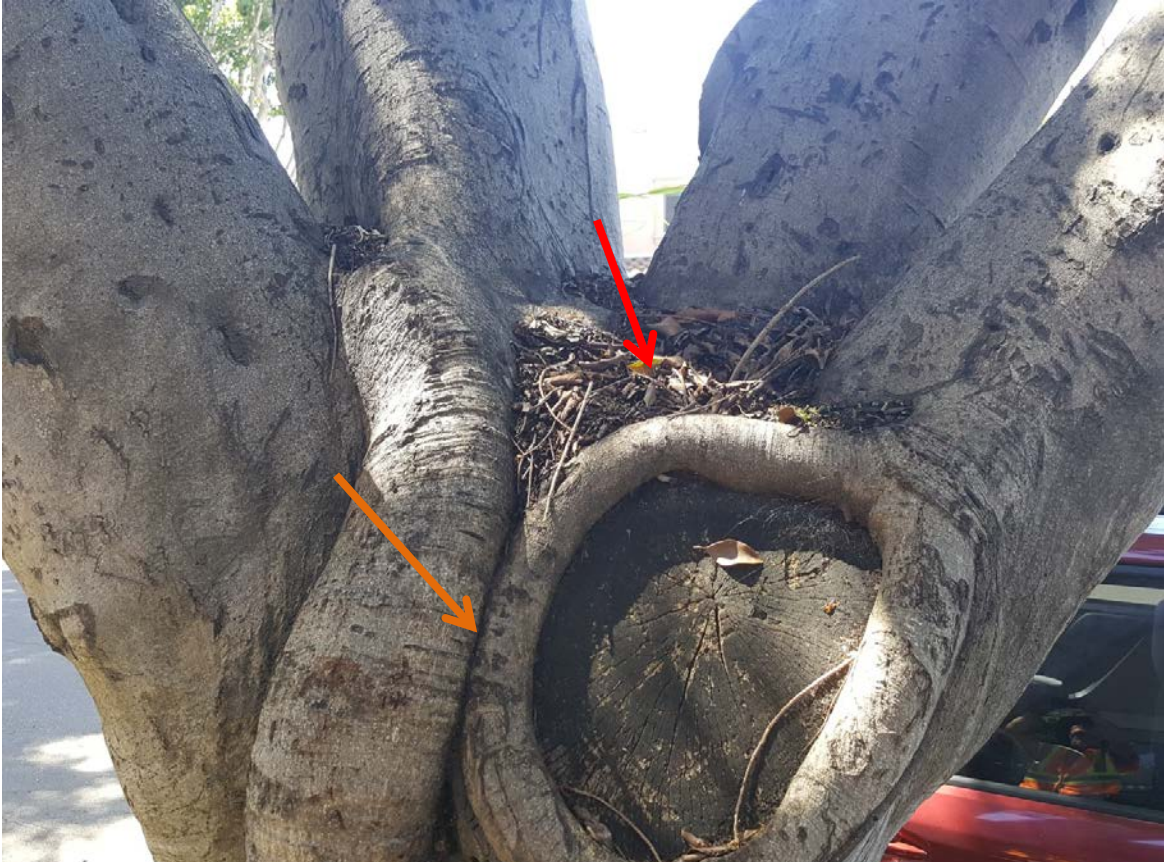
- There was a debris filled cavity between the codominant stems where probing indicated a depth of at least 7 inches. There was included bark present below this cavity (see Photo #3 in Appendix A).

The *likelihood of a failure* within the next year has been assessed as **possible** for the subject tree. This is because of the significant defects and history of failures combined with the fact that there were no failures during this winter's abnormally extreme rain storms. The most likely and relevant failure would be to a large overextended stem or scaffold branch with included bark on the west side of the tree. This potential failure event would be most likely to occur during abnormal or extreme weather conditions.

- There was a debris filled cavity between the codominant stems where probing indicated a depth of at least 7 inches (see **red arrow**).
- There was included bark present below this cavity (see **orange arrow**).

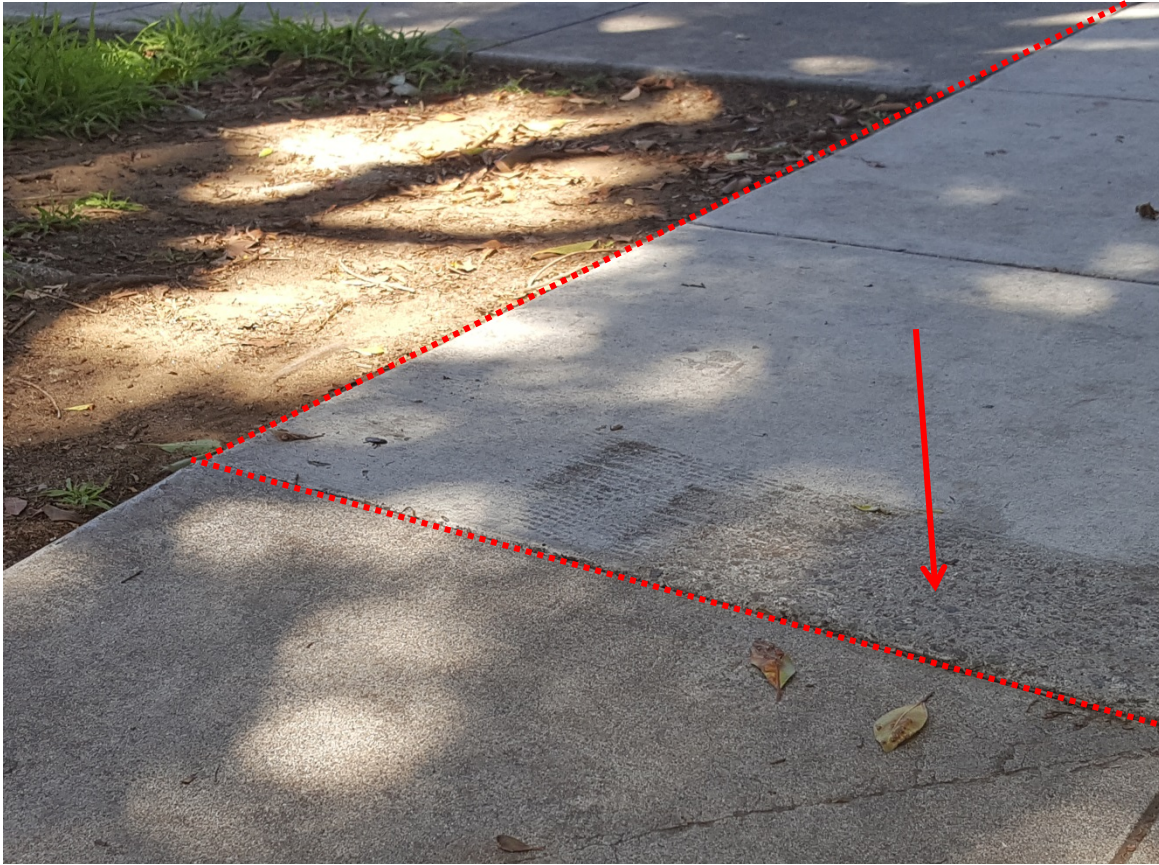
Photo #4

- There was evidence of hardscape repairs such as concrete replacement (red dotted area), and concrete grinding (red arrow) to eliminate trip hazards.

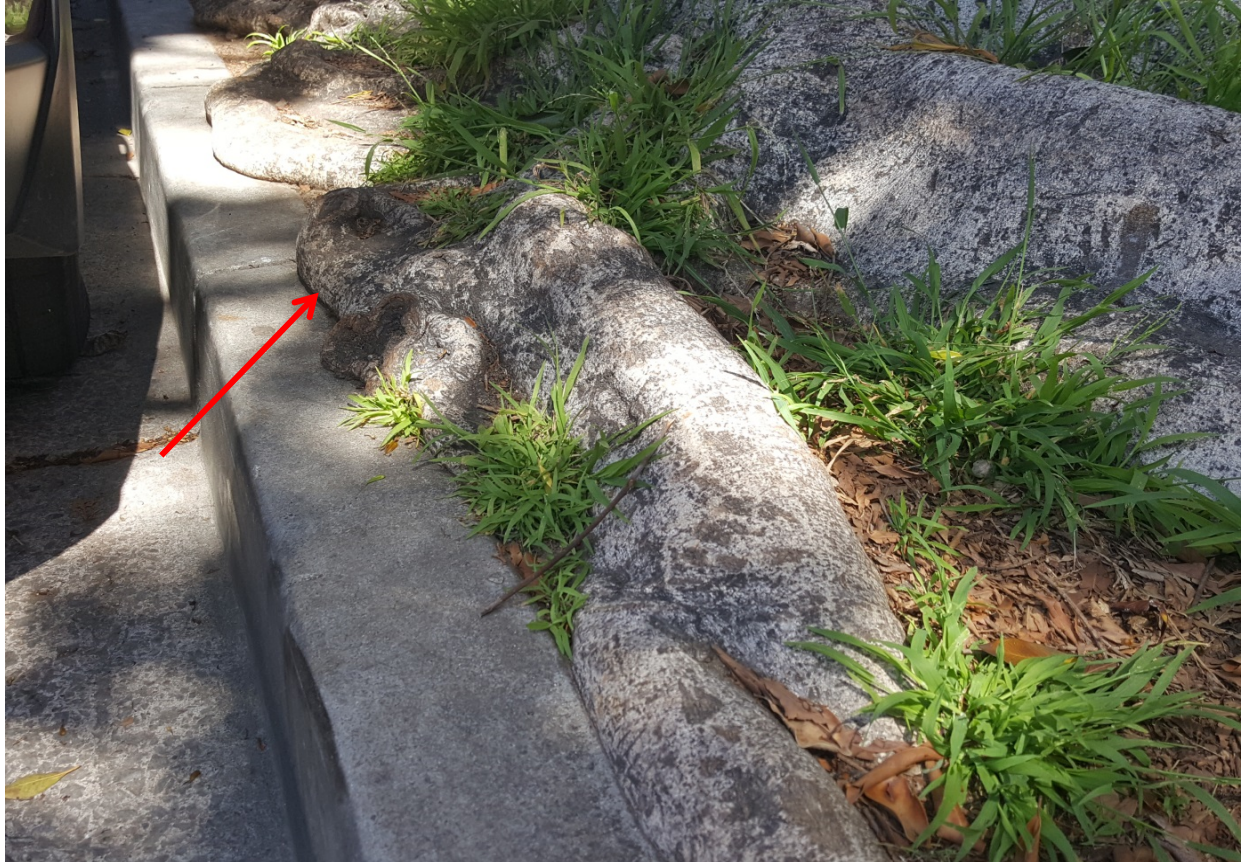
Photo #5

- Some of the larger buttress roots were showing a **contact stress response** to growing next to the curb face (see **red arrows**). This phenomenon occurs when trees grow in close contact with infrastructure. Trunk and root tissues mold, and grow over the infrastructure element providing a level of structural support. There may be an increase in failure potential if the infrastructure element is removed or replaced.
