City of Encinitas

3.27.17 Assessment of Ficus Tree At 629 Second Street (Front-1)

Gene Bordson
Certified Arborist # WE-10777A
Qualified Applicator License# 140768
Qualified Tree Risk Assessor

MARCH 27, 2017

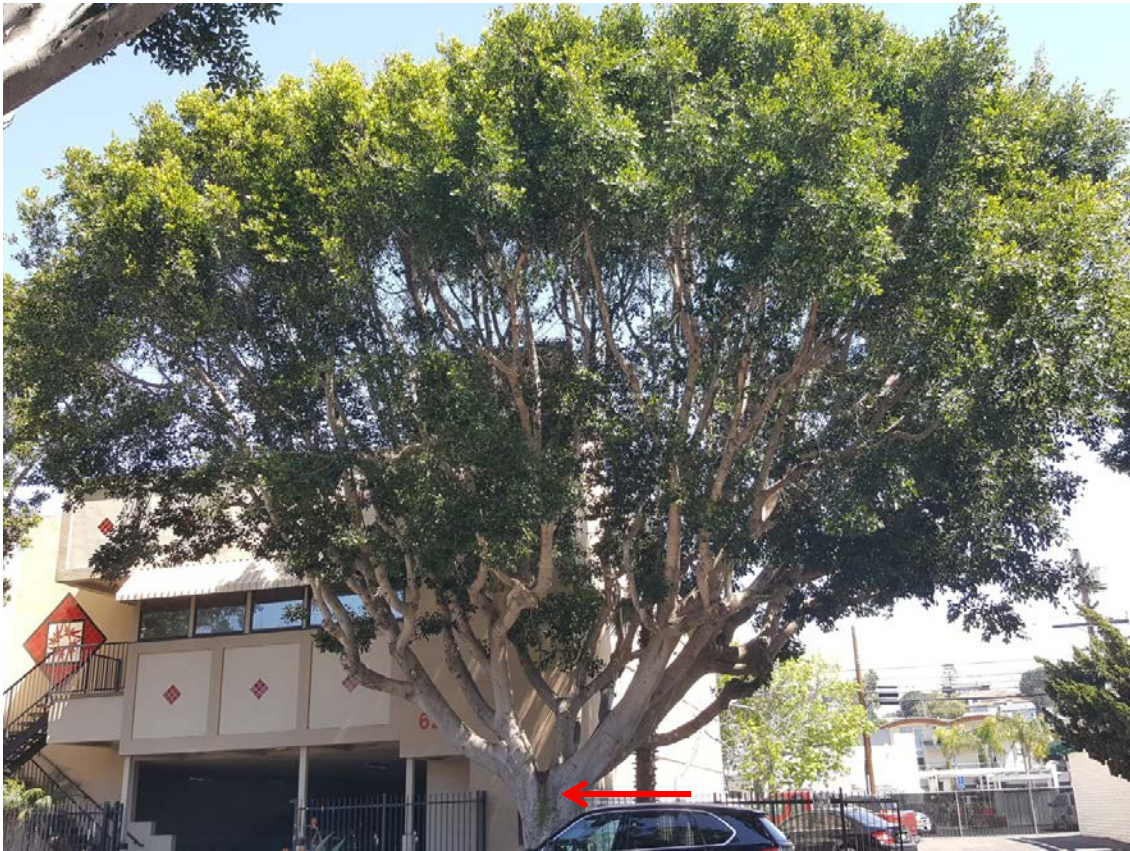
- The tree was growing in an 8.5 foot wide tree well on the east side of 2nd St. and in front of the 629 business address (see Figure 1, as well as Photo #1 in Appendix A).

- Judging by the color and density of the foliage, the tree appeared to be in fair health for the species and time of year. The tree had a moderate **live crown ratio** of approximately 50% which is common for street trees necessitating crown raising for vehicle clearance (see Photo #1 in Appendix A).

- The tree had a DSH² measurement of 32 inches and a height of about 50 feet (measured with a TruPulse laser).
- The tree had multiple overextended **codominant stems** and scaffold branches which are indicative of poor tree structure (see Photo #1 in Appendix A).

- The tree (red arrow) was growing in an 8.5 foot wide tree well on the east side of 2nd St. in front of the 629 business address.
- Judging by the color and density of the foliage, the tree appeared to be in fair health for the species and time of year. The tree had a moderate **live crown ratio** of approximately 50% which is common for street trees necessitating raised crowns for vehicle clearance.
- The tree had multiple overextended **codominant stems** and scaffold branches which are indicative of poor tree structure.

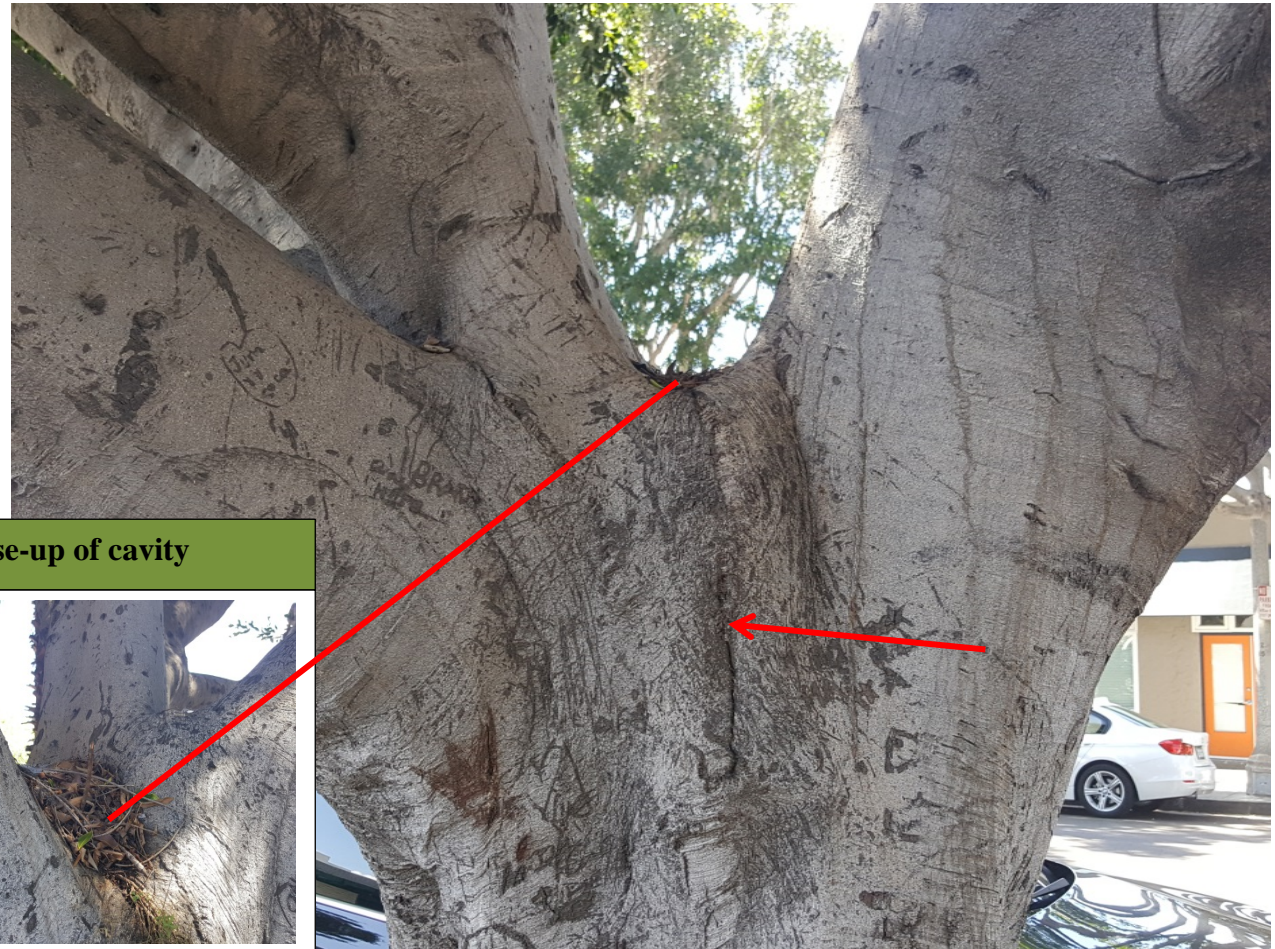
- On the south side of the tree, there was an old injury from a scaffold branch failure which was likely associated with overextended growth with included bark and or a vehicle impact (see Photo #2 in Appendix A).

- The union between the largest stems on the tree had about 12 inches of included bark as well as a debris filled cavity between them (see Photo #3 in Appendix A).

The *likelihood of a failure* within the next year has been assessed as **possible** for the subject tree. This is because of the large stems with included bark and debris filled cavity between them combined with the fact that there is responsive growth around the defect and it has not failed for many years during extreme weather occurrences. This potential failure event would be most likely to occur during abnormal or extreme weather conditions.

Close-up of cavity

- The union between the largest stems on the tree (red arrows) had about 12 inches of included bark as well as a debris filled cavity between them (see red line and close up box on the left).
- There was a fair amount of responsive growth around observed tree defects.

Risk and Mitigation – After performing a **Level 2 Basic Assessment**⁴, the subject tree was assessed to have an overall moderate risk rating. In regards to mitigating these risks, I recommend applying an approximate 25% crown reduction with the structure and canopy balance of the tree in mind (see Appendix B as well as Figure 3 below). This recommended pruning should be done in compliance to ANSI A300 Arboricultural Standards and will need to be applied over multiple spaced out pruning doses (taking up to 5 years) to minimize health impacts on the tree. This is also recommended to allow time for interior growth to further develop and broaden the options for new branches to prune back to. Pruning techniques such as **reduction pruning**, and **removal pruning cuts** should be used (not topping) to achieve this overall squattier appearance and are further explained in Appendix B. The end outcome should be a reduction of **mechanical stress** from overextended loads and an improvement in wind penetration. A residual risk of “Low” should be achieved after implementing these recommended pruning strategies.

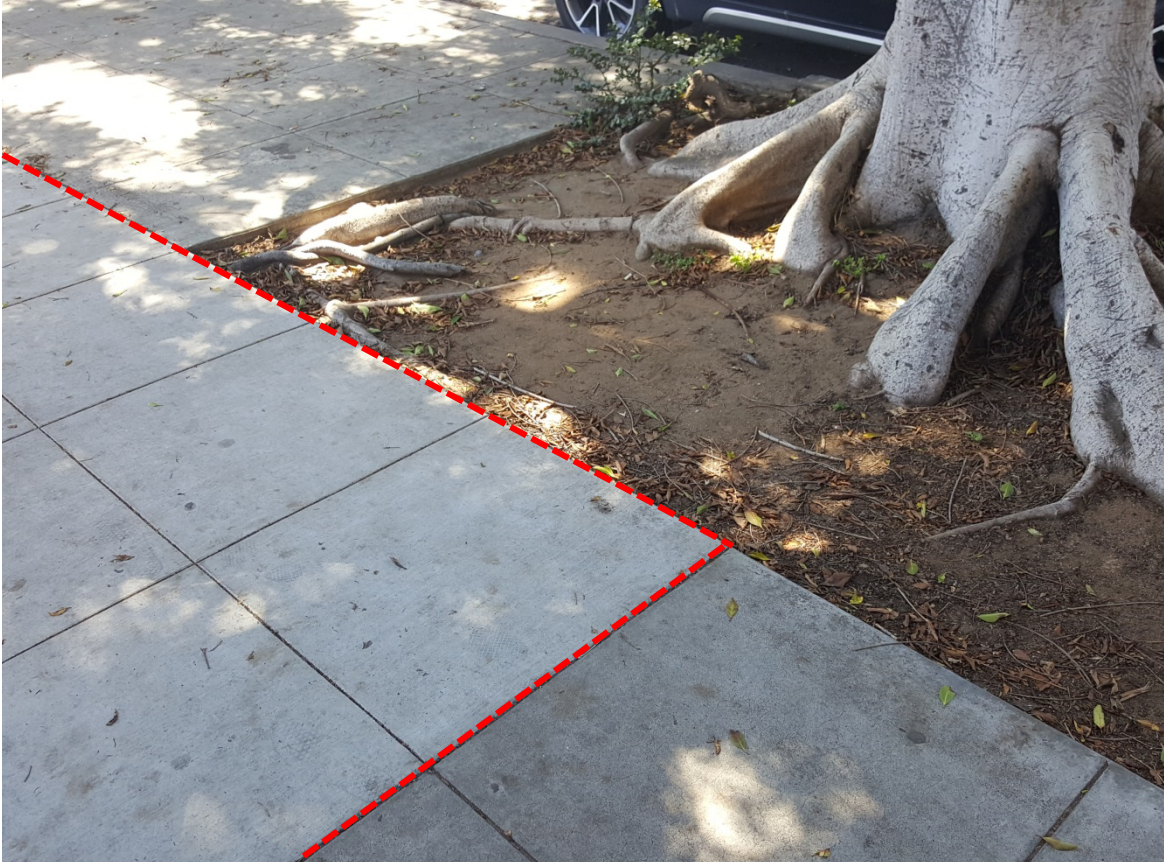
- There was a fair amount of responsive growth around observed tree defects (see Photo #3 in Appendix A).
- There was a section of sidewalk with a lighter tone on the east side of the tree indicating there were likely hardscape repairs due to conflicts with roots (see Photo #3 in Appendix A).

- There was a section of sidewalk with a lighter tone on the east side of the tree indicating there were likely hardscape repairs due to conflicts with roots (see red dotted area).

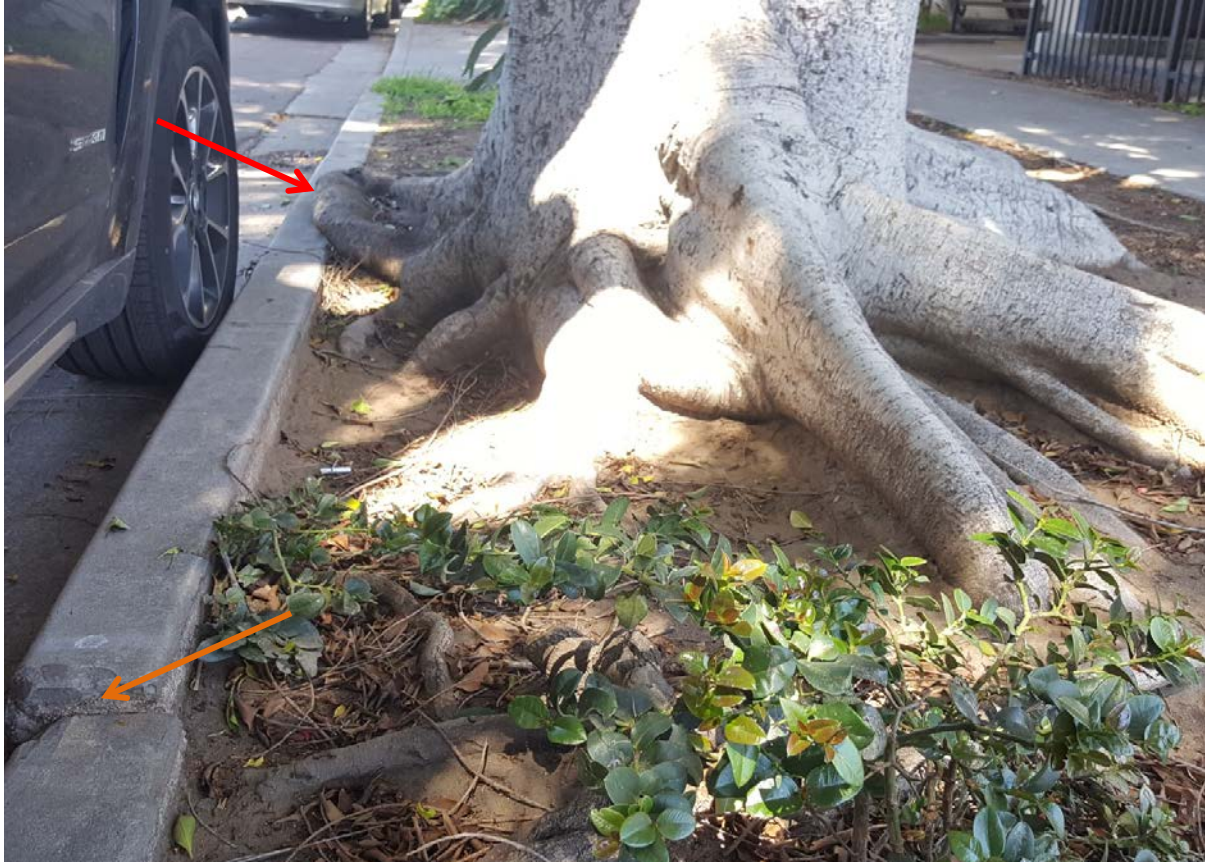
- There was a lifted section of curb face on the west side of the tree (see Photo #4 in Appendix A).
- Some of the larger buttress roots were showing a **contact stress response** to growing next to the curb face. This phenomenon occurs when trees grow in close contact with infrastructure. Trunk and root tissues mold, and grow over the infrastructure element providing a level of structural support. There may be an increase in failure potential if the infrastructure element is removed or replaced (see Photo #4 in Appendix A).

- There was a lifted section of curb face on the west side of the tree (see **orange arrow**).
- Some of the larger buttress roots were showing a **contact stress response** to growing next to the curb face (see **red arrows**). This phenomenon occurs when trees grow in close contact with infrastructure. Trunk and root tissues mold, and grow over the infrastructure element providing a level of structural support. There may be an increase in failure potential if the infrastructure element is removed or replaced.
