City of Encinitas

3.29.17 Assessment of Ficus Tree At 642 Second Street (Front-1)

Gene Bordson
Certified Arborist # WE-10777A
Qualified Applicator License# 140768
Qualified Tree Risk Assessor

MARCH 29, 2017

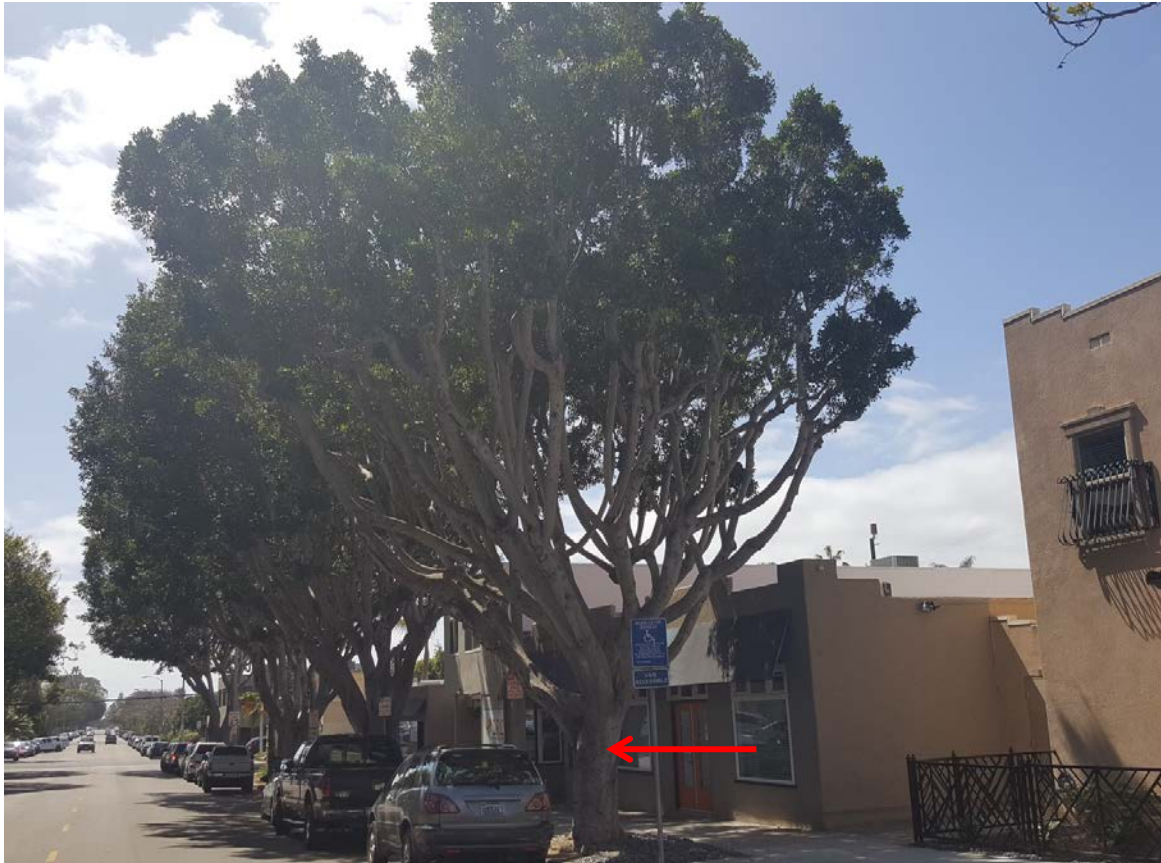
- The tree was growing in a 7 foot wide tree well on the west side of 2nd St. and in front of the 642 business address (see Photo #1 in Appendix A).
- Judging by the color and density of the foliage, the tree appeared to be in fair health for the species and time of year. The tree had a low **live crown ratio** of approximately 40% which is less than ideal yet common for street trees necessitating raised crowns for vehicle/ building clearance (see Photo #1 in Appendix A).

- The tree (red arrow) was growing in a 7 foot wide tree well on the west side of 2nd St. and in front of the 642 business address.
- Judging by the color and density of the foliage, the tree appeared to be in fair health for the species and time of year. The tree had a low **live crown ratio** of approximately 40% which is less than ideal yet common for street trees necessitating raised crowns for vehicle/ building clearance.

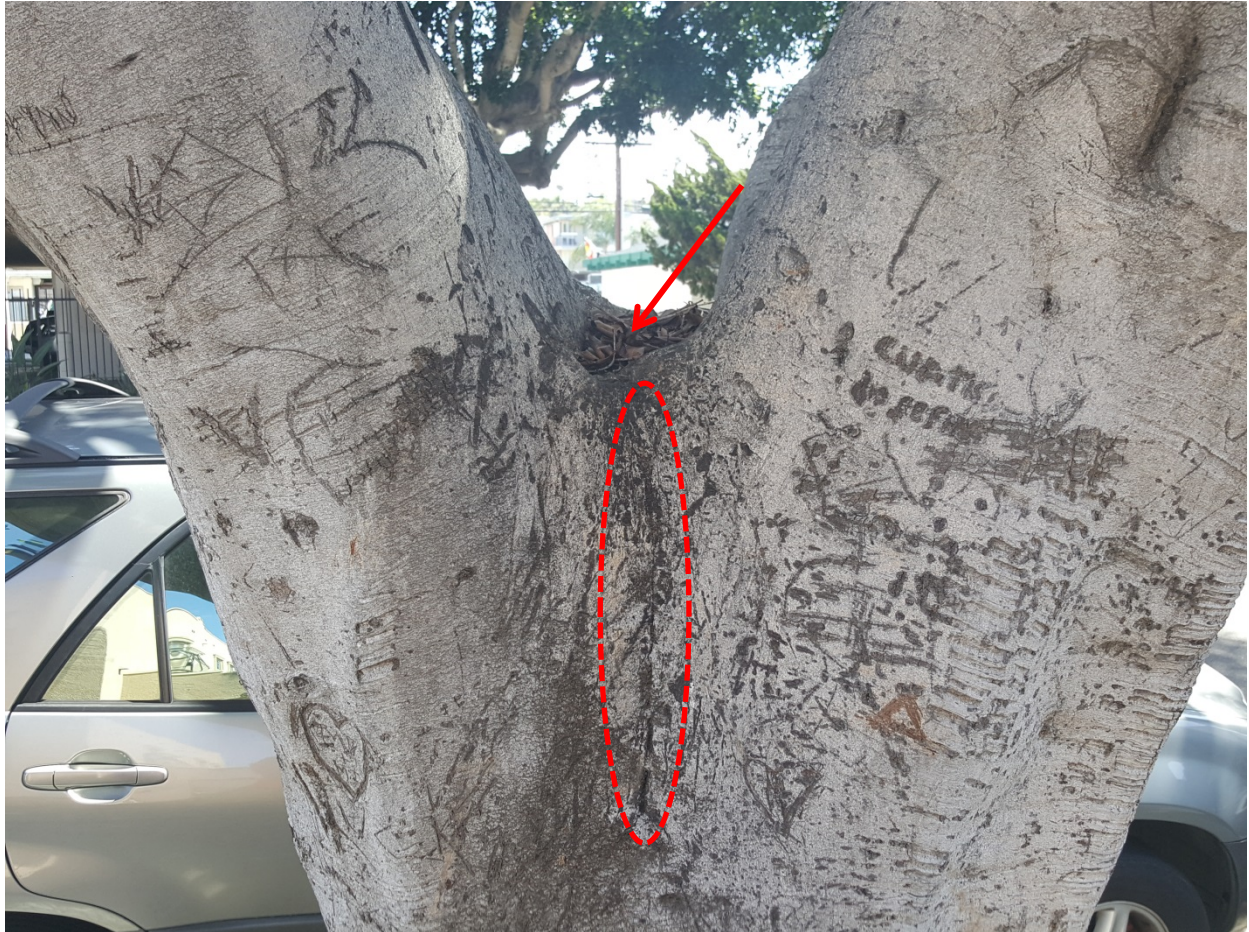
- The tree had a DSH² measurement of 32 inches and a height of about 45 feet (measured with a TruPulse laser).
- The tree had multiple **codominant stems** and branches which are indicative of poor structure yet common to this species (see Photo #2 in Appendix A).

- There were multiple branch unions with evidence of included bark (see Photo #2 in Appendix A).
- There was a debris filled cavity between the stems. Probing the cavity confirmed a depth of about 6 inches (see Photo #2 in Appendix A).

- The tree had multiple **codominant stems** and branches which are indicative of poor structure yet common to this species.
- There were multiple branch unions with evidence of included bark (**red dotted oval**).
- There was a debris filled cavity between the stems (**red arrow**). Probing the cavity confirmed a depth of about 6 inches.

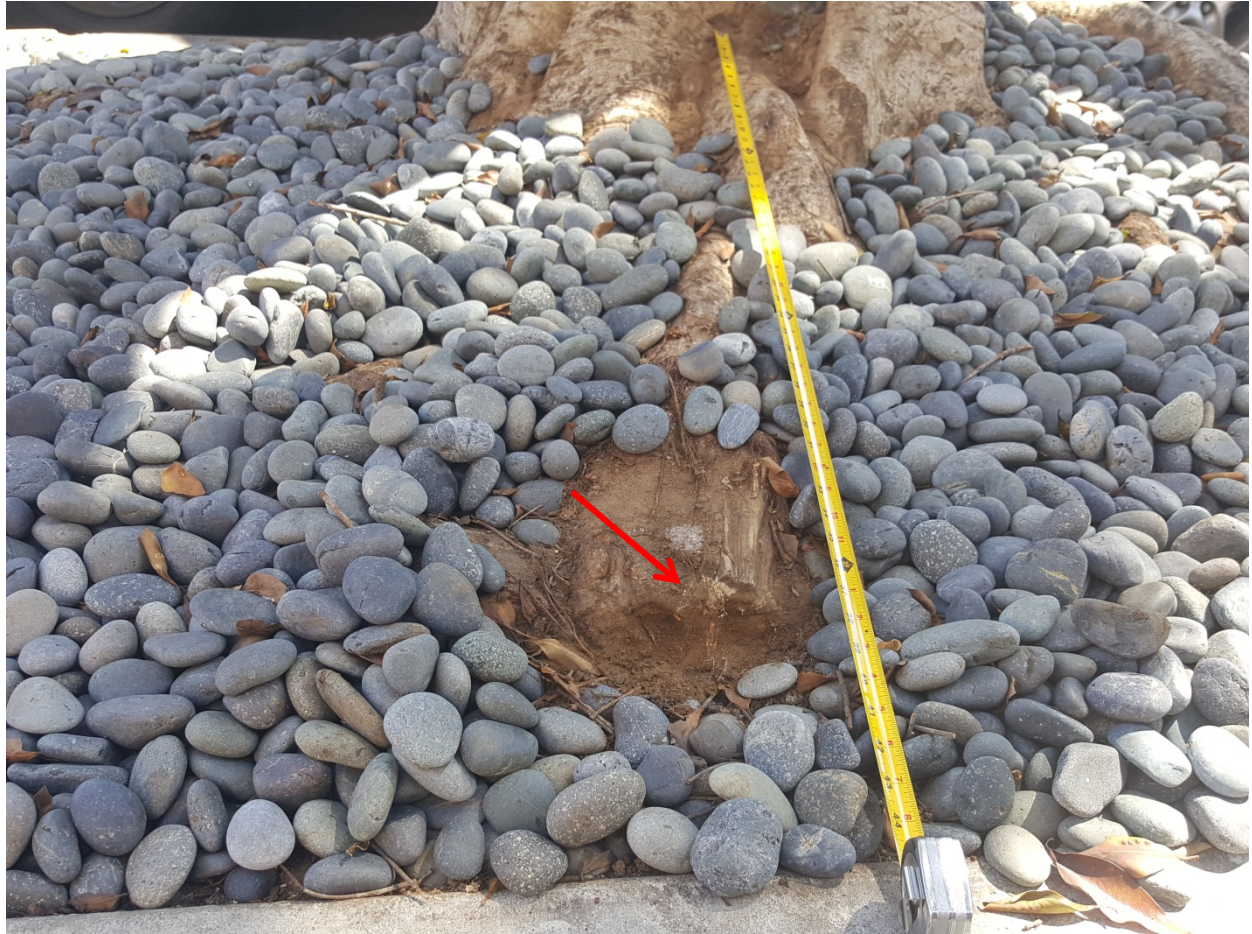
- There appeared to be an old root pruning injury on to one of the roots on the west side of the tree (see Photo #3 in Appendix A).
- There appeared to be some fungal fruiting bodies on some roots on the north side of the tree indicating some root decay (see Photo #4 in Appendix A).

There appeared to be an old root pruning injury on to one of the roots on the west side of the tree (see **red arrow**).

Root Pruning: Root pruning (such as observed on this tree) is an injurious practice that can significantly damage trees and affect their structural strength and health. If future conflicts between roots and infrastructure occur, I recommend looking into alternative mitigation strategies such as **elevated root bridging**, or meandering sidewalks to minimize damage to roots.

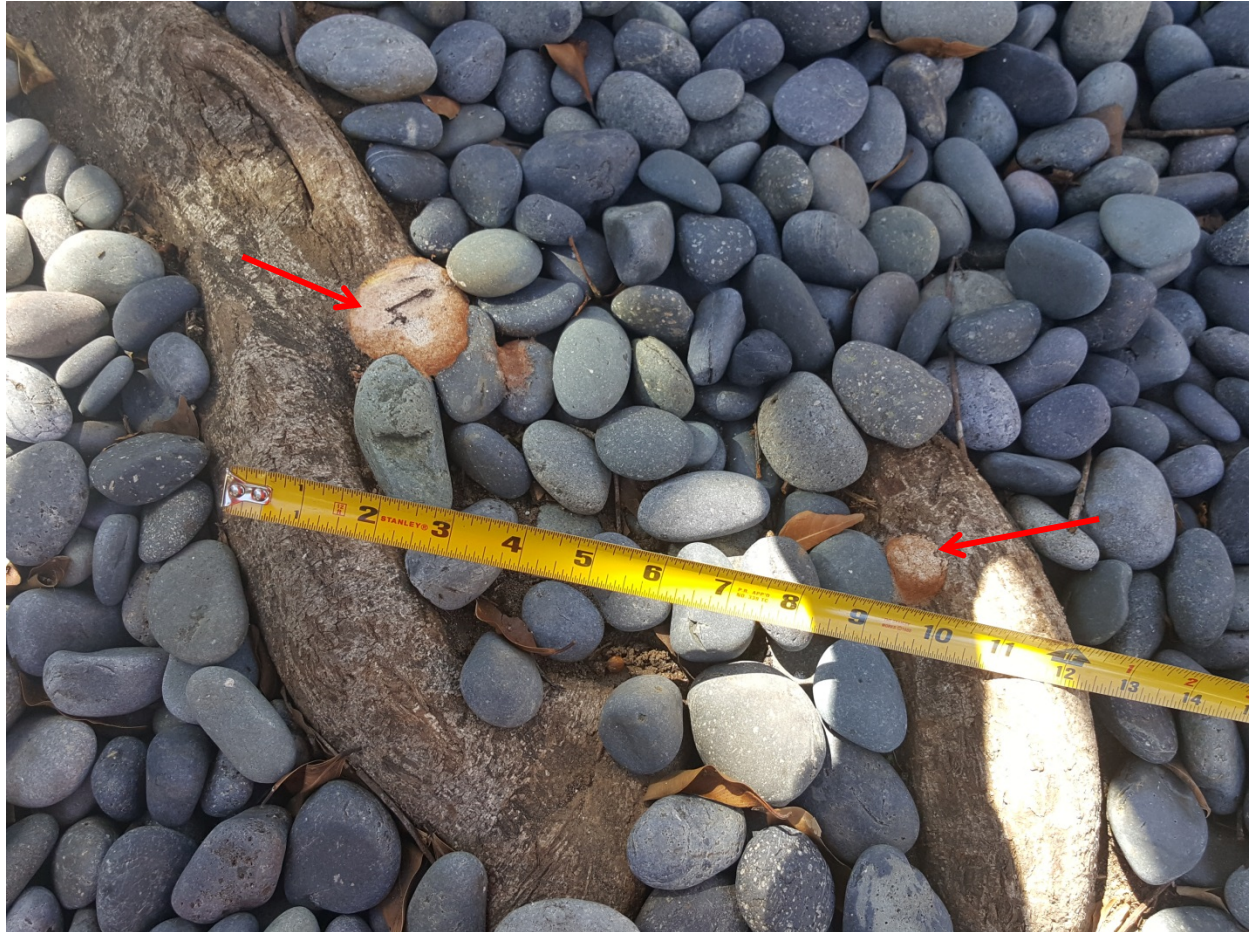
Photo #4

- There appeared to be some fungal fruiting bodies on some roots on the north side of the tree indicating some root decay (see red arrows).

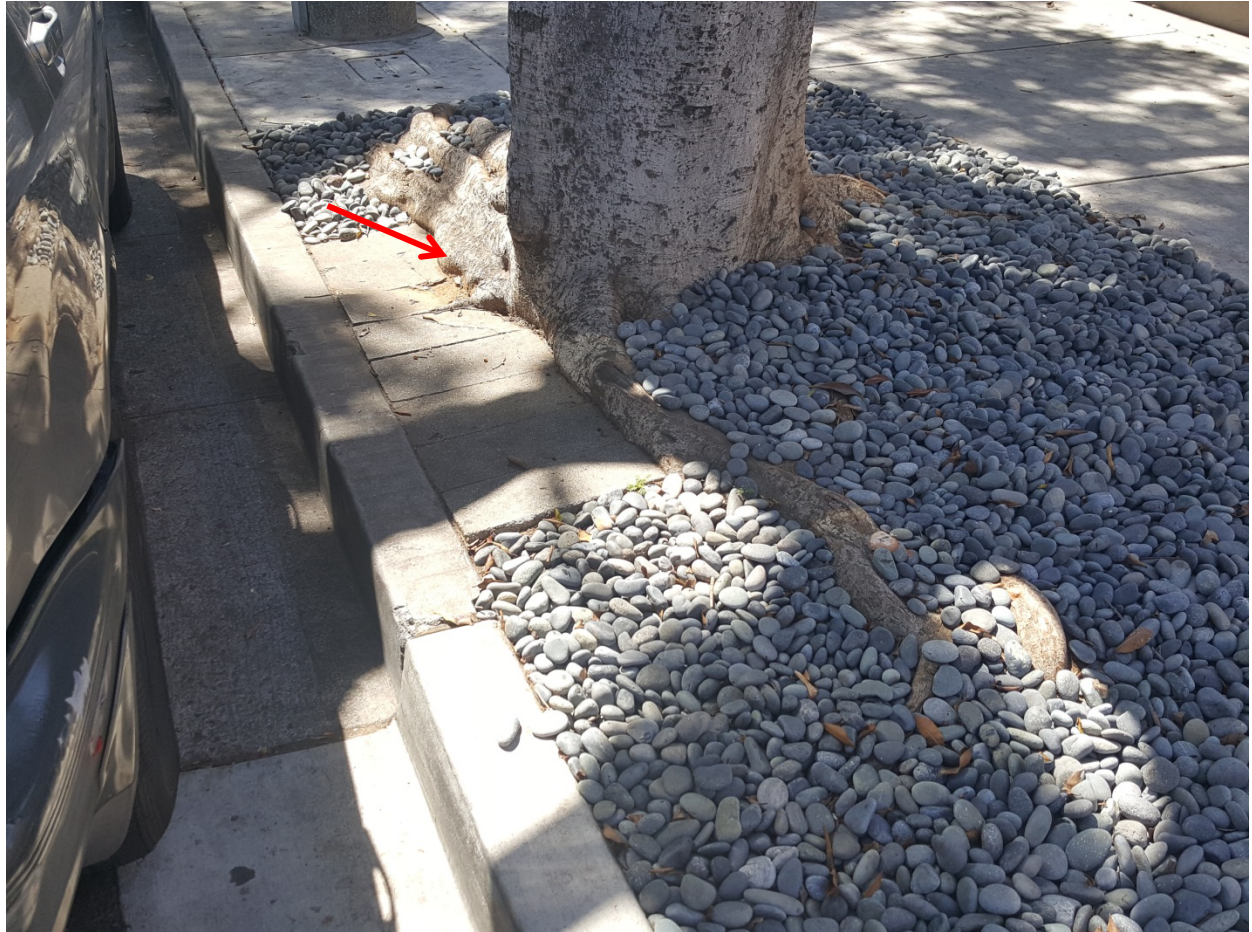
- One of the larger buttress roots were showing a **contact stress response** to growing next to the curb face. This phenomenon occurs when trees grow in close contact with infrastructure. Trunk and root tissues mold, and grow over the infrastructure element providing a level of structural support. There may be an increase in failure potential if the infrastructure element is removed or replaced (see Photo #5 in Appendix A).

- One of the larger buttress roots were showing a **contact stress response** to growing next to the curb face (see **red arrow**). This phenomenon occurs when trees grow in close contact with infrastructure. Trunk and root tissues mold, and grow over the infrastructure element providing a level of structural support. There may be an increase in failure potential if the infrastructure element is removed or replaced.
