# City of Encinitas

## 3.3.17 Assessment of Ficus Tree Near 650 Second Street

MARCH 3, 2017

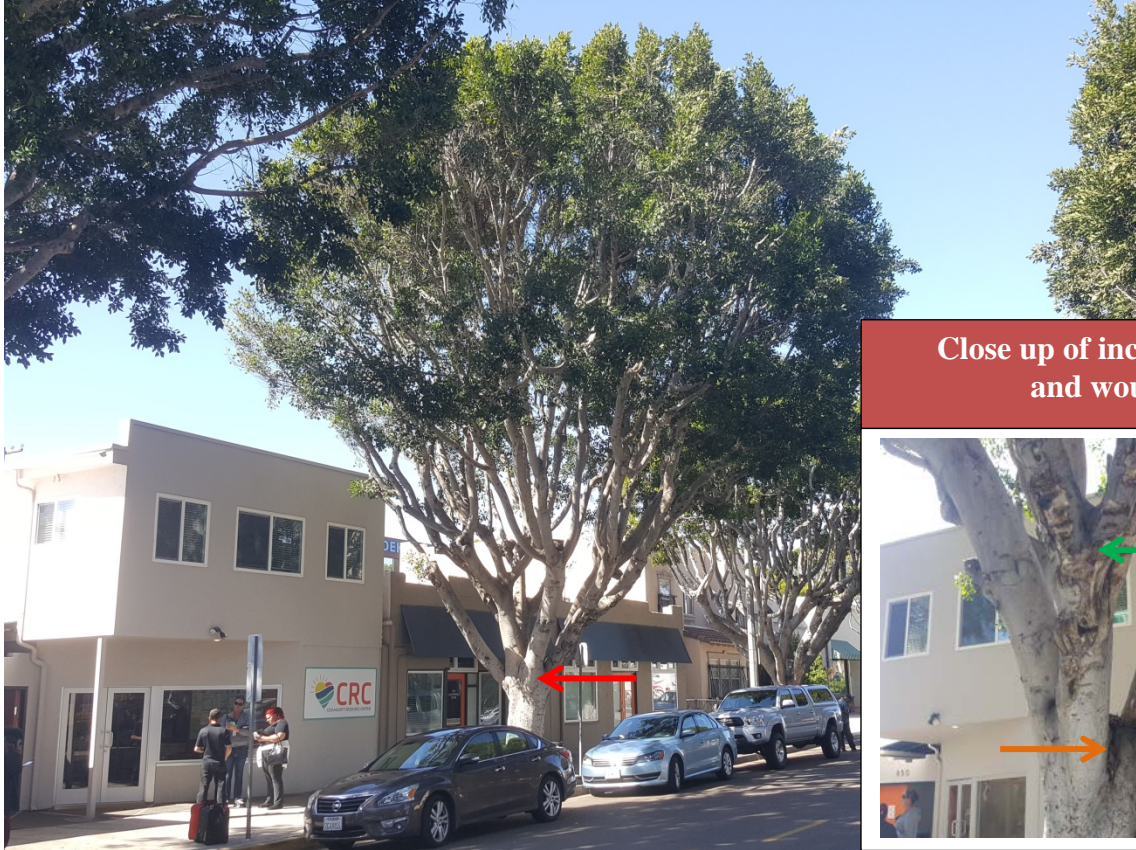
- The tree was growing in a 7 foot wide parkway in front of 650 2<sup>nd</sup> St. (see Figure 1, as well as Photo #1 in Appendix A).
- Judging by the color and density of the foliage, the tree appeared to be in fair health for the species and time of year. There was a **live crown ratio** of approximately 50% which is common for street trees necessitating crown raising for vehicle clearance (see Photo #1 in Appendix A).

- The tree had a DSH<sup>2</sup> measurement of 31 inches and a height of about 50 feet (measured with a TruPulse laser).
- The tree had multiple overextended and **codominant stems** with evidence of **included bark** between some branch unions, all of which are indicative of poor tree structure. There was a fair amount of **responsive wood** growth strengthening these weakened branch unions (see Photo #1 in Appendix A).

- There were multiple wounds on the underside of the stems on the west side of the tree, likely inflicted by passing vehicles (see Photo #1 in Appendix A).

- The tree (red arrow) was growing in a 7 foot wide parkway in front of 650 2<sup>nd</sup> St.
- Judging by the color and density of the foliage, the tree appeared to be in fair health for the species and time of year. There was a **live crown ratio** of approximately 50% which is common for street trees necessitating crown raising for vehicle clearance.
- There were multiple overextended and **codominant stems** with evidence of **included bark** (orange arrow) between some branch unions, all of which are indicative of poor tree structure. There was a fair amount of responsive wood growth strengthening these weakened branch unions.
- There were multiple wounds on the underside of the stems on the west side of the tree, likely inflicted by passing vehicles (see green arrow).

**Risk:** In order to help decrease associated risks to an overall low for the subject tree, I recommend performing an approximate 25% **crown reduction**<sup>4</sup> (see Appendix B as well as Figure 3 below) to reduce the mechanical stress being applied on weakened roots and branch unions. This crown reduction should be done in compliance to ANSI A300 Arboricultural Standards and will need to be applied over multiple spaced out pruning doses (taking up to 5 years) to minimize health impacts on the tree. This is also recommended to allow time for interior growth to further develop and broaden the options for new branches to prune back to. Pruning techniques such as **reduction pruning**, and **removal pruning cuts** should be used (not topping) to achieve this overall squattier appearance and are further explained in Appendix B.

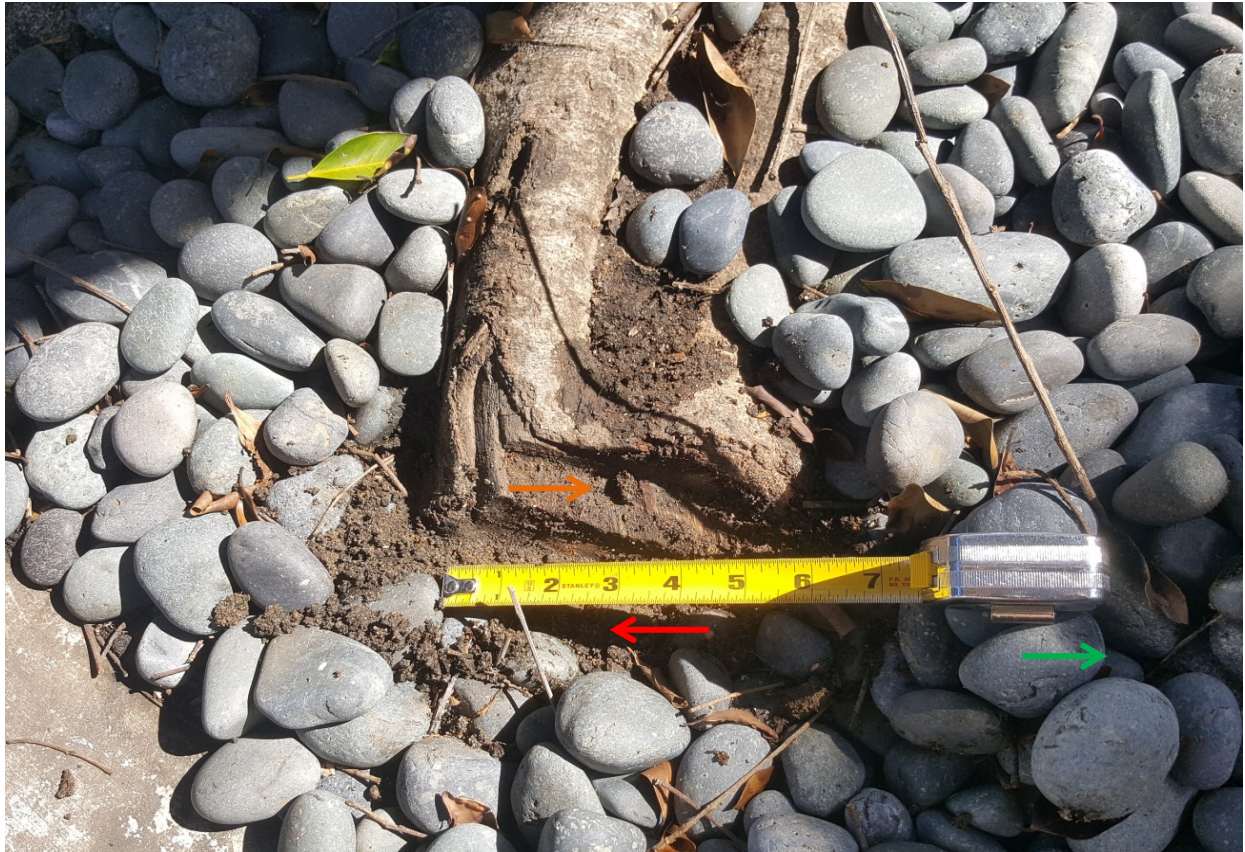
Photo #2

- There was evidence of some significant root pruning about 4.5 feet north the tree's base (see Photo # 2 in Appendix A).
- Some of the larger buttress roots were showing a **contact stress response** to growing next to the curb face (see Photo #3 in Appendix A).

The *likelihood of a failure* within the next year has been assessed as **possible** for the subject tree. The most likely failure would be a large overextended stem (with included bark) on the east side of the tree or uprooting of the entire tree due to root pruning. A failure event would be most likely to occur during abnormal or extreme weather conditions.

- There was evidence of some significant root pruning about 4.5 feet north the tree's base.

**Root Pruning:** Root pruning (such as observed on this tree) is an injurious practice that can significantly damage trees and affect their structural strength and health. If future conflicts between roots and infrastructure occur, I recommend looking into alternative mitigation strategies such as **elevated root bridging**, or meandering sidewalks to minimize damage to roots. It is with the health and safety of the community for which I present all of these recommendations.

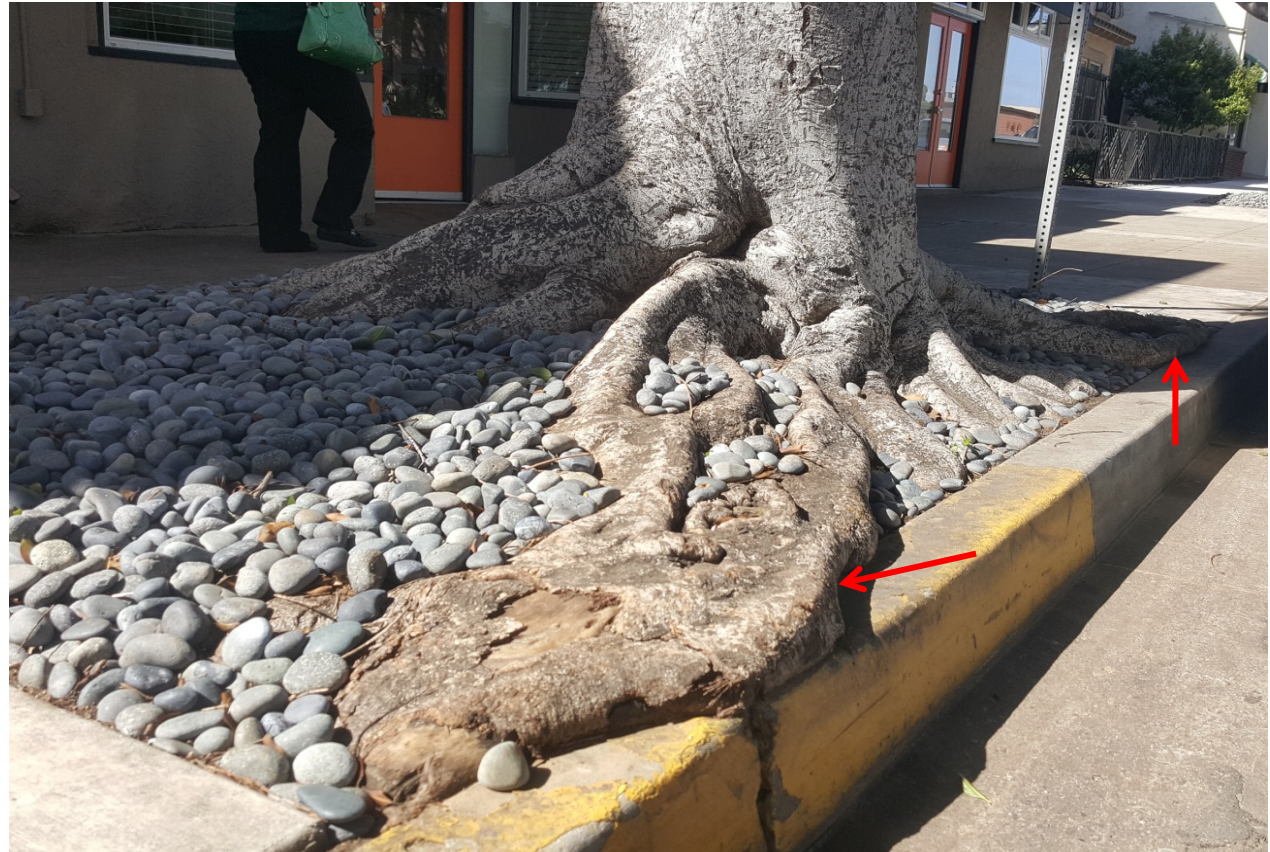
Photo #3

- Some of the larger buttress roots were showing a **contact stress response** to growing next to the curb face (see **red arrows**). This phenomenon occurs when trees grow in close contact with infrastructure. Trunk and root tissues mold, and grow over the infrastructure element providing a level of structural support. There may be an increase in failure potential if the infrastructure element is removed or replaced.

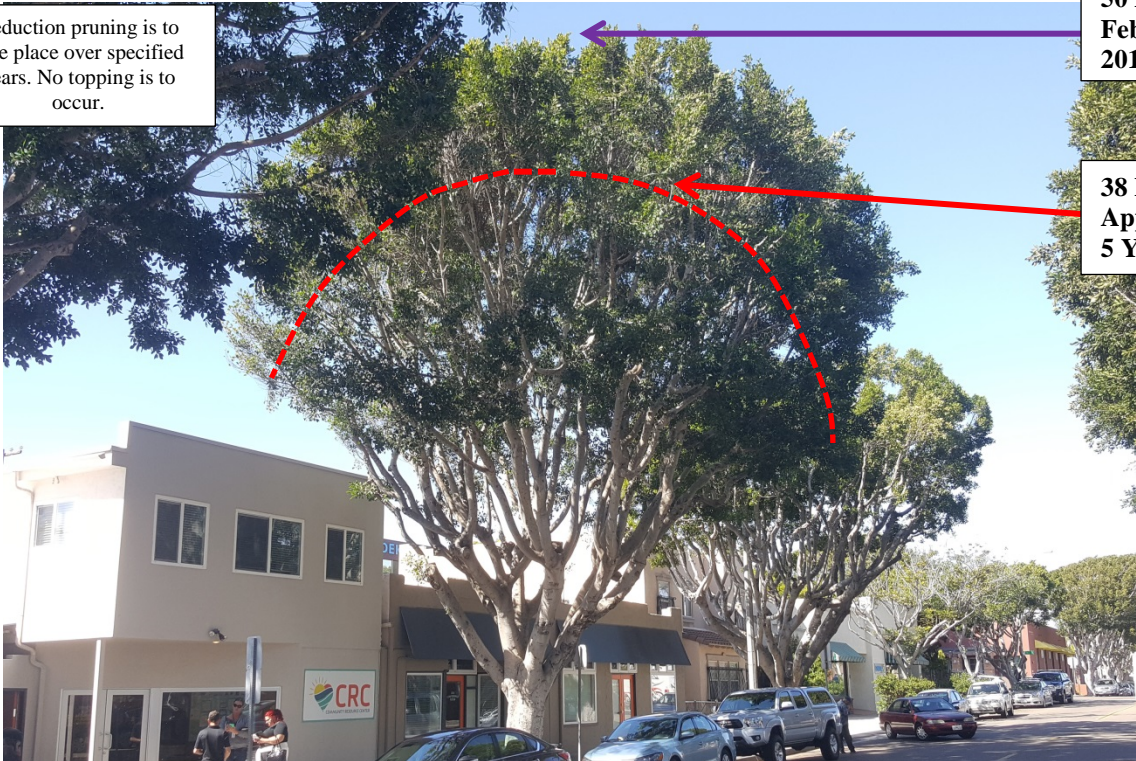
**Crown Reduction Pruning Goal**

**50 Feet  
February  
2017**

**38 Feet in  
Approximately  
5 Years**

This tree had a measured height of 50 feet (see purple arrow). The proposed goal is to achieve a 25% (12.5 feet) **crown reduction through a multi-year pruning plan (taking up to five years)** leaving the tree with a height of approximately 38 feet (see red dotted line and arrow) after the final pruning dose.
