Tree Risk Evaluations

Blue Gum Eucalyptus Assessment, Highway 101 Median, Leucadia,
CA

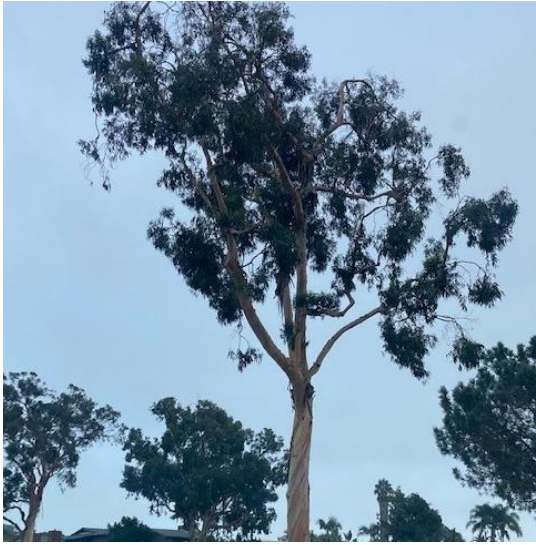
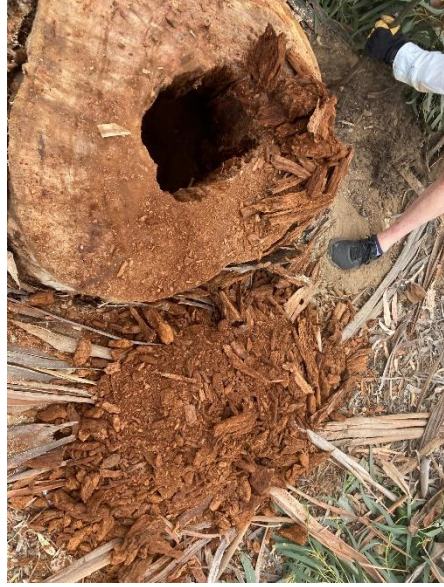
Tree 7908 – Blue Gum

- Single stemmed
- 36-inch diameter at standard height (4.5 feet)
- Height – 55 feet
- Fair to poor health and structural condition
- Occurrences of sulfur fungus in the crown
- No defects of concern observed in the crown
- Extensive decay detected 61% damaged wood at 24 inches above ground level
- High risk

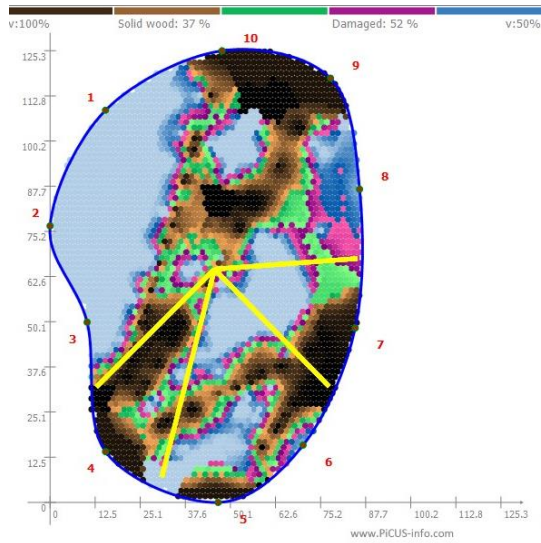
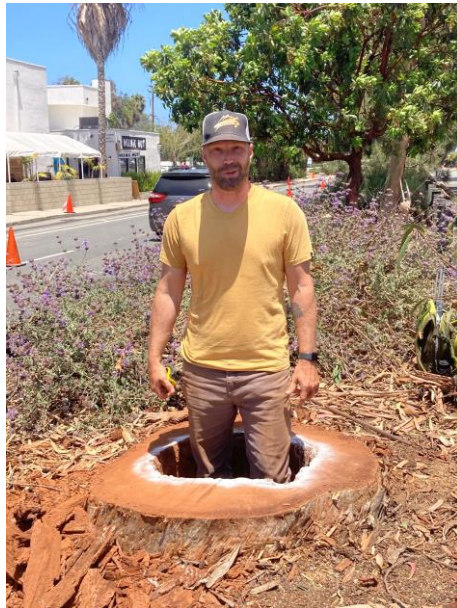
Tree 7920 – Blue Gum

- Single stemmed
- 36-inch diameter at standard height (4.5 feet)
- Height – 55 feet
- Fair to poor health and structural condition
- Occurrences of sulfur fungus in the crown
- No defects of concern observed in the crown
- Extensive decay detected 61% damaged wood at 24 inches above ground level
- High risk
