March 1, 2024

Subject: Indian Laurel Tree Risk Evaluation – 610 2nd Street, City of Encinitas, California 92024

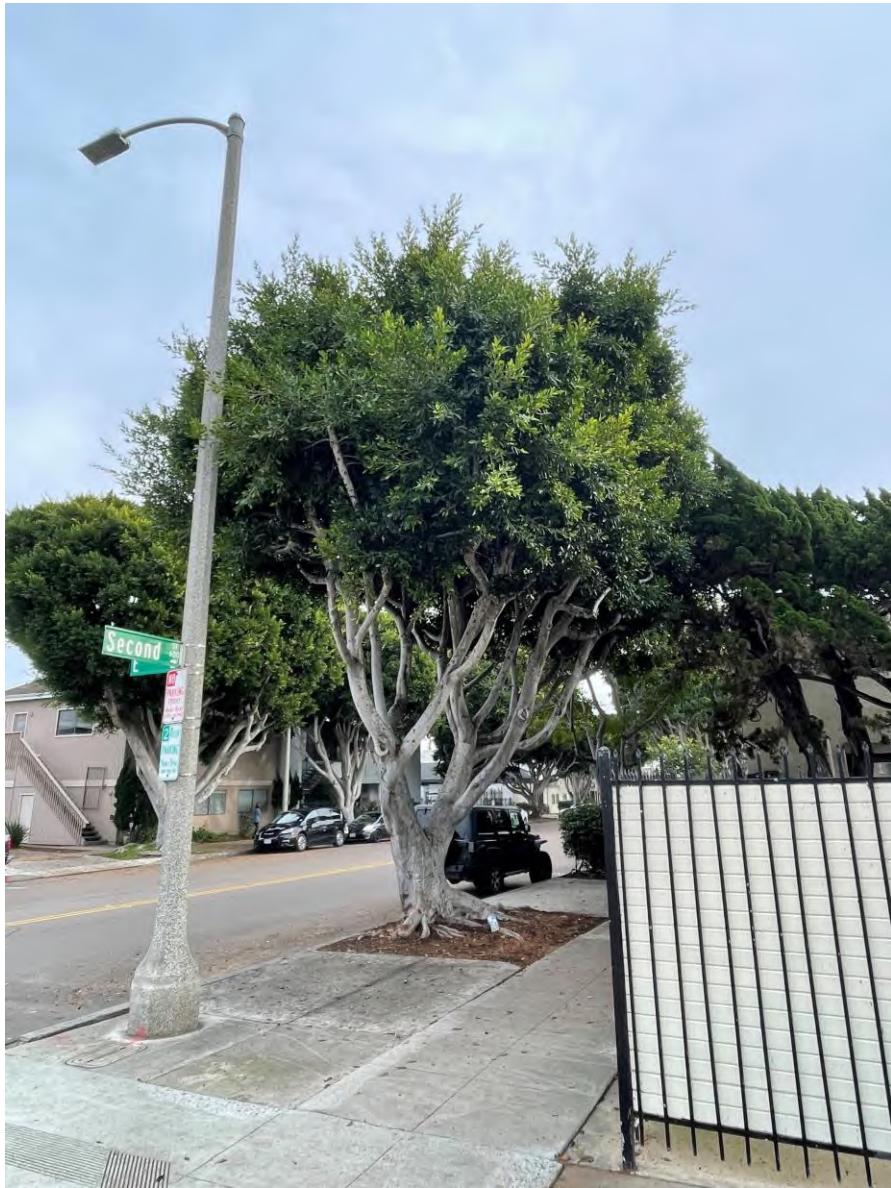
5112ETREE overview facing southeast

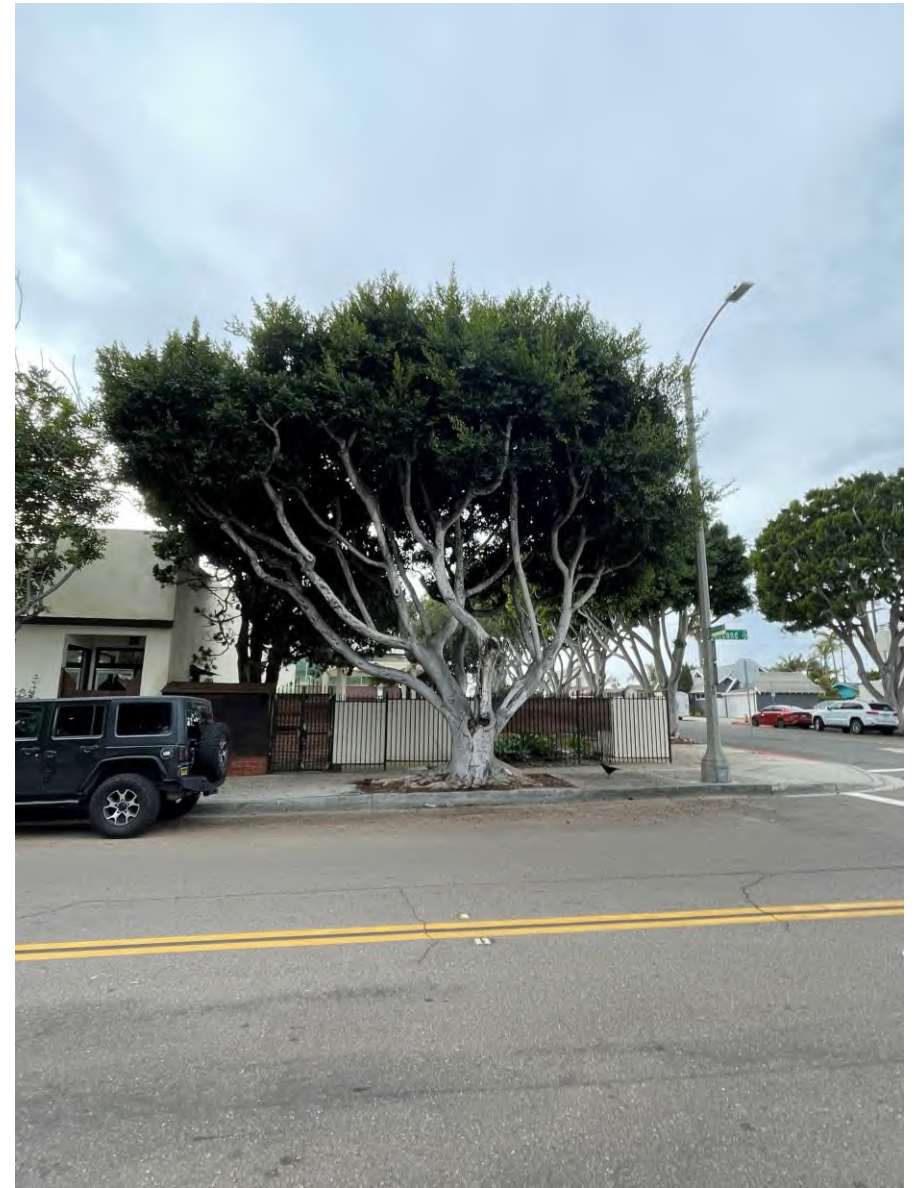
5112ETREE overview facing west

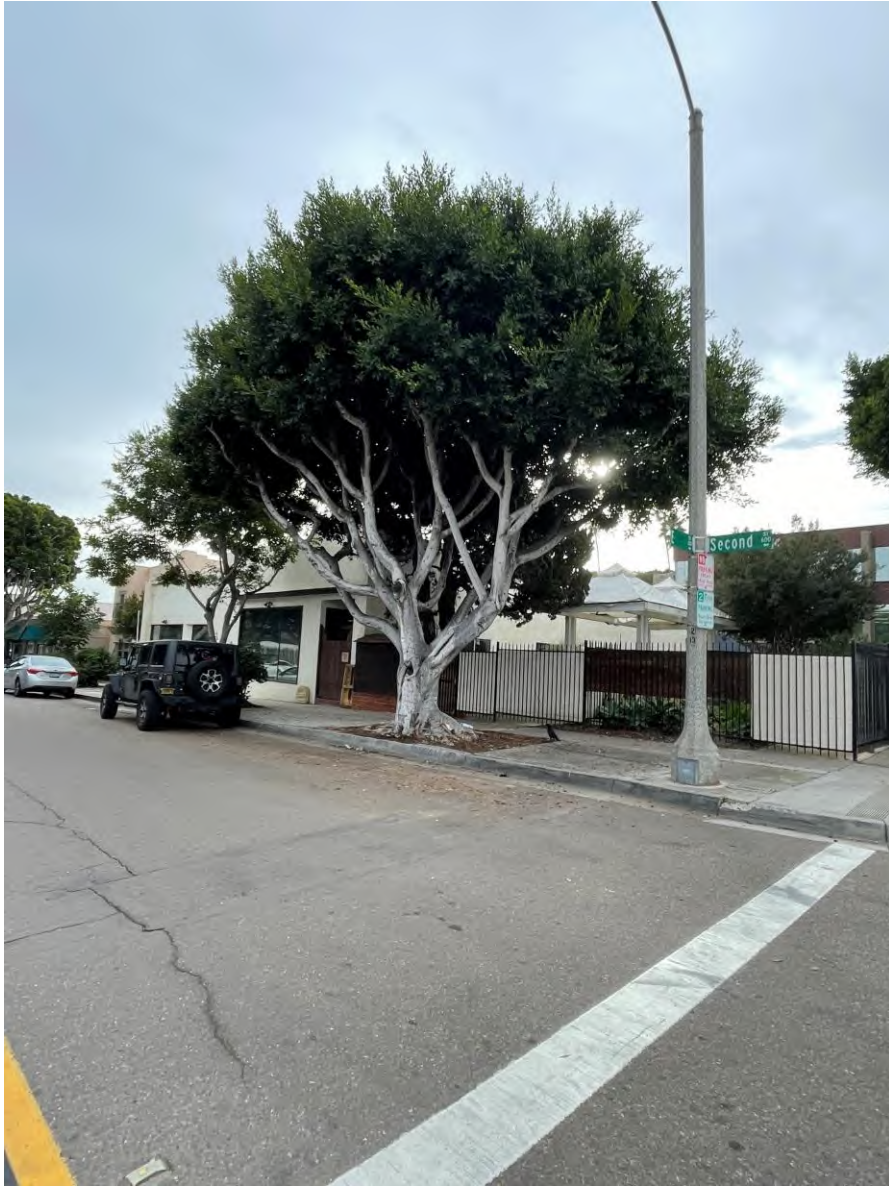
5112ETREE overview facing southwest

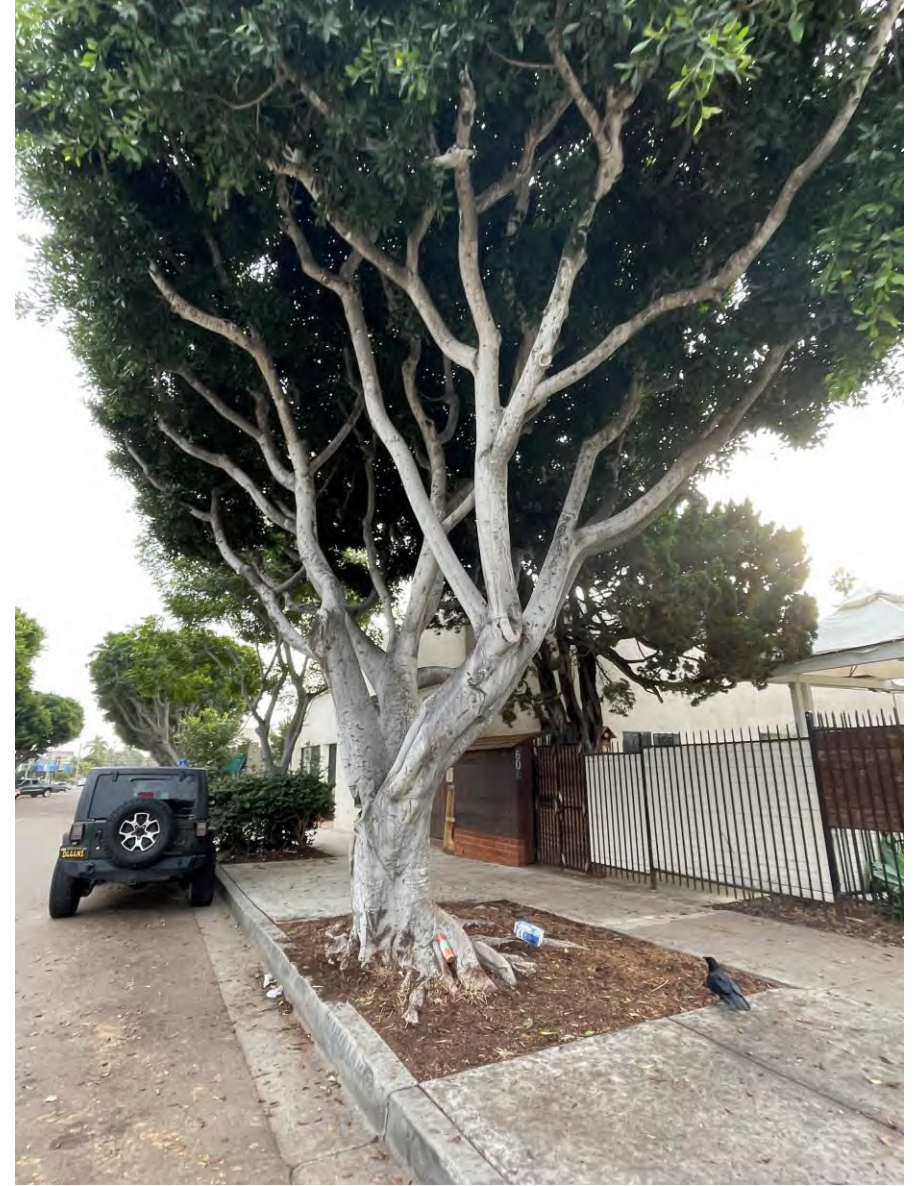
- **Weak attachments:** Co-dominant branch unions formed at small and medium branches, and epicormic growth is evident from pruning wounds.
- **Main concern:** Epicormic growth is evident from reduction cuts.
- **Likelihood of failure:** Improbable to fail within the established 12-month time frame.

Detail photo showing reduced crown

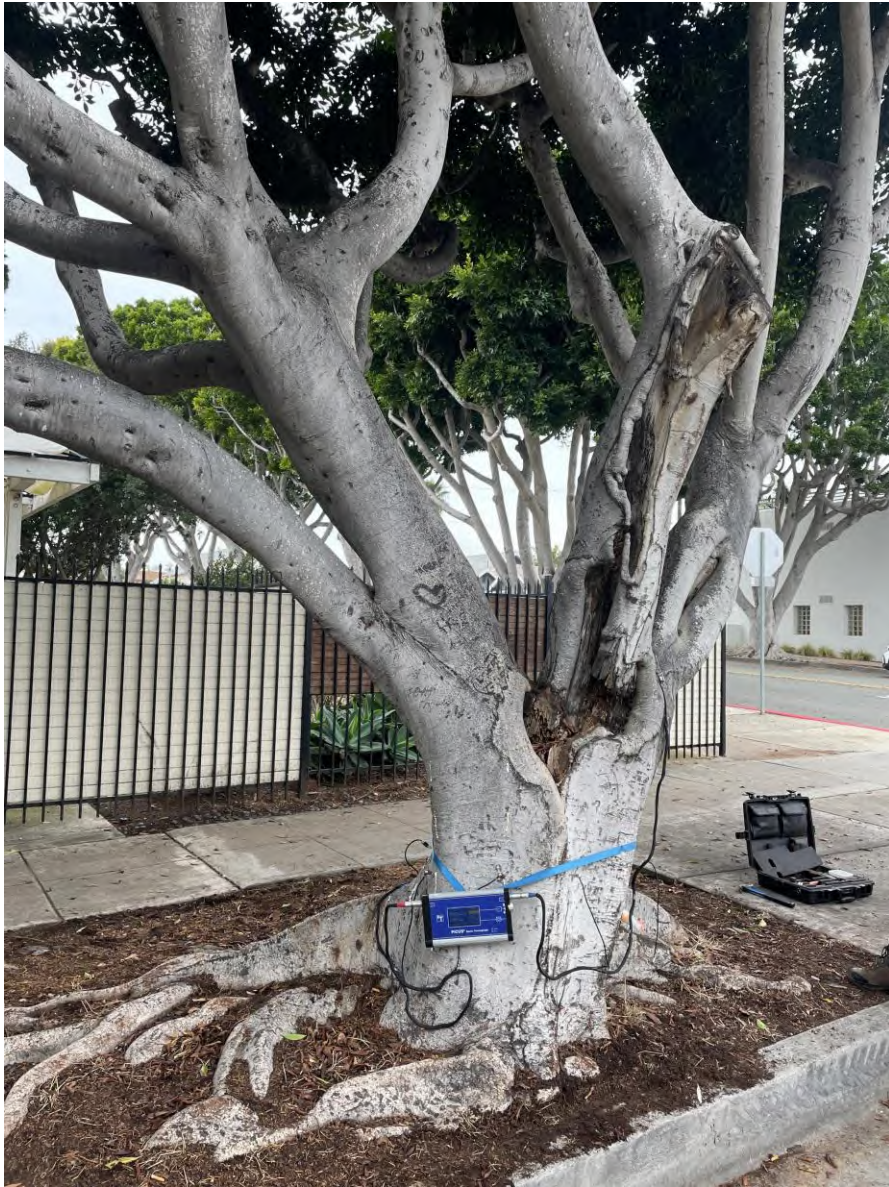
- **Main concern:** A significant wound was observed on the east side of the tree that originates at the union of two main stems (20 inches and 15 inches) and extends up into the middle 15-inch stem. There is extensive heartwood decay present in the wound that includes termite damage and a possible crack.
- **Likelihood of failure:** The main concern identified for the subject tree was classified as probable to fail within the established 12-month time frame.

Detail photo of measuring points placed at 24 inches above soil grade and of heartwood decay in stem

- **Removal and Replacement:** Due to the location of the tree in the landscape, elevated levels of internal decay in the trunk of the tree, and extensive heartwood decay in the union of the co-dominant stems, Dudek recommends this tree be removed as soon as possible. Street parking access should be restricted under the dripline of the tree while the tree is being scheduled for removal. Tree 5112ETREE should be replaced in accordance with the Downtown Specific Plan, Section 7.5 Street Tree Concept Plan. In particular, a 24" box *Quercus suber* should be planted following the ISA's Best Management Practices for tree planting.

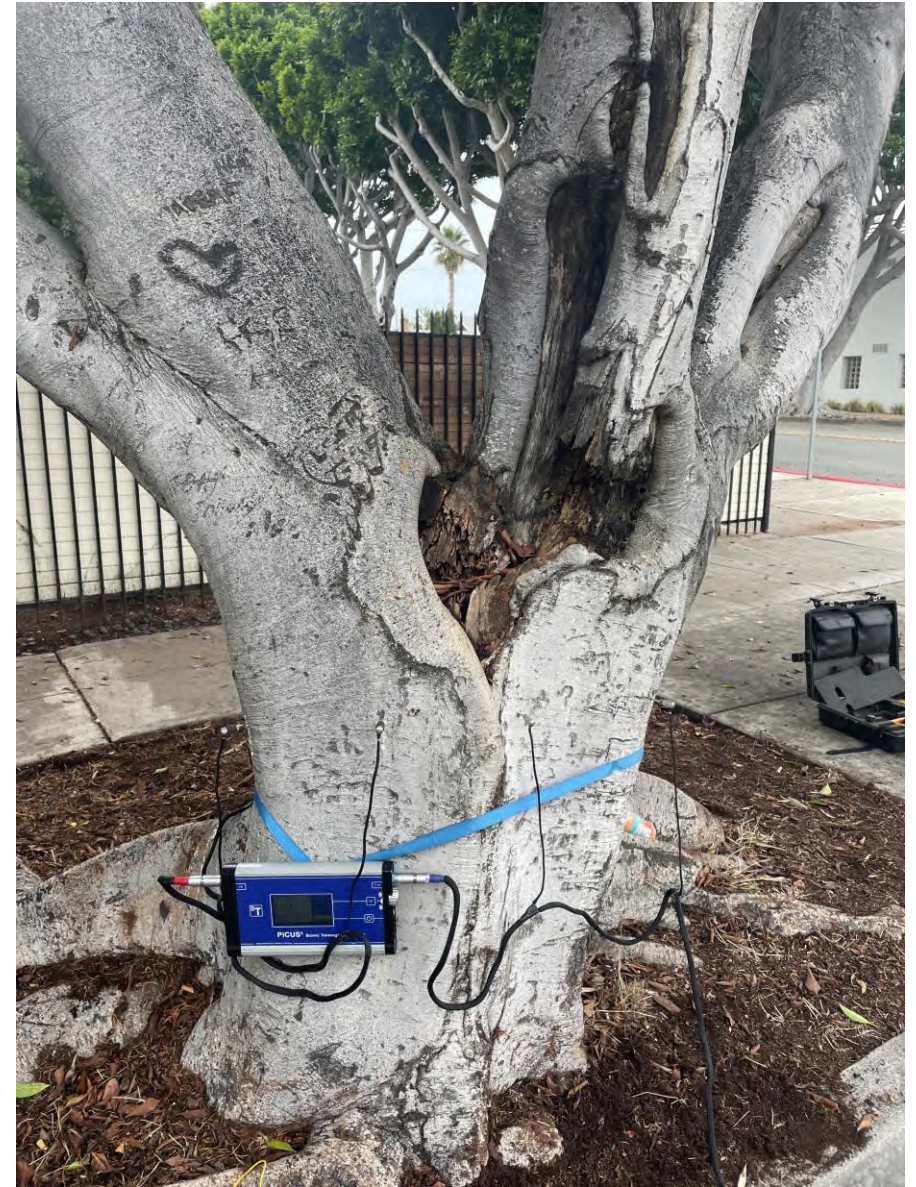
Detail photo of measuring points placed at 30 inches above soil grade and of heart wood decay in codominant stem union

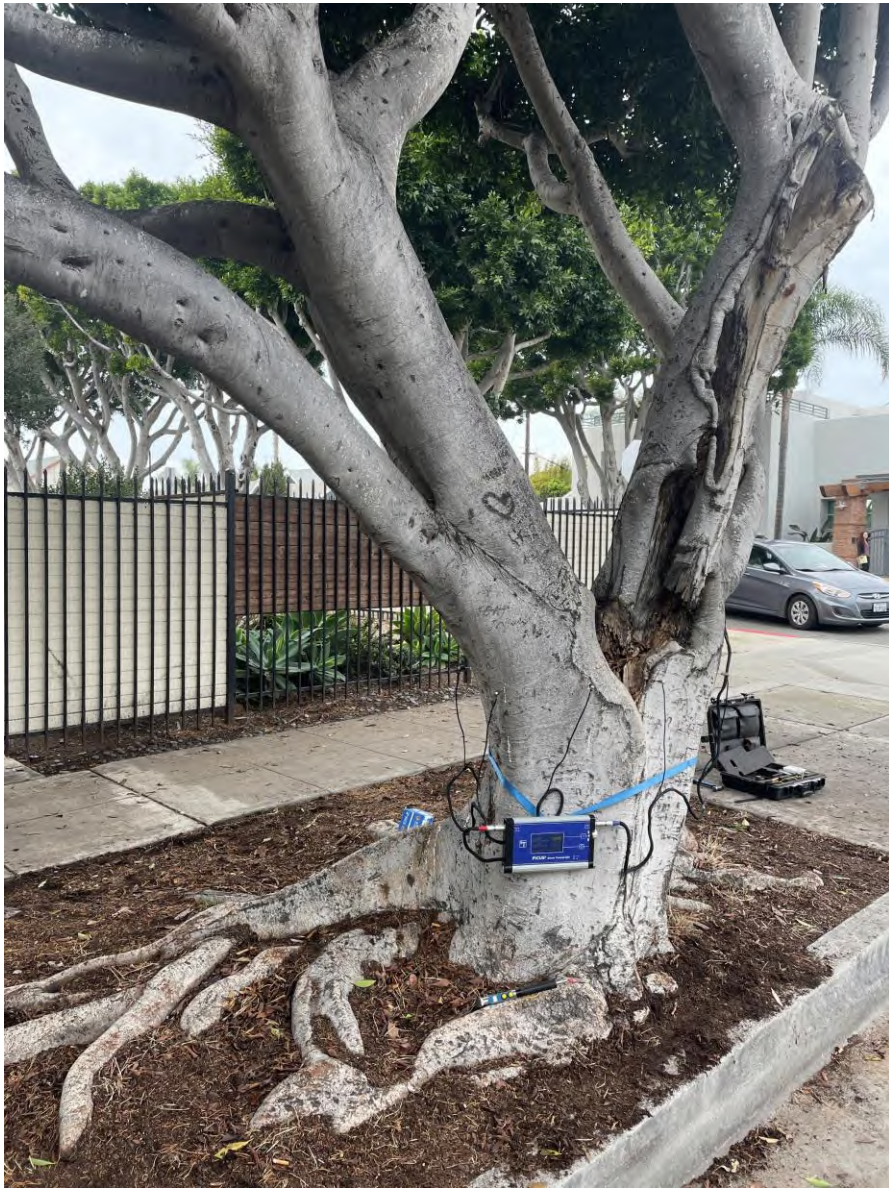
Detail photo of measuring points placed at 38 inches above soil grade

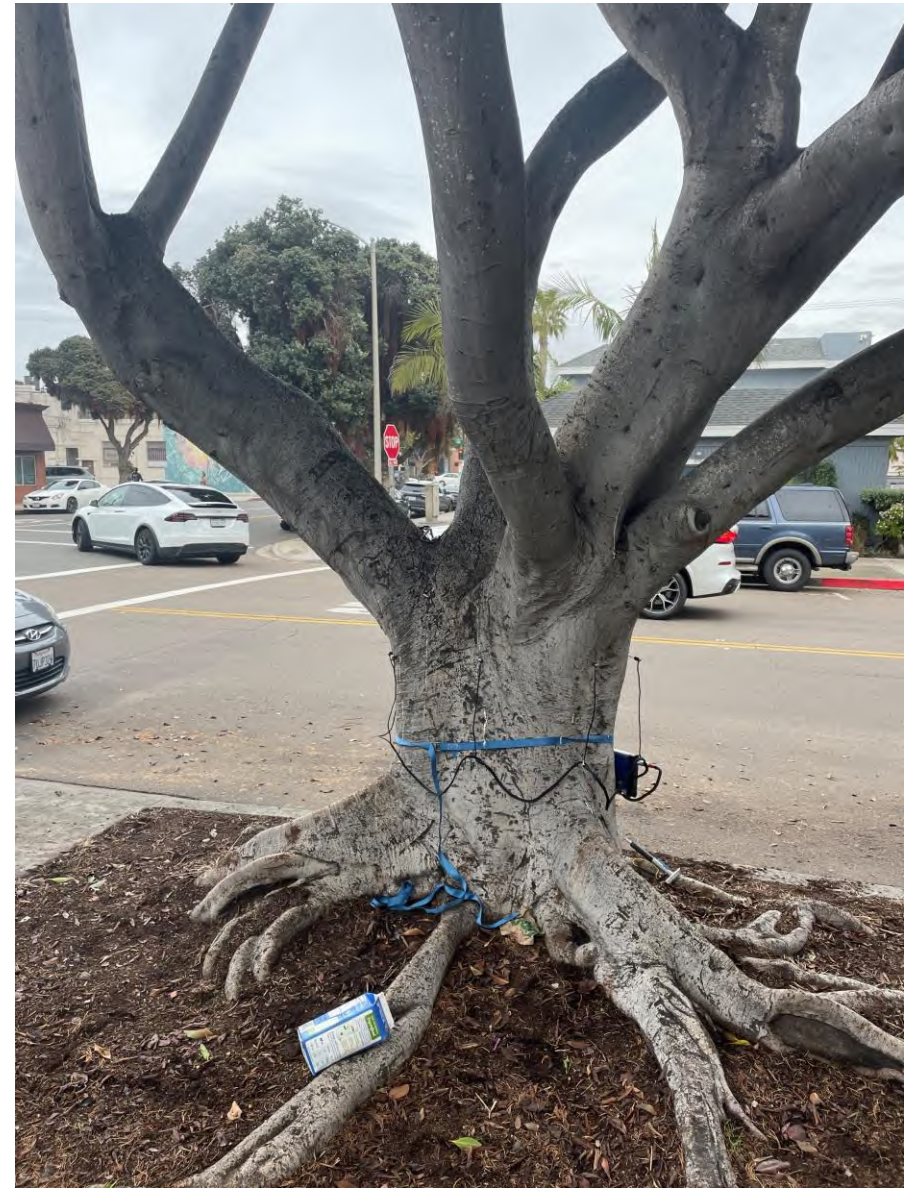
Trunk and sonic tomography unit facing northeast

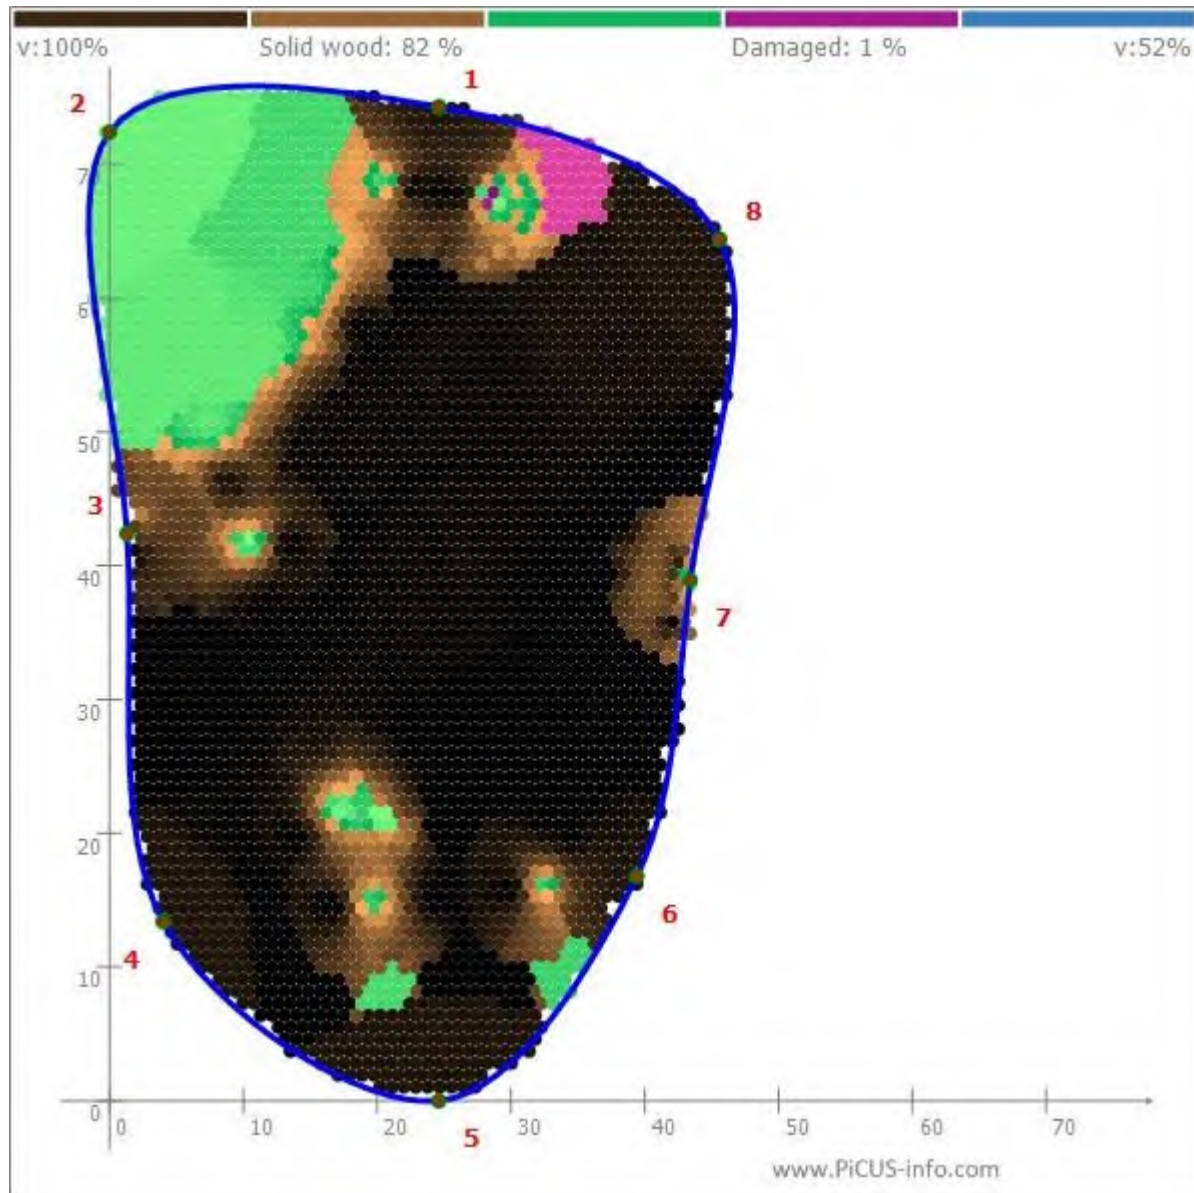
The subject tree was evaluated for the presence of internal decay, damaged wood, and/or cracks at three locations on the trunk below the point of trifurcation (24 inches, 30 inches, and 38 inches above soil grade). Dudek found that the tree had elevated levels of detectable internal damage (10% to 20% internal damage and/or decay) at all of the reading locations. Attachment D, Sonic Tomography Matrix, presents the sonic tomography evaluation. Individual sonic tomograms for the tree are presented in Attachment E, Sonic Tomography Images.

Tree 5112ETREE sonic tomography reading at 24 inches above soil grade

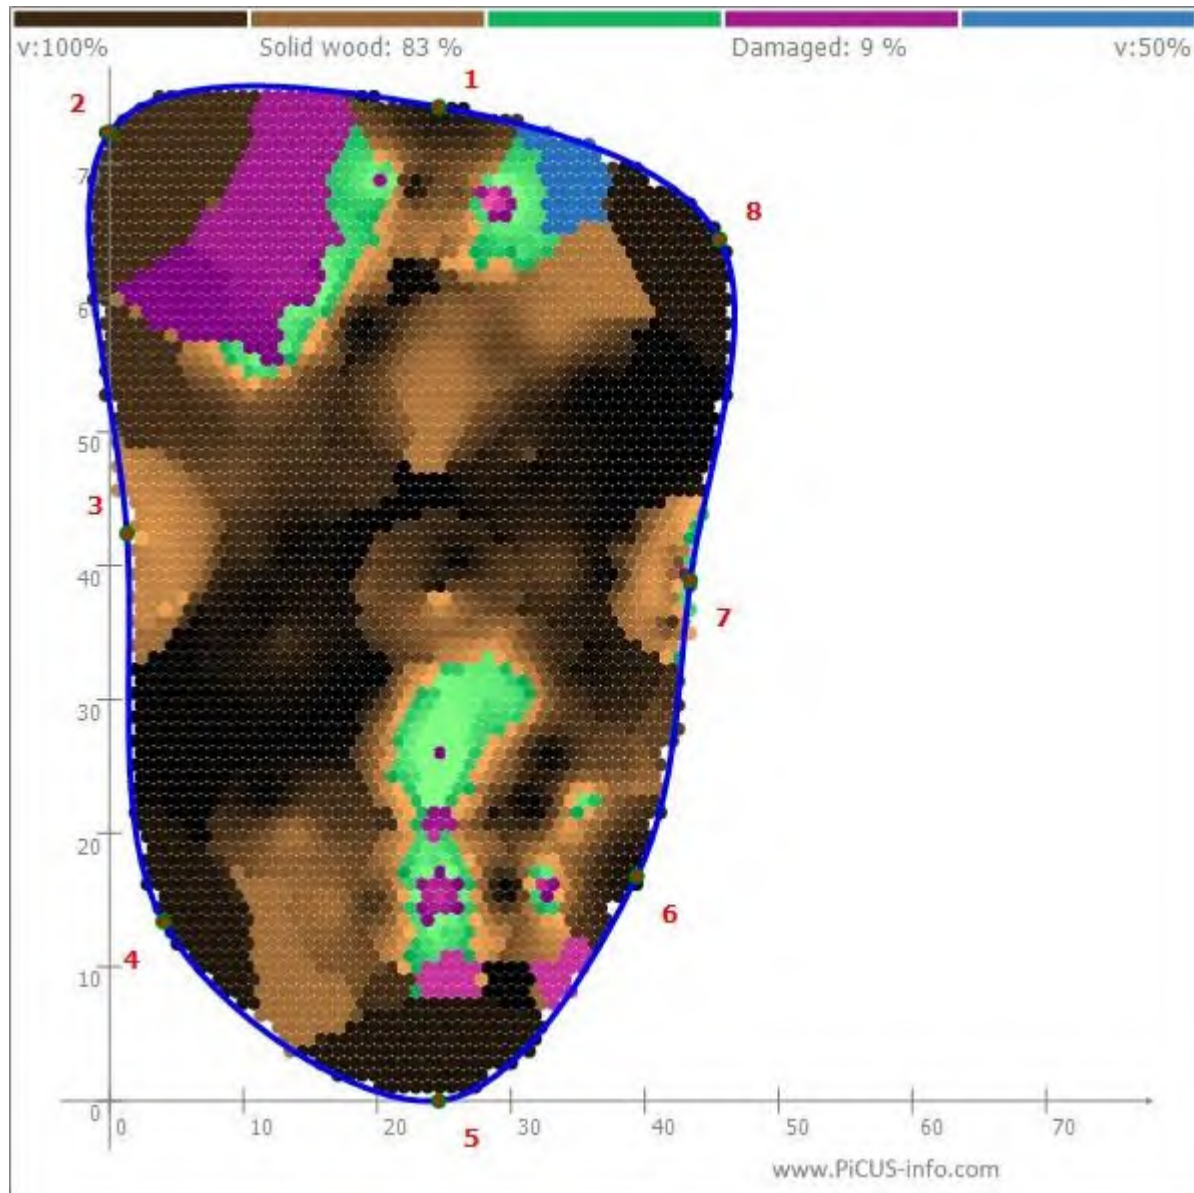
Tree 5112ETREE sonic tomography reading at 30 inches above soil grade

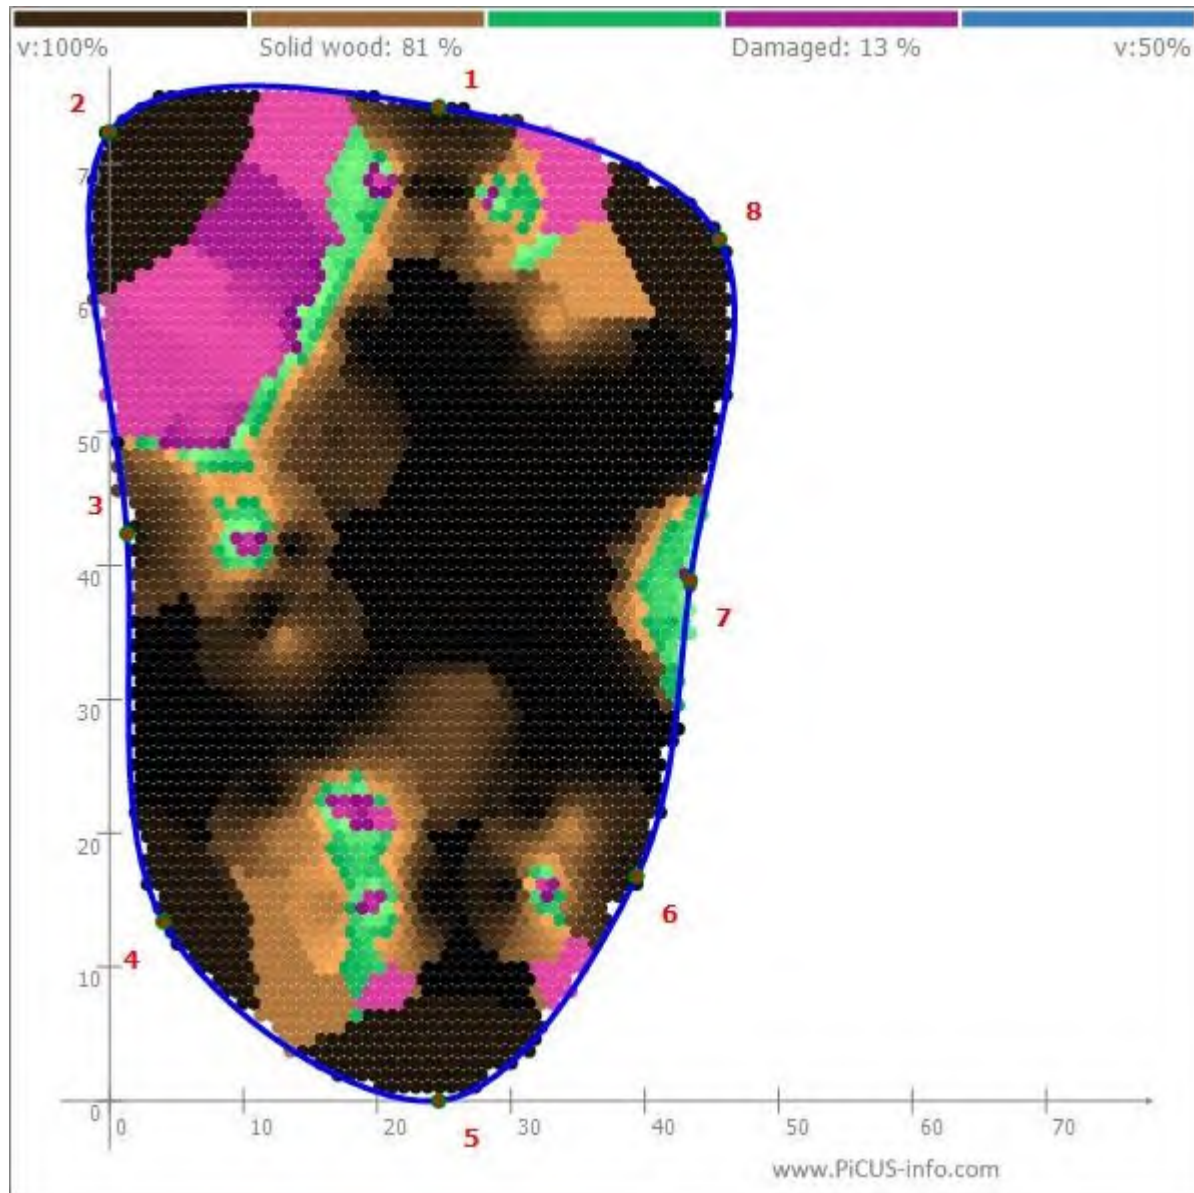
Tree 5112ETREE sonic tomography reading at 38 inches above soil grade
