# City of Encinitas

## 3.27.17 Assessment of Ficus Tree At 655 Second Street (Front-1)

MARCH 27, 2017

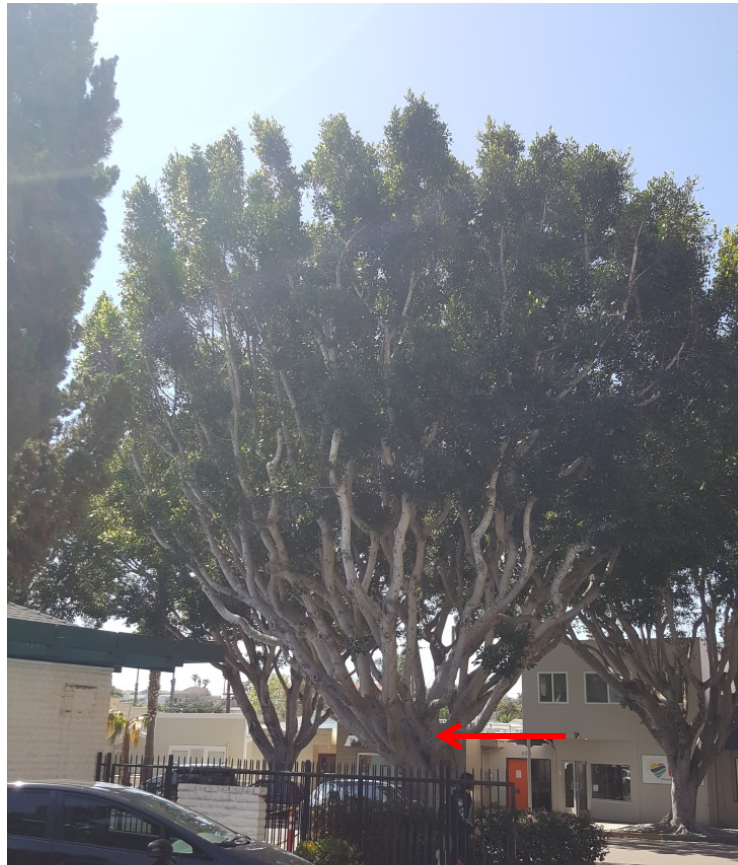
- The tree was growing in an 8.5 foot wide tree well on the east side of 2<sup>nd</sup> St. and in front of the 655 business address (see Figure 1, as well as Photo #1 in Appendix A).

- Judging by the color and density of the foliage, the tree appeared to be in fair health for the species and time of year. The tree had a moderate **live crown ratio** of approximately 50% which is common for street trees necessitating crown raising for vehicle clearance (see Photo #1 in Appendix A).

- The tree (red arrow) was growing in an 8.5 foot wide tree well on the east side of 2<sup>nd</sup> St. in front of the 629 business address.
- Judging by the color and density of the foliage, the tree appeared to be in fair health for the species and time of year. The tree had a moderate **live crown ratio** of approximately 50% which is common for street trees necessitating raised crowns for vehicle clearance.

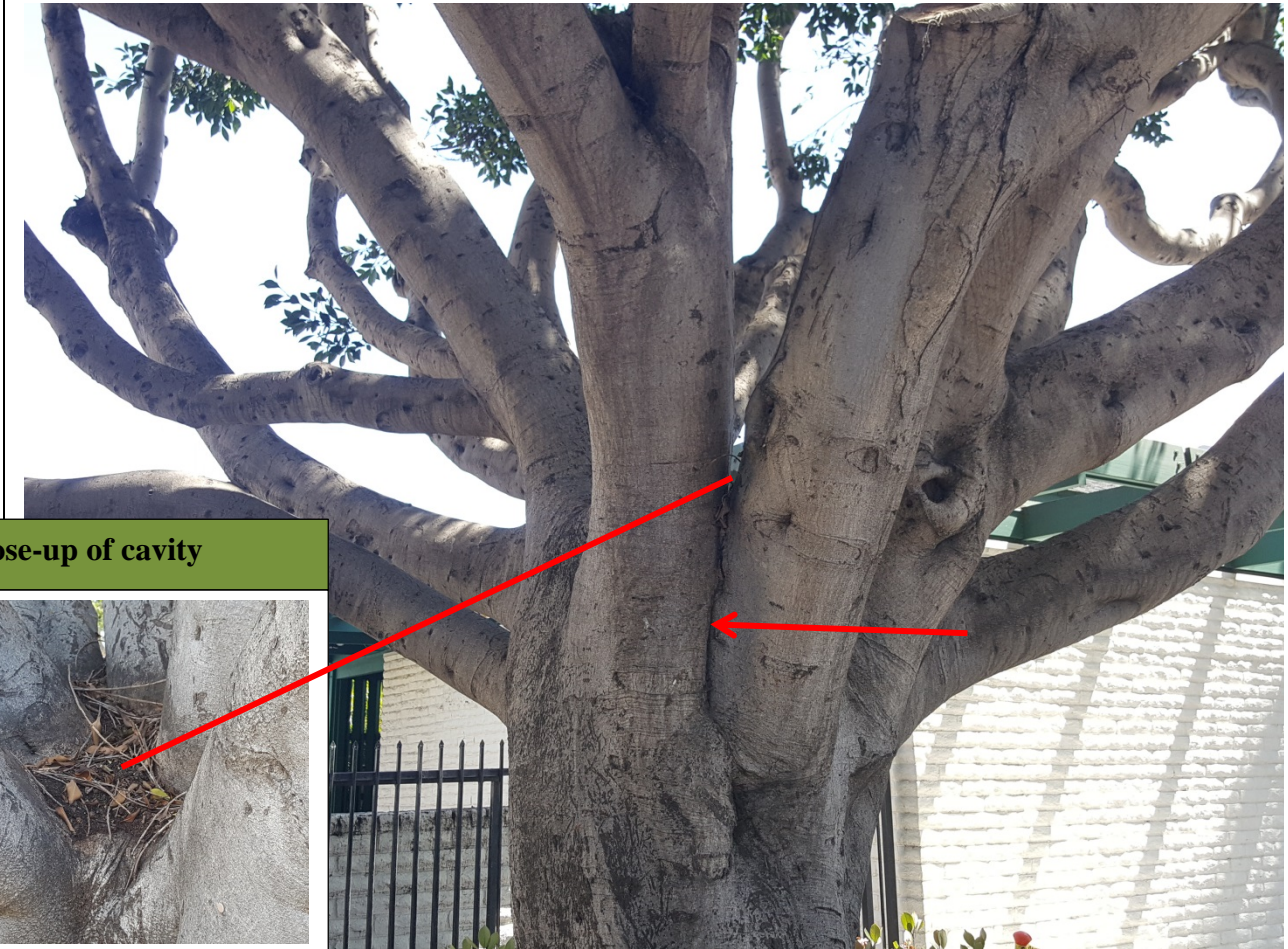
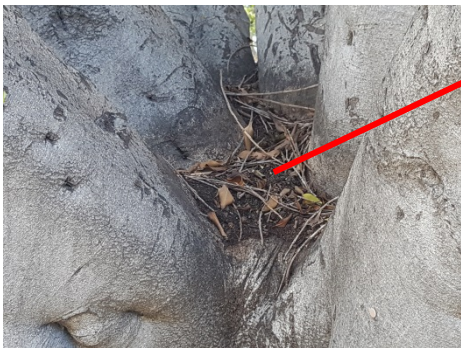
- The tree had a DSH<sup>2</sup> measurement of 30 inches and a height of about 50 feet (measured with a TruPulse laser).
- The tree had multiple overextended **codominant stems** and scaffold branches which are indicative of poor tree structure. Some of these stems had included bark (see Photo #2 in Appendix A).

- There was a debris filled cavity between the multiple stems (see Photo #2 in Appendix A).
- The pedestrian walkway area just west of the tree was in the middle of being repaired and was partially coned off (see Photo #3 in Appendix A).

The defects of greatest concern for the subject tree were the significant root pruning, and the large overextended stems/ scaffold branches with included bark and a debris filled cavity. These defects, along with the fact the tree did not experience a failure throughout this winter's abnormally heavy rain storms were taken into account. The *likelihood of a failure* within the next year was assessed as **possible** for the subject tree due to these factors. This potential failure event would be most likely to occur during abnormal or extreme weather conditions.

Close-up of cavity

- The tree had multiple overextended **codominant stems** and scaffold branches which are indicative of poor tree structure. Some of these stems had included bark (see **red arrow**).
- There was a debris filled cavity between the multiple stems (see **red line** and close up box on the left).

1. Remove the tree and replace it with a with a healthy site adequate species.
2. Applying and maintaining an approximate 25% crown reduction with the structure and canopy balance of the tree in mind (see Appendix B as well as Figure 3 below). This recommended pruning should be done in compliance to ANSI A300 Arboricultural Standards and will need to be applied over multiple spaced out pruning doses (taking up to 5 years) to minimize health impacts on the tree. This is also recommended to allow time for interior growth to further develop and broaden the options for new branches to prune back to. Pruning techniques such as **reduction pruning**, and **removal pruning cuts** should be used (not topping) to achieve this overall squattier appearance and are further explained in Appendix B. The end outcome should be a reduction of **mechanical stress** from overextended loads and an improvement in wind penetration. A residual risk of “Low” should be achieved after implementing these recommended pruning strategies.

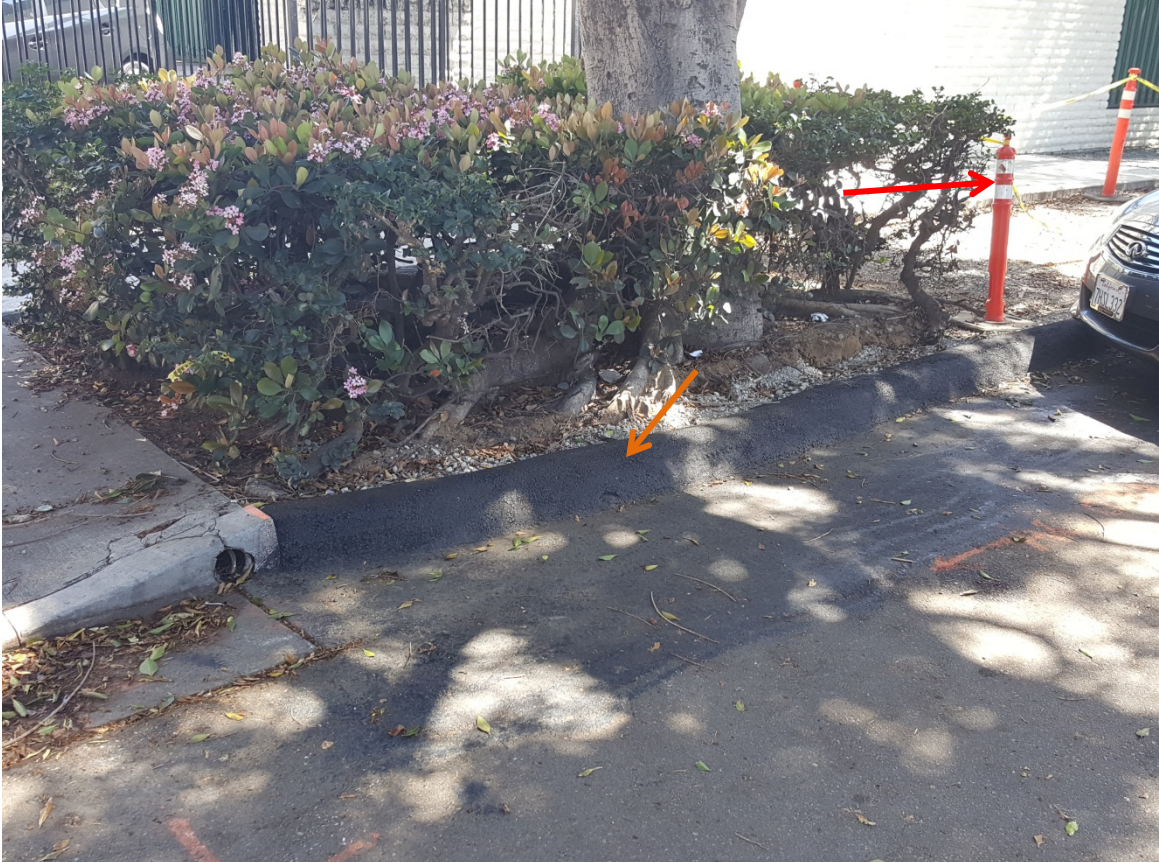
- The curb face in front of the tree appeared to have been recently replaced with asphalt (see Photo #3 in Appendix A).
- There was one large root that appeared to have been pruned for hardscape repairs about 5 feet east of the base tree's base. There were epicormic roots growing as a responsive growth to this root injury indicating that it was likely done some years ago (see Photo #4 in Appendix A).

- The pedestrian walkway area just west of the tree was in the middle of being repaired and was partially coned off (see **red arrow**).
- The curb face in front of the tree appeared to have been recently replaced with asphalt (see **orange arrow**).

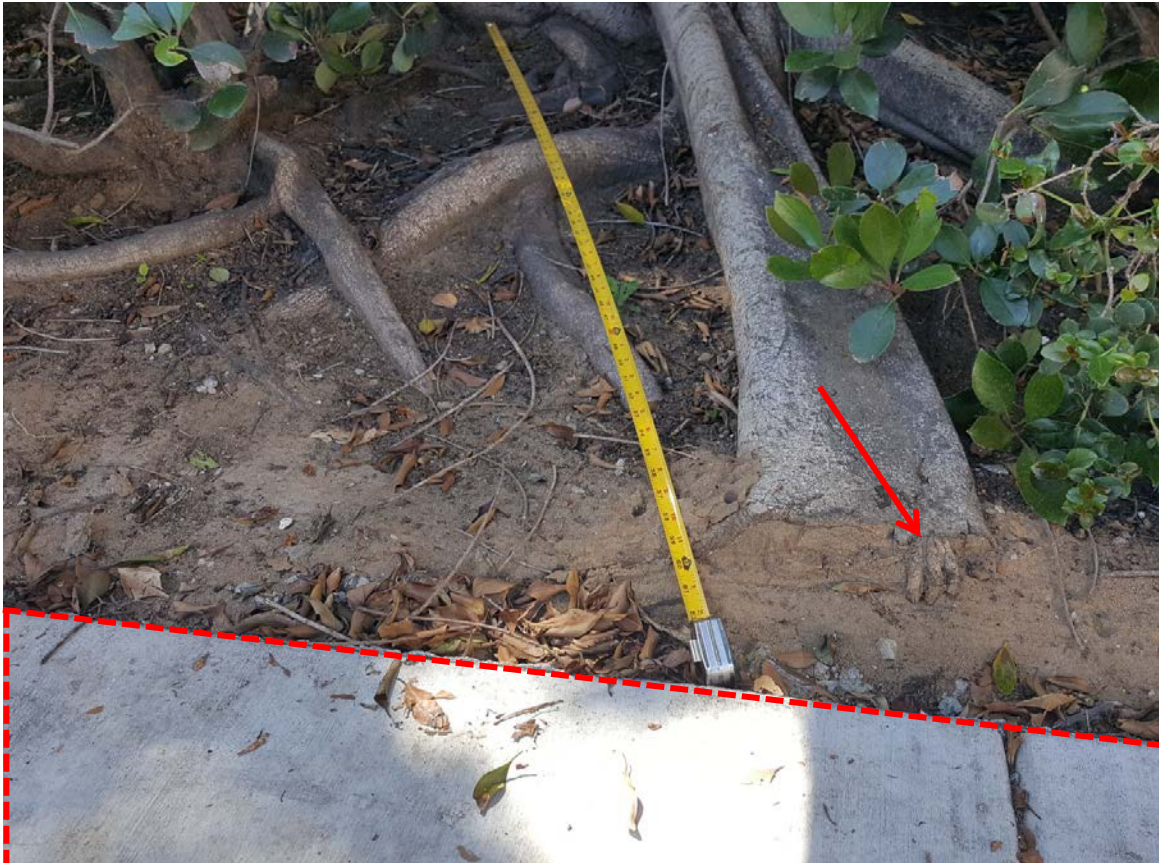
- There was a section of sidewalk with a lighter tone on the east side of the tree indicating there were likely recent hardscape repairs to eliminate trip hazards (see Photo #4 in Appendix A).
- There were ficus tree roots observed growing about 35 feet east of the tree in the business's private parking lot and an adjacent landscaped bed (see Photo #5 in Appendix A).
- There was cracking and lifting occurring in numerous areas of the parking lot, likely related to conflicts between the tree's roots and the infrastructure (see Photo #5 in Appendix A).

**Root Pruning:** Root pruning (such as observed on this tree) is an injurious practice that can significantly damage trees and affect their structural strength and health. If future conflicts between roots and infrastructure occur, I recommend looking into alternative mitigation strategies such as **elevated root bridging**, or meandering sidewalks to minimize damage to roots. If root pruning cuts must be made, I recommend doing so selectively under the supervision of a Certified Arborist and as far away from the trunk as possible using sharp tools to avoid tearing and crushing of roots. It is with the health and safety of the community that I present these recommendations.

- There was one large root that appeared to have been pruned for hardscape repairs about 5 feet east of the base tree's base (see **red arrow**). There were epicormic roots growing as a responsive growth to this root injury indicating that it was likely done some years ago.
- There was a section of sidewalk with a lighter tone on the east side of the tree indicating there were likely recent hardscape repairs to eliminate trip hazards (see **red dotted area**).

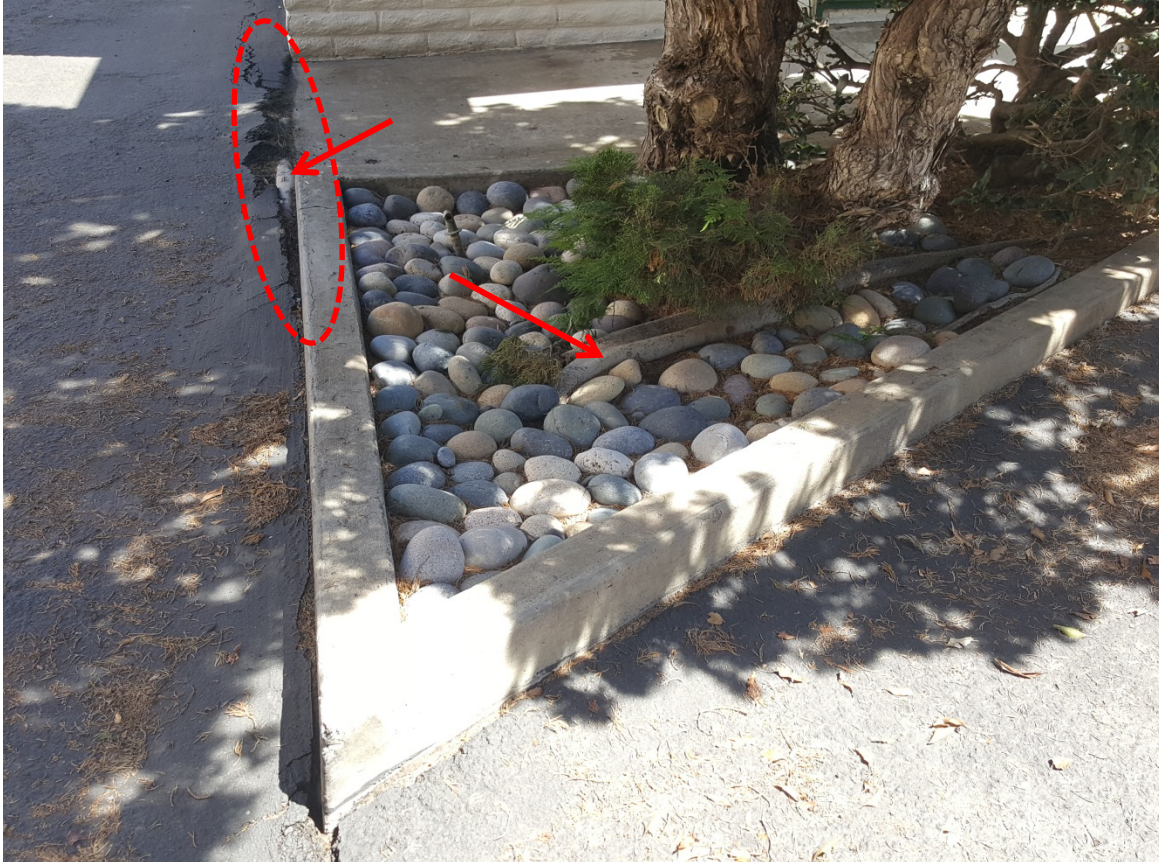
Photo #5

- There were ficus tree roots observed growing about 35 feet east of the tree in the business's private parking lot and an adjacent landscaped bed (see **red arrows**).
- There was cracking and lifting occurring in numerous areas of the parking lot, likely related to conflicts between the tree's roots and the asphalt (see **red dotted oval**).
