# City of Encinitas

## 5.23.17 Assessment of Ficus Tree At 655 2<sup>nd</sup> Street (Front-2)

Gene Bordson  
Certified Arborist # WE-10777A  
Qualified Applicator License# 140768  
Qualified Tree Risk Assessor

MAY 23, 2017

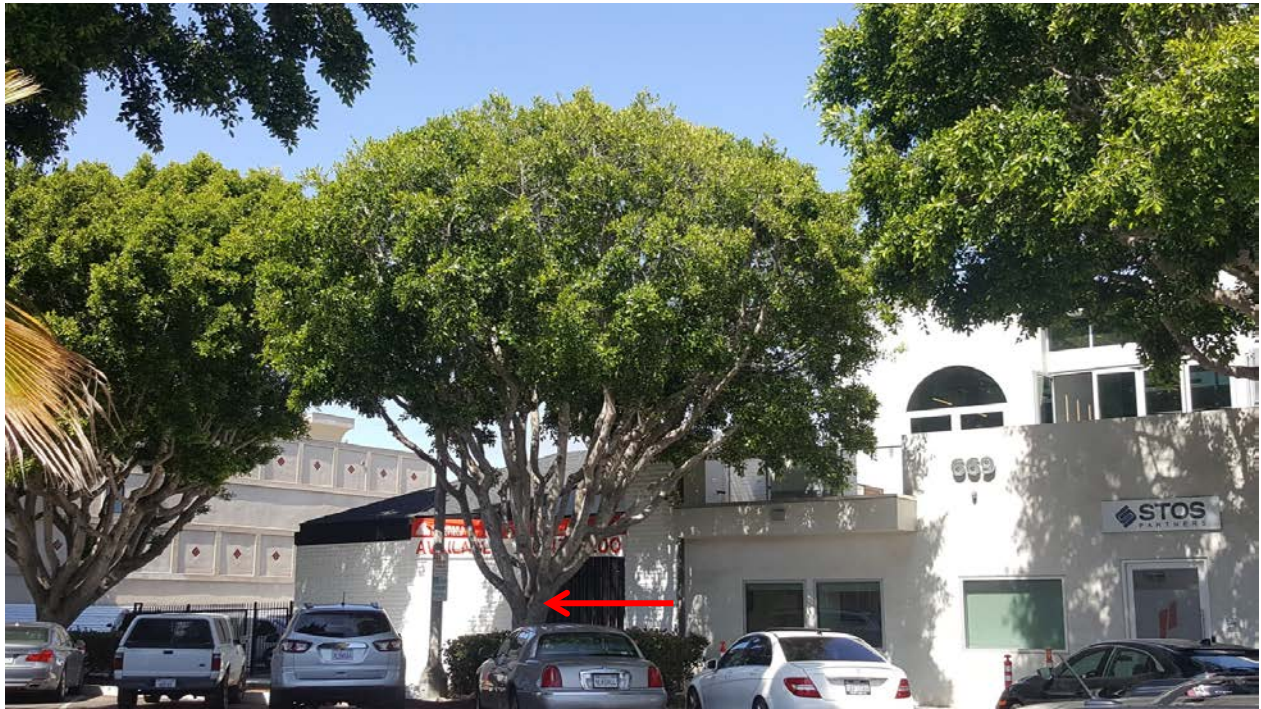
- The tree was located on the east side of the road between 655 and 669 2<sup>nd</sup> St. (see Photo #1 in Appendix A as well as Figure 1).
- Judging by the color and density of the foliage, the tree appeared to be in fair health for the species and time of year. The tree had a moderate **live crown ratio** of approximately 50% which is common for street trees necessitating raised crowns for vehicle and building clearance (see Photo #1 in Appendix A).

- The tree (**red arrow**) was located on the east side of the road between 655 and 669 2<sup>nd</sup> St.
- Judging by the color and density of the foliage, the tree appeared to be in fair health for the species and time of year. The tree had a moderate **live crown ratio** of approximately 50% which is common for street trees necessitating raised crowns for vehicle and building clearance.

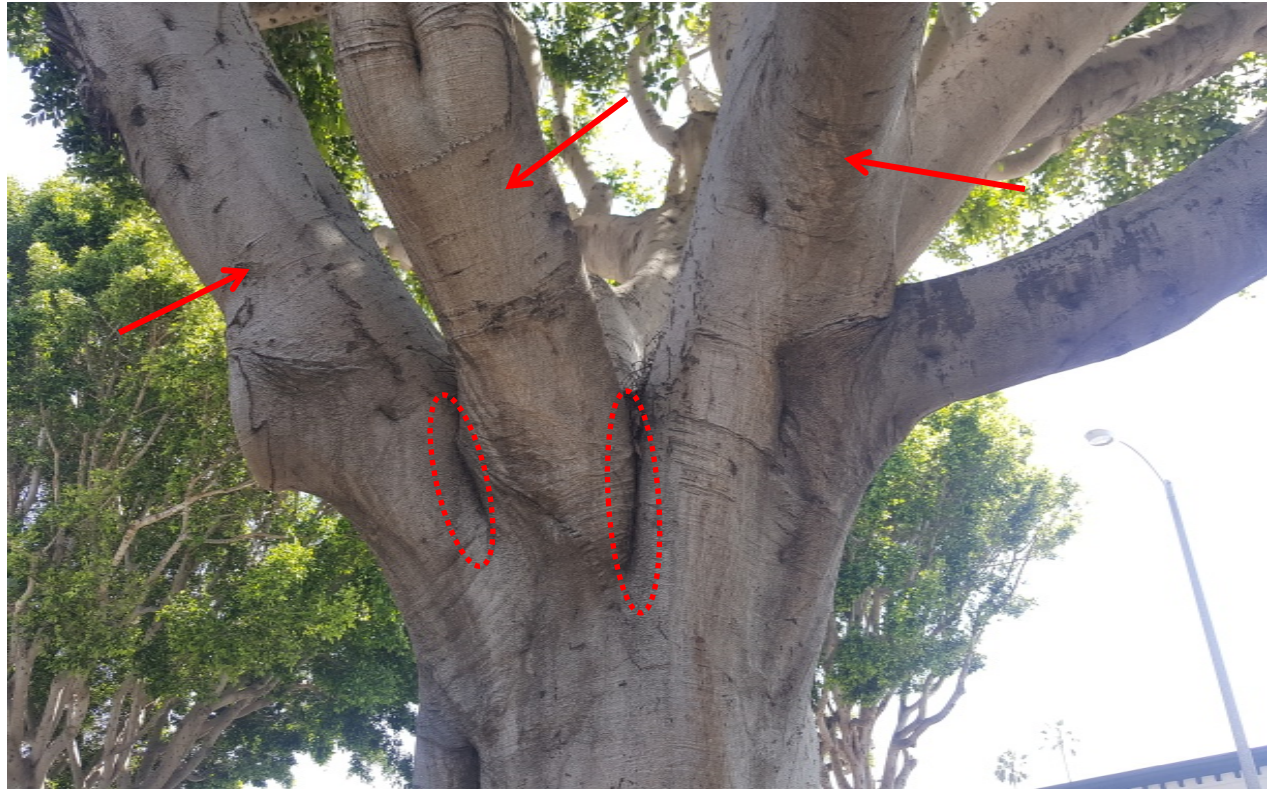
- The tree had a DSH<sup>2</sup> measurement of 24 inches and a height of about 40 feet (measured with a TruPulse laser).
- The tree had multiple codominant stems and scaffold branches which are indicative of poor structure yet fairly common among this species (see Photo #2 in Appendix A).

- Some of the stems and scaffold branches had included bark as well as small debris filled cavities between the branch unions (see Photo #2 in Appendix A).

The defects of greatest concern for the subject tree were the overextended stems/scaffold branches with presence of included bark and shallow decay filled cavities. The *likelihood of a stem/scaffold branch failure* within the next year was assessed as **possible** for the subject tree. This was determined by taking into account the defects, as well as the fact that the first mitigation pruning dose was accomplished and no failures had occurred during the abnormally extreme winter storms. A failure event would be most likely to occur during abnormal or extreme weather conditions.

- The tree had multiple codominant stems (**red arrows**) and scaffold branches which are indicative of poor structure yet fairly common among this species.
- Some of the stems and scaffold branches had included bark (**red dotted ovals**) as well as small debris filled cavities between the branch unions.

After performing a **Level 2 Basic Assessment**<sup>4</sup>, the subject tree was assessed to currently have an overall moderate risk rating. In regards to mitigating these risks, I recommend continuing to apply the crown reduction pruning dose of approximately 6% per year as previously recommended in the report from 10/21/2016. At this point in time, an approximate 10 foot overall crown reduction (while retaining interior growth) still remains to achieve the overall recommended goal (see Appendix B and Figure 3 below). This recommended pruning should be done in compliance to ANSI A300 Arboricultural Standards and will need to be applied over multiple spaced out pruning doses to minimize health impacts on the tree. This is also recommended to allow time for interior growth to further develop and broaden the options for new branches to prune back to.

Pruning techniques such as **reduction pruning**, and **removal pruning cuts** should be used (not topping) to achieve this overall squattier appearance and are further explained in Appendix B. The end outcome should be a reduction of **mechanical stress** from overextended loads. A residual risk of “Low” should be achieved after completing these recommended pruning strategies. It is with the health and safety of the community that I present these recommendations.

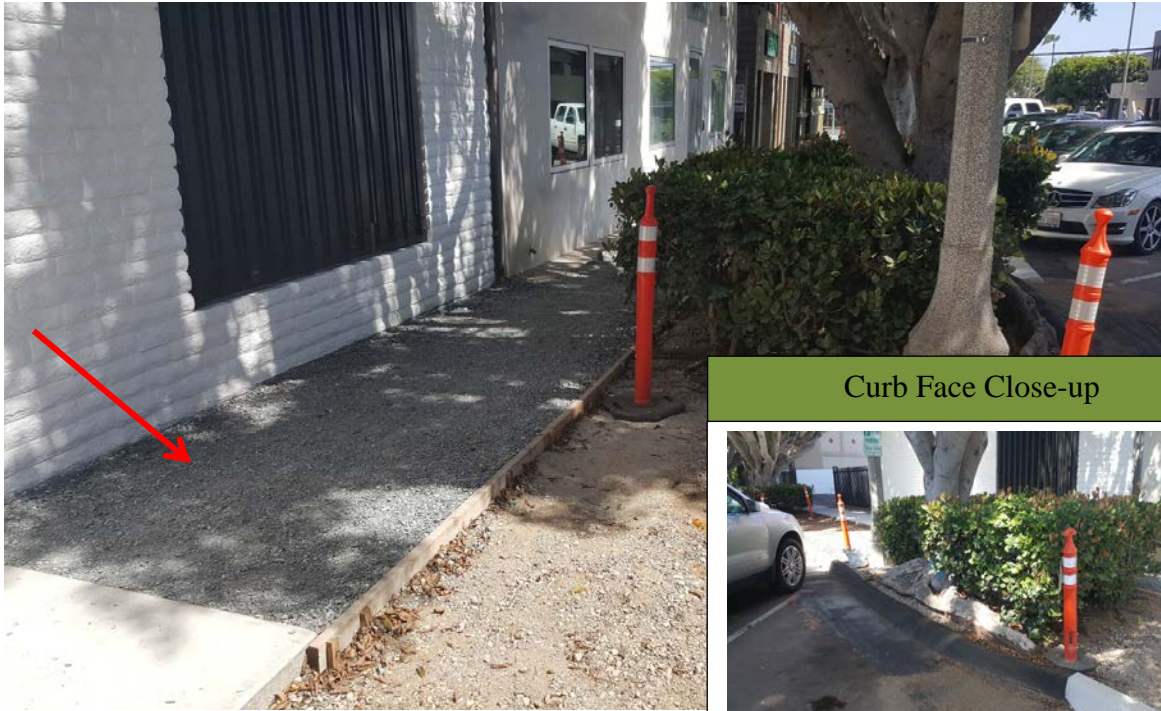
- The area surrounding the tree was in the process of being improved. The curb face had been replaced with asphalt and the sidewalk had been removed and replaced with temporary gravel to lay root bridging plates over (see Photo #3 in Appendix A).

- The area surrounding the tree was in the process of being improved. There the curb face had been replaced with asphalt (see close-up) and the sidewalk had been removed and replaced with temporary gravel (red arrow) to lay root bridging plates over.
