City of Encinitas

5.23.17 Assessment of Ficus Tree At 669 2nd Street (Front-1)

MAY 23, 2017

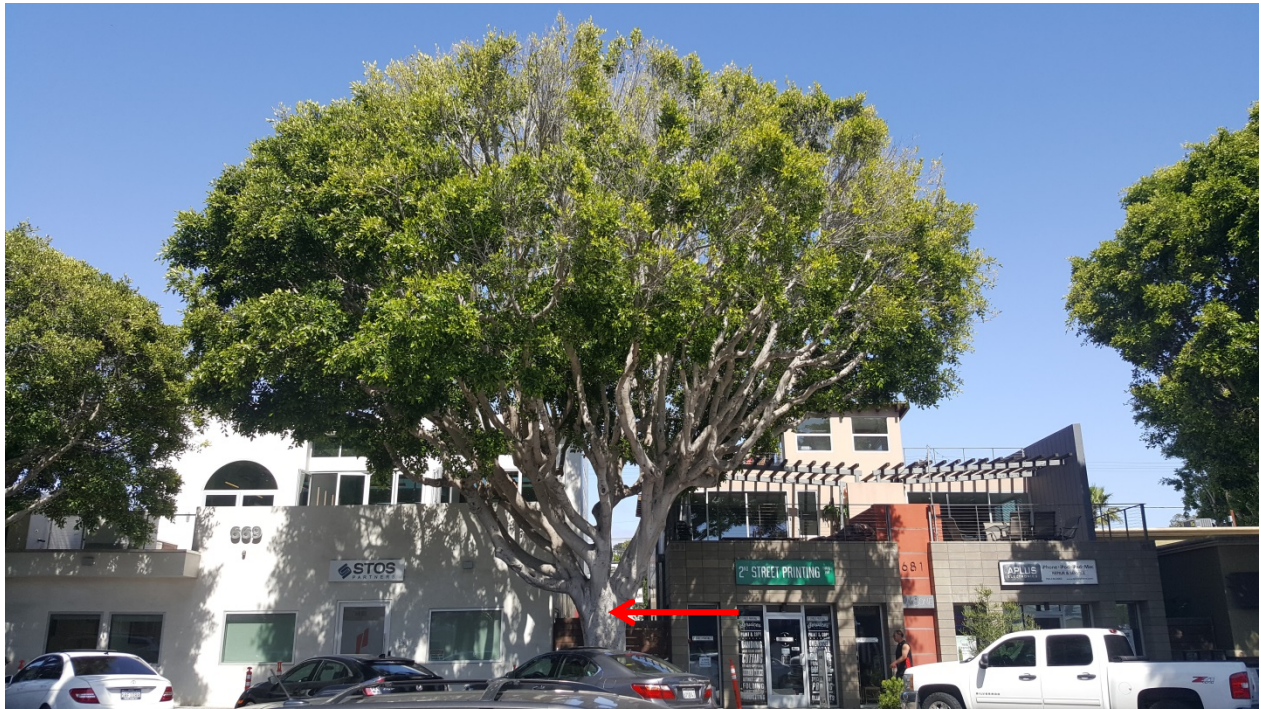
- The tree was located on the east side of the road in front of 669 2nd St. (see Photo #1 in Appendix A as well as Figure 1).
- Judging by the color and density of the foliage, the tree appeared to be in fair health for the species and time of year. The tree had a moderate **live crown ratio** of approximately 50% which is common for street trees necessitating raised crowns for vehicle and building clearance (see Photo #1 in Appendix A).

- The tree (**red arrow**) was located on the east side of the road between 699 and 681 2nd St.
- Judging by the color and density of the foliage, the tree appeared to be in fair- poor health for the species and time of year. The canopy appeared to be more sparse than normal on its upper south side.
- The tree had a moderate **live crown ratio** of approximately 50% which is common for street trees necessitating raised crowns for vehicle and building clearance.

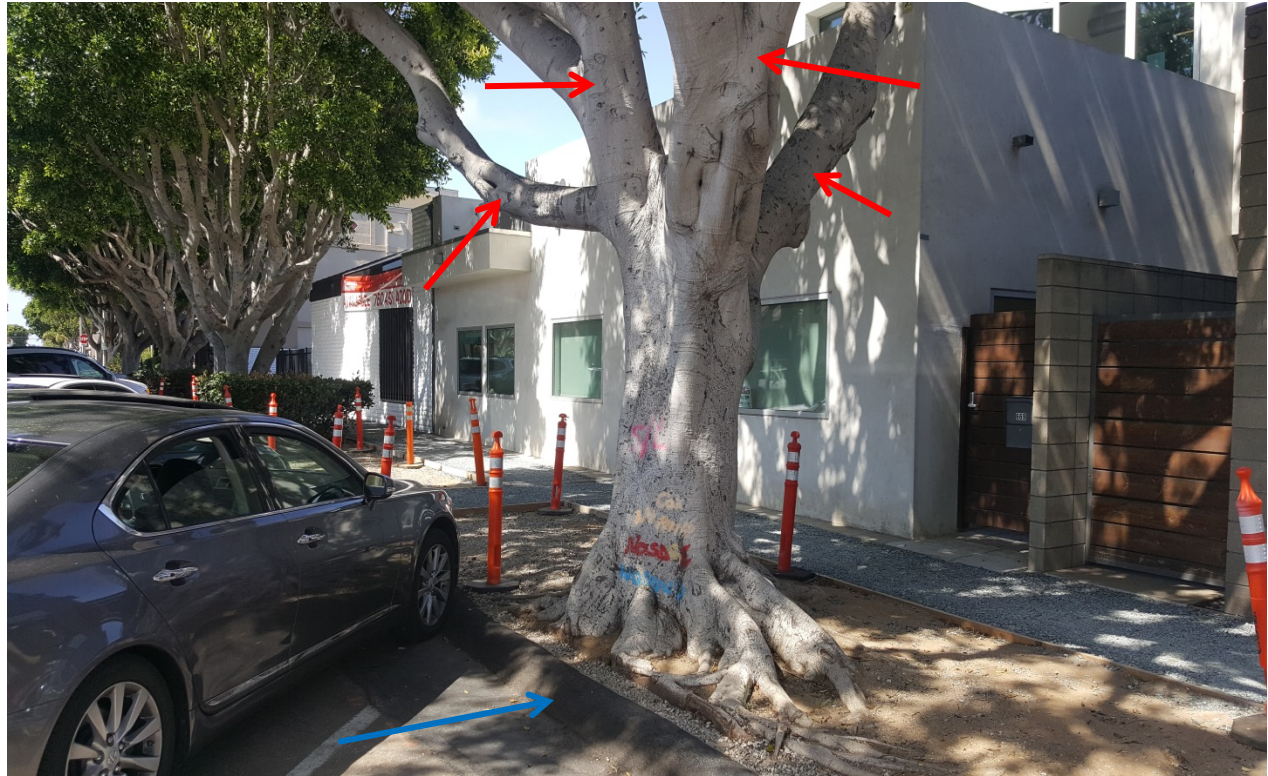
- The tree had a DSH² measurement of 33 inches and a height of about 56 feet (measured with a TruPulse laser).
- The tree had multiple codominant stems and scaffold branches which are indicative of poor structure yet fairly common among this species (see Photo #2 in Appendix A).

- Some of the stems and scaffold branches had included bark as well as small debris filled cavities between the branch unions.
- The area surrounding the tree was in the process of being improved. The curb face had been replaced with asphalt and the sidewalk had been removed and replaced with temporary gravel to lay root bridging plates over (see Photo #2 in Appendix A).

- On August 3rd, 2016, the subject tree was assessed at an overall high risk rating, the defect of greatest concern were the overextended codominant stems/ scaffold branches with included bark.

The defects of greatest concern for the subject tree were the overextended stems/scaffold branches. The *likelihood of a stem/scaffold branch failure* within the next year was assessed as **possible** for the subject tree. This was determined by taking into account the defects, as well as the fact that the first mitigation pruning dose was accomplished and no failures had occurred during the abnormally extreme winter storms. A significant root failure is also a possibility (because of root pruning history) but less likely to occur given the lack of indicators. A failure event would be most likely to occur during abnormal or extreme weather conditions.

- The tree had multiple codominant stems (red arrows) and scaffold branches which are indicative of poor structure yet fairly common among this species.
- The area surrounding the tree was in the process of being improved. There the curb face had been replaced with asphalt (blue arrow) and the sidewalk had been removed and replaced with temporary gravel to lay root bridging plates over.
- Some of the stems and scaffold branches had included bark as well as small debris filled cavities between the branch unions.

After performing a **Level 2 Basic Assessment**⁴, the subject tree was assessed to currently have an overall moderate risk rating. In regards to mitigating these risks, I recommend continuing to apply the crown reduction pruning dose of approximately 6% per year as previously recommended in the report from 10/21/2016. At this point in time, an approximate 14 foot overall crown reduction (while retaining interior growth) still remains to achieve the overall recommended goal (see Appendix B and Figure 3 below). This recommended pruning should be done in compliance to ANSI A300 Arboricultural Standards and will need to be applied over multiple spaced out pruning doses to minimize health impacts on the tree. This is also recommended to allow time for interior growth to further develop and broaden the options for new branches to prune back to. Pruning techniques such as **reduction pruning**, and **removal pruning cuts** should be used (not topping) to achieve this overall squattier appearance and are further explained in Appendix B. The end outcome should be a reduction of **mechanical stress** from overextended loads. A residual risk of “Low” should be achieved after completing these recommended pruning strategies. It is with the health and safety of the community that I present these recommendations.

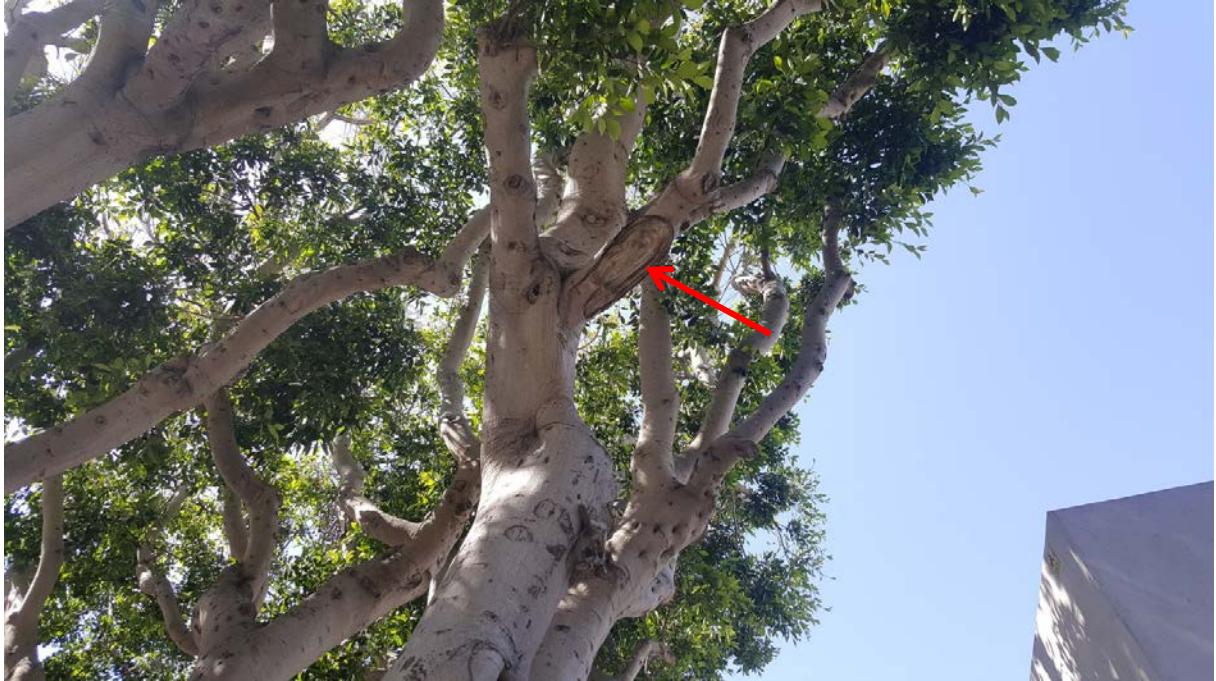
- The tree had a few old root wounds, likely from hardscape repairs in the past.
- There was evidence of some past branch failures visible within the canopy (see Photo #3 in Appendix A).

- There was evidence of some past branch failures (red arrow) visible within the canopy.
