City of Encinitas

4.10.17 Assessment of Ficus Tree At 687 2nd Street (Side-1)

Gene Bordson
Certified Arborist # WE-10777A
Qualified Applicator License# 140768
Qualified Tree Risk Assessor

APRIL 10, 2017

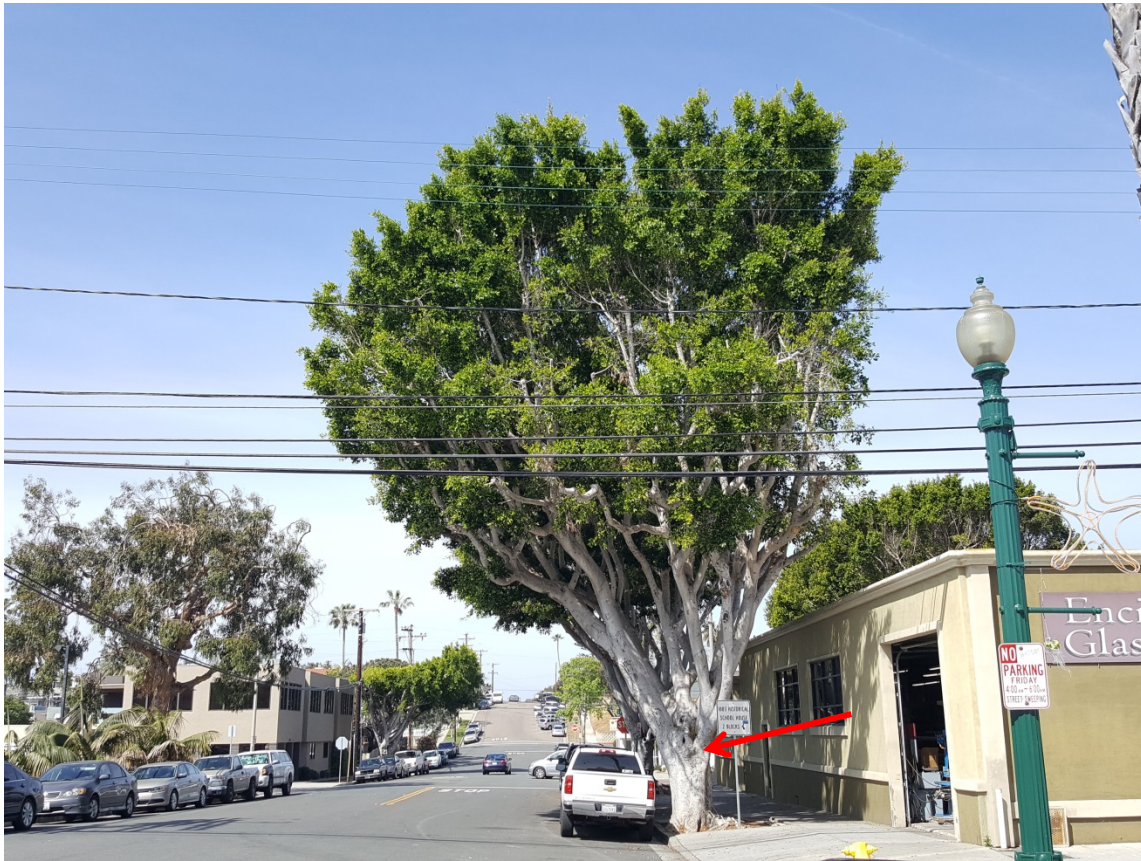
- The tree was growing in a tree well on the south side of F St. (see Figure 1 and Photo #1 in Appendix A).
- Judging by the color and density of the foliage, the tree appeared to be in fair health for the species and time of year. The tree had a moderate **live crown ratio** of approximately 50% which is common for street trees necessitating raised crowns for vehicle and building clearance (see Photo #1 in Appendix A).

- The tree had a DSH² measurement of 36 inches and a height of about 55 feet (measured with a TruPulse laser).
- The tree had multiple codominant stems and overextended scaffold branches which are indicative of poor structure yet fairly common among this species (see Photo #1 in Appendix A).

- The tree had a canopy unbalance because of pruning for building and powerline clearance (see Photo #1 in Appendix A).
- Some of the stems and scaffold branches had presence of included bark as well as a small debris cavity between the branch unions (see Photo #2 in Appendix A).

- The tree (red arrow) was growing in a tree well on the south side of F St.
- Judging by the color and density of the foliage, the tree appeared to be in fair health for the species and time of year. The tree had a moderate **live crown ratio** of approximately 50% which is common for street trees necessitating raised crowns for vehicle and building clearance.
- The tree had multiple codominant stems and overextended scaffold branches which are indicative of poor structure yet fairly common among this species.
- There were powerlines running directly east of the trees' canopy.
- The tree had a canopy unbalance because of pruning for building and powerline clearance.

Risk and Mitigation – After performing a **Level 2 Basic Assessment**⁴, the subject tree was assessed to have an overall moderate risk rating. In regards to mitigating these risks, I recommend applying and maintaining an approximate 30% overall crown reduction (retaining interior growth) with the structure and canopy balance of the tree in mind (see Appendix B as well as Figure 3 below). This recommended pruning should be done in compliance to ANSI A300 Arboricultural Standards and will need to be applied over multiple spaced out pruning doses (taking up to 5 years) to minimize health impacts on the tree. This is also recommended to allow time for interior growth to further develop and broaden the options for new branches to prune back to. Pruning techniques such as **reduction pruning**, and **removal pruning cuts** should be used (not topping) to achieve this overall squattier appearance and are further explained in Appendix B. The end outcome should be a reduction of **mechanical stress** from overextended loads. A residual risk of “Low” should be achieved after implementing these recommended pruning strategies. It is with the health and safety of the community that I present these recommendations.

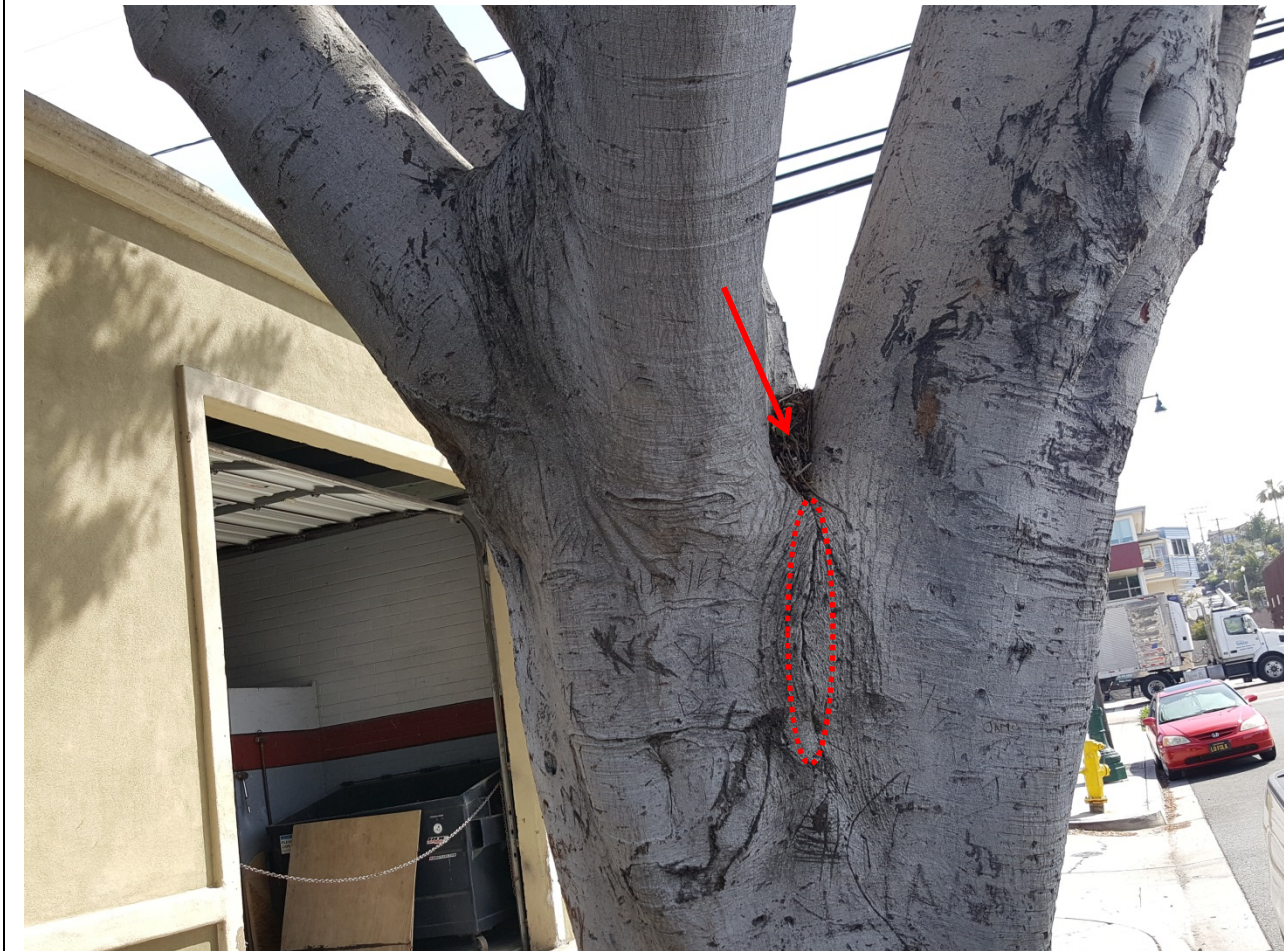
Photo #2

The defects of greatest concern for the subject tree were the significant root injuries as well as the overextended stems/ scaffold branches with significant presence of included bark. The *likelihood of a root or stem/ scaffold branch failure* within the next year was assessed as **possible** for the subject tree. A failure event would be most likely to occur during abnormal or extreme weather conditions.

- Some of the stems and scaffold branches had presence of included bark (red dotted oval) as well as a shallow debris cavity between the branch unions (red arrow).

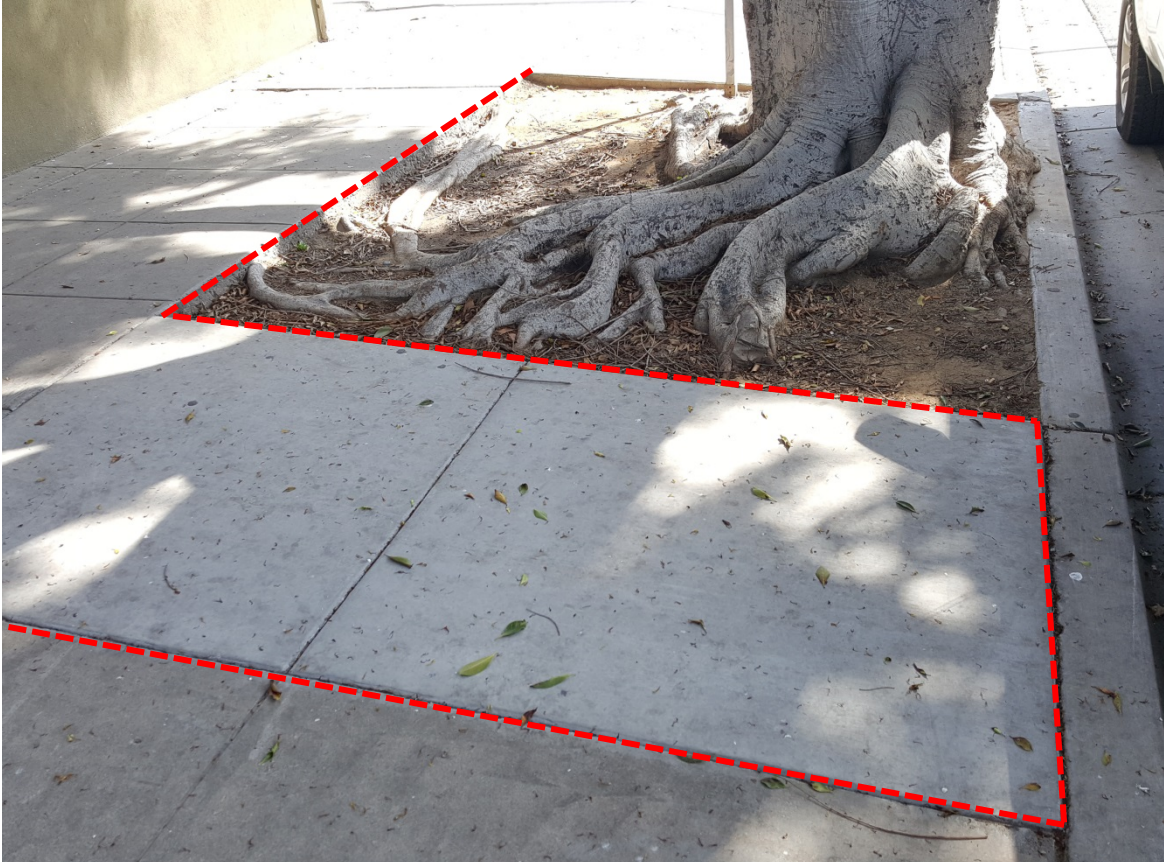
- Judging by the lighter tone of concrete, it appeared that a large area of sidewalk had been replaced around the tree (see Photo #3 in Appendix A).

- Judging by the lighter tone of concrete, it appeared that a large area of sidewalk had been replaced around the tree (see red dotted area).

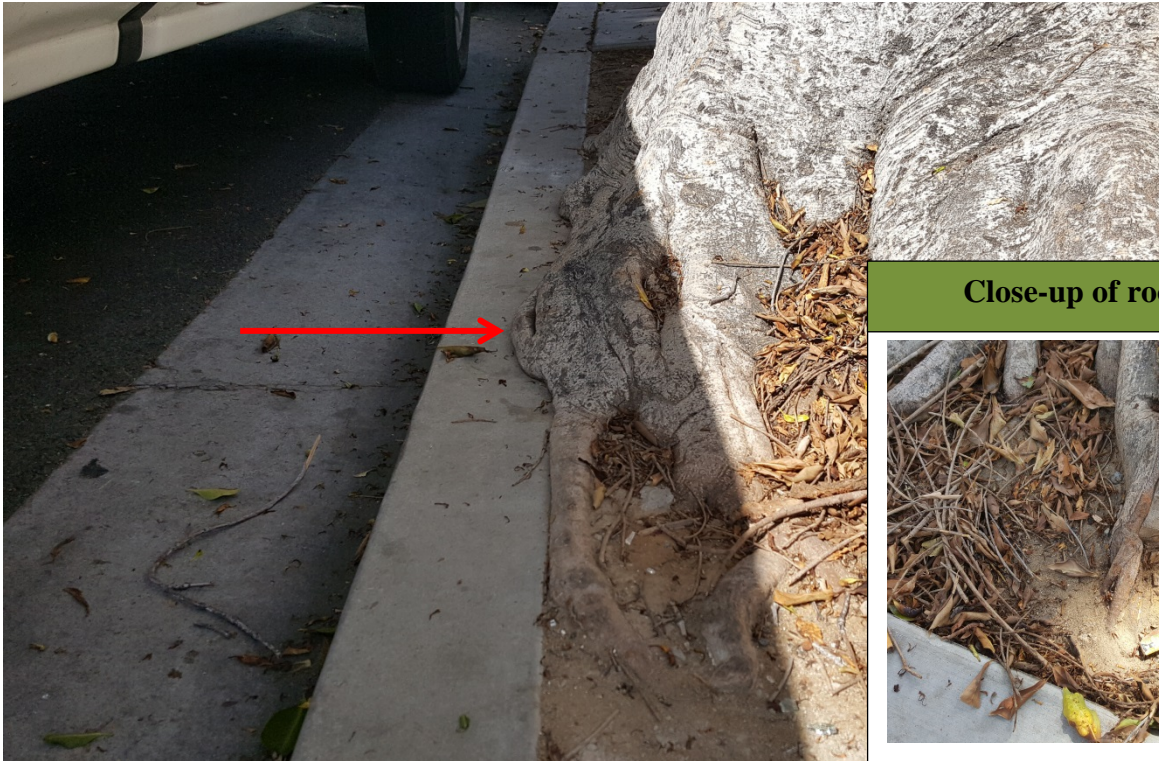
- Some of the buttress roots were showing a **contact stress response** to growing next to the curb face. This phenomenon occurs when trees grow in close contact with infrastructure. Trunk and root tissues mold, and grow over the infrastructure element providing a level of structural support. There may be an increase in failure potential if the infrastructure element is removed or replaced. There also appeared to be some older damage to the living tissues on the top of the root (see Photo #4 in Appendix A).
- There were multiple significant root injuries observed around the tree (see close-up box on right) likely related to root pruning for hardscape repairs.
- Vehicles appeared to use this area of 2nd Street frequently throughout the day.

Close-up of root injuries

- Some of the buttress roots were showing a **contact stress response** to growing next to the curb face (see **red arrow**). This phenomenon occurs when trees grow in close contact with infrastructure. Trunk and root tissues mold, and grow over the infrastructure element providing a level of structural support. There may be an increase in failure potential if the infrastructure element is removed or replaced. There also appeared to be some older damage to the living tissues on the top of the root.
- There were multiple significant root injuries observed around the tree (see close-up box on right) likely related to root pruning for hardscape repairs.

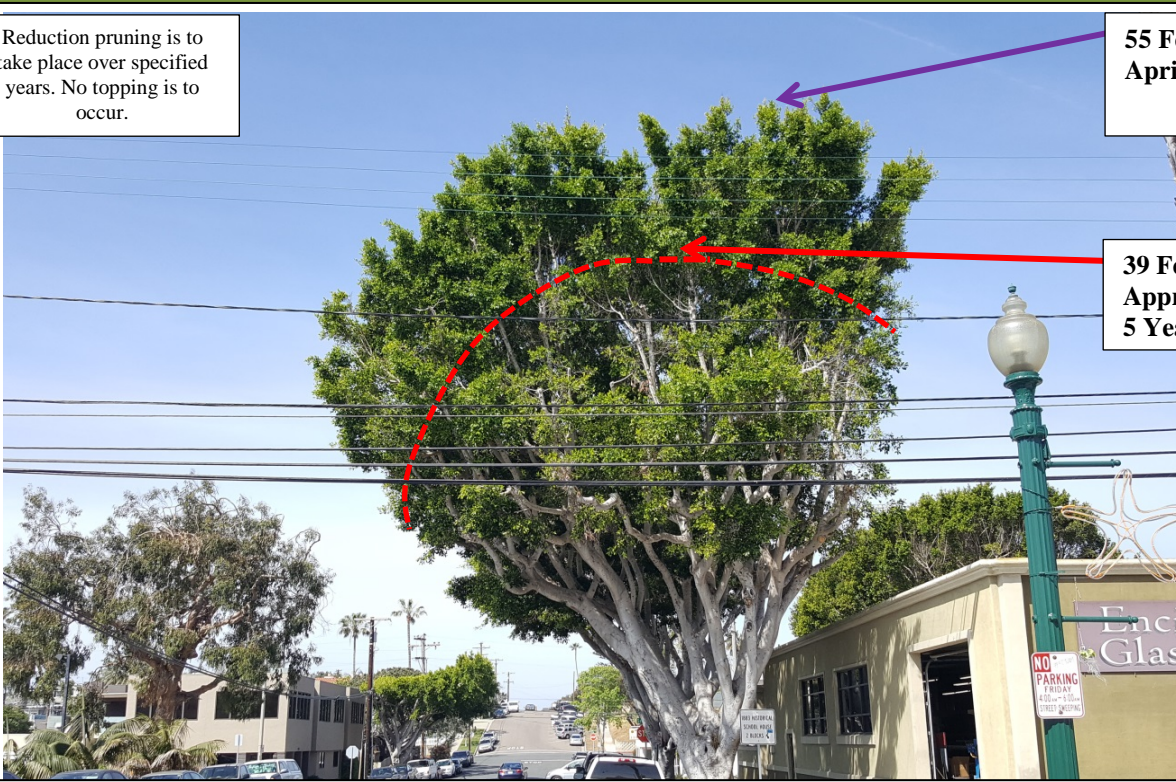
Crown Reduction Pruning Goal

55 Feet
April 2017

39 Feet in
Approximately
5 Years

Reduction pruning is to take place over specified years. No topping is to occur.

This tree had a measured height of 55 feet (see purple arrow). The proposed goal is to achieve a 30% (16.5 feet) **crown reduction through a multi-year pruning plan (up to five years)** leaving the tree with a height of approximately 39 feet (see red dotted line and arrow) after the final pruning dose.
