City of Encinitas

3.30.17 Assessment of Ficus Tree At 965 Second Street (Front-2)

Gene Bordson
Certified Arborist # WE-10777A
Qualified Applicator License# 140768
Qualified Tree Risk Assessor

MARCH 30, 2017

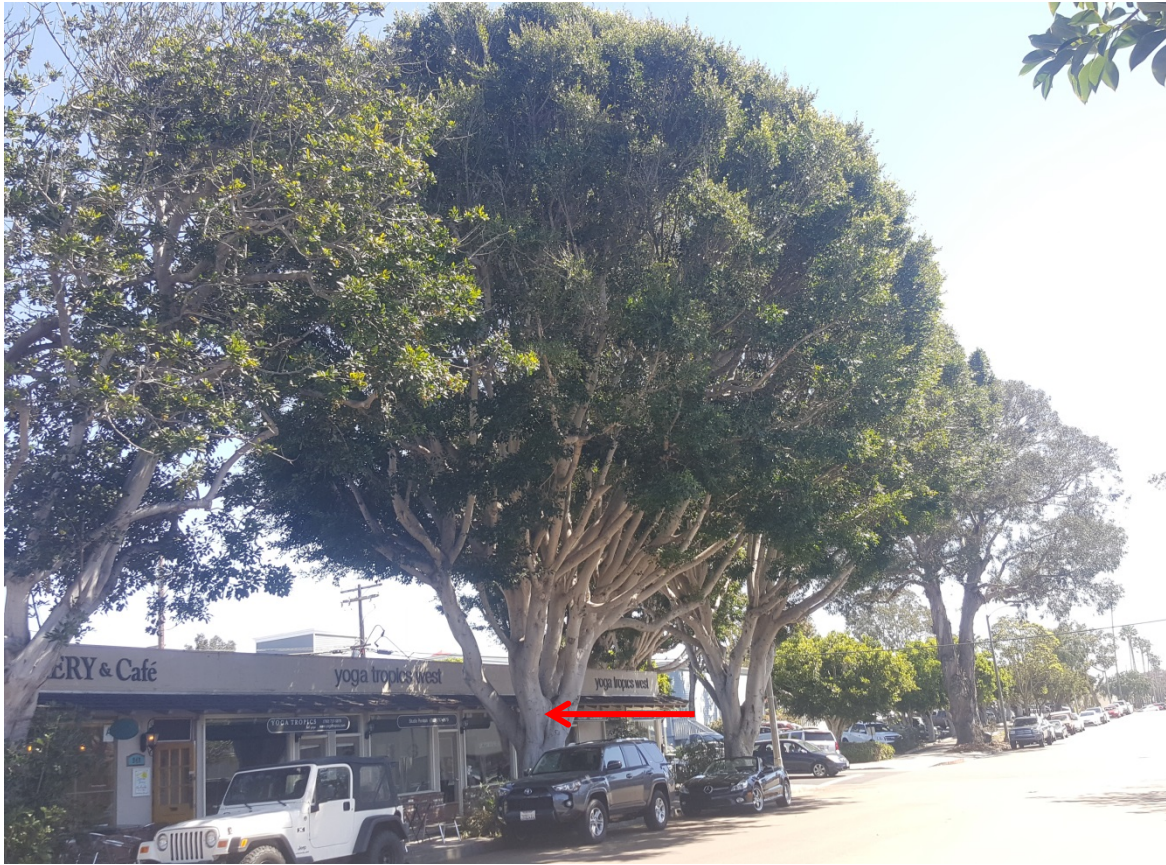
- The tree was growing in a 7.5 foot wide tree well on the east side of 2nd St. and in front of the 965 business address (see Photo #1 in Appendix A).
- Judging by the color and density of the foliage, the tree appeared to be in fair health for the species and time of year. The tree had a low **live crown ratio** of approximately 50% which is common for street trees necessitating raised crowns for vehicle/ building clearance (see Photo #1 in Appendix A).

- The tree (**red arrow**) was growing in a 7.5 foot wide tree well on the east side of 2nd St. and in front of the 965 business address.
- Judging by the color and density of the foliage, the tree appeared to be in fair health for the species and time of year. The tree had a low **live crown ratio** of approximately 50% which is common for street trees necessitating raised crowns for vehicle/ building clearance.

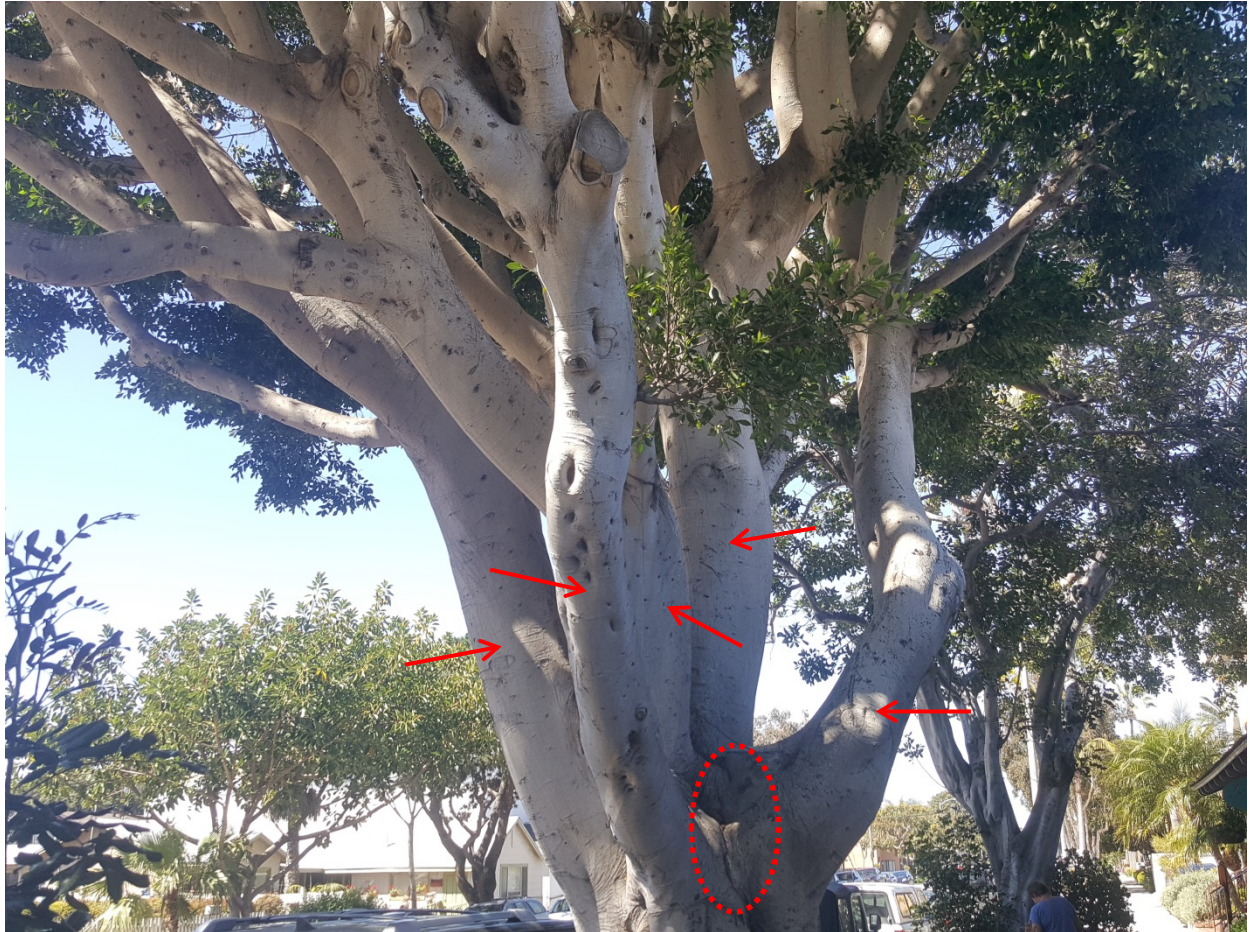
- The tree had a DSH² measurement of 37 inches and a height of about 55 feet (measured with a TruPulse laser).
- The tree had multiple overextended **codominant stems** and branches with included bark which is indicative of poor structure yet common to this species (see Photo #2 in Appendix A).

The *likelihood of a failure* within the next year has been assessed as **possible** for the subject tree. The most likely failure would be to one of the large overextended stems or scaffold branches with included bark. A windthrow/ root failure event could also happen however the large amount of **contact stress response** on the west side of the tree reduced this likelihood. Failure events would most likely occur during abnormal or extreme weather conditions.

- The tree had multiple overextended **codominant stems** (red arrows) and branches with included bark (red dotted oval) which is indicative of poor structure yet common to this species.

Risk: In order to help decrease associated risks to an overall moderate to a low for the subject tree, I recommend performing an approximate 25% **crown reduction**⁴ (see Appendix B as well as Figure 3 below). This crown reduction will decrease the mechanical stress applied to the root system because of the increased wind penetration and reduced leverage effects from overextended growth. The work performed should be done in compliance to ANSI A300 Arboricultural Standards and will need to be applied over multiple spaced out pruning doses (taking up to 5 years) to minimize health impacts on the tree. This is also recommended to allow time for interior growth to further develop and broaden the options for new branches to prune back to. Pruning techniques such as **reduction pruning**, and **removal pruning cuts** should be used (not topping) to achieve this overall squattier appearance and are further explained in Appendix B. It is with the health and safety of the community in mind that I present these recommendations.

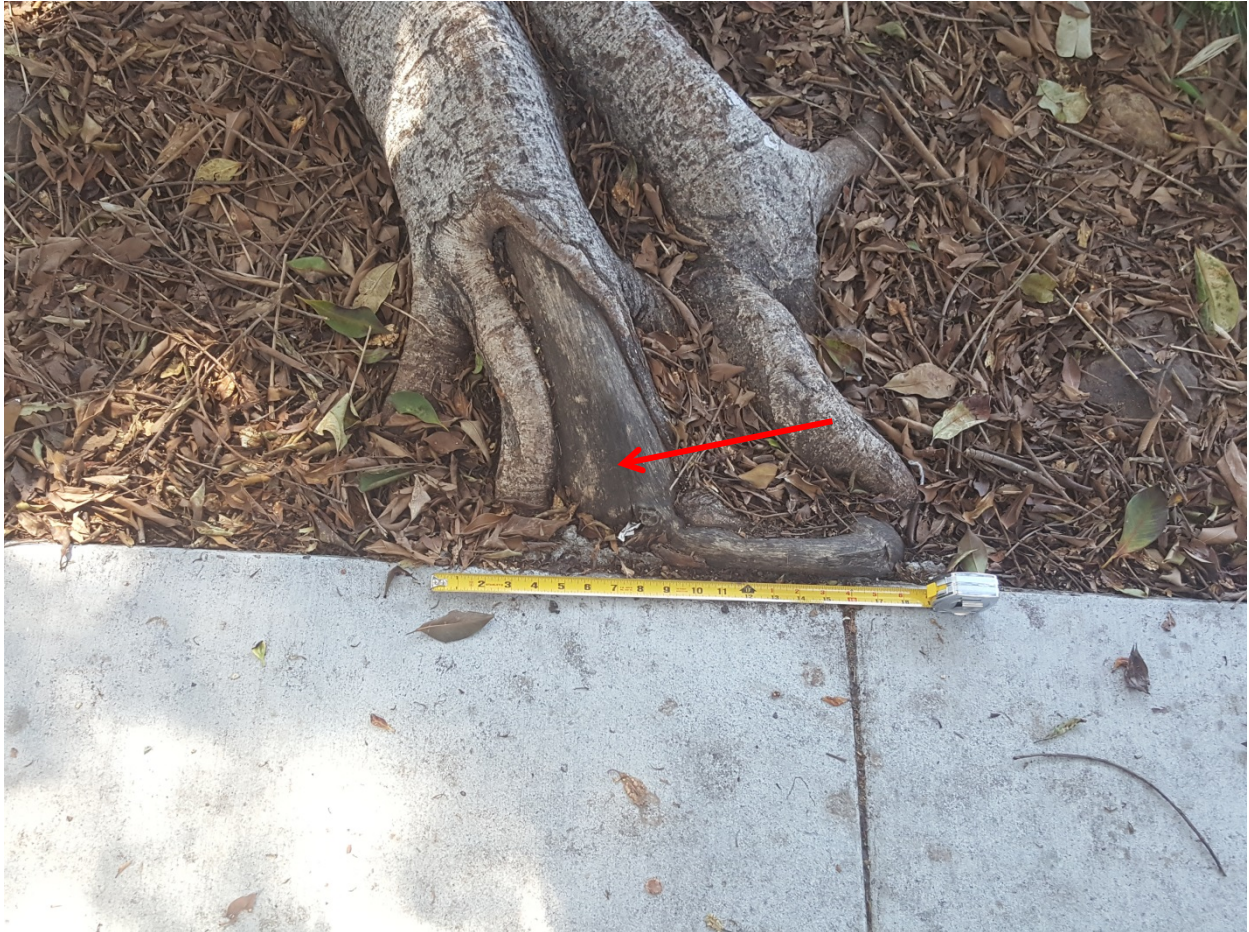
- There was an older root injury present on the east side of the tree next to the sidewalk (see Photo #3 in Appendix A).
- Judging by the lighter tone of concrete, it appeared that the sidewalk on 3 sides of the tree had been replaced within the last couple of years (see Photo #4 in Appendix A).

There was an older root injury present on the east side of the tree next to the sidewalk (see red arrow).

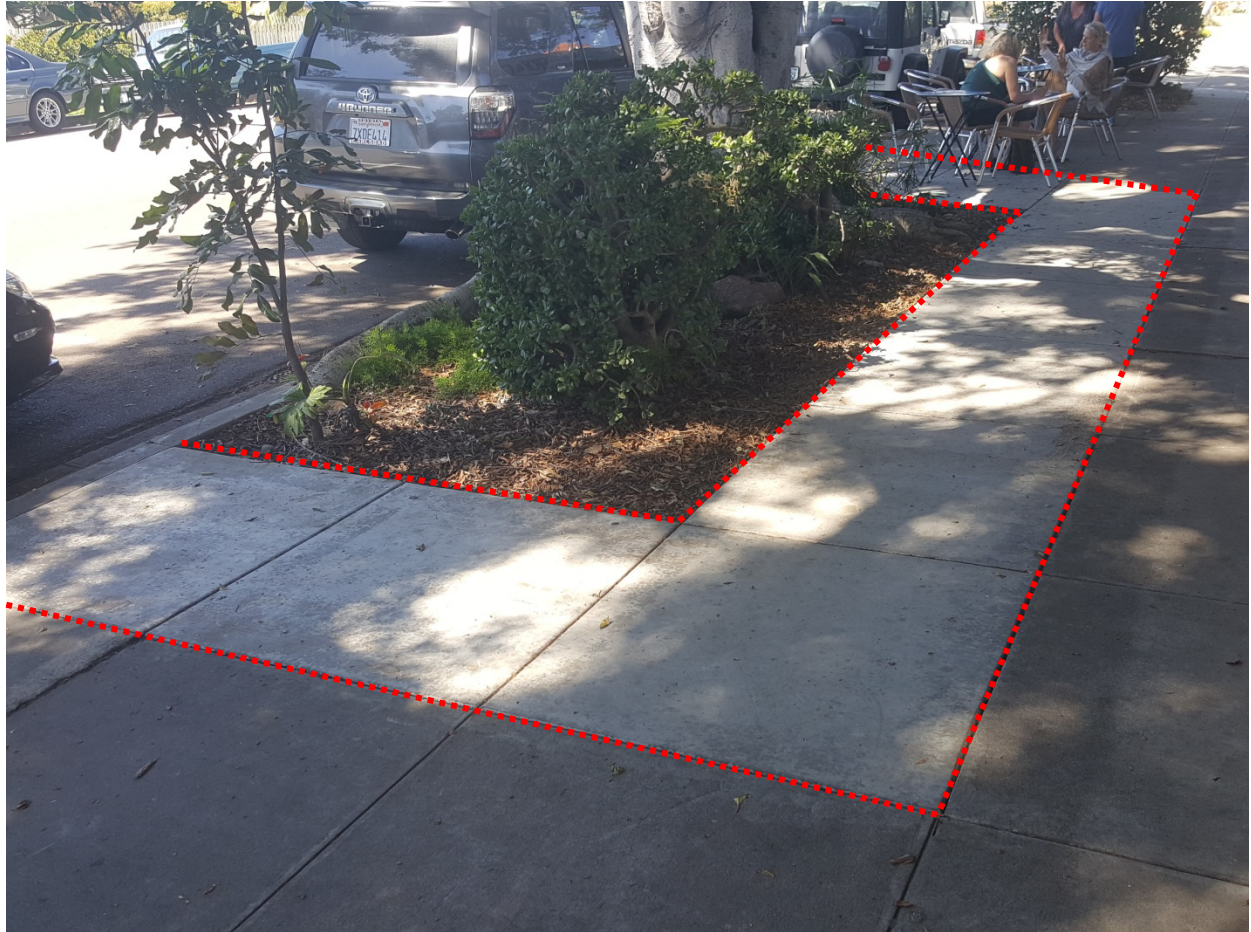
- Vehicles appeared to use this area of 2nd Street frequently throughout the day.
- There was an outdoor dining area on the north side of the tree that appeared to be used occasionally to frequently by people (see Photo #4 in Appendix A).

- Judging by the lighter tone of concrete, it appeared that the sidewalk on 3 sides of the tree had been replaced within the last couple of years (see **red dotted area**).
- There was an outdoor dining area on the north side of the tree that appeared to be used occasionally to frequently by people.

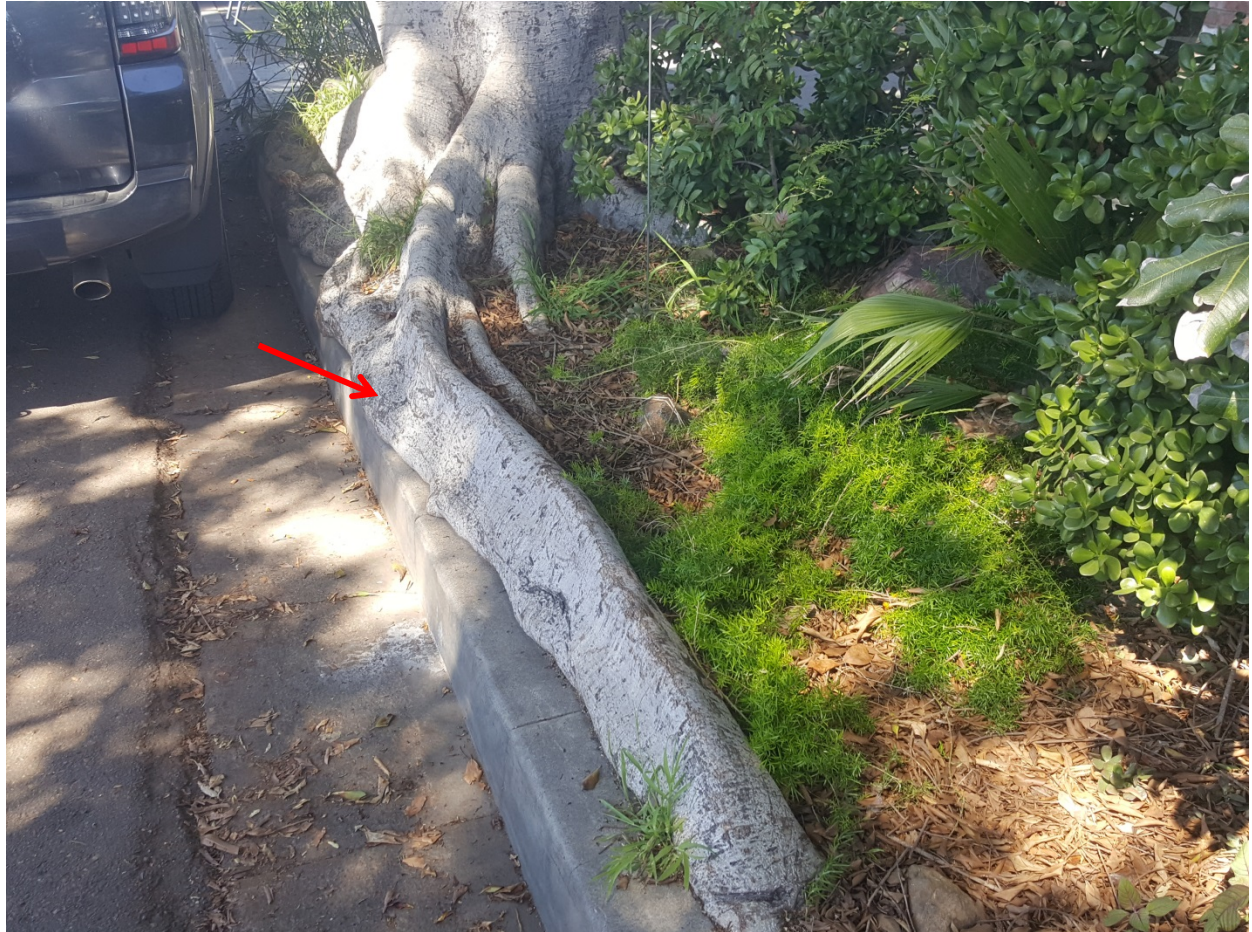
- One of the larger buttress roots was showing a **contact stress response** to growing next to the curb face. This phenomenon occurs when trees grow in close contact with infrastructure. Trunk and root tissues mold, and grow over the infrastructure element providing a level of structural support. There may be an increase in failure potential if the infrastructure element is removed or replaced (see Photo #5 in Appendix A).

- One of the larger buttress roots was showing a **contact stress response** to growing next to the curb face (see **red arrow**). This phenomenon occurs when trees grow in close contact with infrastructure. Trunk and root tissues mold, and grow over the infrastructure element providing a level of structural support. There may be an increase in failure potential if the infrastructure element is removed or replaced.
