City of Encinitas

4.6.17 Assessment of Ficus Tree At 143 D St. (Front-1)

Gene Bordson
Certified Arborist # WE-10777A
Qualified Applicator License# 140768
Qualified Tree Risk Assessor

APRIL 6, 2017

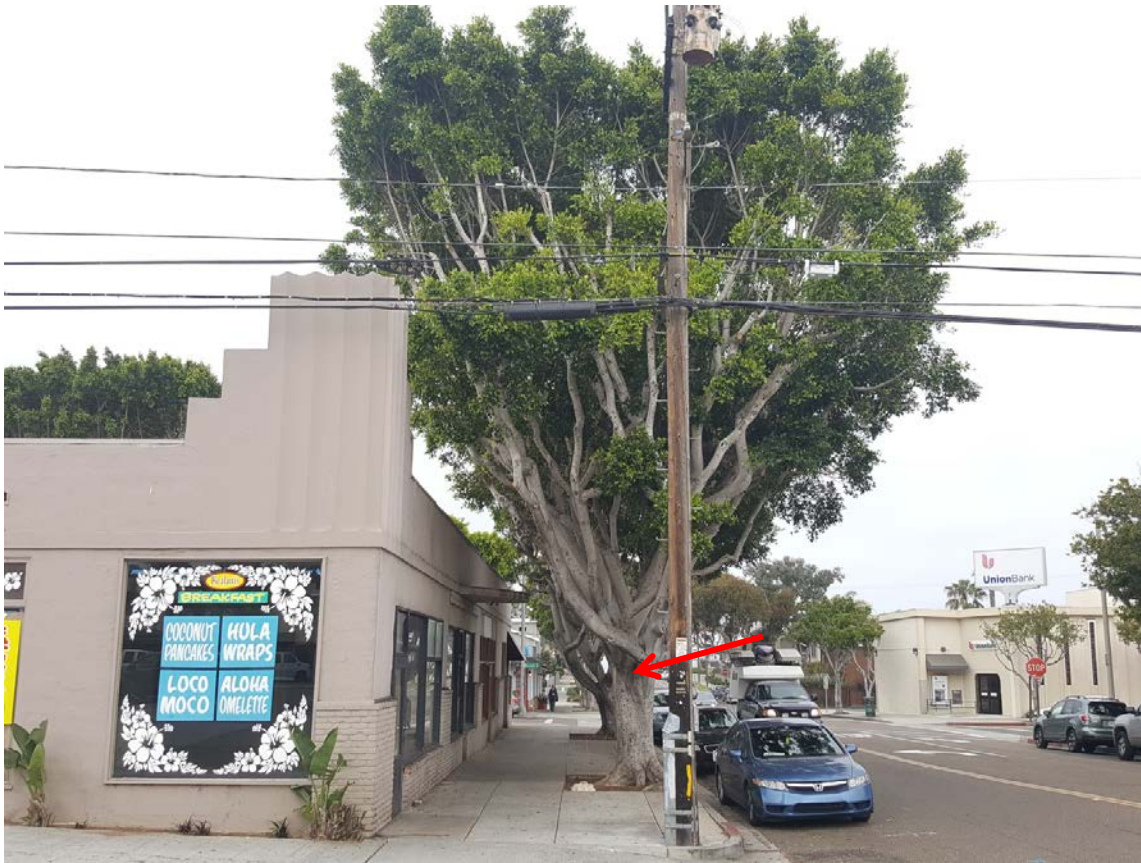
- The tree was growing in a tree well on the south side of D St. in front of the 143 business address (see Photo #1 in Appendix A).
- Judging by the color and density of the foliage, the tree appeared to be in fair health for the species and time of year. The tree had a moderate **live crown ratio** of approximately 50% which is common for street trees necessitating raised crowns for vehicle and building clearance (see Photo #1 in Appendix A).

- The tree had a DSH² measurement of 28 inches and a height of about 45 feet (measured with a TruPulse laser).
- The tree had multiple codominant stems and overextended scaffold branches which are indicative of poor structure yet fairly common among this species (see Photo #1 in Appendix A).

- There were powerlines running through the trees' canopy (see Photo #1 in Appendix A).
- Some of the stems and scaffold branches had presence of included bark as well as a small debris cavity between the branch unions (see Photo #2 in Appendix A).

- The tree (red arrow) was growing in a tree well on the south side of D St. in front of the 143 business address.
- Judging by the color and density of the foliage, the tree appeared to be in fair health for the species and time of year. The tree had a moderate **live crown ratio** of approximately 50% which is common for street trees necessitating raised crowns for vehicle and building clearance.
- The tree had multiple codominant stems and overextended scaffold branches which are indicative of poor structure yet fairly common among this species.
- There were powerlines running through the trees' canopy.

Risk and Mitigation – After performing a **Level 2 Basic Assessment**⁴, the subject tree was assessed to have an overall moderate risk rating. In regards to mitigating these risks, I recommend applying and maintaining an approximate 25% overall crown reduction with the structure and canopy balance of the tree in mind (see Appendix B and Figure 3 below). This recommended pruning should be done in compliance to ANSI A300 Arboricultural Standards and will need to be applied over multiple spaced out pruning doses (up to five years) to minimize health impacts on the tree. This is also done to allow time for interior growth to further develop and broaden the options for new branches to prune back to. Pruning techniques such as **reduction pruning**, and **removal pruning cuts** should be used (not topping) to achieve this overall squattier appearance and are further explained in Appendix B. The end outcome should be a reduction of **mechanical stress** from overextended loads. A residual risk of “Low” should be achieved after implementing these recommended pruning strategies. It is with the health and safety of the community that I present these recommendations.

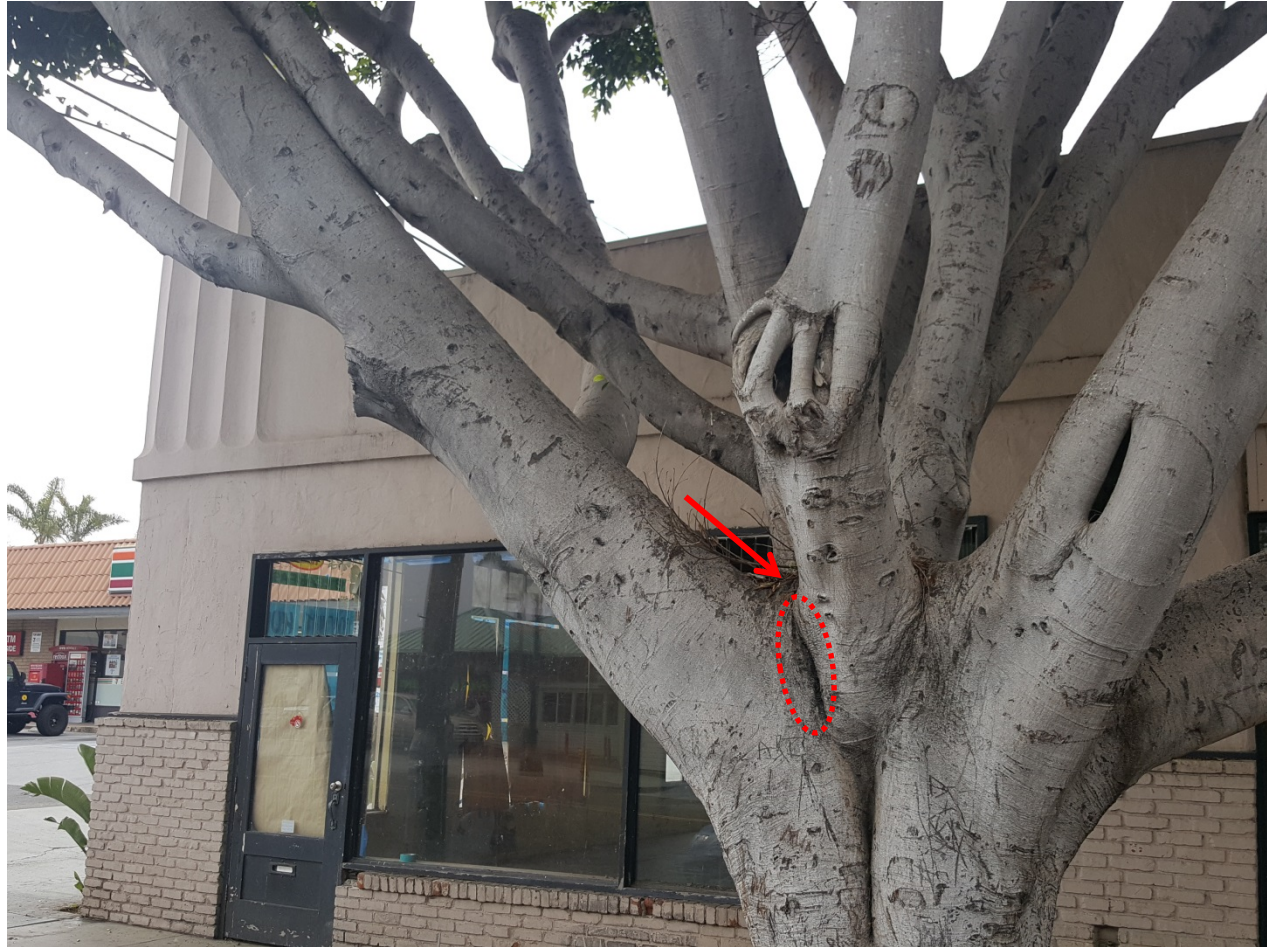
Photo #2

The defect of greatest concern for the subject tree was the overextended stems/ scaffold branches with included bark. The *likelihood of this failure* within the next year was assessed as **possible** for the subject tree. Failure events would be most likely to occur during abnormal or extreme weather conditions.

- Some of the stems and scaffold branches had presence of included bark (red dotted oval) as well as a shallow debris cavity between the branch unions (red arrow).

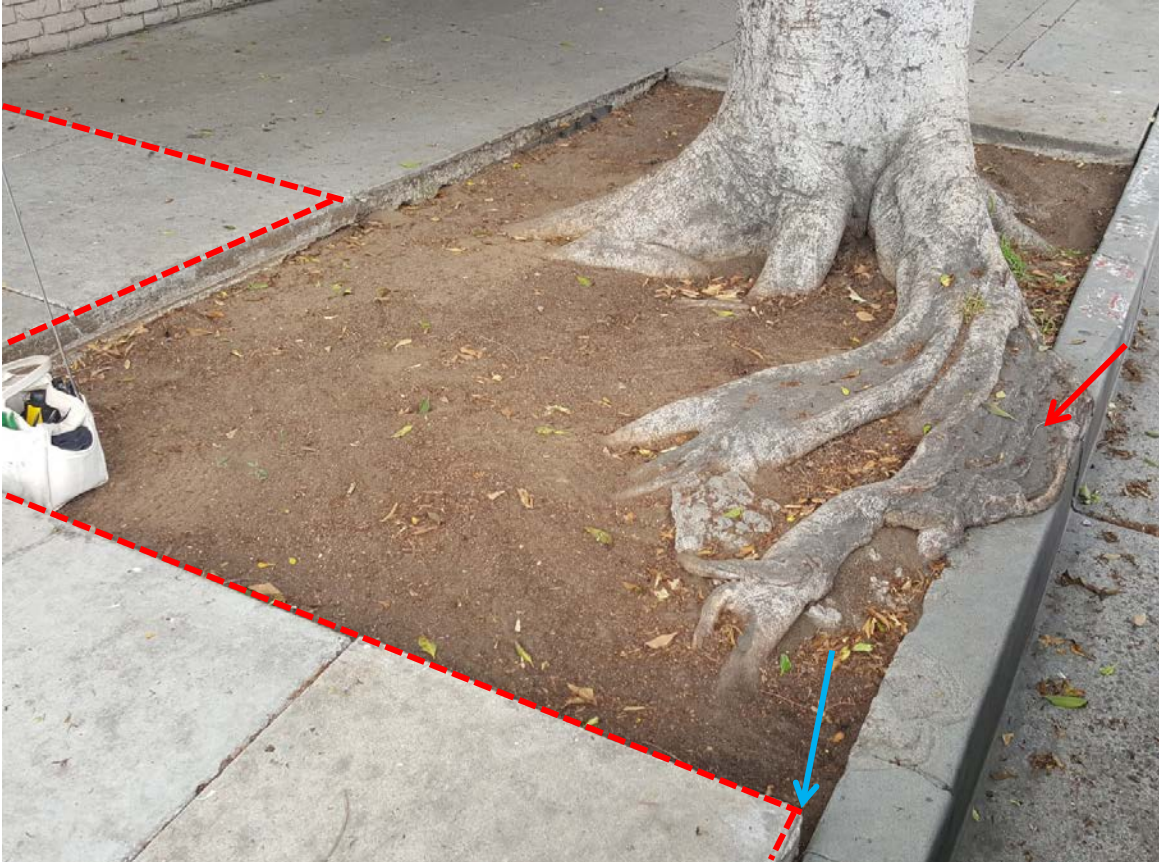
- Judging by the lighter tone of concrete, it appeared that a large area of sidewalk had been replaced around the tree (see Photo #3 in Appendix A).
- There appeared to be some cracking and sidewalk deflections surrounding the tree (see Photo #3 in Appendix A).

- Judging by the lighter tone of concrete, it appeared that a large area of sidewalk had been replaced around the tree (see **red dotted area**).
- There appeared to be some cracking and sidewalk deflections surrounding the tree (**blue arrow**).
- Some of the buttress roots were showing a **contact stress response** to growing next to the curb face (see **red arrow**). This phenomenon occurs when trees grow in close contact with infrastructure. Trunk and root tissues mold, and grow over the infrastructure element providing a level of structural support. There may be an increase in failure potential if the infrastructure element is removed or replaced. There also appeared to be some older damage to the living tissues on the top of the root.

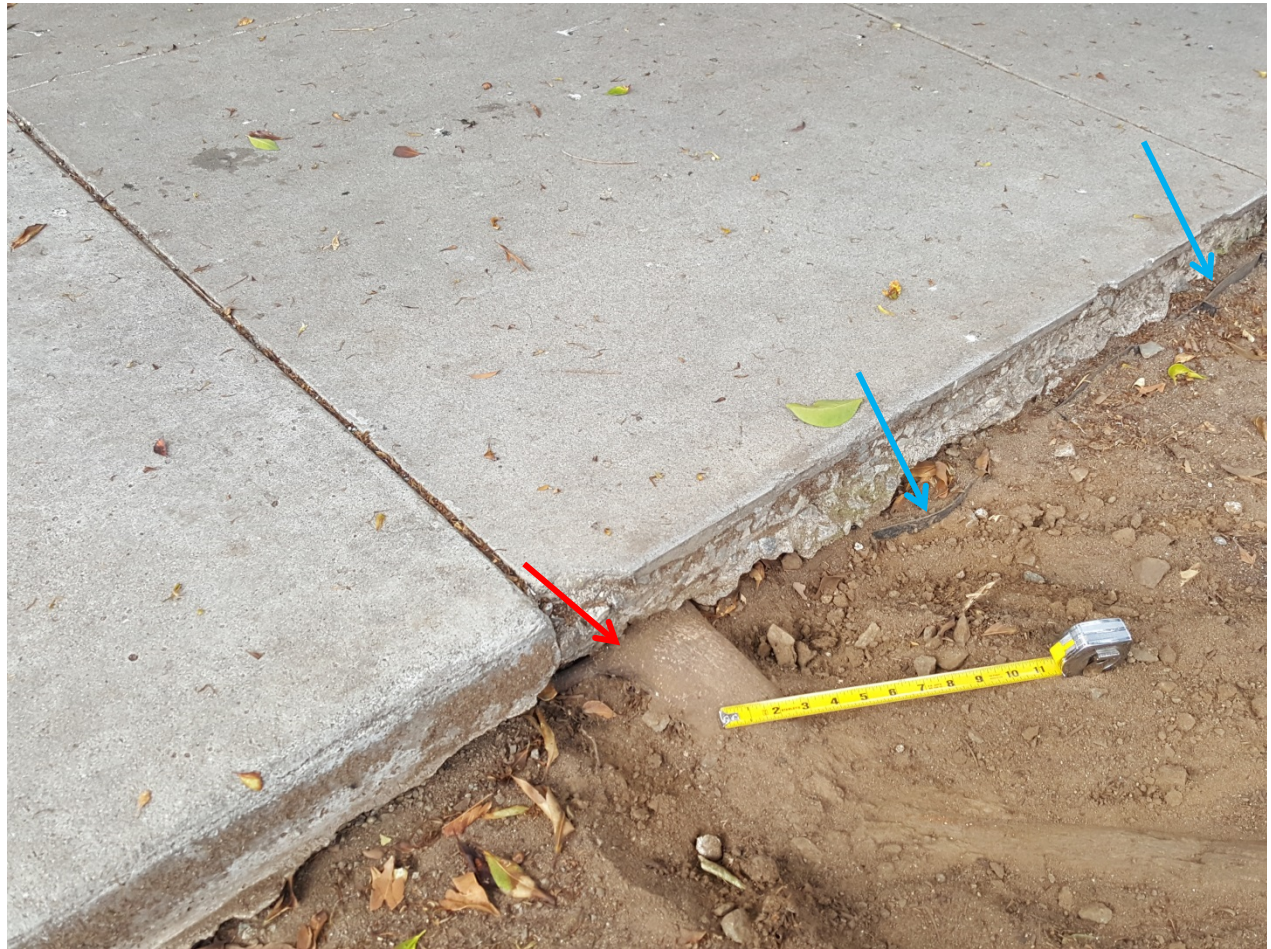
- Some of the buttress roots were showing a **contact stress response** to growing next to the curb face. This phenomenon occurs when trees grow in close contact with infrastructure. Trunk and root tissues mold, and grow over the infrastructure element providing a level of structural support. There may be an increase in failure potential if the infrastructure element is removed or replaced. There also appeared to be some older damage to the living tissues on the top of the root (see Photo #3 in Appendix A).
- There tree had a root barrier visible around sections of the tree well, some of the roots seemed to have grown over this obstruction (see Photo #4 in Appendix A).

There tree had a root barrier (blue arrows) visible around sections of the tree well, some of the roots seemed to have grown over this obstruction (see red arrow).
