# City of Encinitas

## 3.22.17 Assessment of Ficus Tree Near 501 Second Street

MARCH 22, 2017

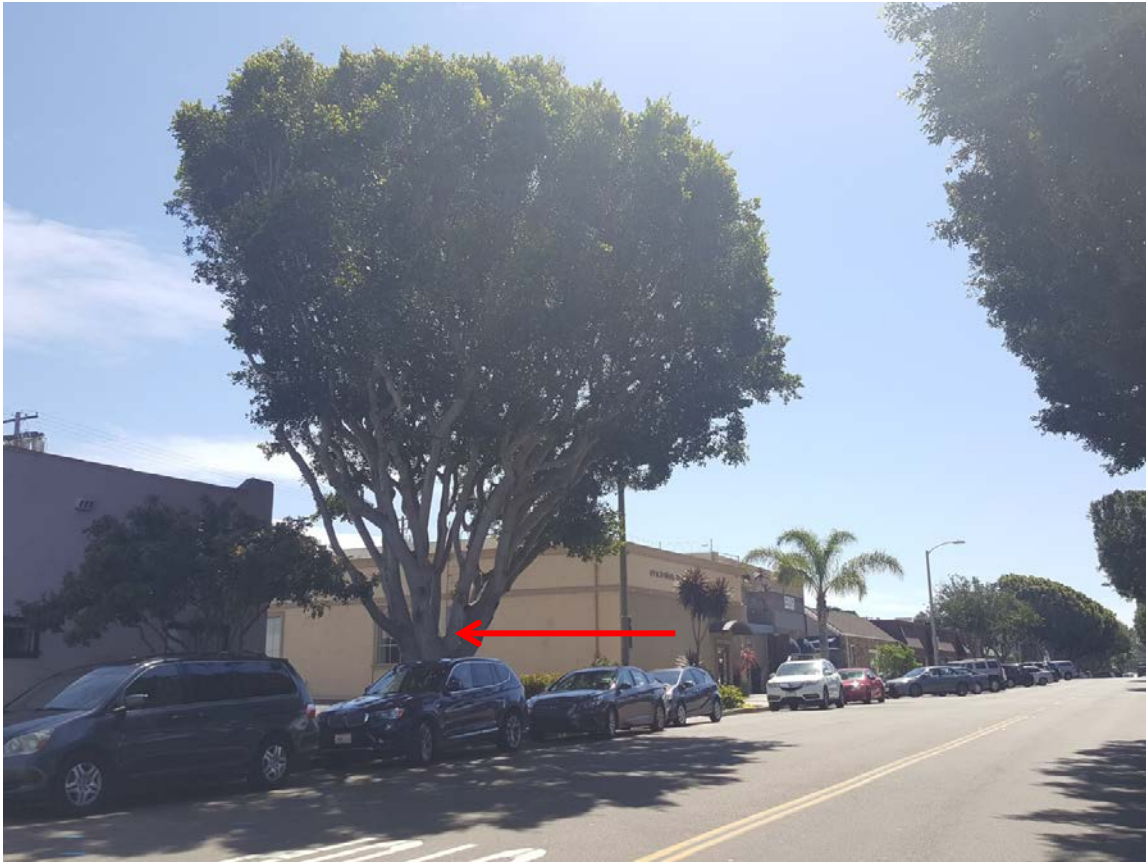
- The tree was growing in a 7 foot wide tree well on the east side of 2<sup>nd</sup> St. on the side of the 149 D St. business address (see Figure 1 and Photo #1 in Appendix A).

- The tree had a DSH<sup>2</sup> measurement of 34 inches and a height of about 50 feet (measured with a TruPulse laser).
- Judging by the color and density of the foliage, the tree appeared to be in fair health for the species and time of year. There was a moderate **live crown ratio** of approximately 50% which is common for street trees necessitating raised crowns for vehicle clearance (see Photo #1 in Appendix A).

- The tree had multiple codominant stems and scaffold branches which are an indication of poor structure (see Photo #1 in Appendix A).
- The tree's canopy was a bit unbalanced towards 2<sup>nd</sup> St. because of past pruning for building clearance (see Photo #1 in Appendix A).

- There was an empty parking lot on the south-east side of the tree (see Photo #1 in Appendix A).
- There was a fair amount of included bark observed between some of the codominant stems and branches (see Photo #2 in Appendix A).

- The tree (**red arrow**) was growing in a 7 foot wide tree well on the east side of 2<sup>nd</sup> St. on the side of the 149 D St. business address.
- Judging by the color and density of the foliage, the tree appeared to be in fair health for the species and time of year. The tree had a moderate **live crown ratio** of approximately 50% which is common for street trees necessitating raised crowns for vehicle clearance.
- The tree's canopy was a bit unbalanced towards 2<sup>nd</sup> St. because of past pruning for building clearance.
- The tree had multiple codominant stems and scaffold branches which are an indication of poor structure.
- There was an empty parking lot on the south-east side of the tree (**orange arrow**).

**Risk and Mitigation** – After performing a **Level 2 Basic Assessment**<sup>4</sup>, the subject tree was assessed to have an overall moderate risk rating. In regards to mitigating risks, I recommend applying an approximate 25% overall crown reduction with the structure and canopy balance of the tree in mind (see Appendix B and Figure 3 below). This recommended pruning should be done in compliance to ANSI A300 Arboricultural Standards and will need to be applied over multiple spaced out yearly pruning doses (up to five years) to minimize health impacts on the tree. This is also done to allow time for interior growth to further develop and broaden the options for new branches to prune back to. Pruning techniques such as **reduction pruning**, and **removal pruning cuts** should be used (not topping) to achieve this overall squattier appearance and are further explained in Appendix B. The end outcome should be a reduction of **mechanical stress** from overextended loads and an improvement in wind penetration. A residual risk of “Low” should be achieved after implementing these recommended pruning strategies.

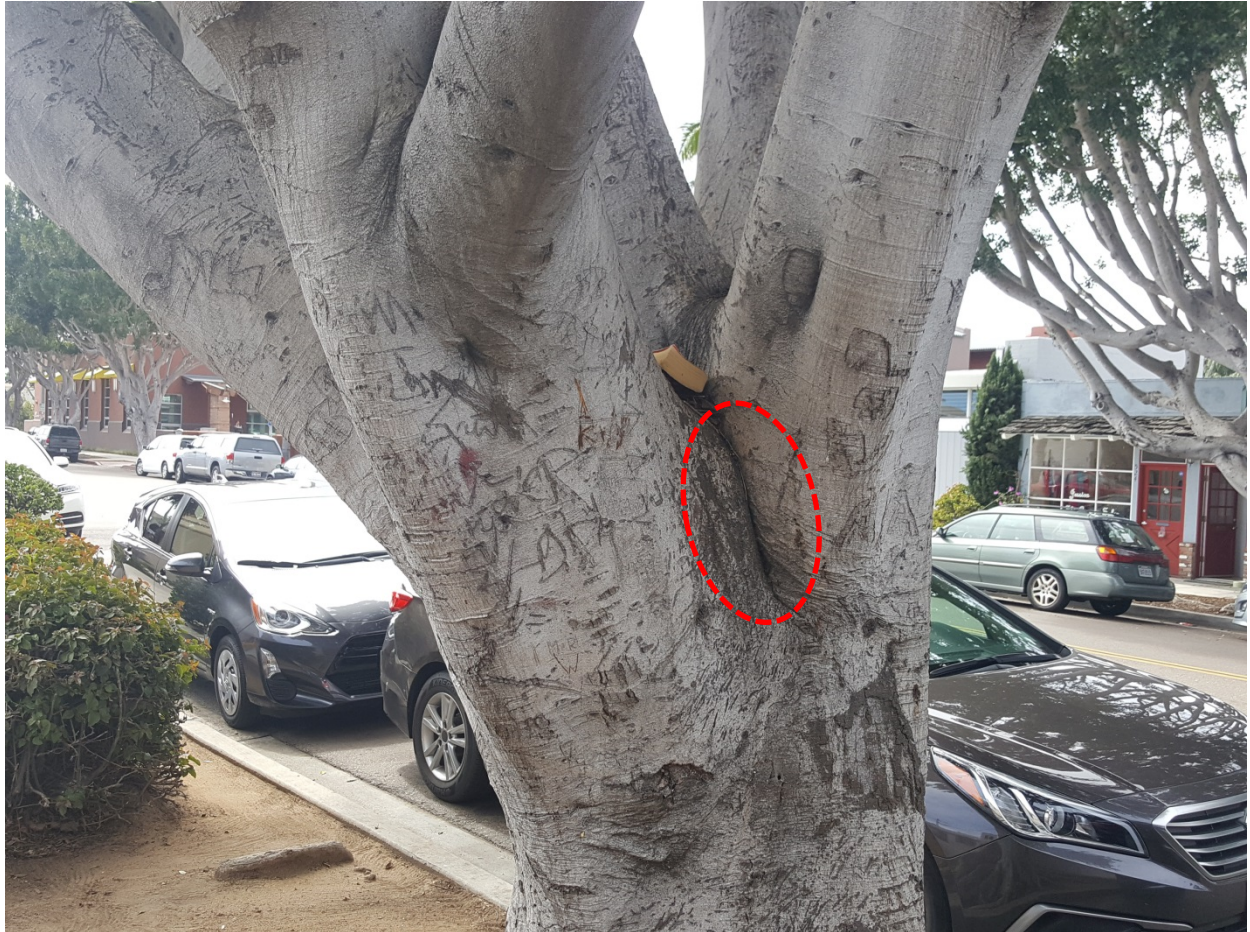
Photo #2

The most likely and relevant failure would be to one of the roughly 7-13 inch diameter and 10-30 foot long stems or scaffold branches with overextended growth and included bark. This failure would be most likely to occur during abnormal or extreme weather conditions.

Shown above (red dotted oval) is an example of included bark on the subject tree.

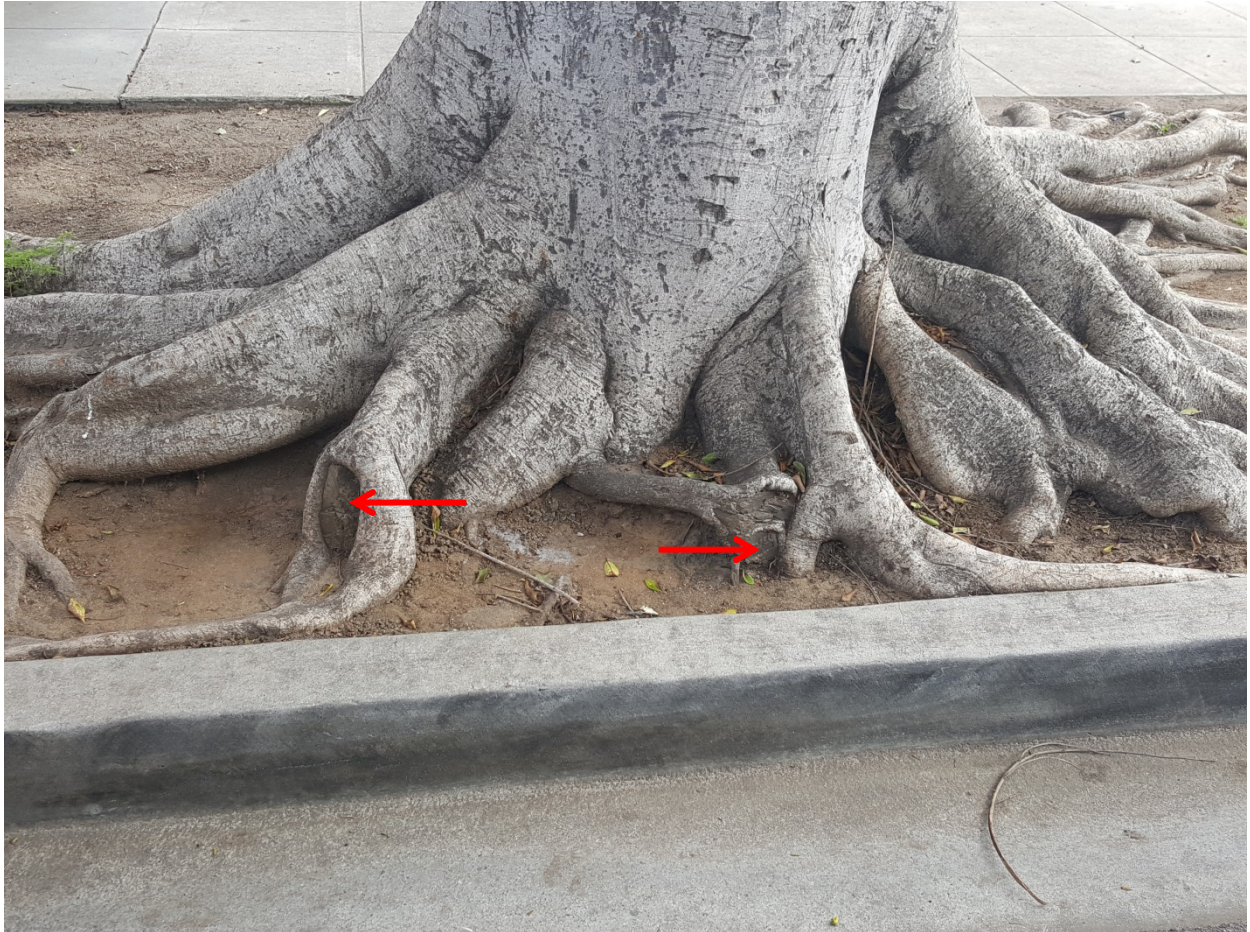
- There was evidence of large older root pruning injuries that appeared to have continued growing without signs of significant decay (see Photo #3 in Appendix A).

There was evidence of large older root pruning injuries that appeared to have continued growing without signs of significant decay (red arrows).

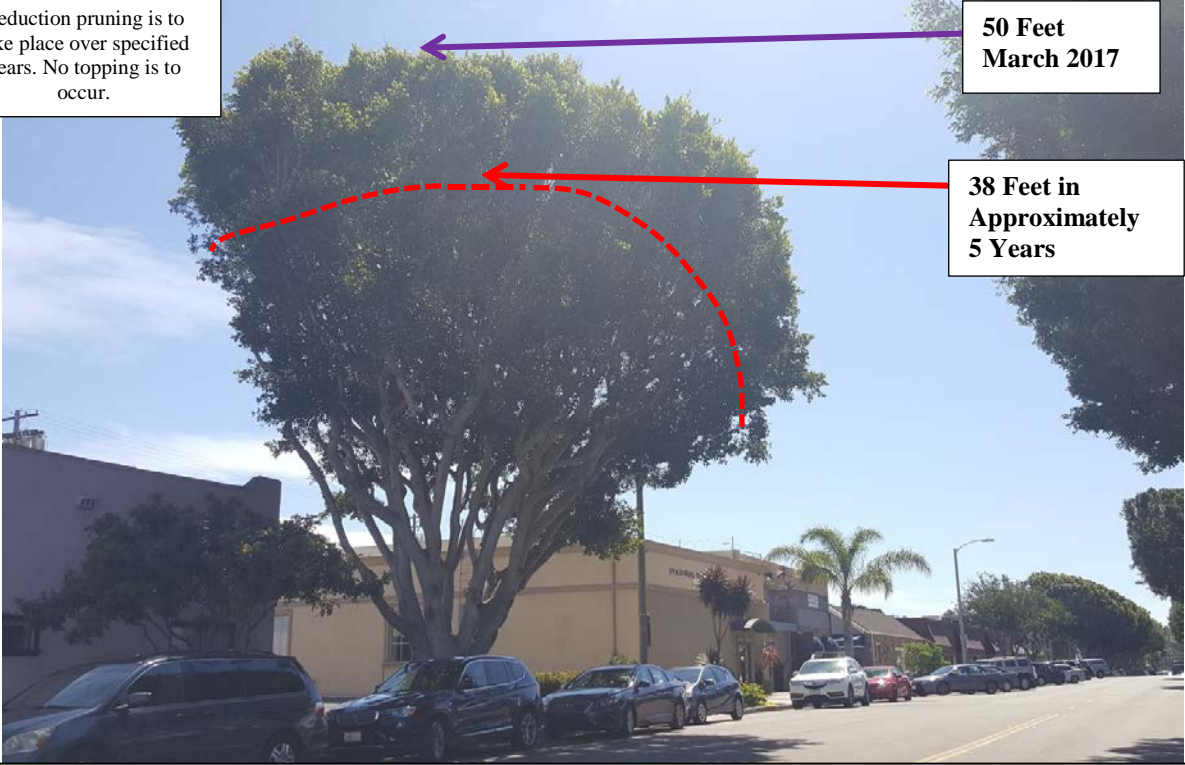
**Crown Reduction Pruning Goal**

This tree had a measured height of 50 feet (see purple arrow). The proposed goal is to achieve a 25% (12.5 feet) **crown reduction through a multi-year pruning plan (up to five years)** leaving the tree with a height of approximately 38 feet (see red dotted line and arrow) after the final pruning dose.

Reduction pruning is to take place over specified years. No topping is to occur.
