City of Encinitas

3.3.17 Assessment of Ficus Tree Near 700 F Street

Gene Bordson
Certified Arborist # WE-10777A
Qualified Applicator License# 140768
Qualified Tree Risk Assessor

MARCH 3, 2017

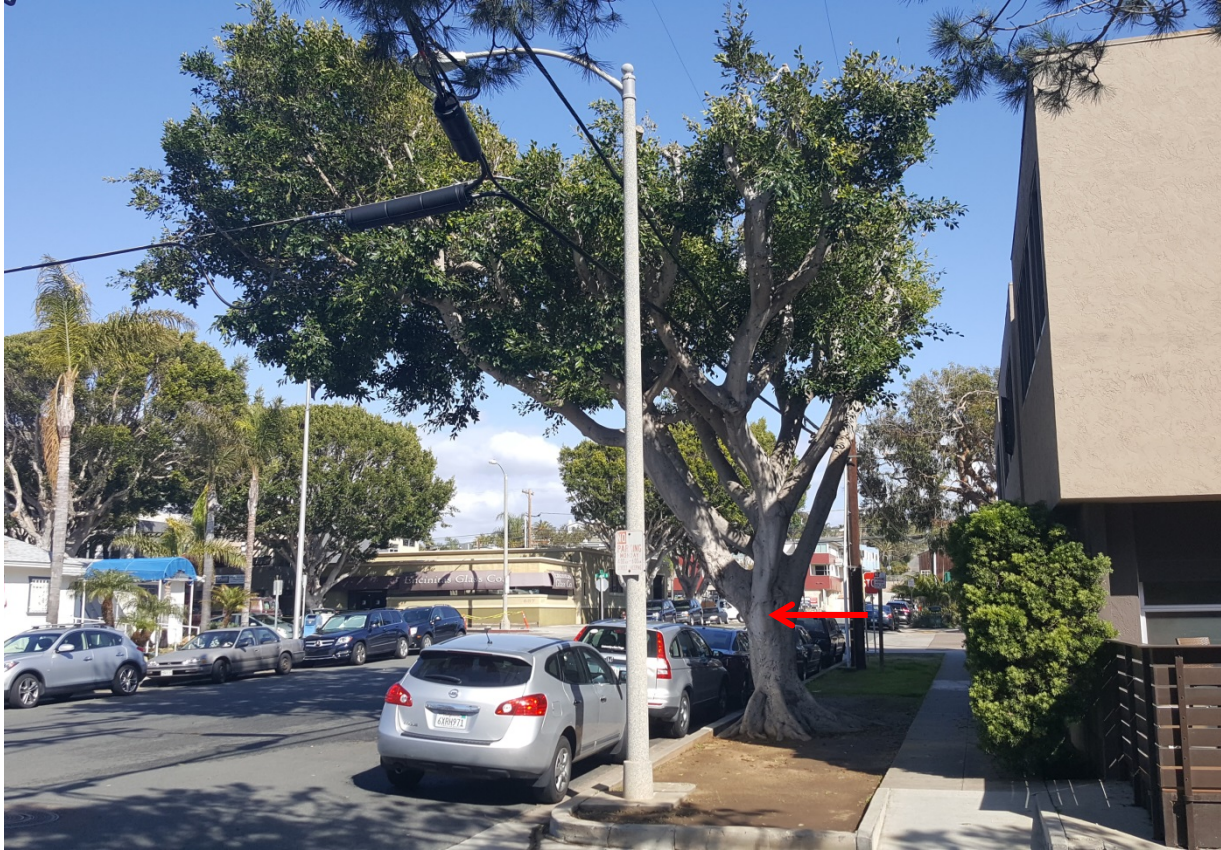
- The tree was growing in an 8 foot wide parkway on the south side F St. near the 700 building (see Figure 1, as well as Photo #1 in Appendix A).
- Judging by the color and density of the foliage, the tree appeared to be in fair health for the species and time of year (see Photo #1 in Appendix A).

- The tree had a DSH² measurement of 29 inches and a height of about 35 feet (measured with a TruPulse laser).
- The tree appeared to have been pruned for powerline and building clearance. This resulted in a canopy imbalance towards F St. and very poor structure with overextended **codominant** stems (see Photo #1 in Appendix A).

The subject tree had very poor structure as a result of being heavily pruned for power line and road clearance. The *likelihood of failure* within the next year has been assessed as **possible** for an overextended stem or scaffold limb. Uprooting of the tree could also occur but is improbable because of large amount of **response growth** on buttress roots opposite to the lean. A failure event would be most likely to occur during abnormal or extreme weather conditions.

- The tree (red arrow) was growing in an 8 foot wide parkway on the south side F St. near the 700 building.
- Judging by the color and density of the foliage, the tree appeared to be in fair health for the species and time of year.
- The tree appeared to have been heavily pruned for powerline and building clearance. This resulted in a canopy imbalance towards F St. and very poor structure with overextended codominant stems.

Risk Mitigation: The tree under discussion is presenting an overall moderate risk. To decrease the overall risk down to low I have two optional recommendations to present:

1. If City does not view this tree as an asset worth preserving under the limiting site conditions, then removal and replacement with a healthy, more site specific tree can be considered.
2. Perform selective reduction pruning techniques on overextended stems/scaffold branches on the north side of the tree (see Appendix B for review of recommended pruning techniques). The work performed should be done in compliance to ANSI A300 Arboricultural Standards and may need to be applied over multiple spaced out pruning doses to minimize health impacts on the tree.

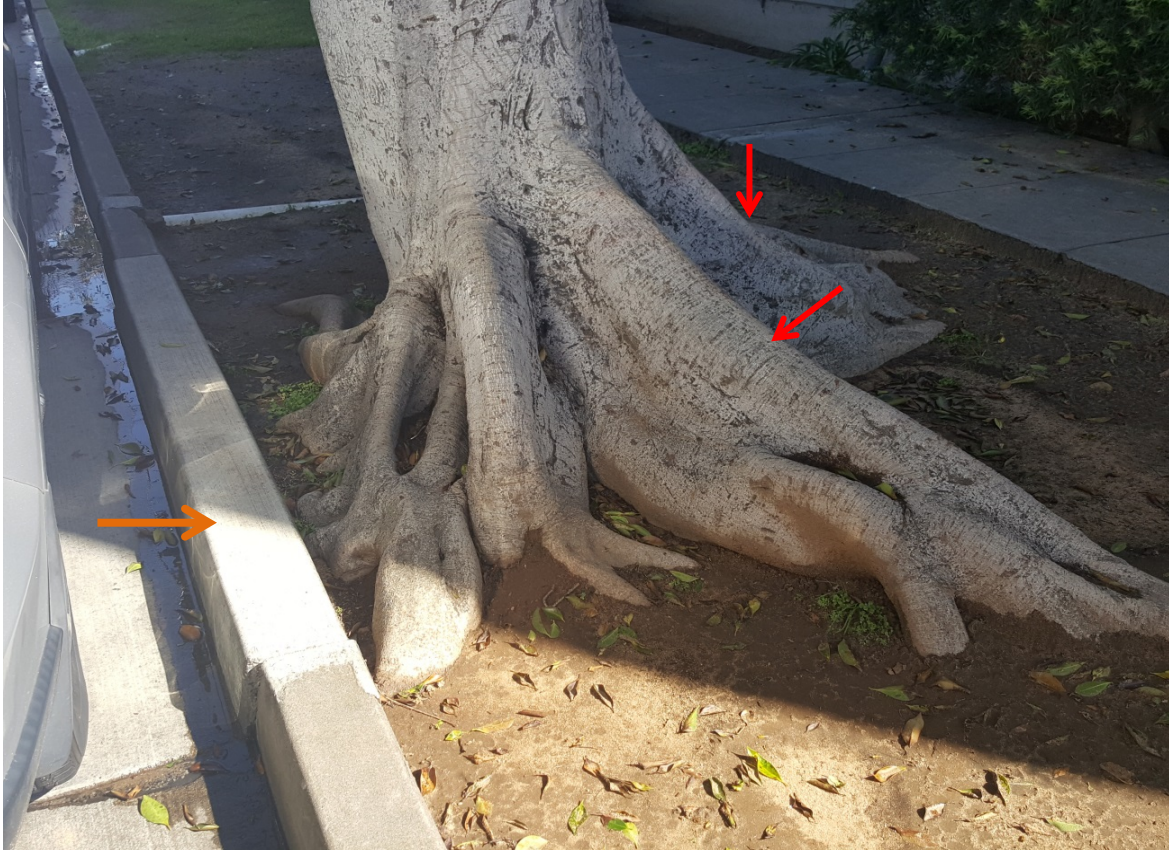
- The tree had large **buttress roots** on the south side of the trunk likely a **response growth** to compensate for the canopy imbalance (see Photo #2 in Appendix A).

- There was a slight deflection in the curb face in front of the tree. The lighter tone of the concrete indicated that a section of the curb face had likely been replaced not too long ago (see Photo #2 in Appendix A).

- The tree had large **buttress roots** (red arrows) on the south side of the trunk, likely a **response growth** to compensate for the canopy imbalance.
- There was a slight deflection in the curb face in front of the tree (orange arrow). The lighter tone of the concrete indicated that a section of the curb face had likely been replaced not too long ago.
