# City of Encinitas

## 4.20.17 Assessment of Ficus Tree At 120 I St. / W (Front-2)

Gene Bordson  
Certified Arborist # WE-10777A  
Qualified Applicator License# 140768  
Qualified Tree Risk Assessor

APRIL 20, 2017

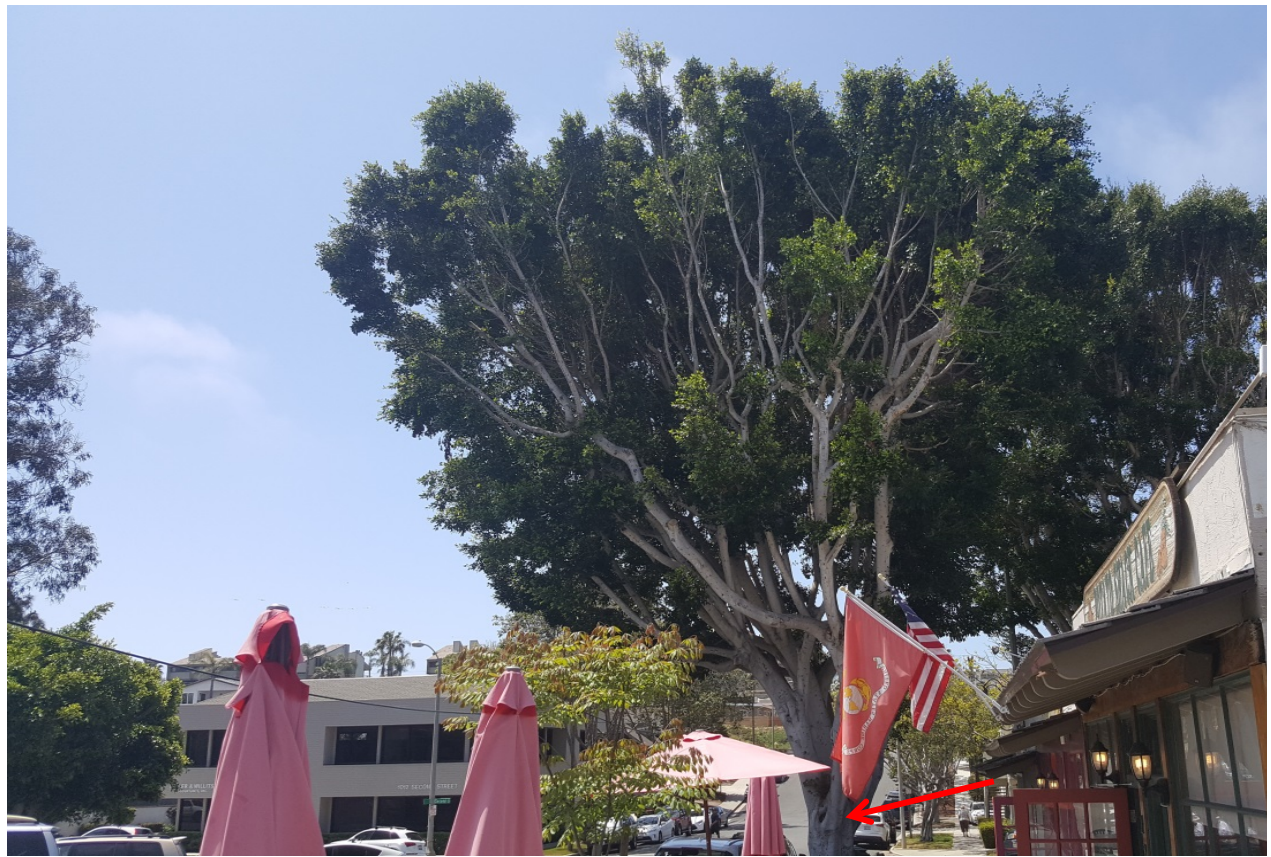
- The tree was growing in a tree well on the north side of I St. (see Figure 1 and Photo #1 in Appendix A).
- Judging by the color and density of the foliage, the tree appeared to be in fair health for the species and time of year. There was a lack of foliage on the east side of the tree likely related to shading out from an adjacent tree which had been removed. The tree had a moderate **live crown ratio** of approximately 50% which is common for street trees necessitating raised crowns for vehicle and building clearance (see Photo #1 in Appendix A).

- The tree had a DSH<sup>2</sup> measurement of 37 inches and a height of about 55 feet (measured with a TruPulse laser).
- The tree had multiple codominant stems and overextended scaffold branches which are indicative of poor structure yet fairly common among this species (see Photo #1 in Appendix A).

- The tree (red arrow) was growing in a tree well on the north side of I St.
- Judging by the color and density of the foliage, the tree appeared to be in fair health for the species and time of year. There was a lack of foliage on the east side of the tree likely related to shading out from an adjacent tree which had been removed. The tree had a moderate **live crown ratio** of approximately 50% which is common for street trees necessitating raised crowns for vehicle and building clearance.
- The tree had multiple codominant stems and overextended scaffold branches which are indicative of poor structure yet fairly common among this species.

After performing a **Level 2 Basic Assessment**<sup>4</sup>, the subject tree was assessed to have an overall moderate risk rating. In regards to mitigating these risks, I recommend applying and maintaining an approximate 25% crown reduction (retaining interior growth) with the structure and canopy balance of the tree in mind (see Appendix B and Figure 3 below). This recommended pruning should be done in compliance to ANSI A300 Arboricultural Standards and will need to be applied over multiple spaced out pruning doses (up to five years). This is done to minimize health impacts on the tree and allow time for interior growth to further develop and broaden the options for new branches to prune back to. Pruning techniques such as **reduction pruning**, and **removal pruning cuts** should be used (not topping) to achieve this overall squattier appearance and are further explained in Appendix B. The end outcome should be a reduction of **mechanical stress** from overextended loads. A residual risk of “Low” should be achieved after implementing these recommended pruning strategies. It is with the health and safety of the community that I present these recommendations.

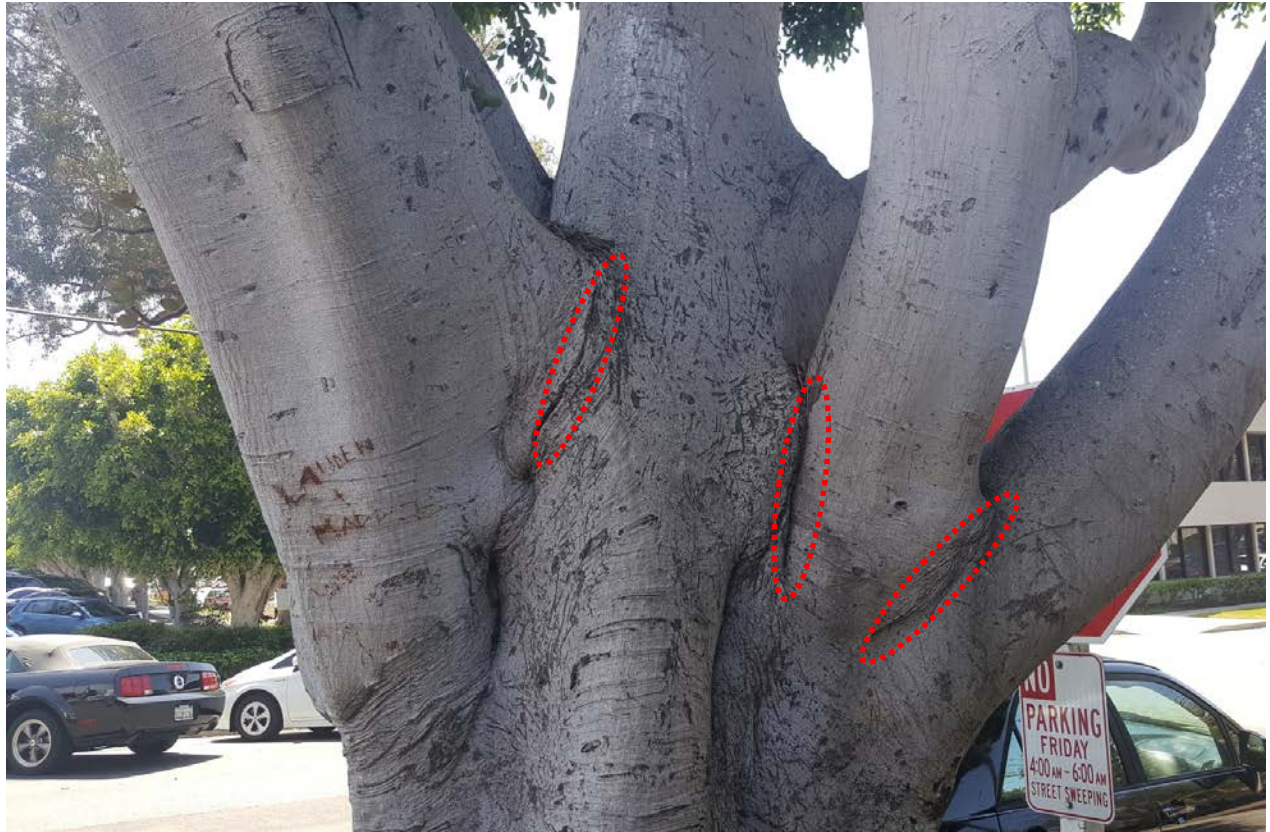
- Some of the stems and scaffold branches had presence of significant included bark (see Photo #2 in Appendix A).

The defects of greatest concern for the subject tree were the overextended stems/ scaffold branches with weakly developed branch unions. The *likelihood of a failure* within the next year was assessed as **possible** for the subject tree. A failure event would be most likely to occur during abnormal or extreme weather conditions.

- Some of the stems and scaffold branches had presence of included bark (red dotted oval).

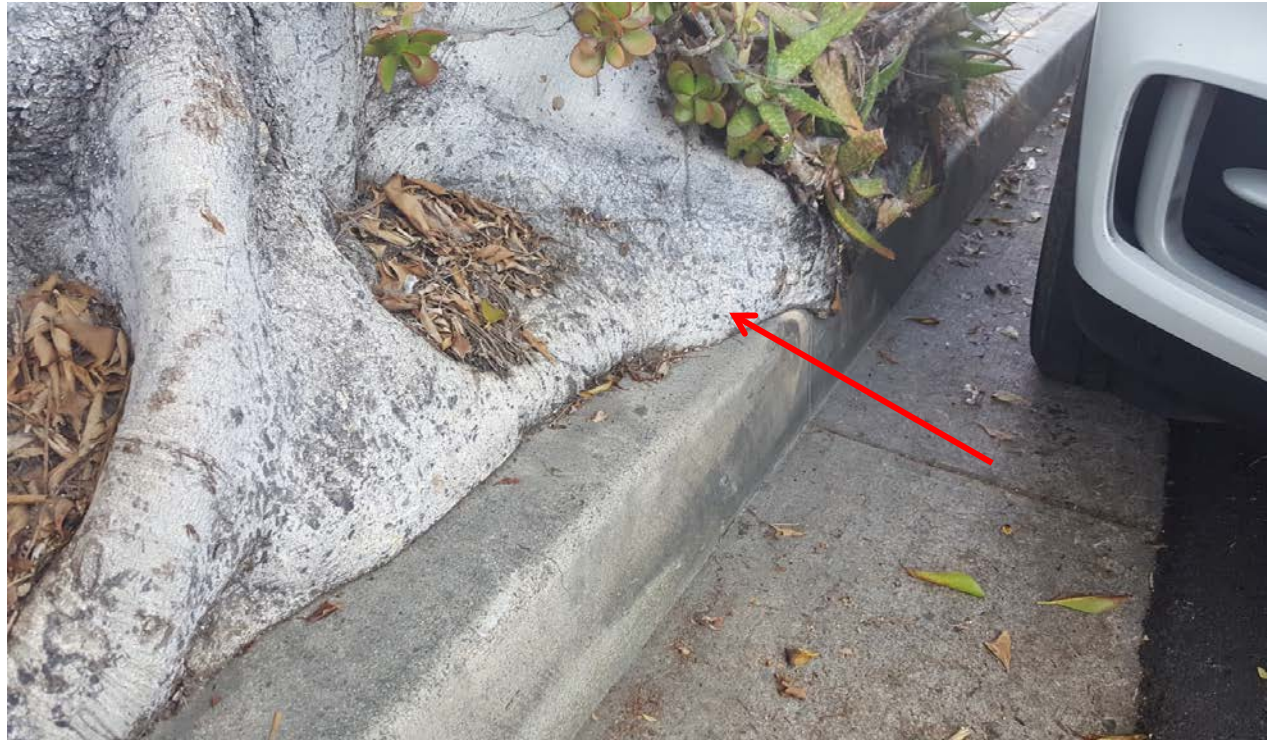
- Some of the buttress roots were showing a **contact stress response** to growing next to the curb face. This phenomenon occurs when trees grow in close contact with infrastructure. Trunk and root tissues mold, and grow over the infrastructure element providing a level of structural support. There may be an increase in failure potential if the infrastructure element is removed or replaced. There also appeared to be some older damage to the living tissues on the top of the root (see Photo #3 in Appendix A).
- There was what appeared to be a bird's nest in the upper canopy of the tree. Bird activity was not observed during the time of inspection.
- Vehicles appeared to use this area of I Street frequently throughout the day.

- Some of the buttress roots were showing a **contact stress response** to growing next to the curb face (see **red arrow**). This phenomenon occurs when trees grow in close contact with infrastructure. Trunk and root tissues mold, and grow over the infrastructure element providing a level of structural support. There may be an increase in failure potential if the infrastructure element is removed or replaced. There also appeared to be some older damage to the living tissues on the top of the root.
