City of Encinitas

4.14.17 Assessment of Ficus Tree At 222 J Street /W (Front-2)

APRIL 14, 2017

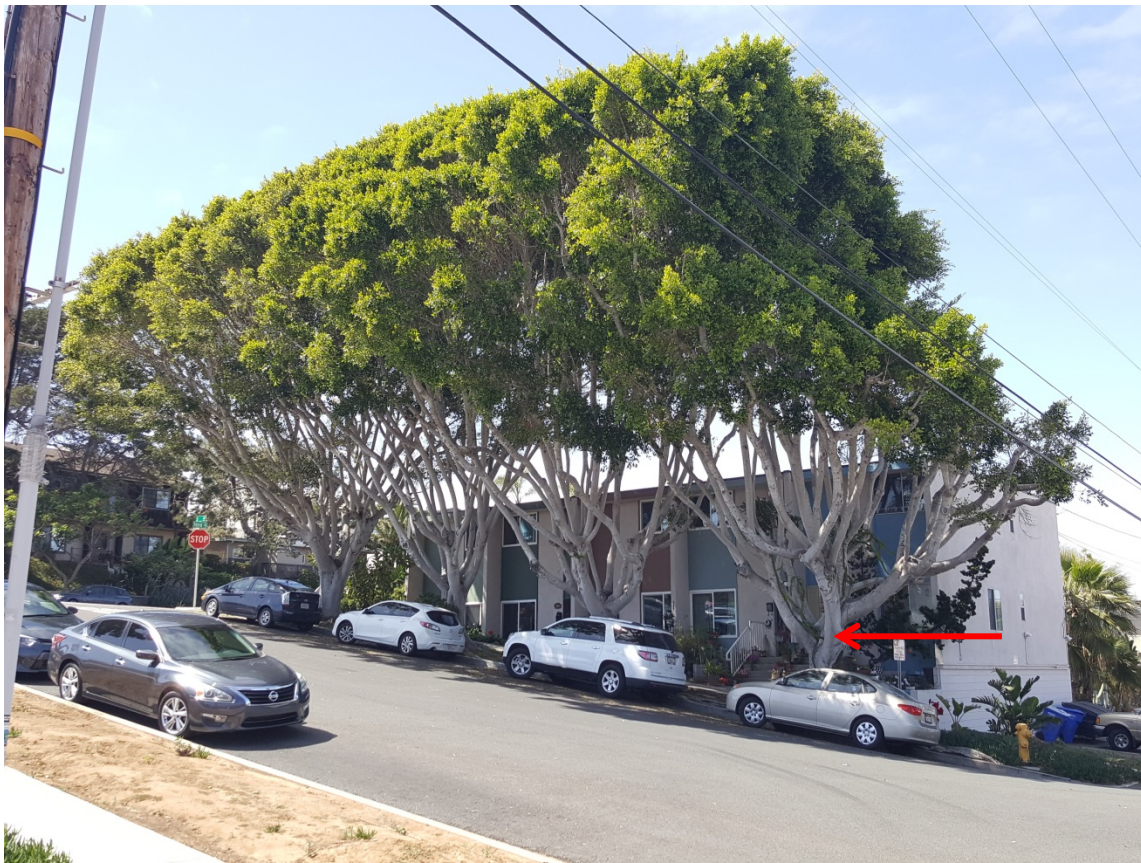
- The tree was growing in a parkway on the north side of J St. (see Figure 1 and Photo #1 in Appendix A).
- Judging by the color and density of the foliage, the tree appeared to be in fair health for the species and time of year. The tree had a moderate **live crown ratio** of approximately 50% which is common for street trees necessitating raised crowns for vehicle and building clearance (see Photo #1 in Appendix A).

- The tree had a DSH² measurement of 32 inches and a height of about 45 feet (measured with a TruPulse laser).
- The tree had multiple codominant stems and overextended scaffold branches which are indicative of poor structure yet fairly common among this species (see Photo #1 in Appendix A).

- The tree had a canopy unbalance associated with pruning for building and powerline clearance (see Photo #1 in Appendix A).
- The ground had a slope downwards towards the east increasing slip hazards during heavy fruiting (see Photo #1 in Appendix A).

The defects of greatest concern for the subject tree were the overextended scaffold branches (primarily on the west side) with weakly developed branch unions. The *likelihood of a scaffold branch failure* within the next year was assessed as **possible** for the subject tree. A failure event would be most likely to occur during abnormal or extreme weather conditions.

- The tree (red arrow) was growing in a parkway on the north side of J St.
- Judging by the color and density of the foliage, the tree appeared to be in fair health for the species and time of year. The tree had a moderate **live crown ratio** of approximately 50% which is common for street trees necessitating raised crowns for vehicle and building clearance.
- The tree had multiple codominant stems and overextended scaffold branches (primarily on its west side) which are indicative of poor structure yet fairly common among this species.
- There were powerlines running directly east of the trees' canopy.
- The tree had a canopy unbalance because of pruning for building and powerline clearance.
- The ground had a slope downwards towards the east increasing slip hazards during heavy fruiting.

Risk and Mitigation – After performing a **Level 2 Basic Assessment**⁴, the subject tree was assessed to have an overall moderate risk rating. In regards to mitigating these risks, I recommend applying and maintaining an approximate 25% crown reduction (retaining interior growth) mainly focused on overextended growth on the west side of the tree (see Appendix B and Figure 3 below). This recommended pruning should be done in compliance to ANSI A300 Arboricultural Standards and may need to be applied over multiple spaced out pruning doses to minimize health impacts on the tree. This is also done to allow time for interior growth to further develop and broaden the options for new branches to prune back to. Pruning techniques such as **reduction pruning**, and **removal pruning cuts** should be used (not topping) to achieve this overall squattier appearance and are further explained in Appendix B. The end outcome should be a reduction of **mechanical stress** from overextended loads. A residual risk of “Low” should be achieved after implementing these recommended pruning strategies. It is with the health and safety of the community that I present these recommendations.

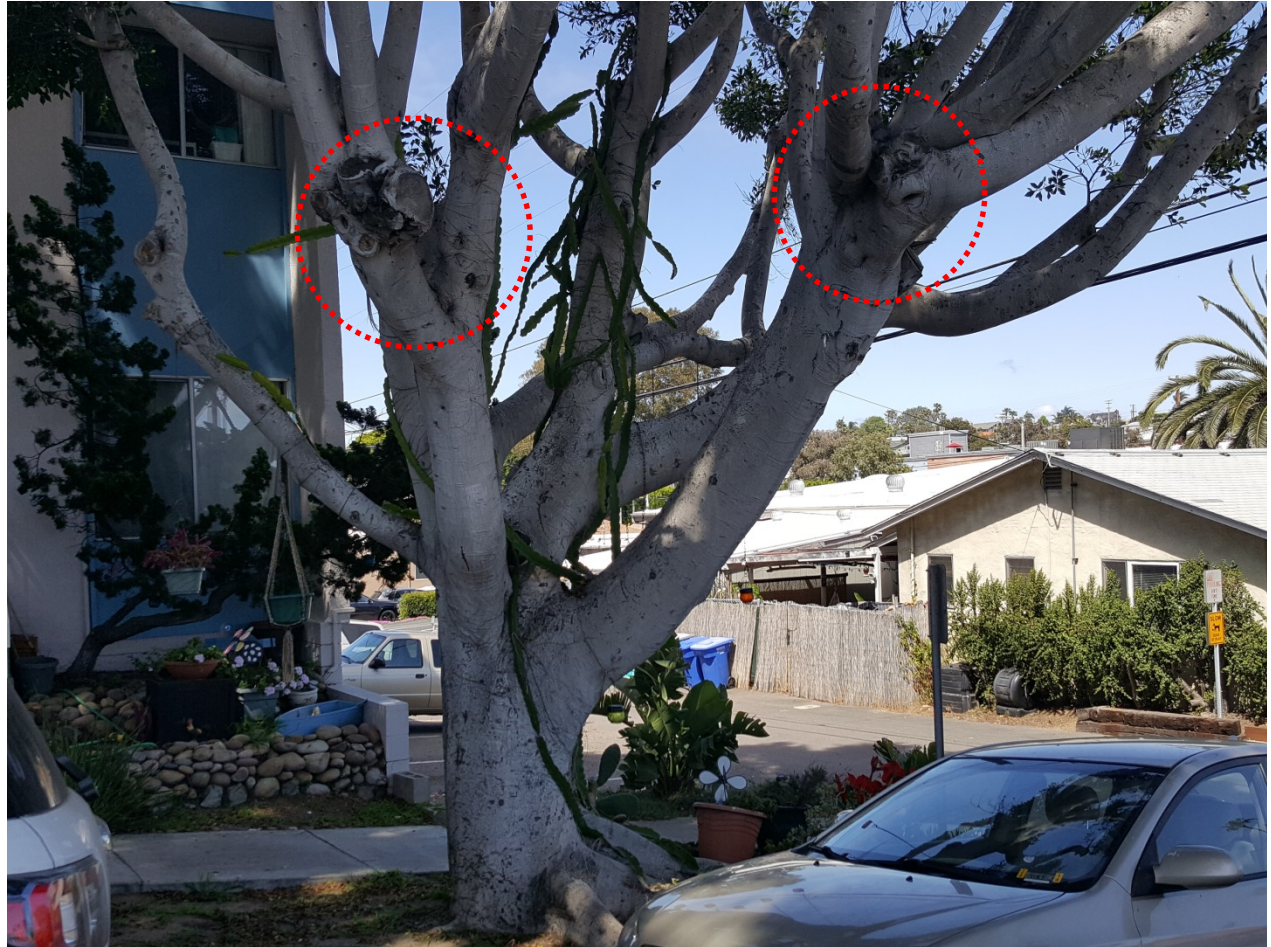
- Significant bark inclusions were not observed on stems; however there was some included bark and poorly structured scaffold branch unions growing from large knuckle like swellings likely associated with heading cuts many years ago (see Photo #2 in Appendix A).

- There was a vining cactus (possibly dragon fruit) growing up into the canopy of the tree (see Photo #2 in Appendix A).

- Significant bark inclusions were not observed on stems, however there was some included bark and poorly structured scaffold branch unions growing from large knuckle like swellings (red dotted circles) likely associated with heading cuts many years ago.
- There was a vining cactus (possibly dragon fruit) growing up into the canopy of the tree.

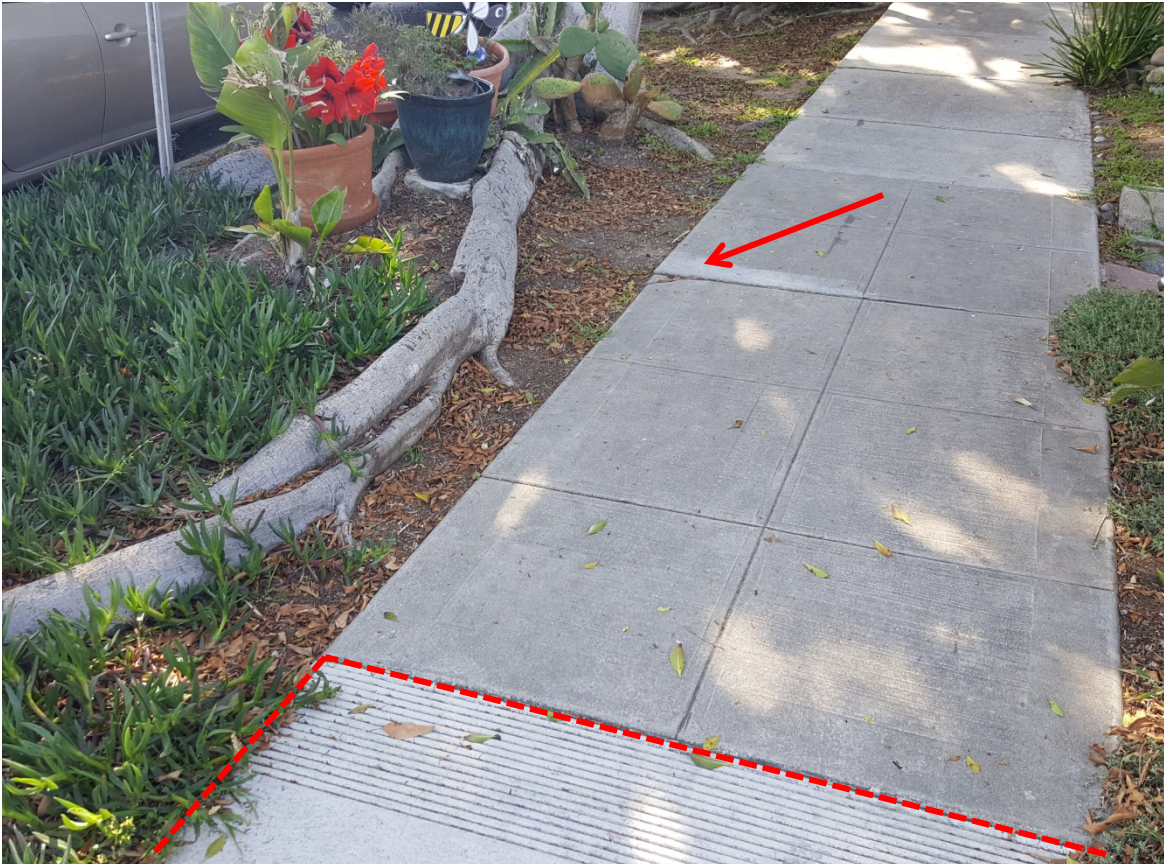
- Judging by the lighter tone of concrete, it appeared that an area of sidewalk had been replaced near the tree. There were also signs of concrete grinding to mitigate trip hazards (see Photo #3 in Appendix A).
- Vehicles appeared to use this area of 2nd Street frequently throughout the day.

- Judging by the lighter tone of concrete, it appeared that an area of sidewalk had been replaced near the tree (see red dotted area). There were also signs of concrete grinding to mitigate trip hazards (red arrow).
