**PHASE I AND II ENVIRONMENTAL SITE
ASSESSMENT REPORT**

**1190 ISLAND VIEW LANE AND
1220-1240 MELBA ROAD
ENCINITAS, CALIFORNIA**

**TORREY PACIFIC CORPORATION
ENCINITAS, CALIFORNIA**

**MARCH 15, 2021
PROJECT NO. G2438-62-02**

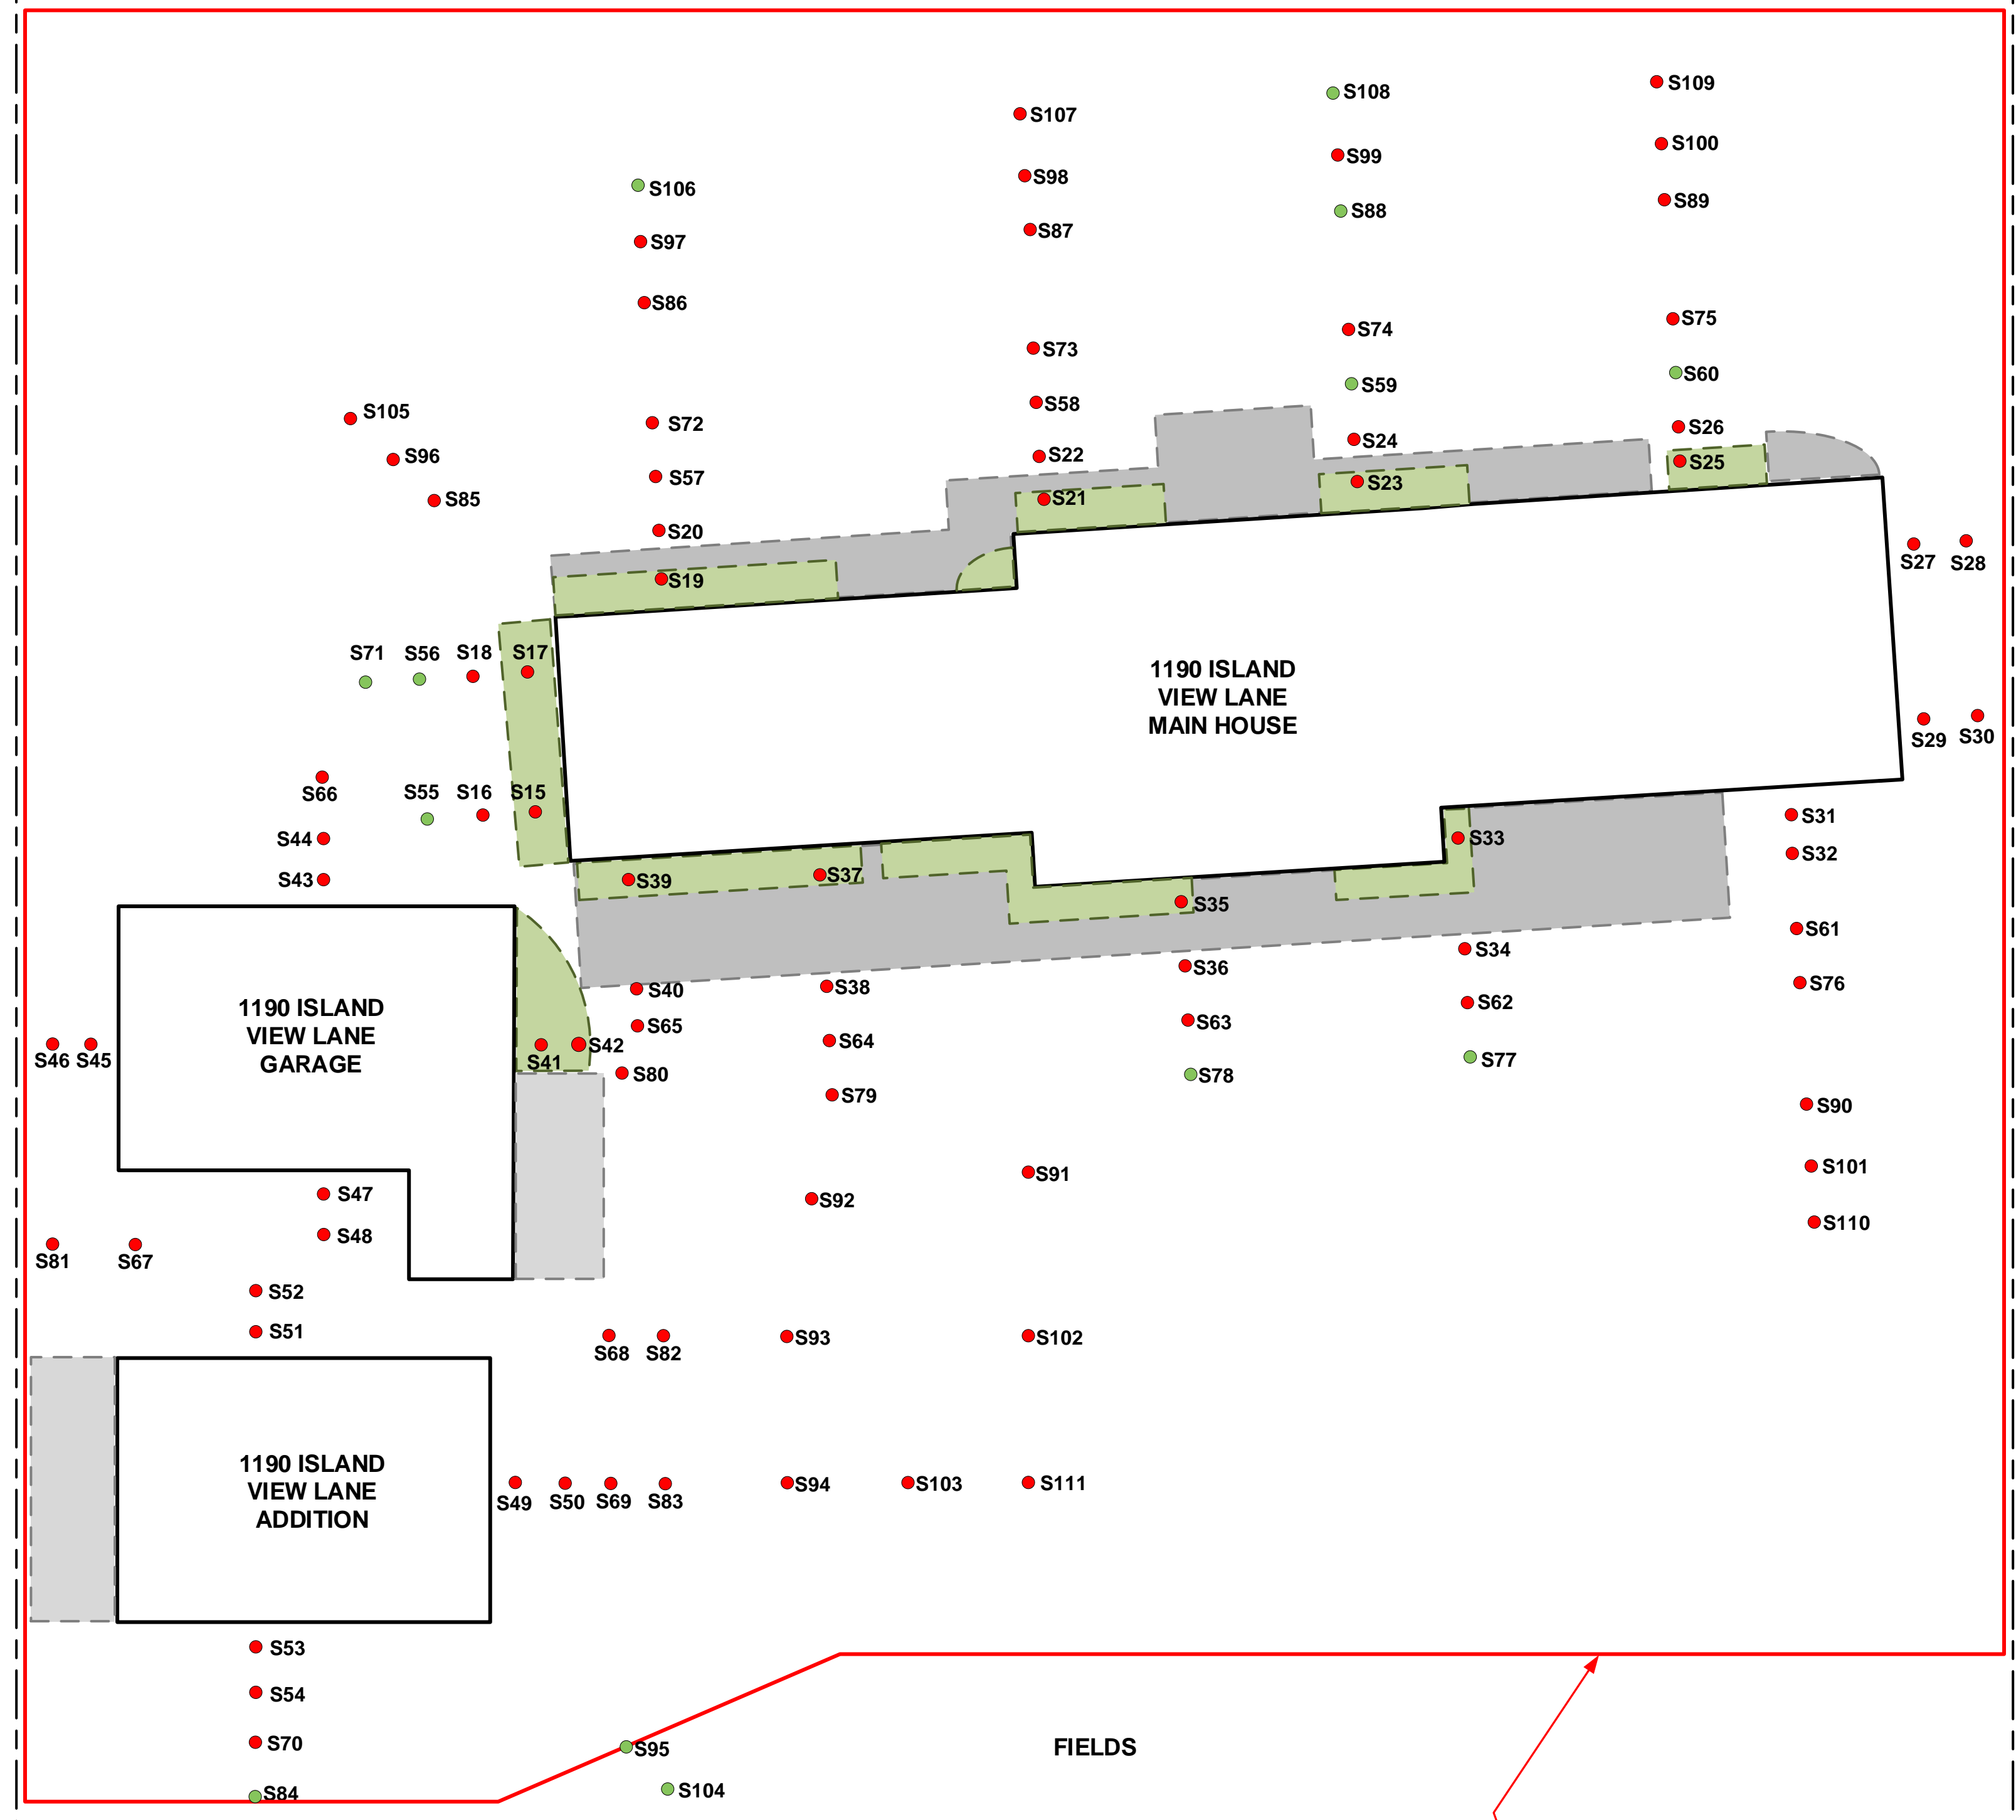
SOIL SAMPLE LOCATION MAP-
1190 ISLAND VIEW LANE

- S111 - APPROX LOCATION OF SOIL SAMPLE THAT EXCEEDED RESIDENTIAL ESLs FOR OCPS
- S112 - APPROX LOCATION OF SOIL SAMPLE THAT DID NOT EXCEED RESIDENTIAL ESLs FOR OCPS
- APPROXIMATE LOCATION OF PLANTER BOXES
- APPROXIMATE AREA COVERED BY CONCRETE

ESTIMATED LIMITS OF
OCP-IMPACTED SOIL

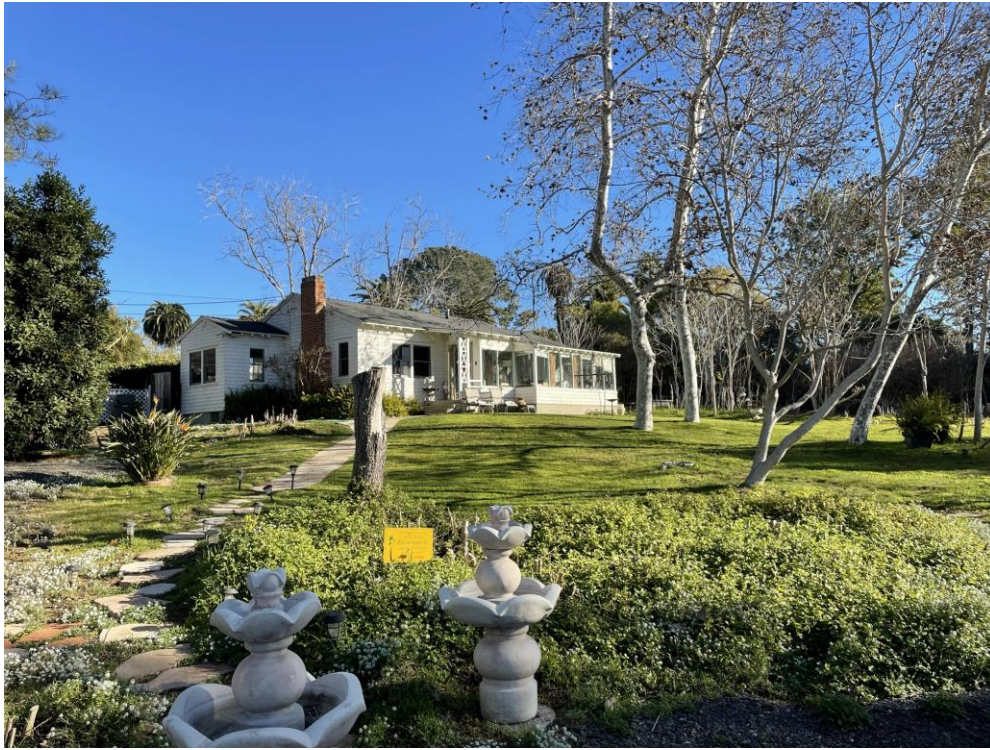
The southern half of the Site is developed with four occupied single-family residences (Photograph Nos. 1 through 4). The residences at 1220, 1230A, 1230B, and 1240 Melba Road appeared to have been well maintained and in good condition. The central portion of the Site contains remnants of former greenhouses, two active greenhouses, and a dilapidated structure (Photograph Nos. 5 through 9). Mr. Staver reported that this structure was formerly used as an office for the former Staver Bros Greenhouse business. The two active greenhouses are reportedly used by the tenant at 1240 Melba Road for personal use. We observed irrigation and fertilizer systems in these greenhouses (Photograph No. 10). The former and current use of the Site for agricultural purposes is described in Section 5.1.

Photograph #1
Single-family residence at 1220 Melba Road.

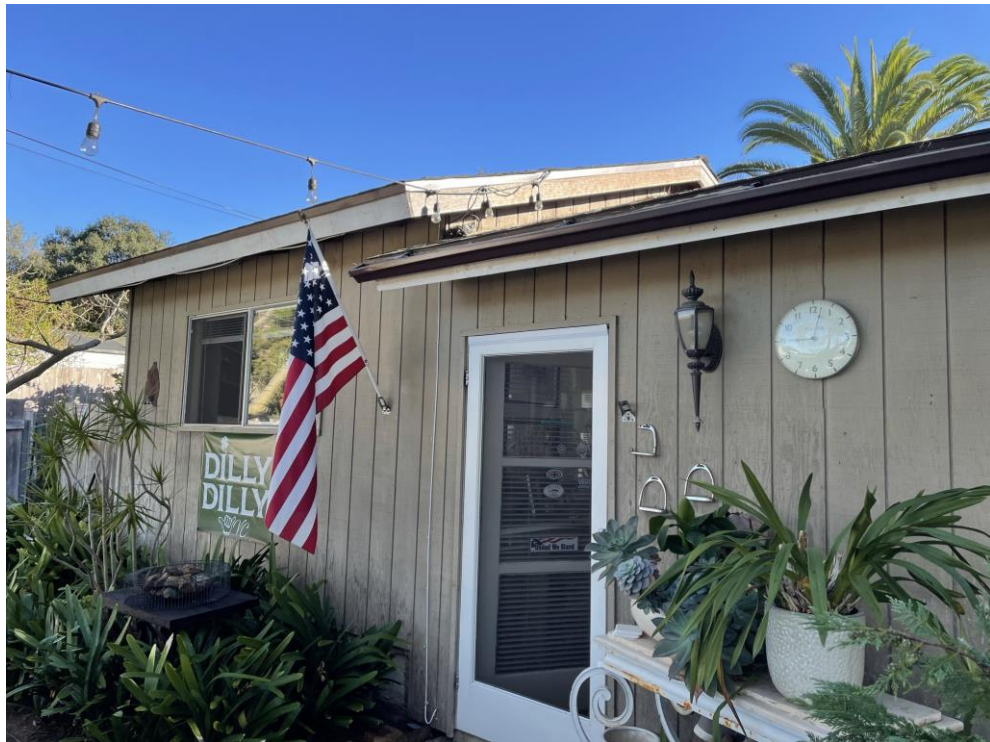
Photograph #2
Single-family residence at 1230A Melba Road.

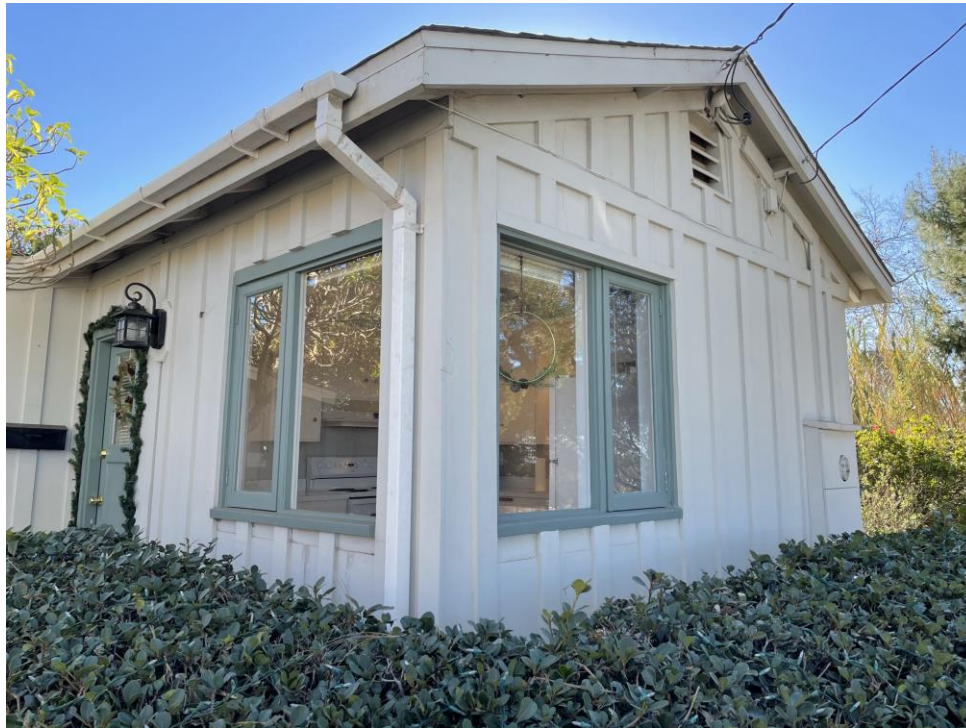
Photograph #3
Single-family residence at 1230B Melba Road.

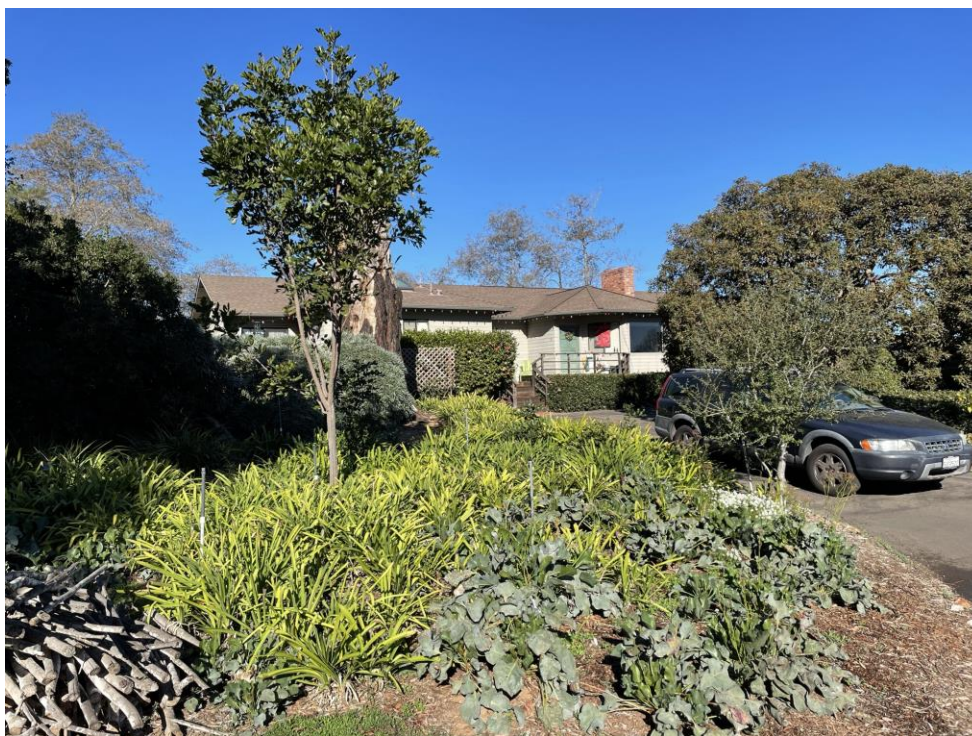
Photograph #4
Single-family residence at 1240 Melba Road.

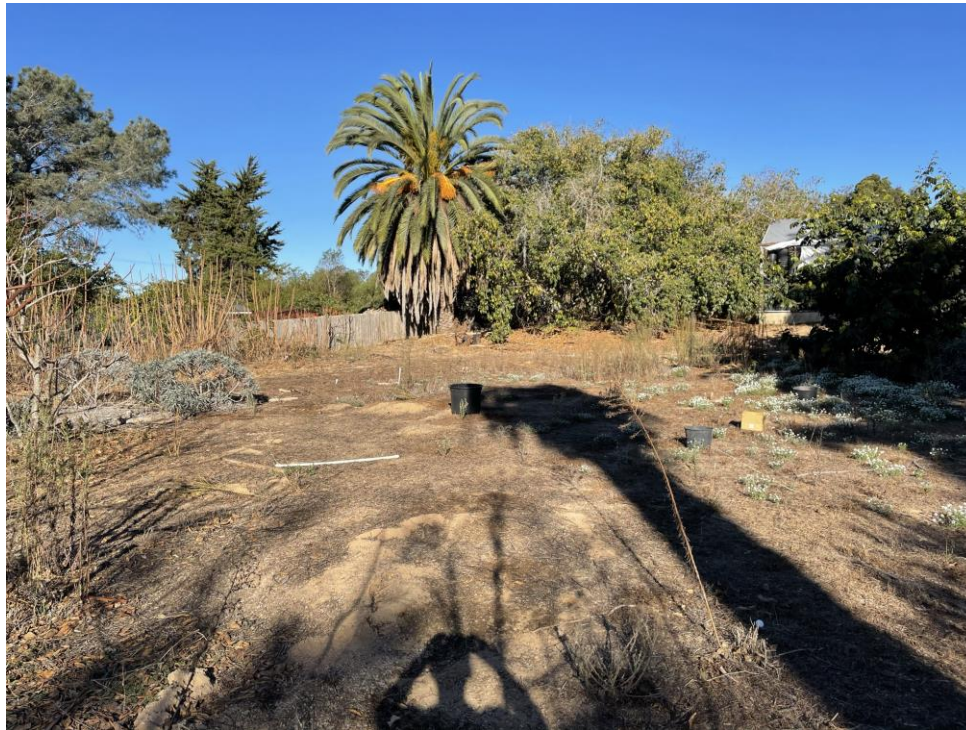
Photograph #5

View to the northwest of former greenhouse locations in central portion of the Site.

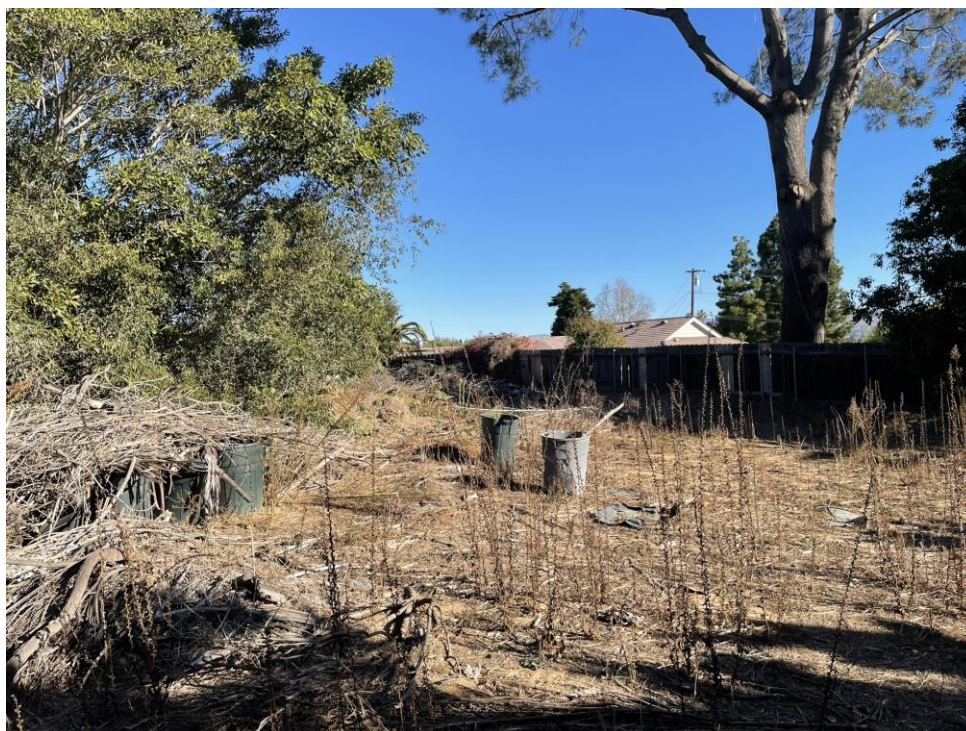
Photograph #6

View to the northeast of former greenhouse locations in eastern portion of the Site.

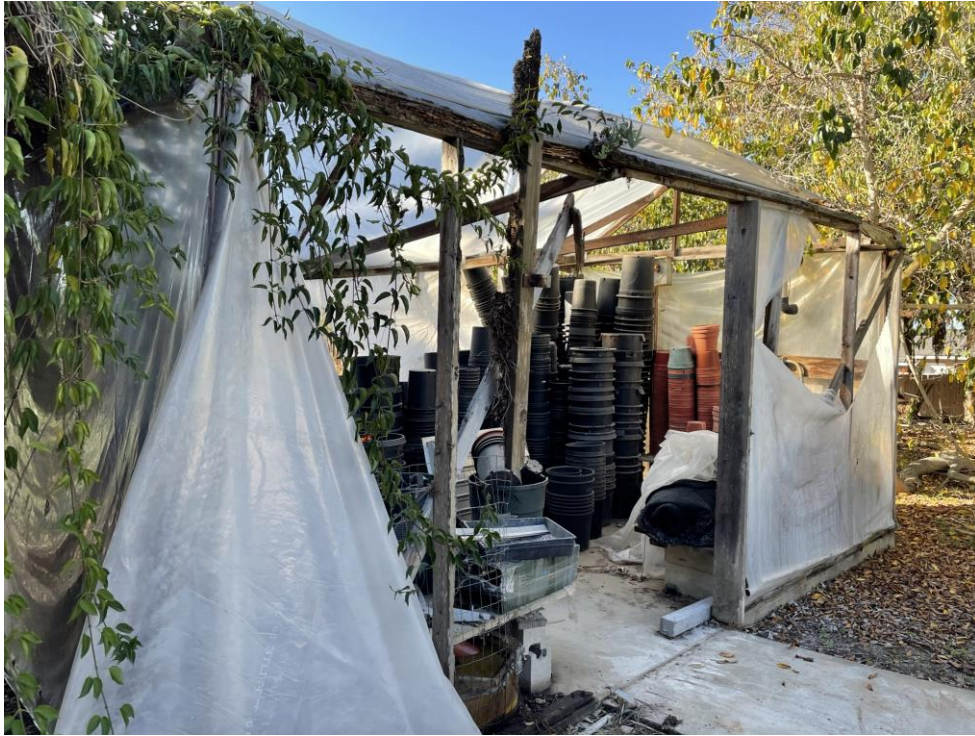
Photograph #7
Former greenhouse in central portion of the Site.

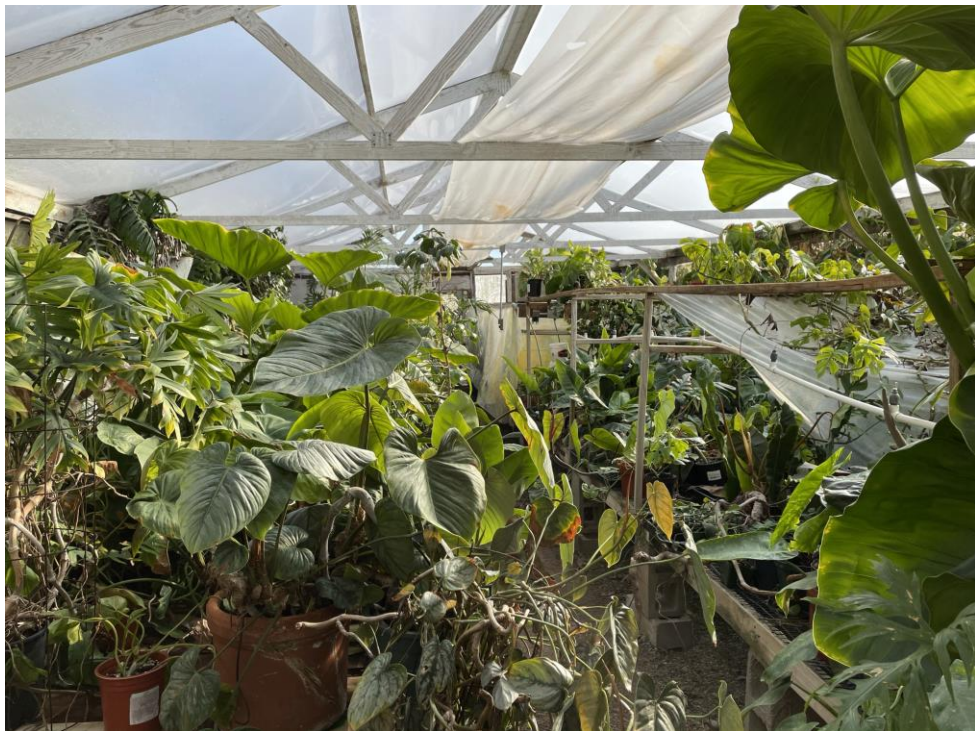
Photograph #8
Greenhouse in central portion of the Site.

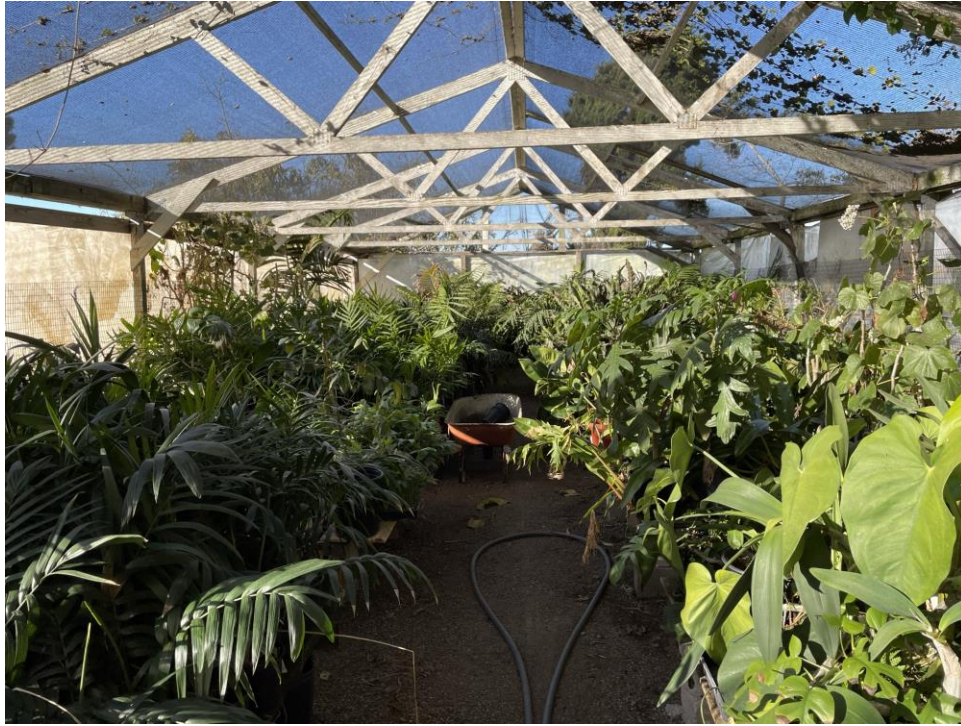
Photograph #9
Greenhouse in central portion of the Site.

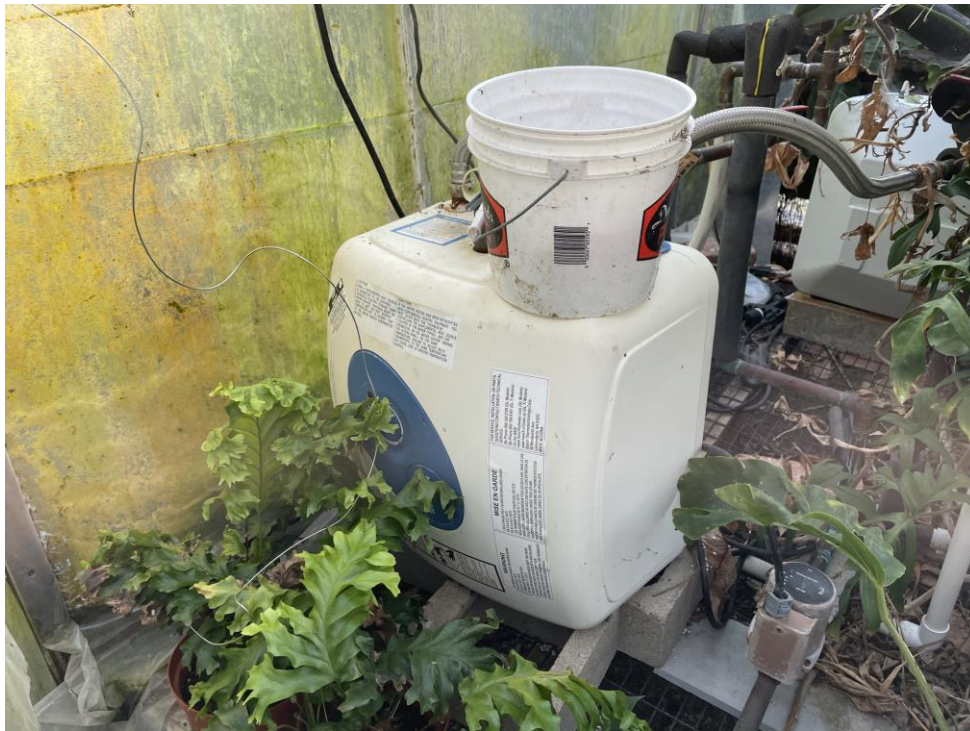
Photograph #10
Fertilizer system in greenhouse.

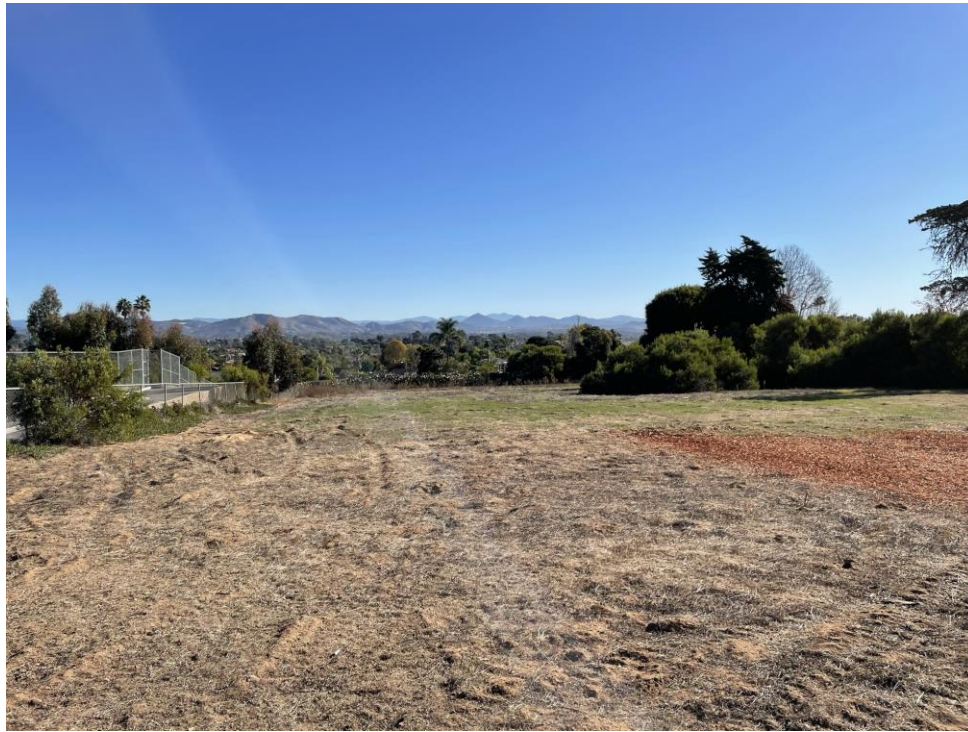
The northern portion of the Site is situated atop a hill and consists of undeveloped land and a vacant single-family residence (Photograph Nos. 11 and 12). The residence consists of a main structure, several freestanding additions and an outhouse that appeared to have been connected to a septic tank (Photograph No. 13). We also observed an approximate 250-gallon propane tank on the exterior of the residence (Photograph No. 14).

Photograph #11
Undeveloped land in northeastern portion of the Site.

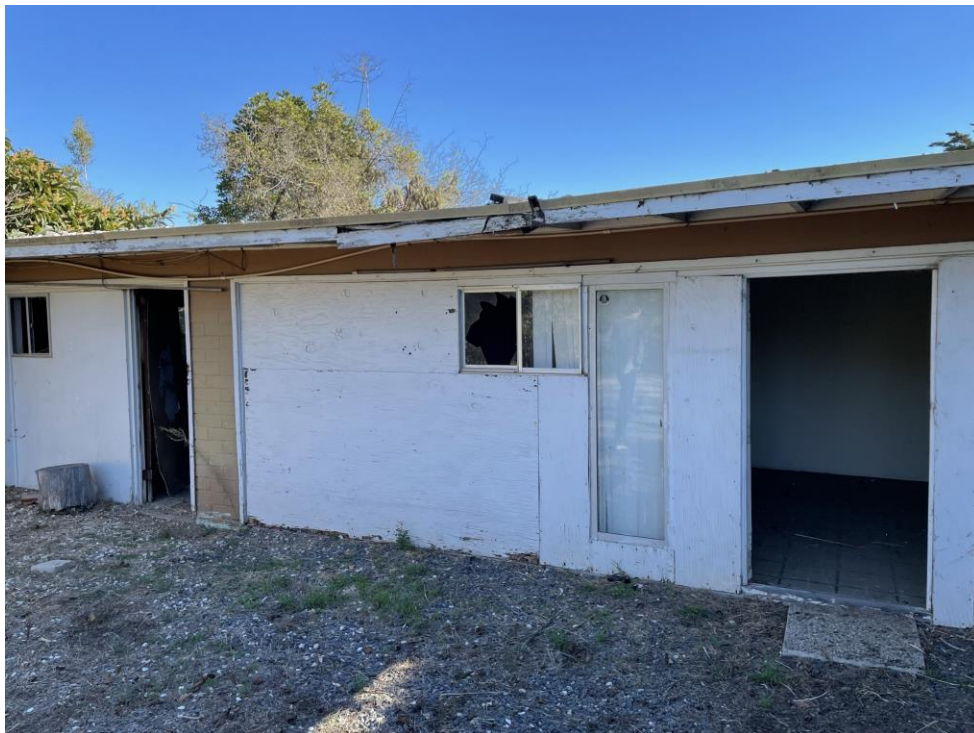
Photograph #12
Dilapidated residence at 1190 Island View Lane.

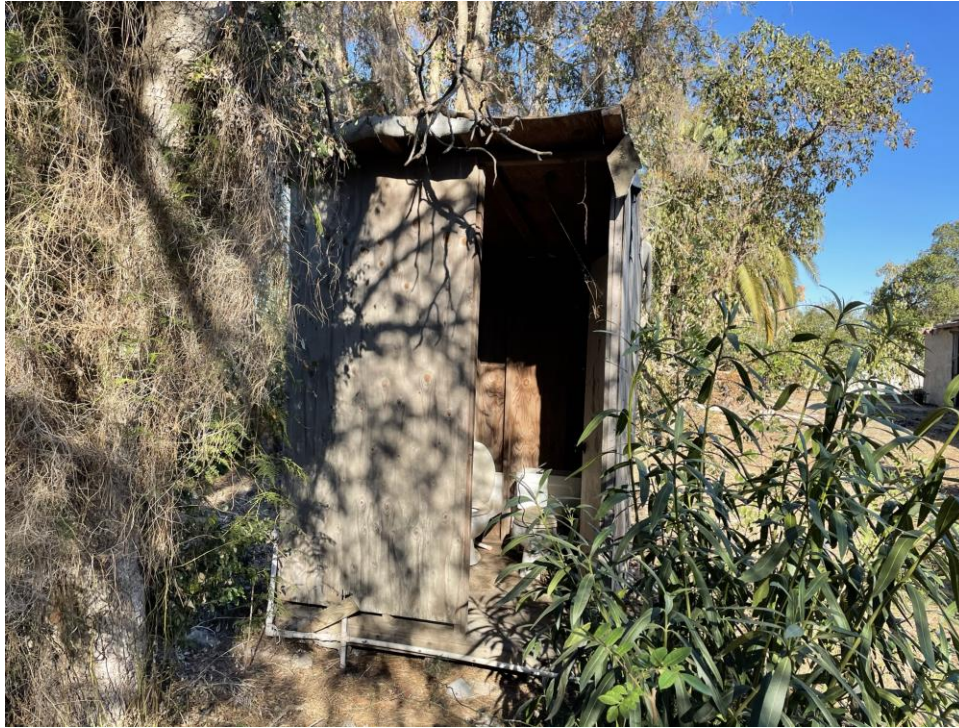
Photograph #13
Outhouse at 1190 Island View Lane.

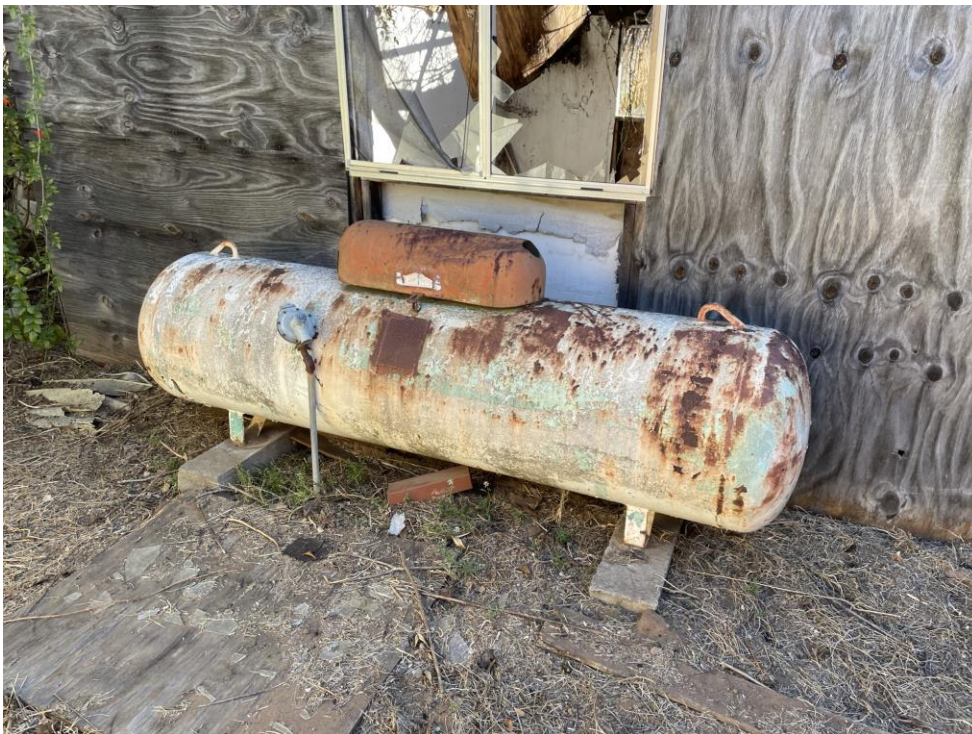
Photograph #14
Propane tank on exterior of residence at 1190 Island View Lane.

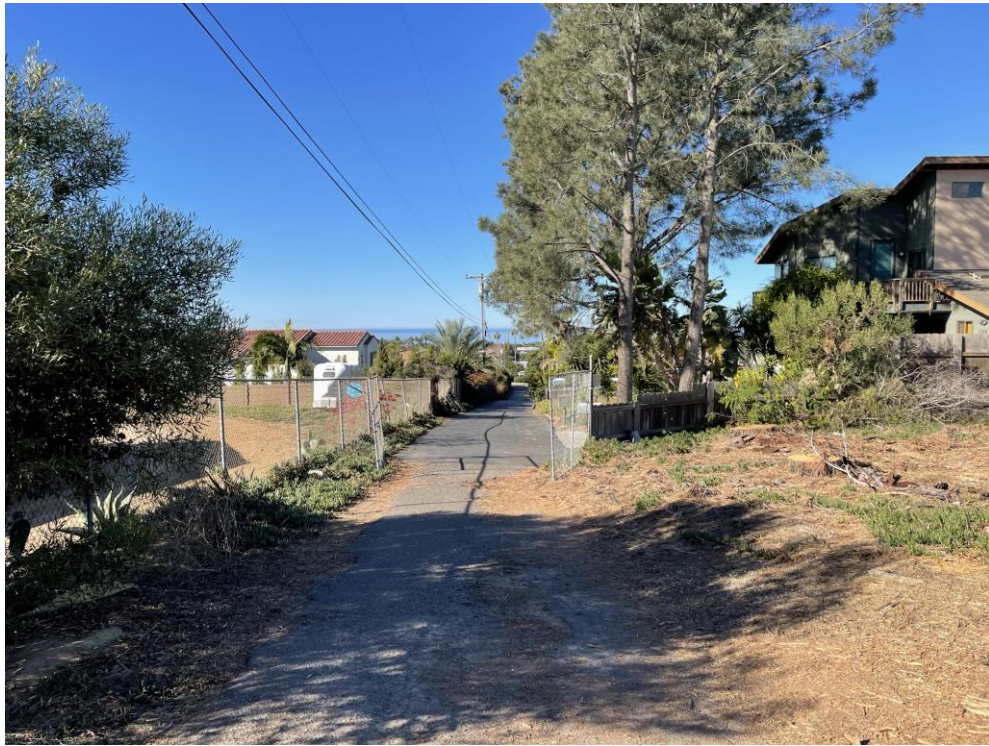
The far western portion of the Site includes Island View Lane, a private driveway (Photograph No. 15). We observed a pole-mounted transformer along Island View Lane (Photograph No. 16).

Photograph #15
View to the west of Island View Lane.

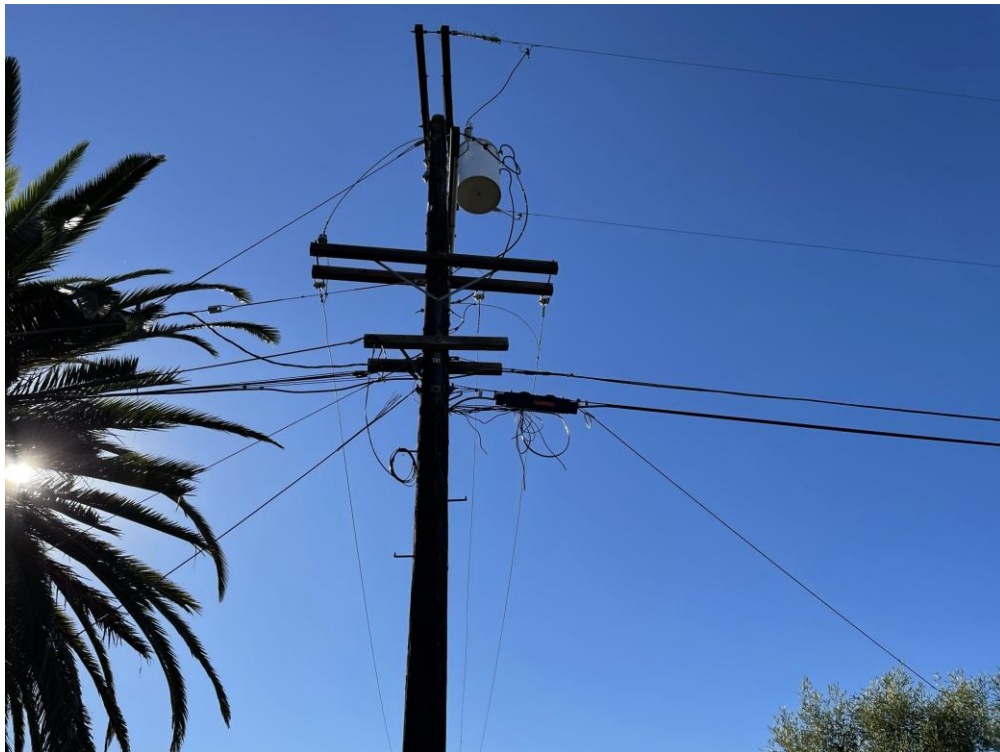
Pole-mounted transformers are present on the Site. Documented discussions with San Diego Gas & Electric Company (SDG&E) representatives regarding transformers indicate that SDG&E has never specified polychlorinated biphenyl (PCB)-containing transformers for its electrical distribution system. Regardless, SDG&E has determined that some older (pre-1980s) mineral transformers were inadvertently contaminated with PCBs by the manufacturer. Based on a statistical sampling and testing program reportedly performed by SDG&E, it is unlikely that transformers found within its service area contain PCBs.

Photograph #16
Pole-mounted transformer in northern portion of the Site.

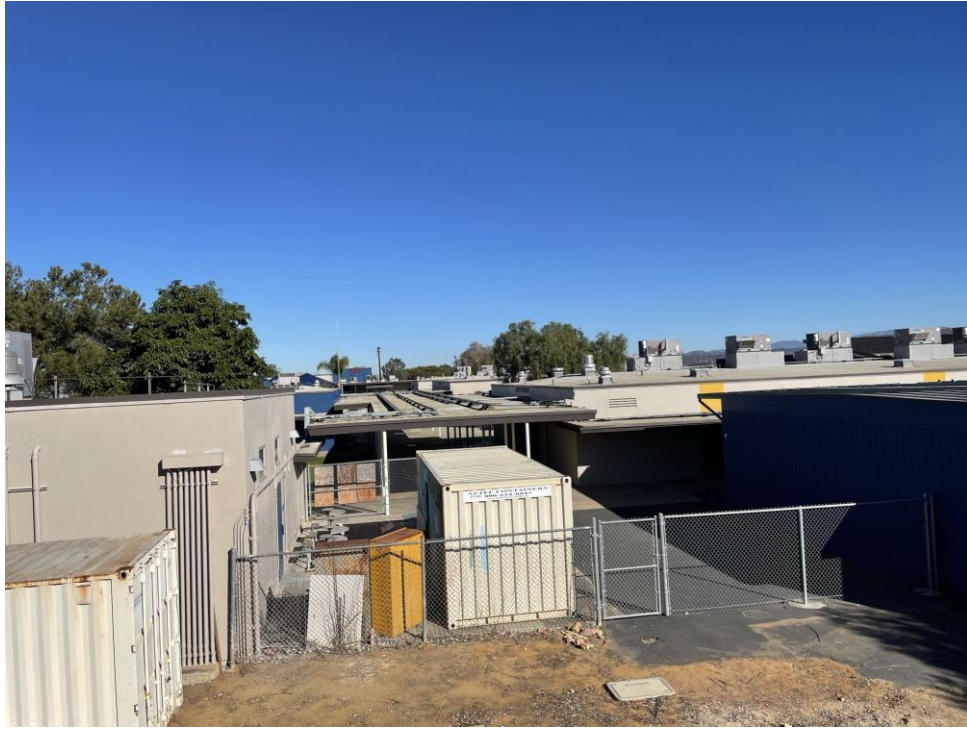
Photograph #17
View to the north of adjacent Oak Crest Middle School.

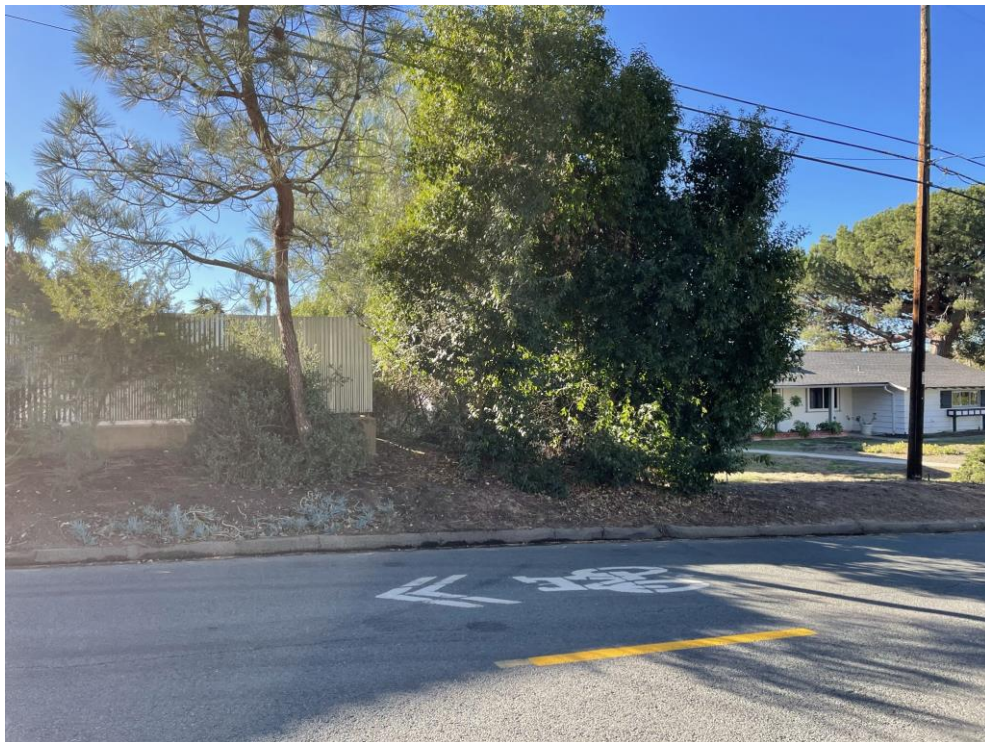
Photograph #18
View to the south of Melba Road, beyond which are single-family residences.

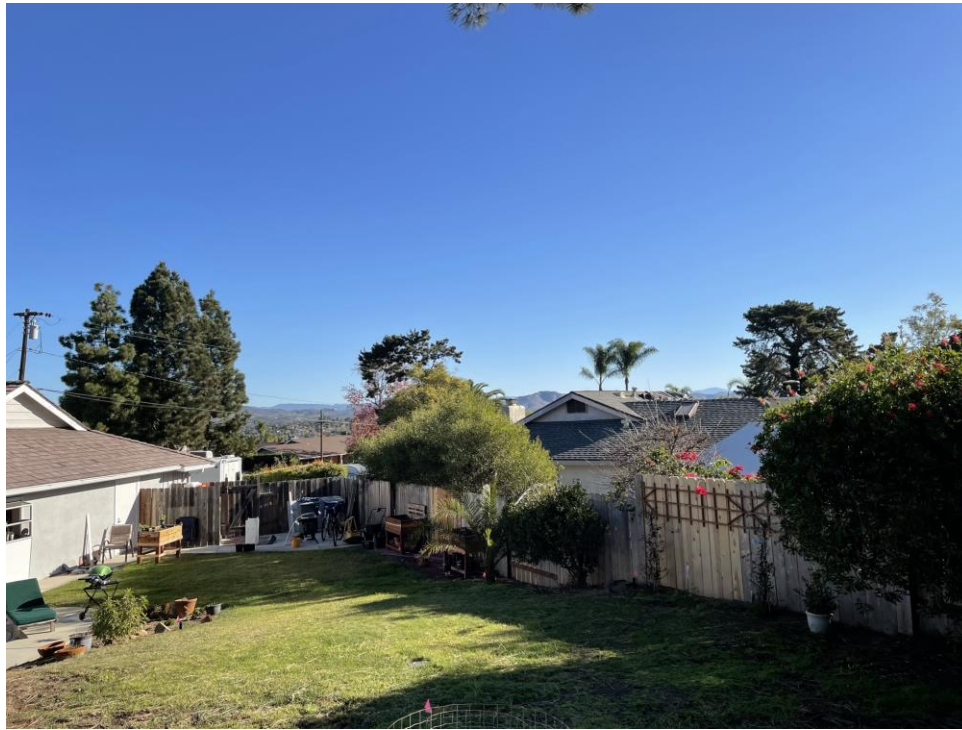
Photograph #19
View to the east of adjacent single-family residences.

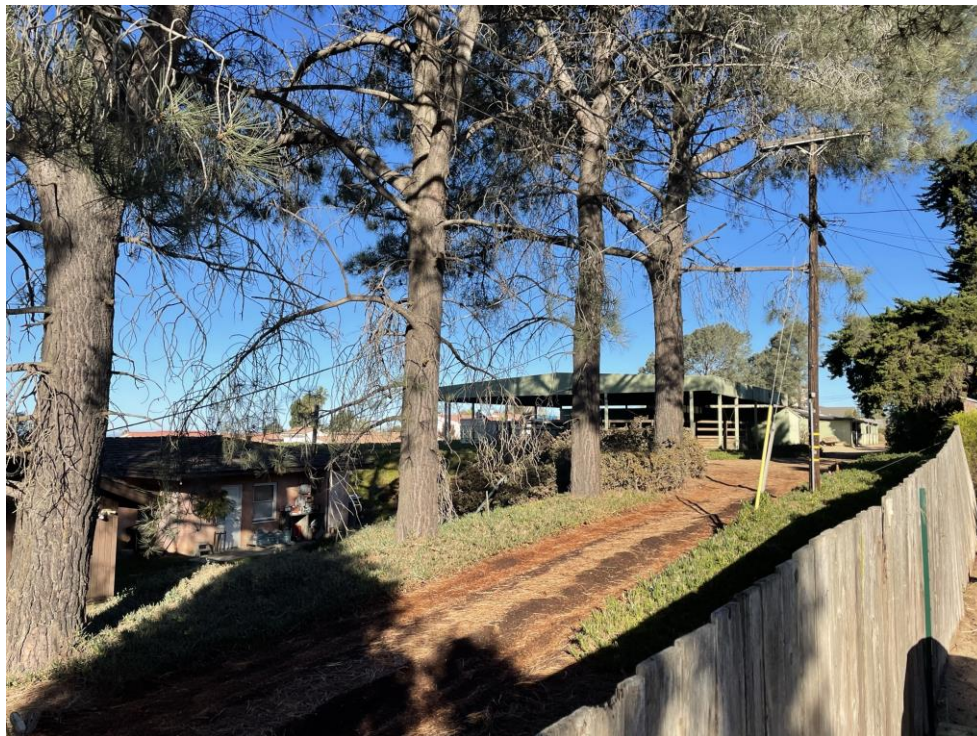
Photograph #20
View to the west of adjacent single-family residences and horse stable.
