CARDIFF AND ENCINITAS SEWER MASTER PLAN UPDATE

April 2011

The purpose of this Sewer Master Plan Update is to evaluate the City of Encinitas (City) existing and future sewer facility needs, make recommendations and prepare a preliminary opinion of probable cost for each of the proposed improvements. This Master Plan evaluates the condition and capacity of the major elements of the existing wastewater collection systems within both the Cardiff and Encinitas Sanitary Divisions, and makes recommendations for future system improvements.

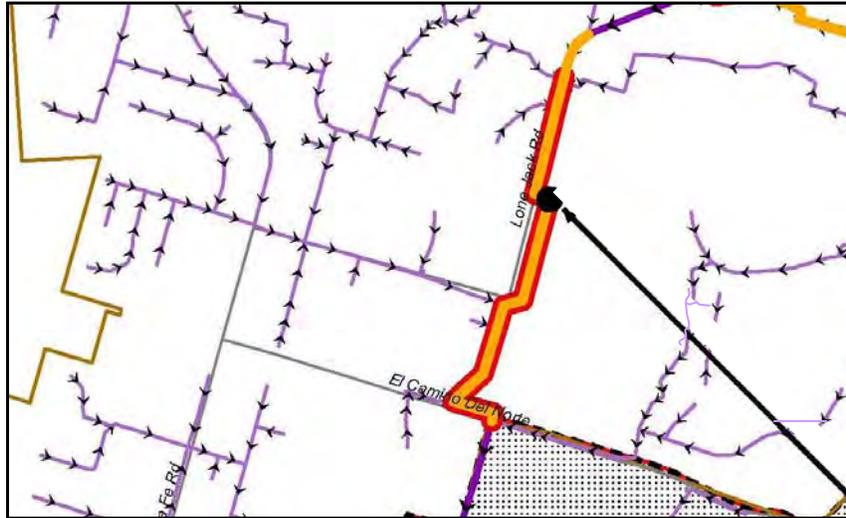
Figure 5-3 OTS 8" Diameter Surcharged Area – Ultimate PWWF

In the upstream (Reach 3) 8-inch diameter section, results from the ultimate PDWF analysis indicate that five reaches in the easement south of the bend in Lone Jack Road are flowing above 75 percent full, and two of these reaches are surcharged. Under the ultimate PWWF condition the entire length of the pipeline between El Camino Del Norte and Little Oaks Park is surcharged, as illustrated in Figure 5-3, and the model indicates flow loss (potential sanitary sewer overflow) at one manhole. Furthermore, flow monitoring during wet weather periods should be conducted to confirm the I&I assumptions this far upstream from the SEJPA meter.

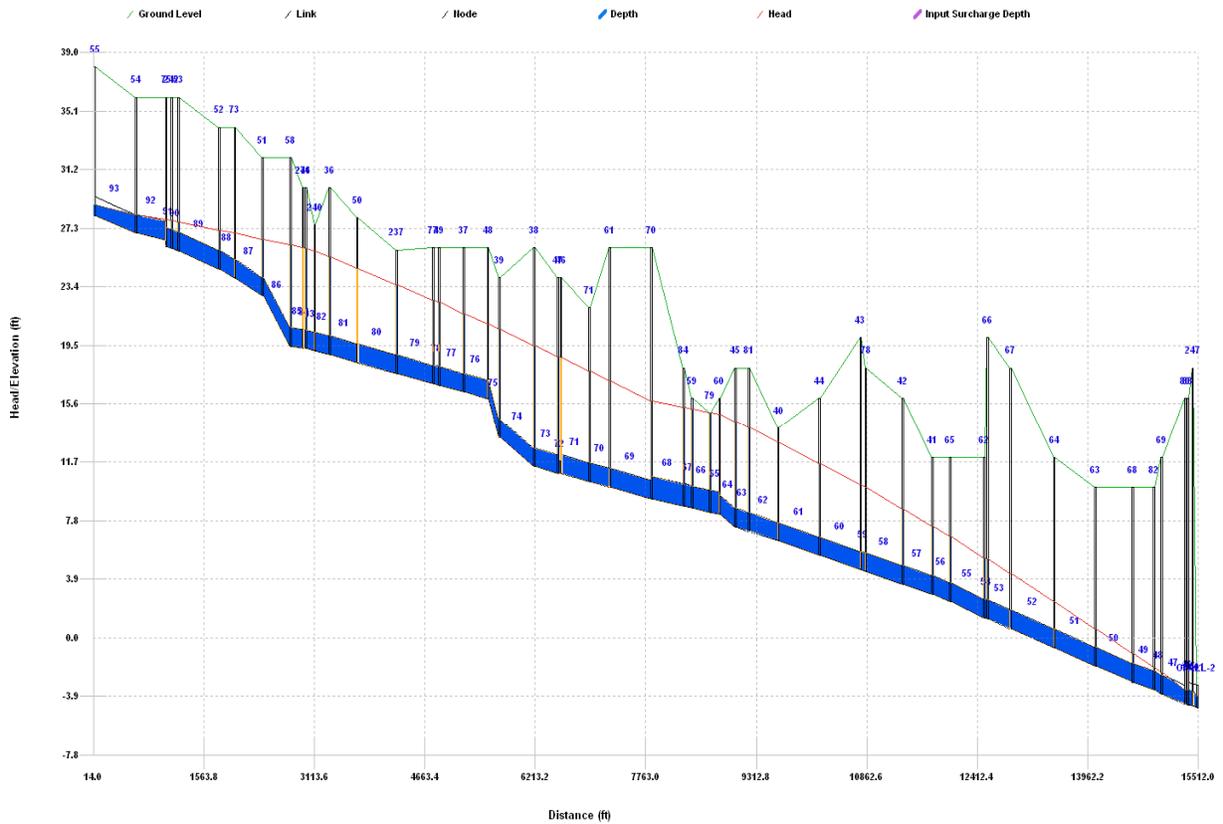
Figure 5-4 OTS Hydraulic Profile – Ultimate PWWF in Downstream Portion

Further downstream, the 15-inch diameter pipeline reaches between 5th Street and the OPS are surcharged under peak wet weather flow conditions. The ultimate flow analysis indicates that pipelines in this area remain less than 75 percent full with peak dry weather flows. However, significant surcharging occurs under the ultimate wet weather flow condition due to excessive I&I flows entering the trunk sewer and upstream collector pipelines. The hydraulic profile of the downstream surcharged areas of the OTS with peak wet weather flows is shown on Figure 5-4. A potential overflow location is indicated at the location where the red line representing the water “head” intersects with the green ground level line.

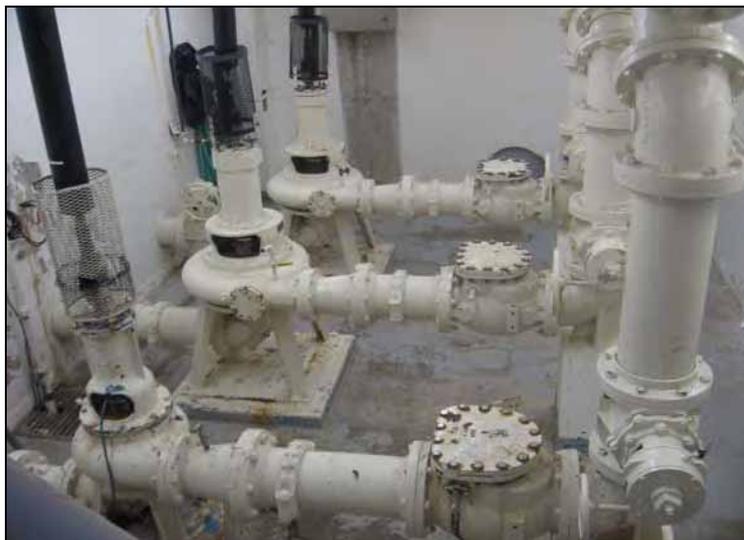
The Cardiff lift station design is similar to the Solana Beach lift station design. It was constructed in the 1980's, and has seen approximately 30 years of service. There are three vertical non-clog pumps that have extended drive shafts that connect to motors located on the upper floor. As originally constructed, the pumps used 230 volt power. The electrical system has subsequently been converted to 460 volt power. There are two 40 hp pumps and one 20 hp pump:

- The 40 hp pumps are Fairbanks-Morse Model B5414 (1100 rpm) non-clog pumps, rated 1,000 gpm at 45 feet TDH.
- The 20 hp pump is a Wemco Model E (1750 rpm) TorqueFlow pump, rated 900 gpm at 43 feet TDH.

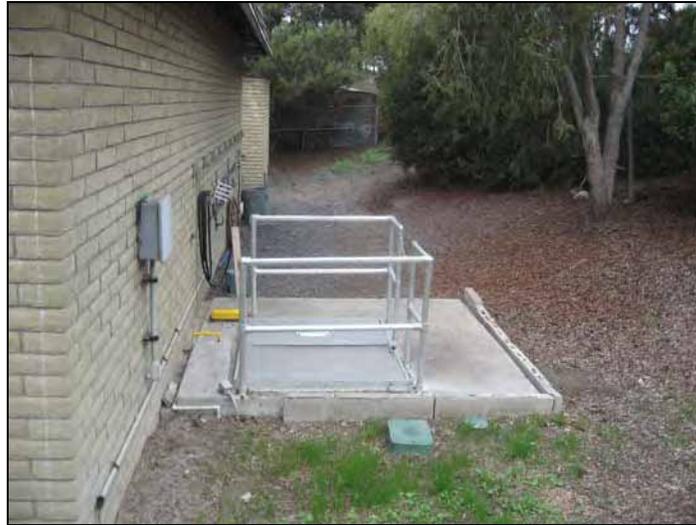
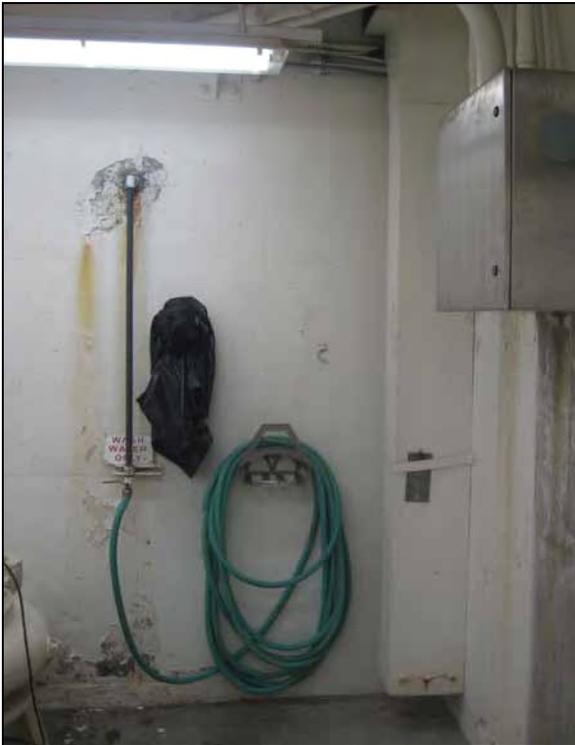
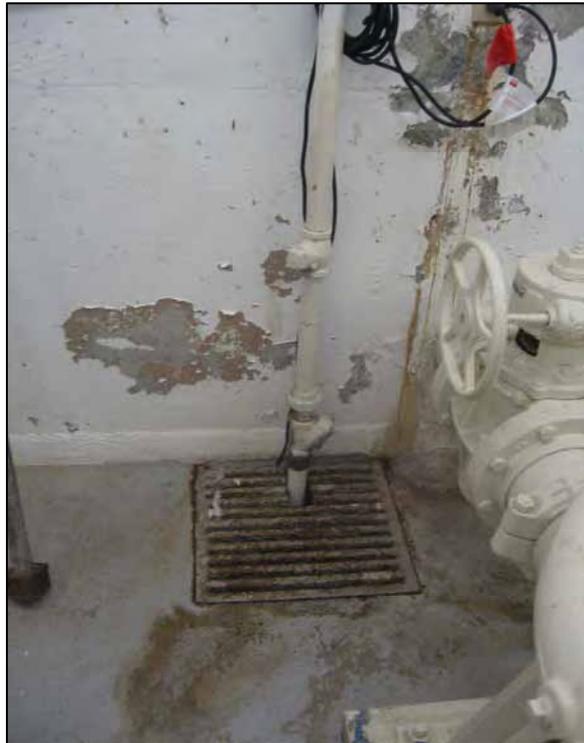
The Pump Room is subject to significant seepage through the concrete walls and by leaks at certain wall penetrations. A wall switch (ON/OFF switch for a fan) is wrapped in plastic to keep it from being damaged by flow that seeps through the walls.

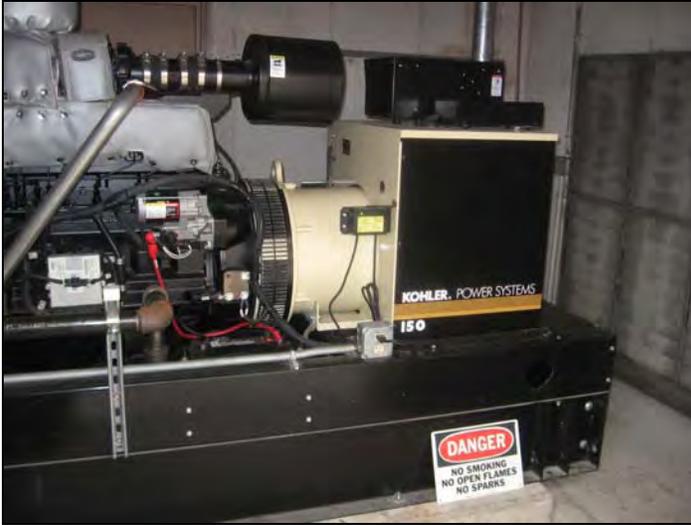
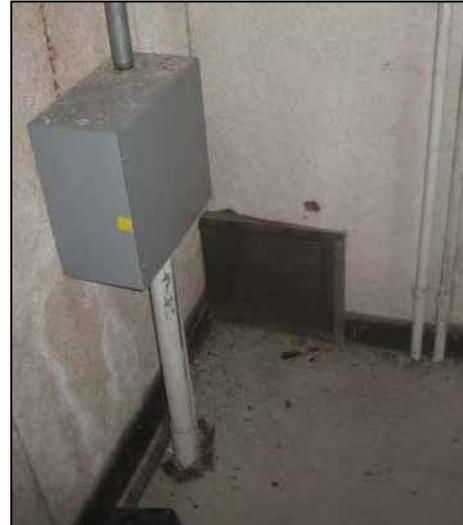
The standby power building is infested with rats that live in the space between the acoustic insulation and the inside face of the masonry walls. The rats are not only unsanitary, but they can damage the equipment and reduce its reliability to operate during periods of utility outage, by chewing on wires and creating open circuits.

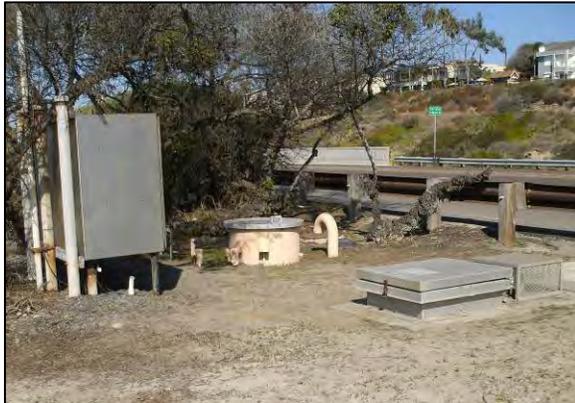
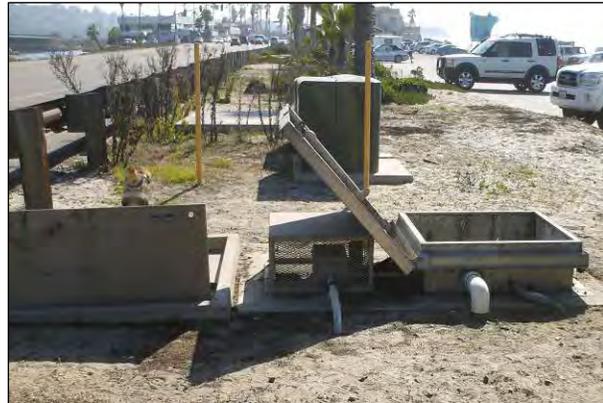
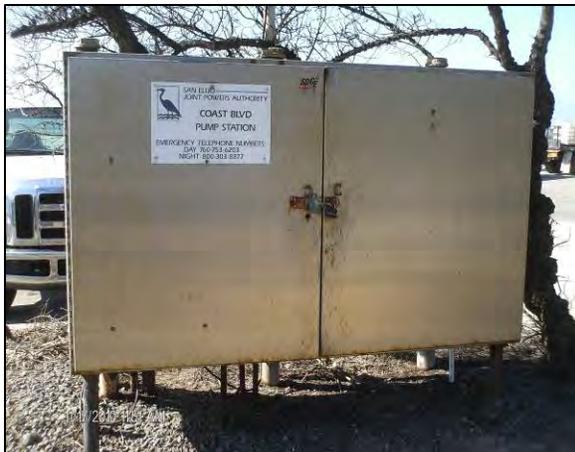
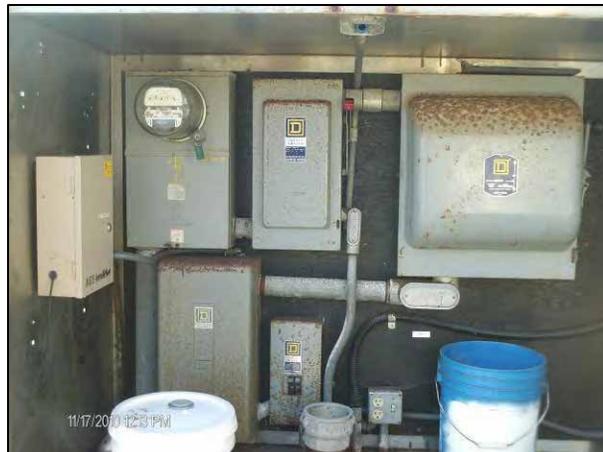
The Coast lift station was originally a suction lift pumping station. Two suction lift pumps were installed in a buried fabricated steel enclosure, with suction piping extending to a nearby concrete wet well. SEJPA Staff were having significant O&M problems with those suction lift pumps, so those pumps were removed. As replacement pumping units, two submersible sewage pumps were then installed in the concrete wet well. The wet well top slab was not modified at that time, which precluded the submersible pump guide rails from extending to the top of the wet well. Thus, when the submersible pumps are slid up the guide rails, they come off those rails several feet below the access hatch which makes it difficult to position the pumps over those rails for re-installation.

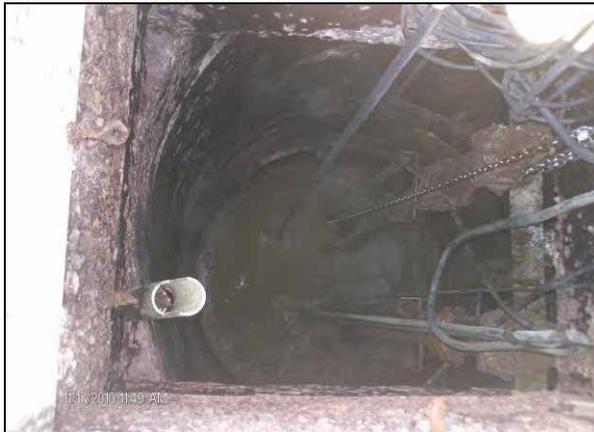
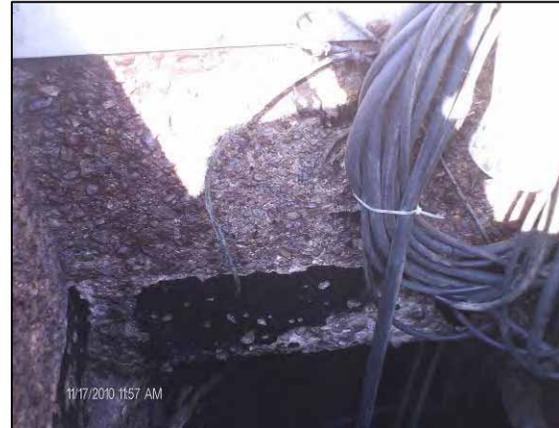
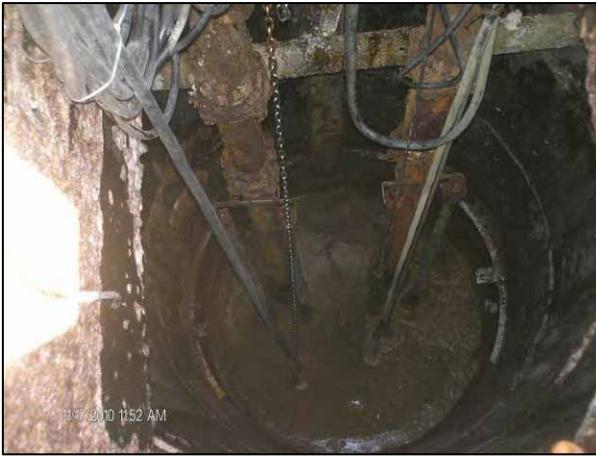
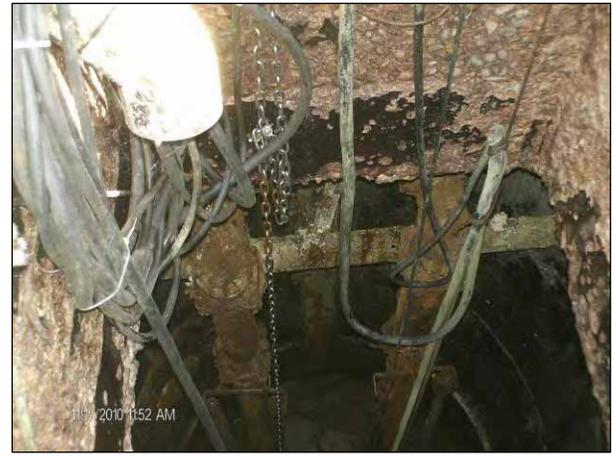
Without entry into the wetwell, it is difficult to observe the condition of the precast wet well “rings” that lie below the access hatch riser. However, it appears that there is deterioration at each of the joints between wet well rings. And it appears that some of the wet well coating remains, though much of that coating system is missing. The wet well would need to be emptied, cleaned, and then inspected up close to determine the condition of the precast concrete. Based on the observations made from ground level, it appears that the wet well rings can be repaired and re-coated for future service. The access hatch riser assembly would require extensive concrete rehabilitation and then re-coating. Or, it may be more cost effective to simply remove and replace the wet well access hatch risers and hatch.

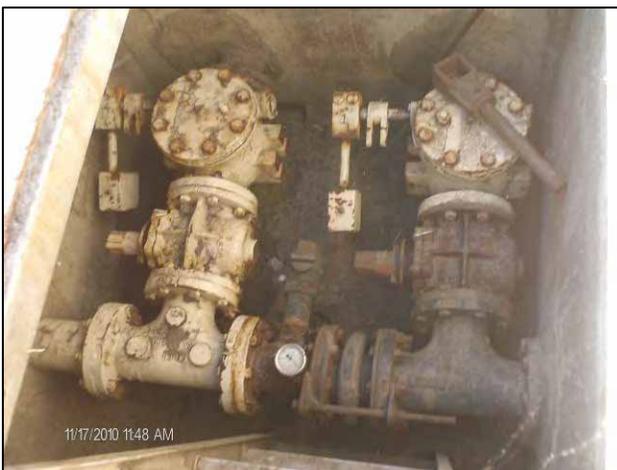
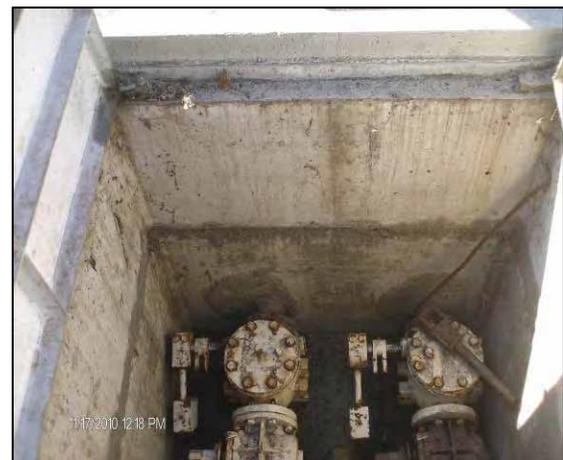
The ductile iron piping, fittings, and valving (check valve and shutoff valve) that are inside the valve vault immediately east of the wet well, are very old and corroded. Given the age of that equipment, their replacement is recommended. It may also be appropriate to replace the valve vault and access hatch.

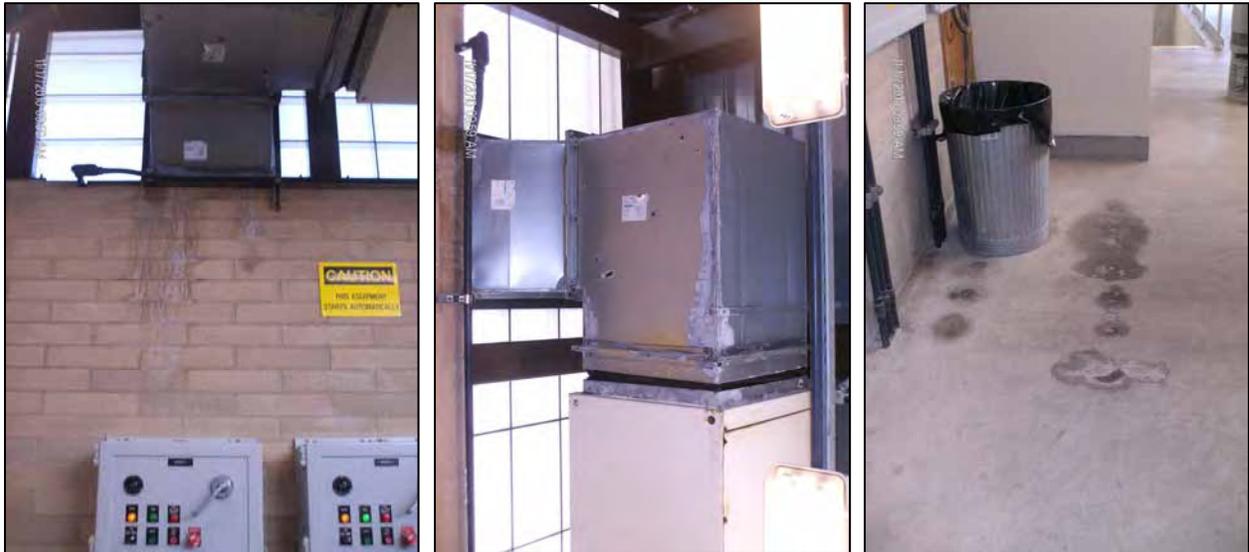
On the upper level along the north wall, there is a fan, ducting and other appurtenances associated the Supply Air system (for ventilation of the pump station dry well). Moisture can be observed dripping down from this ducting system, onto the floor below. This constant drip of moisture is not desired.

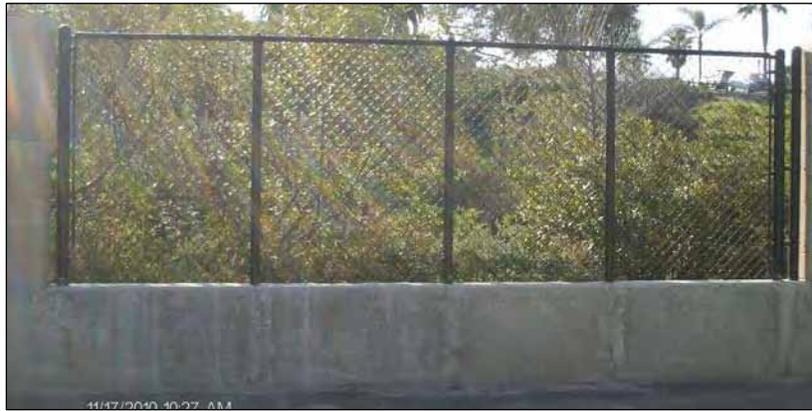
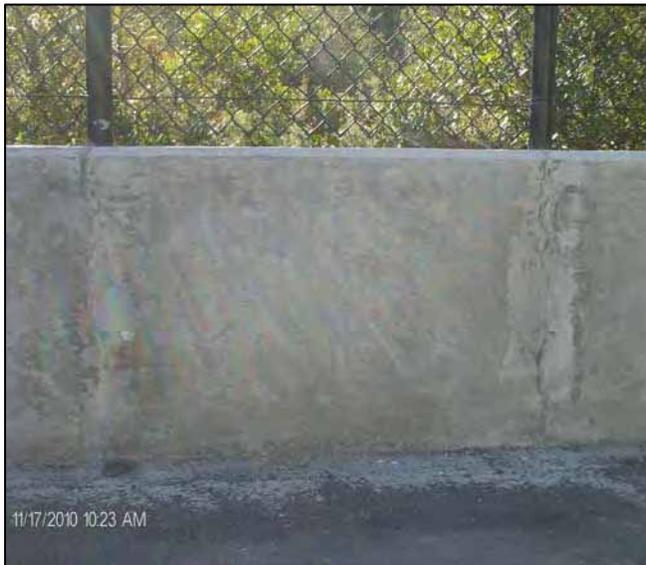
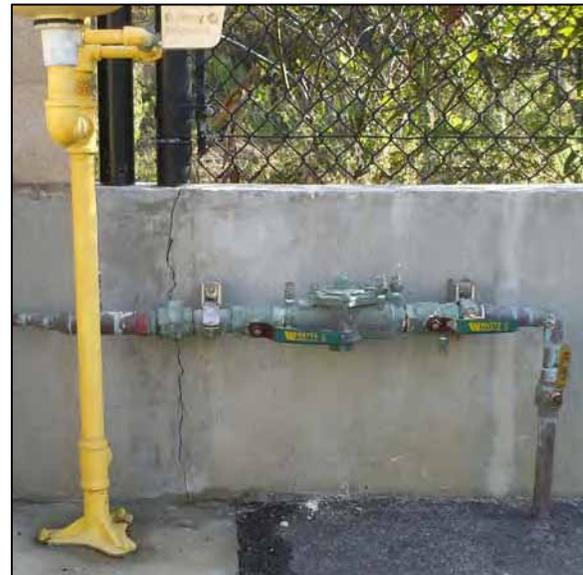
Site fencing is a combination of CMU wall and chainlink fencing. Where present, chainlink fencing is supported by steel posts that are embedded in the masonry wall below. At all locations for the embedded steel posts, the masonry wall is cracked. The wall design may not have properly accommodated the presence of those embedded fence posts. There is evidence that some of the wall cracks have been repaired, but those repairs are temporary at best.

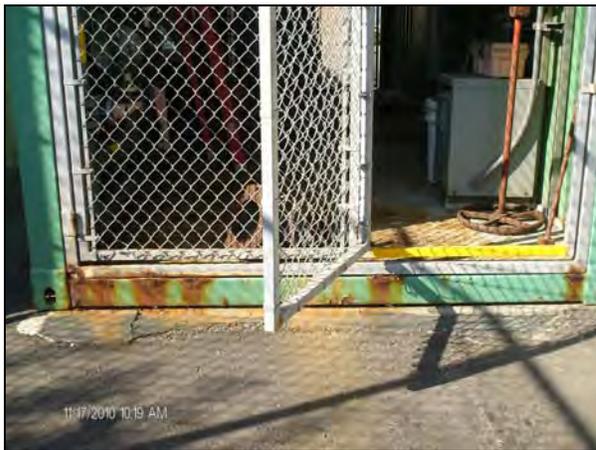
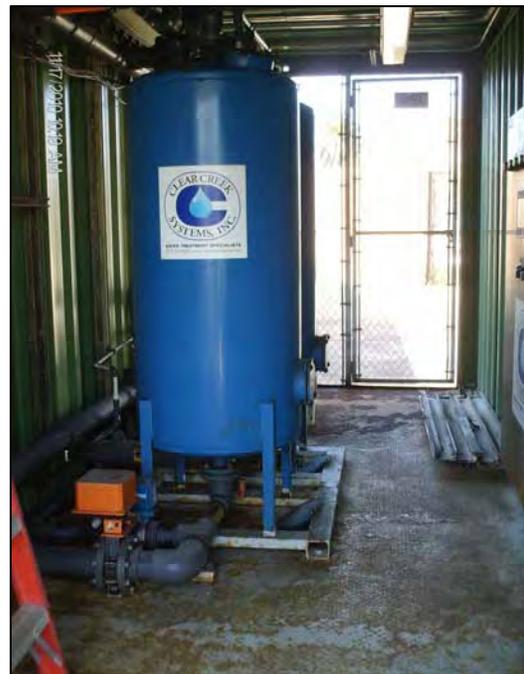
The lift station site facilities include the Urban Runoff Station (URS) which is housed in a modified metal shipping container that is located immediately south of the above-grade pump station building. This metal structure is open at both ends (the east and west ends). Chainlink fencing precludes entry at those ends, but this does not preclude moisture from entering that equipment space. The moisture damages or deteriorates certain equipment (or paper files) that are stored inside this structure. The metal structure has suffered significant deterioration from the weather and needs substantial rehabilitation or replacement with a more permanent structure.
