# City of Encinitas

## Level 3 Assessment of Blue Gum Tree

Near 751 2<sup>nd</sup> Street  
Asset I.D. # 5357TREE

SEPTEMBER 26, 2018

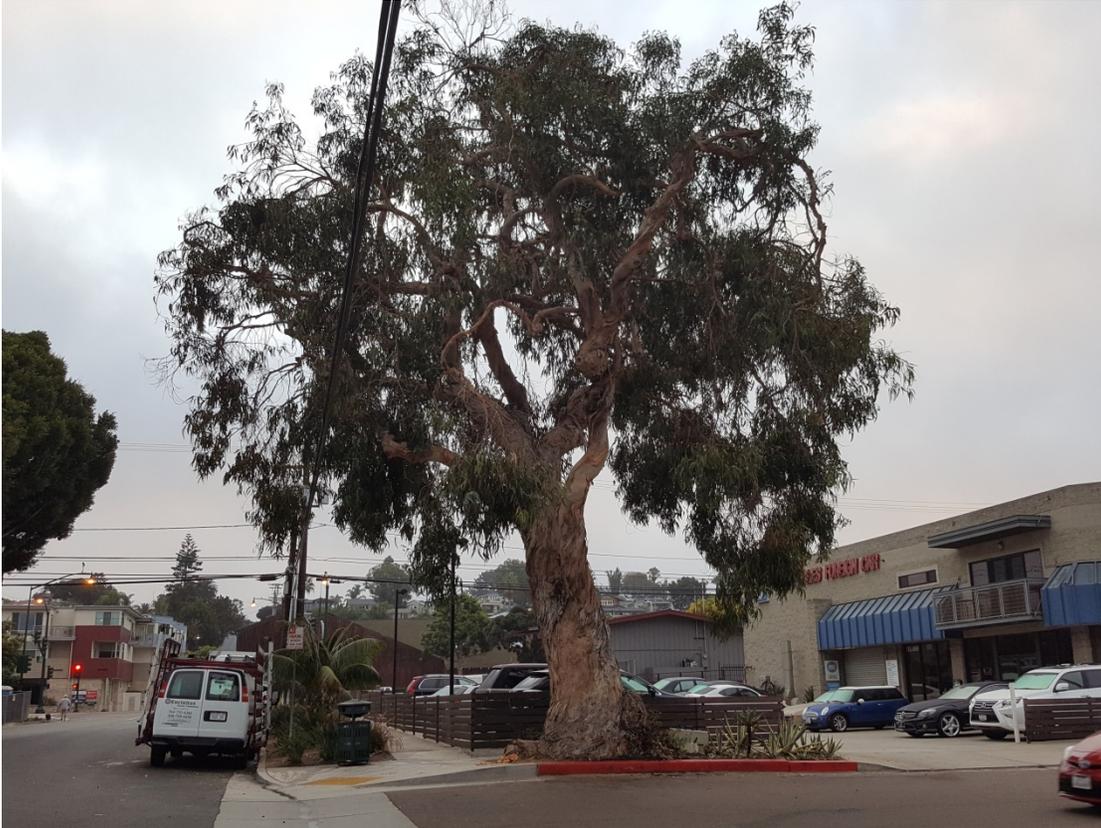
Photo #1

- The tree was located on the north- west corner of 751 2<sup>nd</sup> Street within a parkway.
- The tree had a DSH<sup>1</sup> measurement of 49 inches and a height of about 40 feet.
- Judging by the color and density of the foliage, the tree was in fair to good health for the species and time of year.
- The tree's canopy structure was fair, there were some defects such as a slight lean towards the north- east, some bark inclusions, and branches crossed over each other.
- Sounding wood for signs of decay was not very effective because of the large amount of exfoliating bark common on this species of Eucalyptus. Sounding around the root collar resulted in a dull resonance in several locations indicating some decay.

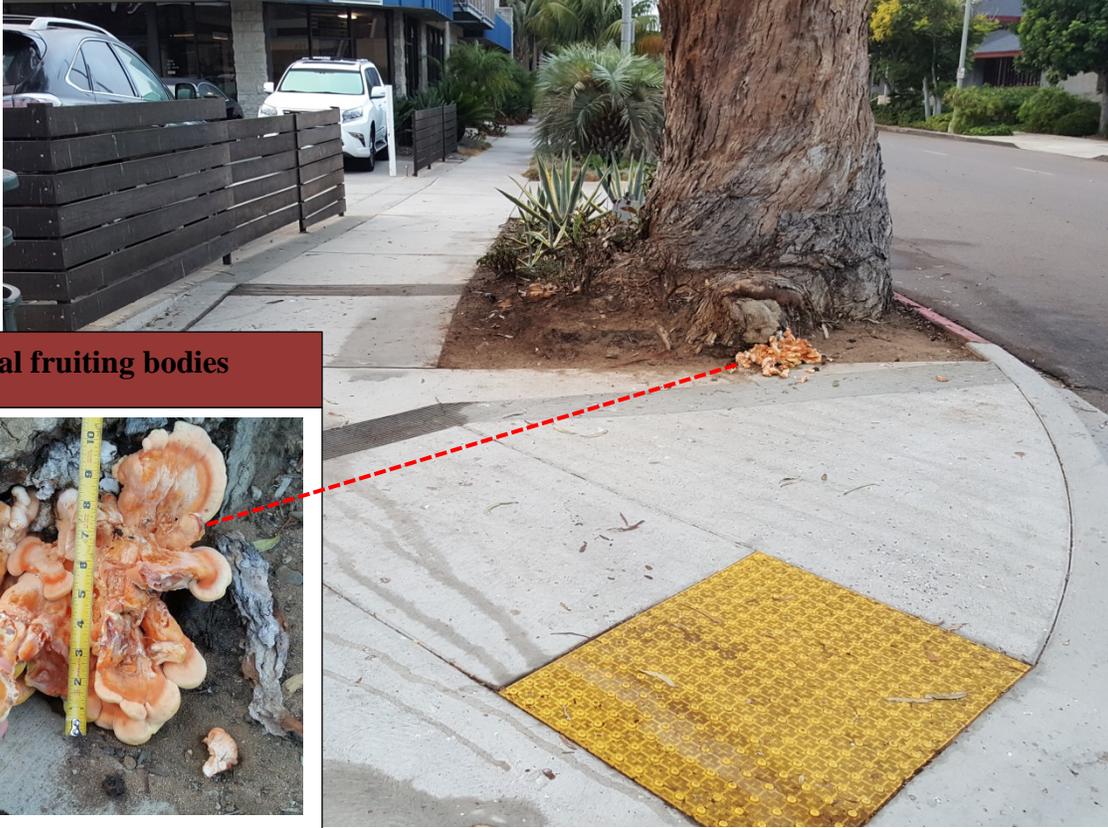
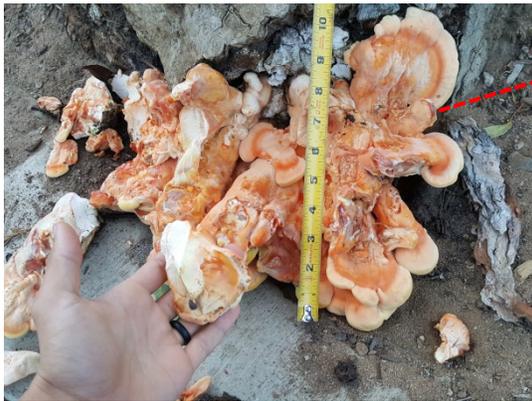
Photo #2

After completing the advanced trunk assessment, the defect of greatest concern was basal/ root decay. This is due to the large clusters of fungal fruiting bodies (likely *Laetiporus gilbertsonii*), evidence of asymmetrical basal/ root decay, a slight lean, and unknown root pruning history. *Laetiporus gilbertsonii* is a fairly aggressive parasitic brown rot fungi commonly found in mature Eucalyptus trees and it is known provoke unpredictable failures (e.g. tree falling over). In addition, this asymmetrical/ off-center decay is more prone to failures than a central decay with an intact shell of intact wood. The *likelihood of failure* because of basal/ root decay was assessed as **possible** within the next 2 years. This failure would most likely occur towards the north- east during a seasonal wind or storm event.

Close-up of fungal fruiting bodies

- There was a large fungal fruiting body resembling *Laetiporus gilbertsonii* on the north side of the tree near the base of the trunk surrounding a decaying wound. There were also remnants of what appeared to be more conks on the south-west side of the tree.
- The sidewalk adjacent to the tree had a light tone indicating it was likely replaced less than 10 years ago.

**Mitigation Pruning/ Monitoring** – Perform an overall crown reduction of approximately 20 percent (about 8 feet) through the use of **reduction pruning** and **removal pruning cut** techniques. This crown reduction should lessen the mechanical forces applied on the tree’s defects of concern and should achieve a reduction in risk to an overall low. For the remaining life of the tree, I would recommend maintaining the newly reduced canopy size and to have the tree periodically monitored for hazards and progression of decay. Adjustment of the irrigation to not spray the tree trunk should also be considered as this can expedite and facilitate wood decay.

**Removal** – Removal of the tree should be considered if the City does not view other mitigation options as fiscally reasonable for preservation of a tree with an incurable fungal disease that will continue to deteriorate its health and structure. This decision would completely eliminate the associated risks, and make space for a healthy new tree(s) to help beautify and diversify the City’s urban forest. You would also lose all the benefits this mature tree is currently providing.

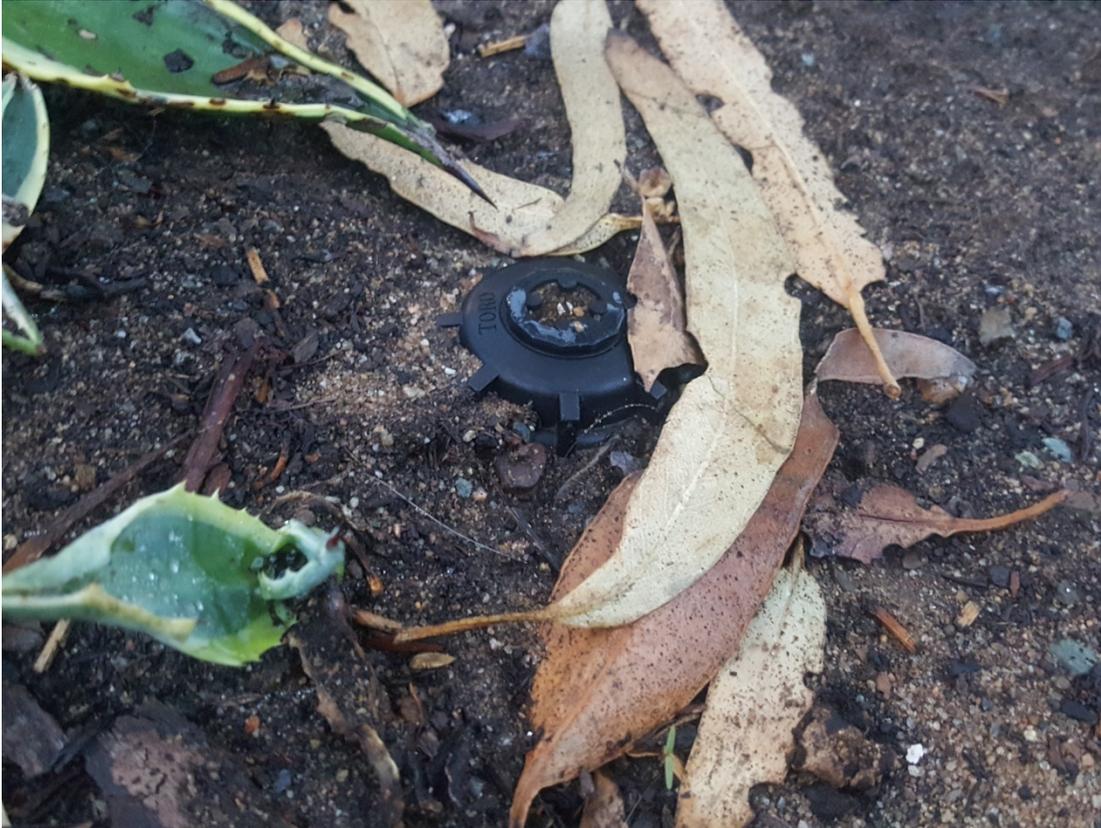
Photo #3

- There was some chewing damage observed on some of the foliage (likely Eucalyptus tortoise beetle).
- The planting area surrounding the tree was irrigated by sprinklers. The trunk of the tree appeared to be getting sprayed by water frequently.

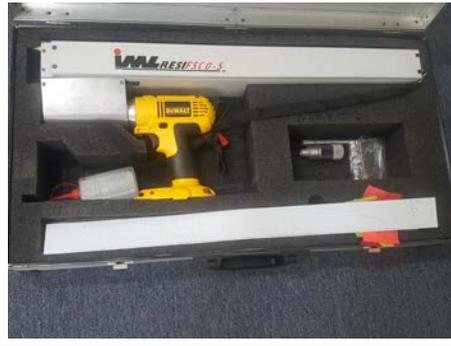
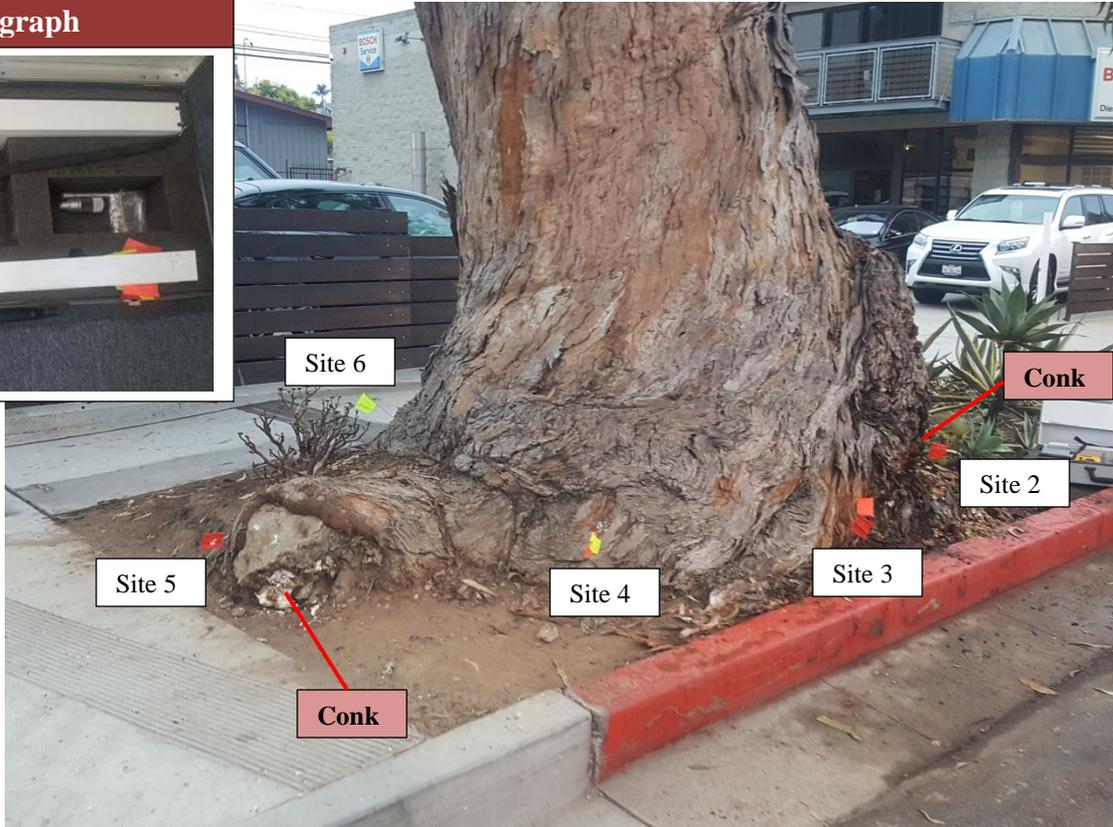
### Resistograph (test locations)

Shown above in the box to the left is a photo of the resistograph that was used to analyze the tree's basal area at about 8-10 inches above grade. This instrument uses a micro drill bit to measure wood resistance as it enters the tree. This data is translated into a graph to evaluate internal wood decay (see resistograph data and analysis on page 13- 15). The color of the flags correlates with the level of decay that was interpreted in the field.

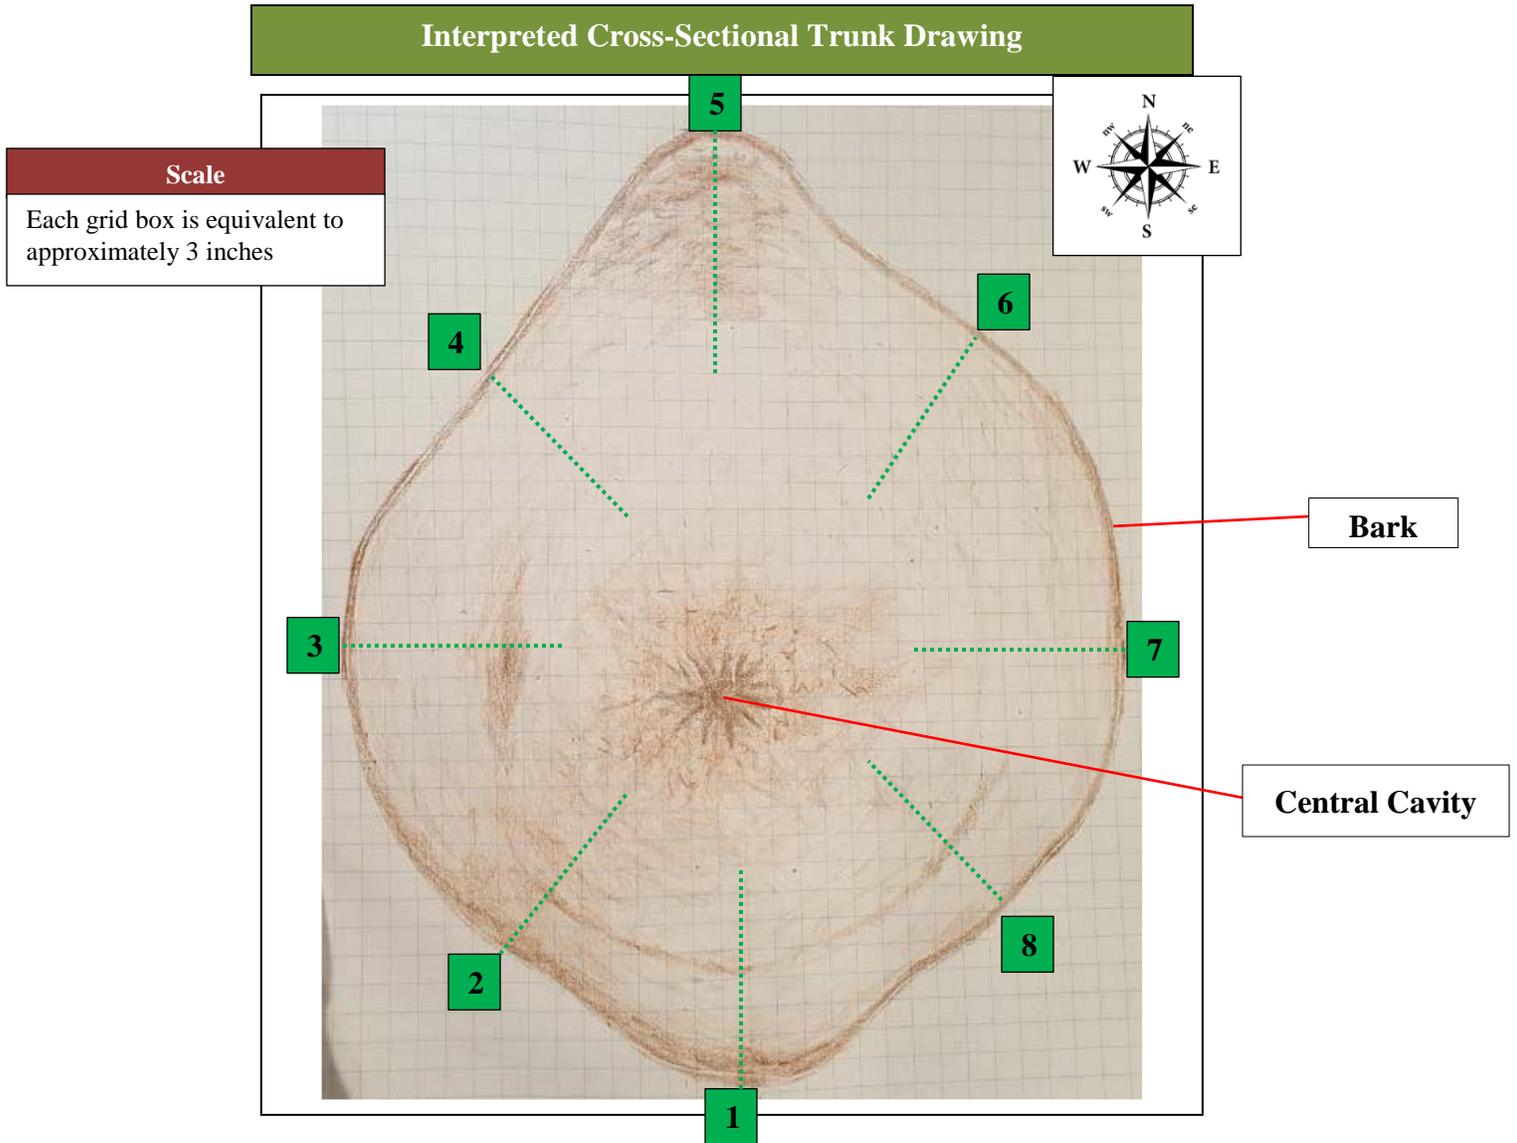
- Shown above is an interpreted cross-sectional trunk drawing at approximately 8 inches above grade with an approximate 260 inch circumference. Data from sonic tomography and the resistograph was used in combination to get a more realistic interpretation of the internal decay.

- 1-8 numbering in green refers to the individual resistograph or sonic tomography test locations and the green dotted lines indicate the approximate depth that the resistograph's drill bit entered the tree.

- In this graph, the shade of brown correlates with the level of internal decay that was interpreted. The darker the shade of brown, the more decayed the wood in that region.

- The data that was collected suggests that there is likely a central cavity surrounded by some significant decay, moderate to significant decay and exfoliating bark around the tree's outer 3 inches or so, moderate to significant decay near site 2 and 5 (where there was evidence of conks), and incipient decay scattered throughout.
