City of Encinitas

4.7.17 Assessment of Ficus Tree At 215 D Street (Front-1)

APRIL 7, 2017

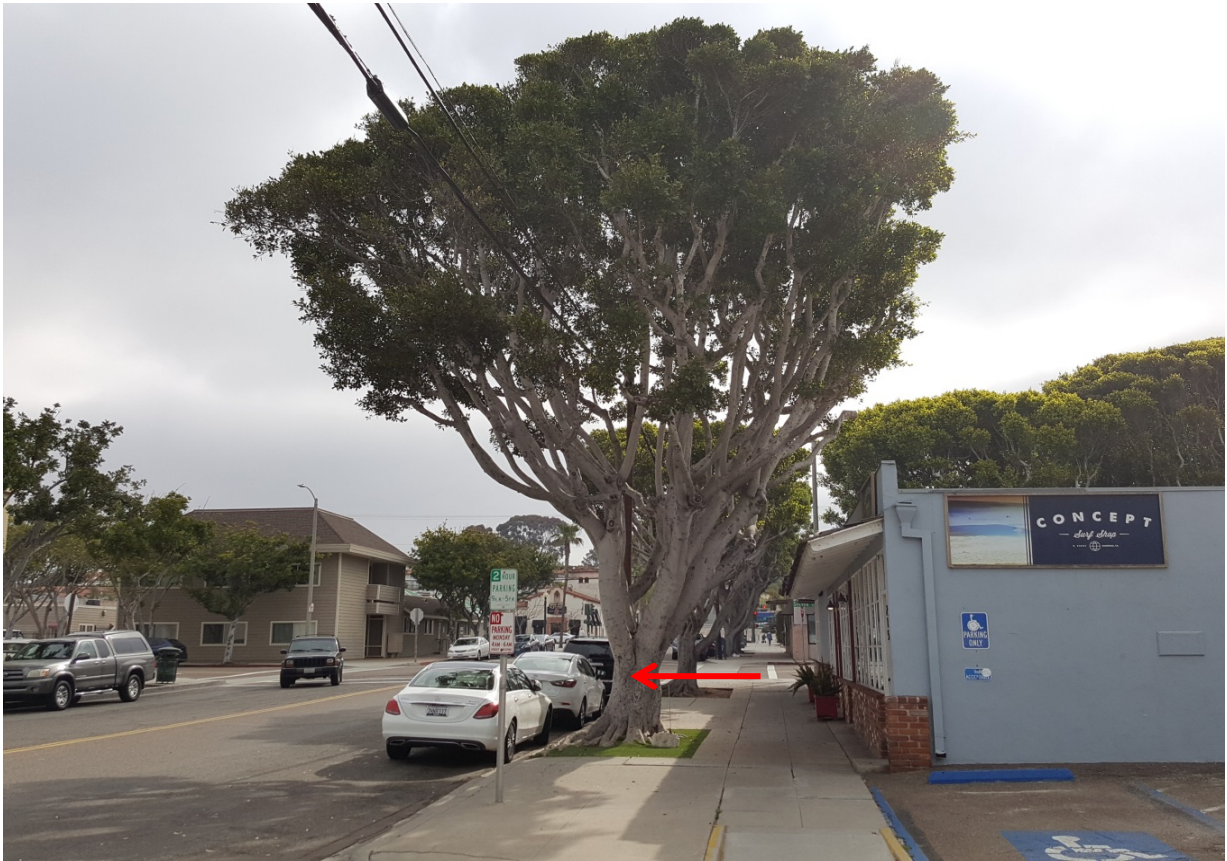
- The tree was growing in a tree well on the south side of D St. in front of the 143 business address (see Photo #1 in Appendix A).
- Judging by the color and density of the foliage, the tree appeared to be in fair health for the species and time of year. The tree had a moderate **live crown ratio** of approximately 50% which is common for street trees necessitating raised crowns for vehicle and building clearance (see Photo #1 in Appendix A).

- The tree had a DSH² measurement of 31 inches and a height of about 40 feet (measured with a TruPulse laser).
- The tree had multiple codominant stems and overextended scaffold branches which are indicative of poor structure yet fairly common among this species (see Photo #1 in Appendix A).

- There were powerlines running through the trees' canopy (see Photo #1 in Appendix A).
- Some of the stems and scaffold branches had presence of included bark as well as a small debris cavity between the branch unions (see Photo #2 in Appendix A).

- The tree (red arrow) was growing in a tree well on the south side of D St. in front of the 143 business address.
- Judging by the color and density of the foliage, the tree appeared to be in fair health for the species and time of year. The tree had a moderate **live crown ratio** of approximately 50% which is common for street trees necessitating raised crowns for vehicle and building clearance.
- The tree had multiple codominant stems and overextended scaffold branches which are indicative of poor structure yet fairly common among this species.
- There were powerlines running through the trees' canopy.

Risk and Mitigation – After performing a **Level 2 Basic Assessment**⁴, the subject tree was assessed to have an overall moderate risk rating. In regards to mitigating these risks, I recommend applying and maintaining an approximate 20% overall crown reduction (retaining interior growth) with the structure and canopy balance of the tree in mind (see Appendix B and Figure 3 below). This recommended pruning should be done in compliance to ANSI A300 Arboricultural Standards and will need to be applied over multiple spaced out pruning doses to minimize health impacts on the tree. This is also done to allow time for interior growth to further develop and broaden the options for new branches to prune back to. Pruning techniques such as **reduction pruning**, and **removal pruning cuts** should be used (not topping) to achieve this overall squattier appearance and are further explained in Appendix B. The end outcome should be a reduction of **mechanical stress** from overextended loads. A residual risk of “Low” should be achieved after implementing these recommended pruning strategies. It is with the health and safety of the community that I present these recommendations.

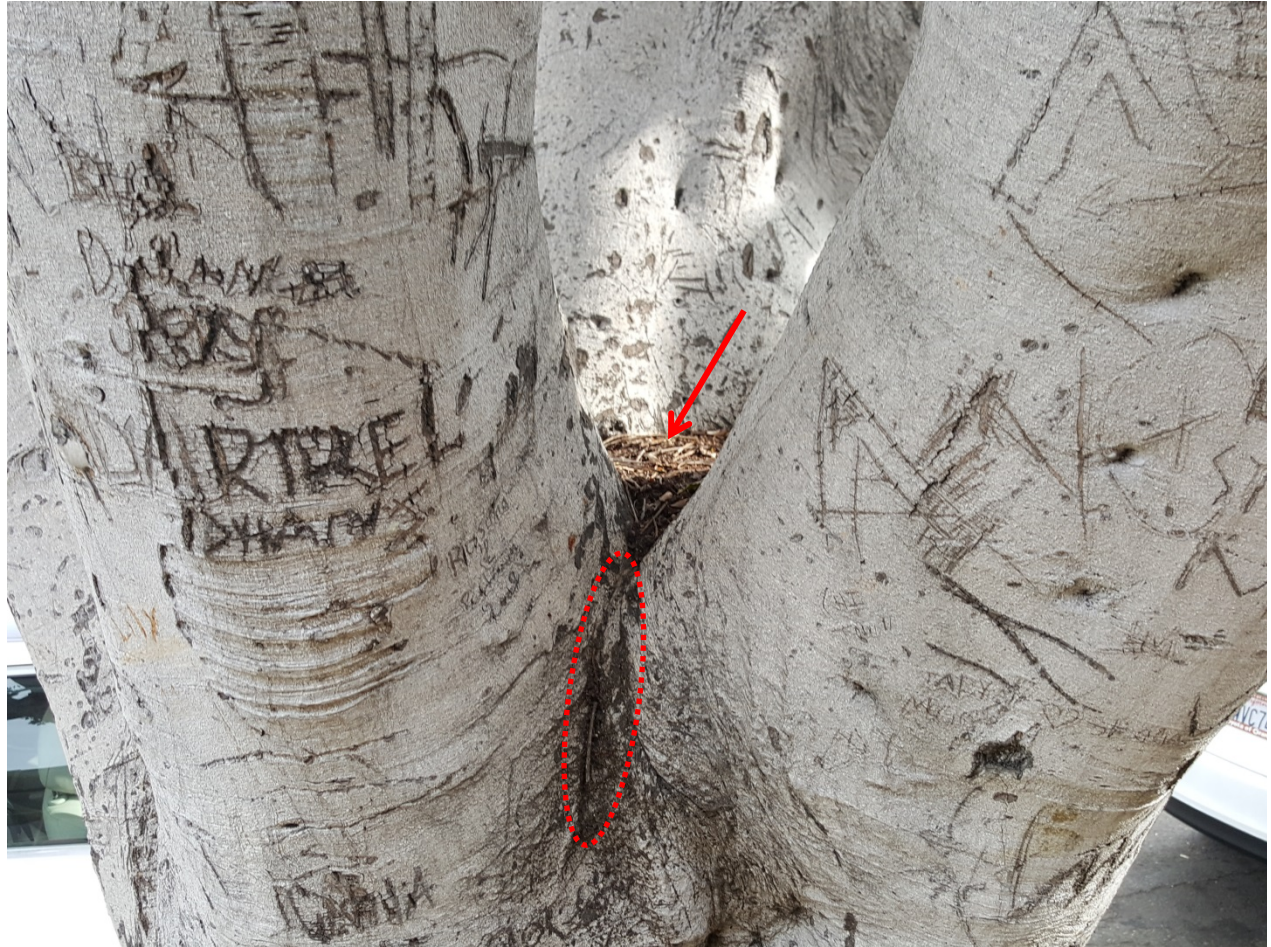
Photo #2

The defect of greatest concern for the subject tree was the overextended stems/ scaffold branches with included bark. The *likelihood of this failure* within the next year was assessed as **possible** for the subject tree. Failure events would be most likely to occur during abnormal or extreme weather conditions.

- Some of the stems and scaffold branches had presence of included bark (red dotted oval) as well as a shallow debris cavity between the branch unions (red arrow).

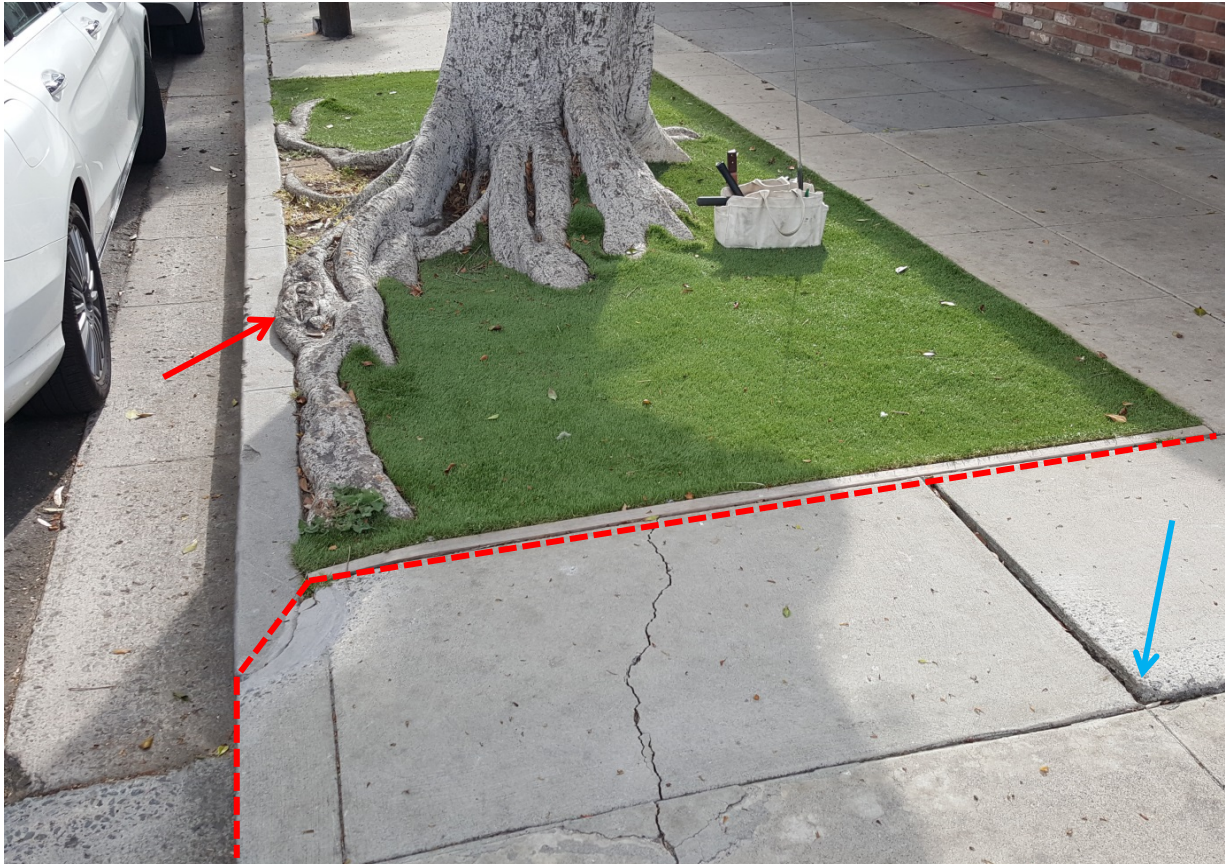
- Judging by the lighter tone of concrete, it appeared that a large area of sidewalk had been replaced around the tree (see Photo #3 in Appendix A).
- There appeared to be some cracking and sidewalk deflections surrounding the tree (see Photo #3 in Appendix A).

- Some of the buttress roots were showing a **contact stress response** to growing next to the curb face. This phenomenon occurs when trees grow in close contact with infrastructure. Trunk and root tissues mold, and grow over the infrastructure element providing a level of structural support. There may be an increase in failure potential if the infrastructure element is removed or replaced. There also appeared to be some older damage to the living tissues on the top of the root (see Photo #3 in Appendix A).
- Vehicles appeared to use this area of 2nd Street frequently throughout the day.

- Judging by the lighter tone of concrete, it appeared that a large area of sidewalk had been replaced around the tree (see **red dotted area**).
- There appeared to be some cracking and sidewalk deflections surrounding the tree (**blue arrow**).
- Some of the buttress roots were showing a **contact stress response** to growing next to the curb face (see **red arrow**). This phenomenon occurs when trees grow in close contact with infrastructure. Trunk and root tissues mold, and grow over the infrastructure element providing a level of structural support. There may be an increase in failure potential if the infrastructure element is removed or replaced. There also appeared to be some older damage to the living tissues on the top of the root.
