**ORANGE COUNTY RAIL-HIGHWAY
GRADE CROSSING SAFETY ENHANCEMENT PROGRAM
SAN CLEMENTE AUDIBLE WARNING SYSTEM STUDY
TECHNICAL MEMORANDUM**

**Parsons Brinckerhoff
505 South Main Street, Suite 900
Orange, CA 92868**

**Orange County Transportation Authority
550 South Main Street
Orange, CA 92868**

June 28, 2011

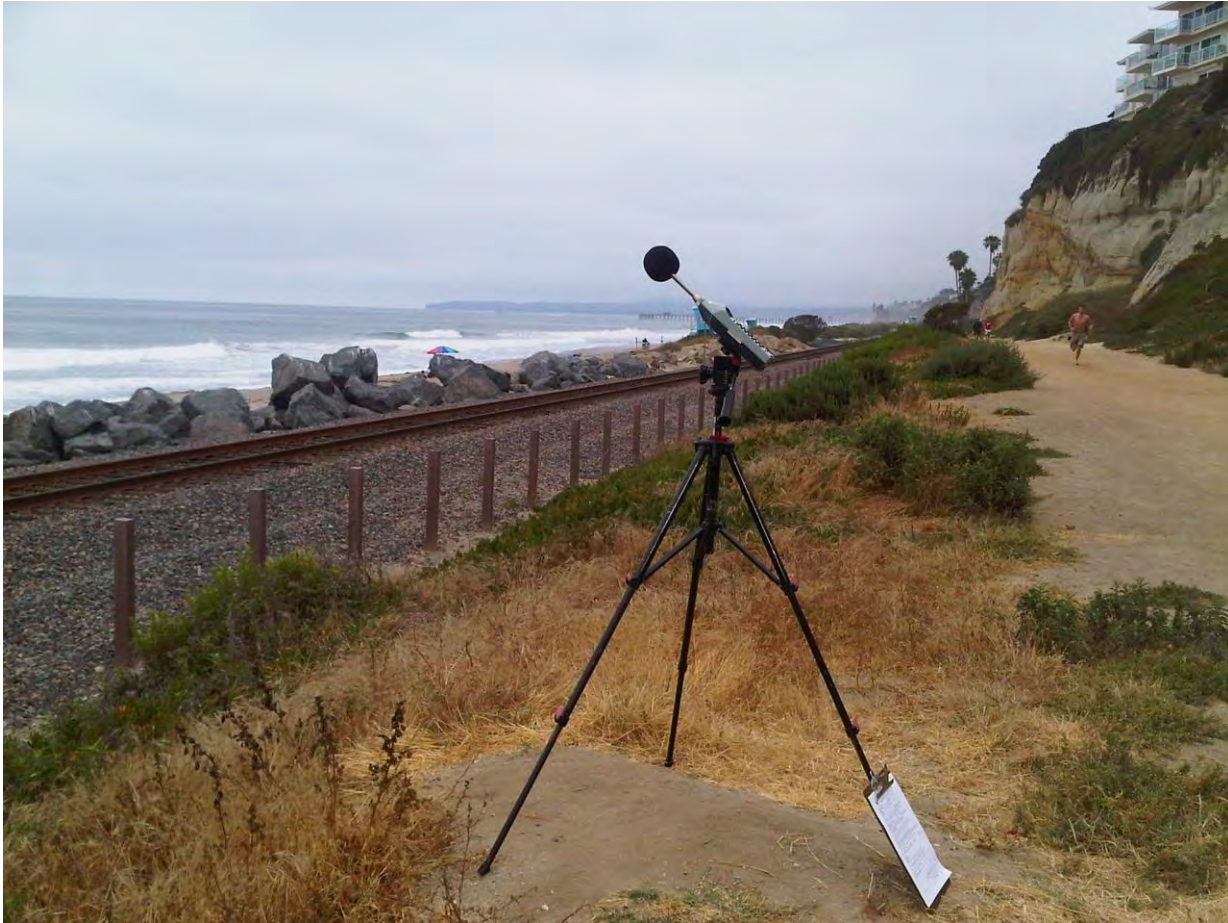
Photo 5—1. View of SCBT Approximately 265 feet Northerly of the Calafia Beach Crossing (during surf noise measurement).

The SCBT is 2.3 miles long, connecting North Beach to Calafia Beach portions of the City's picturesque coastline. The SCBT is about ten feet wide and is constructed of stabilized decomposed granite except for occasional concrete steps near the actual crossings of the railroad tracks. Although most of the SCBT is sandwiched between railroad tracks and residential development perched atop steep bluffs, the SCBT is very natural in ambience and appearance as shown in Photo 5-1, below, looking northerly from the Calafia Beach trail head.

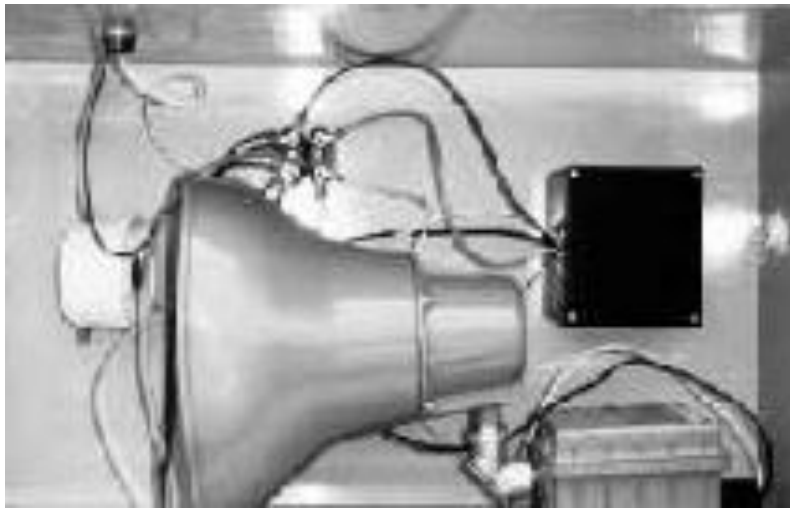
Photo 7—1. Early Version of Automated Horn

As part of the development of the Rule, the Volpe investigators measured traditional train horns and earlier versions of “automated horns” that evolved into the current WH, the sound level of which is defined by the present federal Rule. A typical early version experimental horn is pictured below in Photo 7-1 from the FRA Research Results document. At peak sound levels, a typical automated horn at the same distance was approximately 13 dB quieter than the locomotive-mounted train horn. The lower sound level of the automated horn compared to the train horn was a significant factor in explaining why the automated horn was perceived as less annoying than the train horn during testing and observations. Unlike the actual train horn, the automated horn did not meet the minimum sound level required of train horns by the Rule. For WH systems in operation, and the newer WH systems tested, the frequency distribution of the wayside horn signal was similar but not identical to the train horns measured in the study. For the 14 sites where sound measurements were collected, the WH had a negative community impact only during nighttime hours (Multer Rapoza 1998).

The train horns tested contained a broader band of acoustic signal (i.e., more frequencies) that is more difficult to mask than the signal produced by the early automated horns. Rapoza and Rickley (1995), using acoustical data, determined that an automated horn with a single tone and a maximum sound level of 87 dBA would be less detectable inside a moving motor vehicle than the Nathan 5 chime and Leslie 3 chime train horns that predominate on most locomotives today. The motorists could detect the audible warning up to 400 feet from the grade crossing when the car was stopped and idling. However, in a moving car in which the background noise level was in the 55-65 dBA range, the motorist would fail to detect the automated horn in time to stop before arriving at the grade crossing.

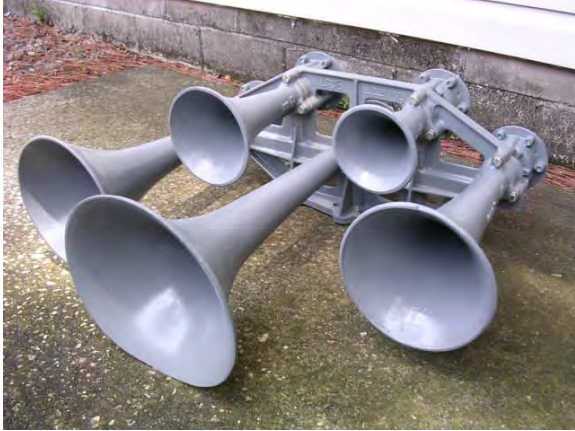
Photo 7—2. Leslie S5T Five-Chime Train Horn

Typical five-chime and three-chime horns that are mounted on the locomotive or lead car of heavy-rail trains may be seen in Photos 7-2, 7-3 and 7-4, below. Photo 7-5 shows a typical stand-alone pole-mounted WH with control box. Sometimes the WH is incorporated on other crossing-related structures.

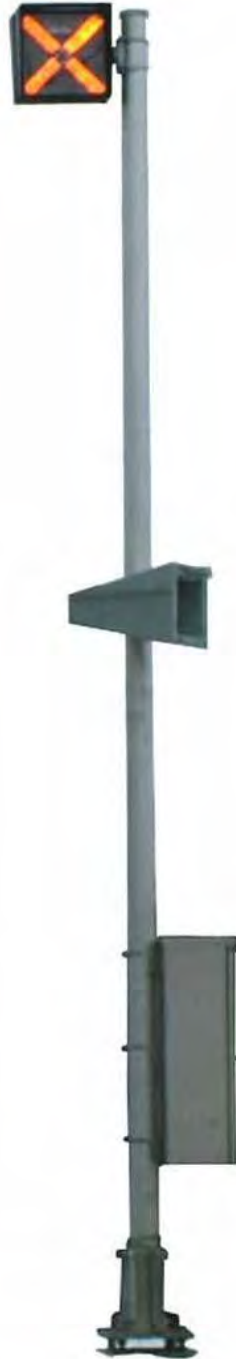
Photo 7—5. A Typical WH from Railroad Controls, Limited

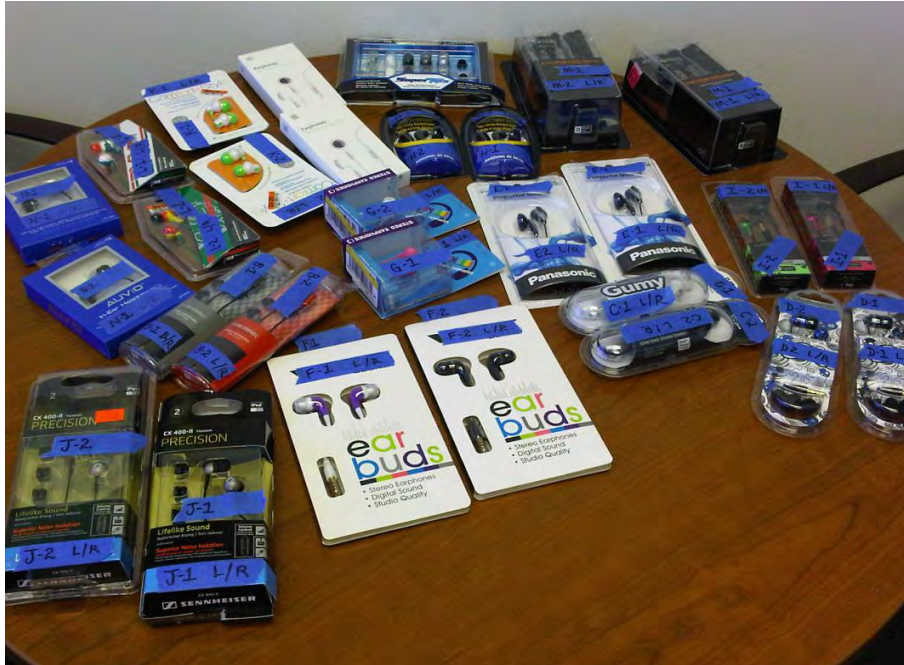
Photo 9—1. Identical Pairs of Earbud Samples Marked and Ready for Delivery to Test Facility

The retail price of a pair of stereo earbuds ranges from \$1.99 to over \$450.00. The earbuds that cost \$75 to \$100.00 are approaching "audiophile" or high quality and are only occasionally considered for recreational use. Earbuds that cost over \$100.00 are generally considered "audiophile" or very- high-end quality and would rarely, if at all, be considered for recreational use such as jogging due to potential damage from perspiration, dropping, dirt, etc. Thus, a range of earbuds was selected for testing that cost between \$2.50 and \$100.00. Photo 9-1, below, shows many of the earbuds that were obtained for testing.

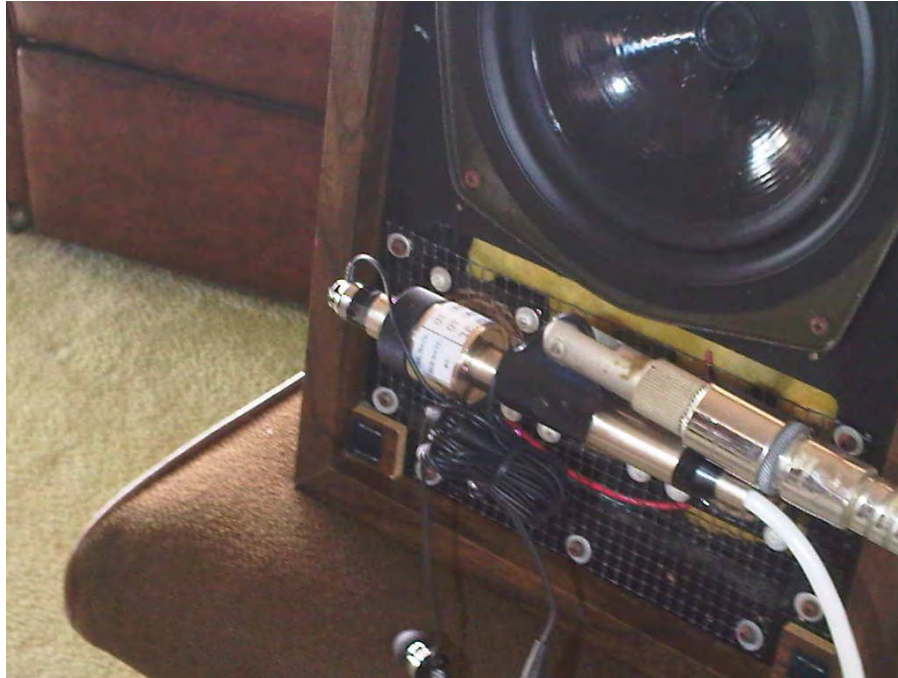
The test consisted of blasting random noise containing many frequencies from a loudspeaker toward the test fixture. Sound levels were measured and noted without and with an earbud present to determine the sound attenuation performance of each earbud under test.

Photo 9—2. Earbud Inserted into Ear Simulator In Front of Excitation Source

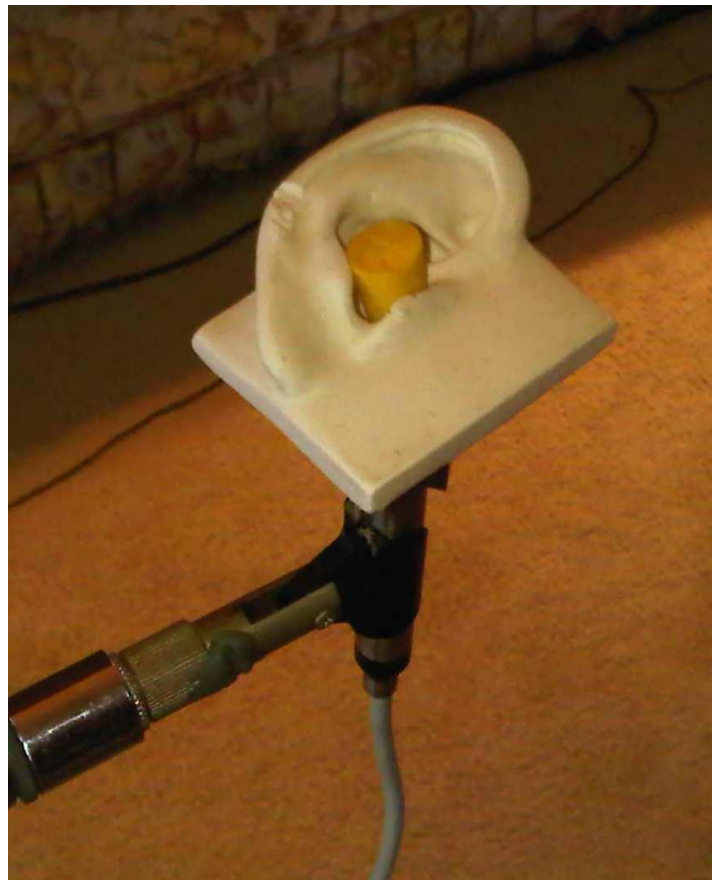
Photo 9—3. Close up of KEMAR Rubber Pinna Used for Testing the Loose Fit, Flat-faced Concha Type Earbuds. Shown with EAR® Insert Hearing Protector Tested as a Control

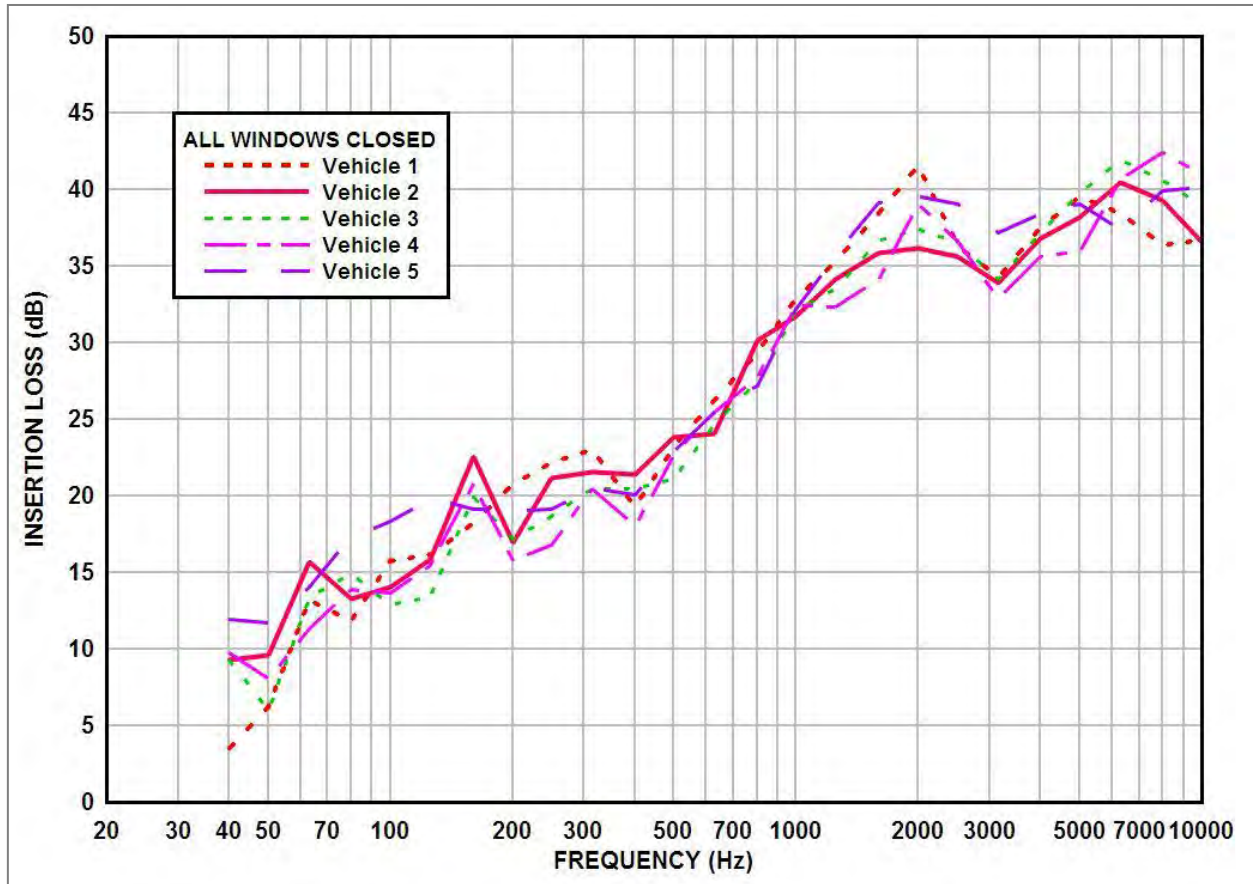
Figure 12—2. Measured Insertion Loss Spectra for five 2005 Test Vehicles⁶.

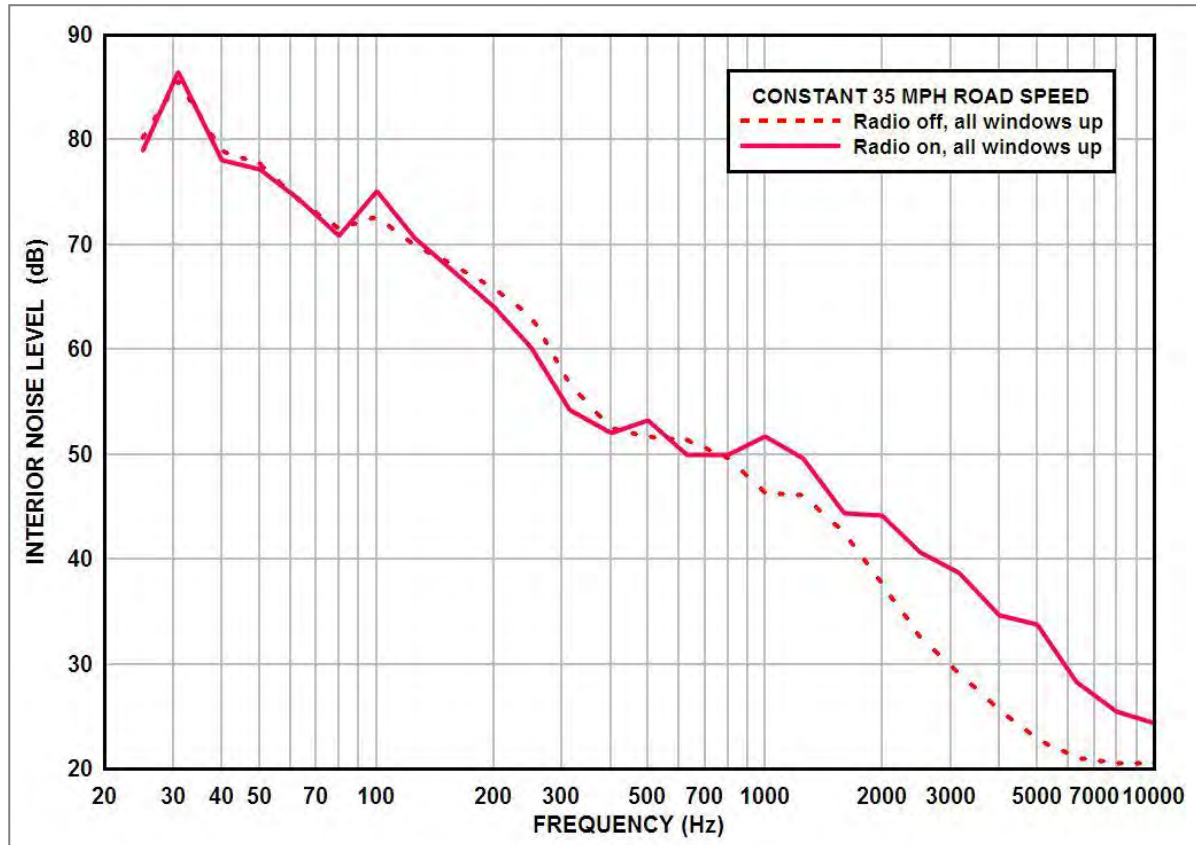
Figure 12—3. Vehicle Interior Background Noise Levels, 35 mph for five 2005 test vehicles⁷.

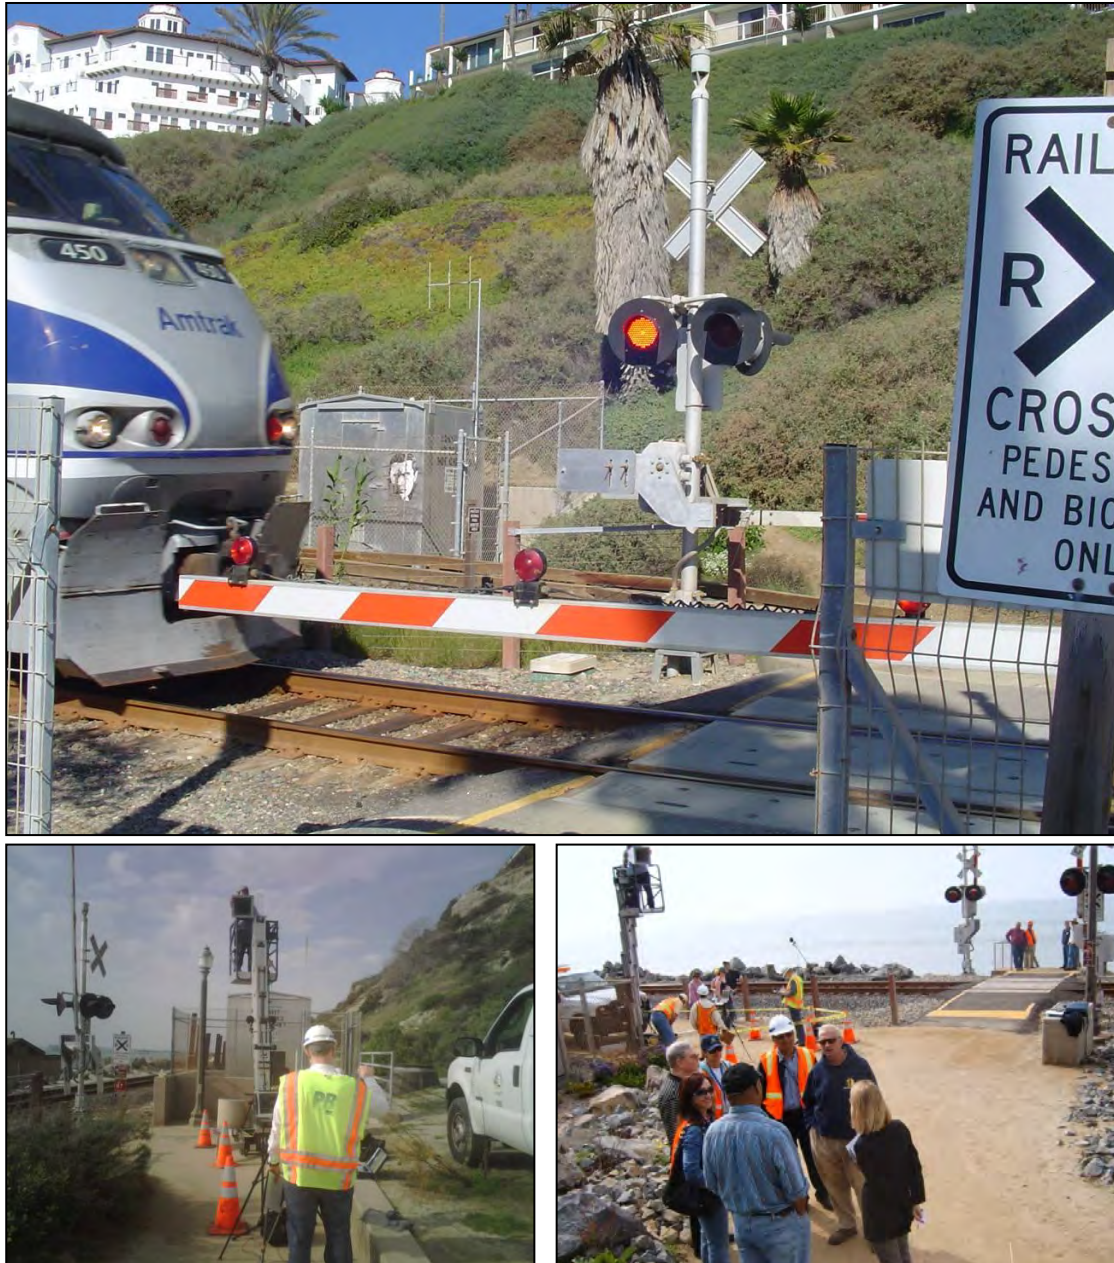
In addition to sounding of train horns, existing safety features include fencing to direct pedestrians-bicycles to legal crossings, informational and warning signs of various sorts, and two each of the standard pole-mounted cross-buck, automated gate arm with flashing gate arm lights, two alternating flashing lights, and electronic crossing bells. Photo triplet 13-2, below shows some of these features.

Photo Triplet 13—2. Safety Features of Typical SCBT/Railroad Crossing Locations.

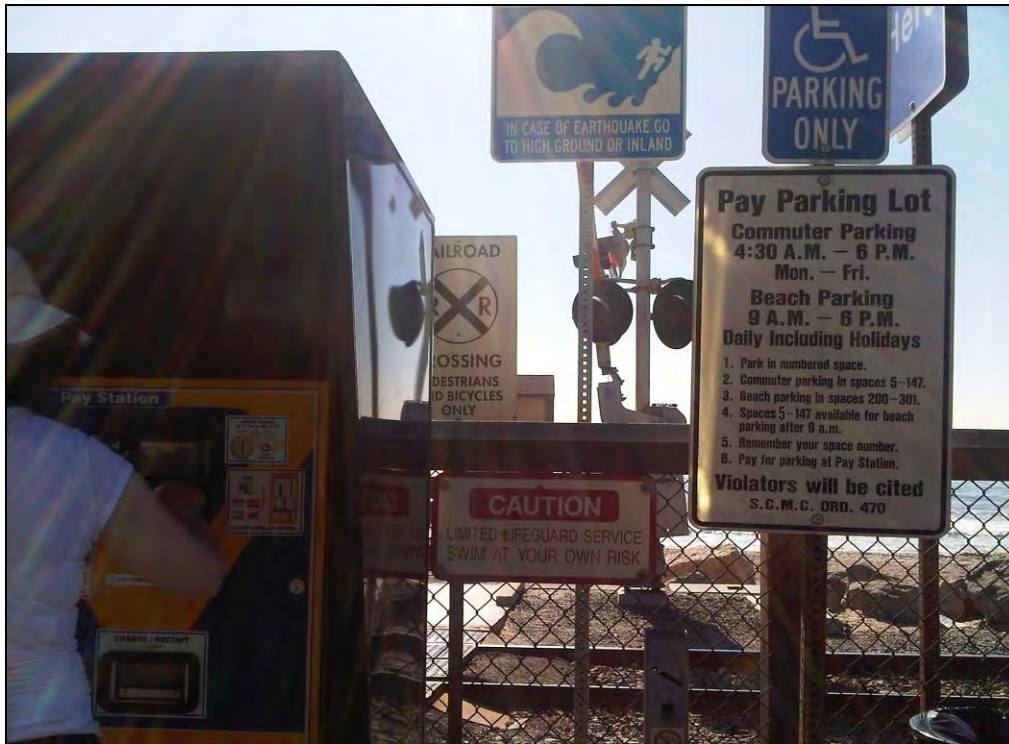
Photo 13—3. Sign Overload at the Threshold of a Crossing.

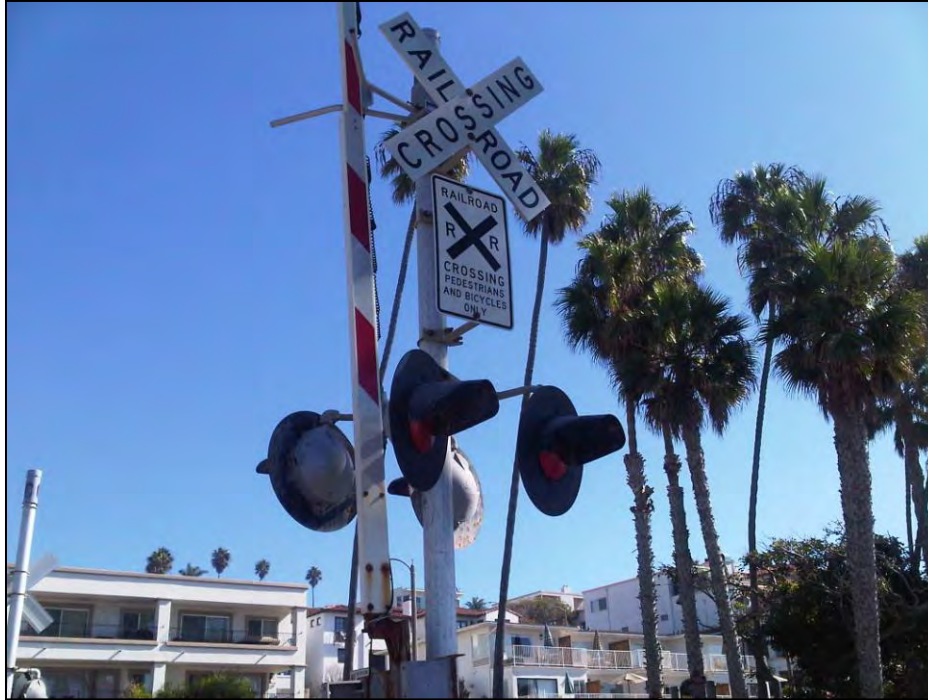
Photo 13—4. Pedestrians and Bicycles Crossing Sign Way Up the Pole.

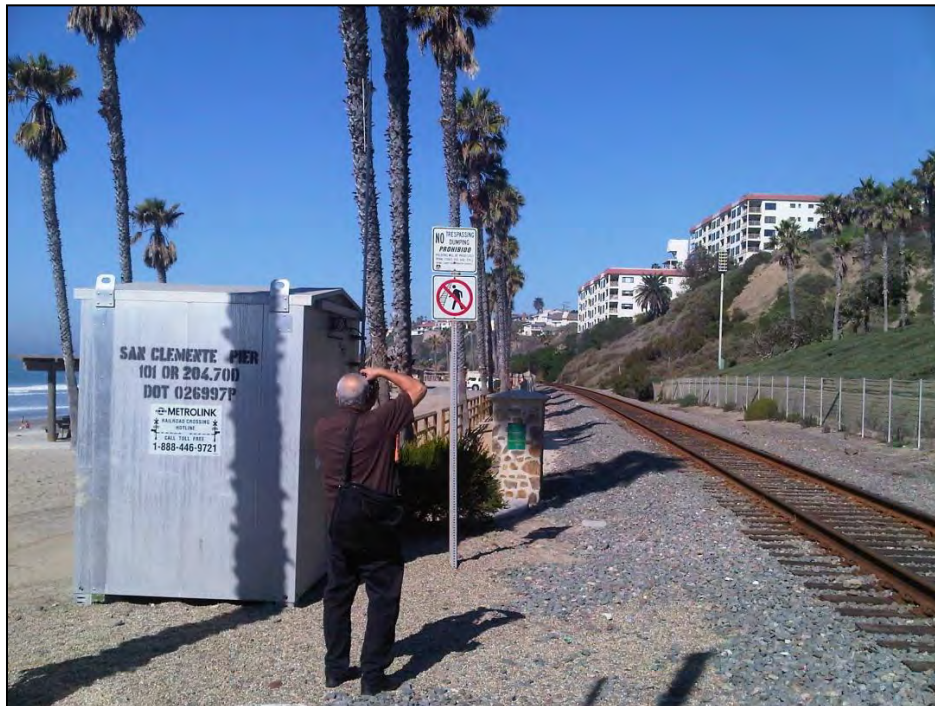
As shown in Photo 13-5, below, one often needs to actively look for a warning sign that is not necessarily in the line-of-sight of the User's physical orientation, and then decipher its meaning.

Photo 13—5. Small and Somewhat Cryptic Warning Sign

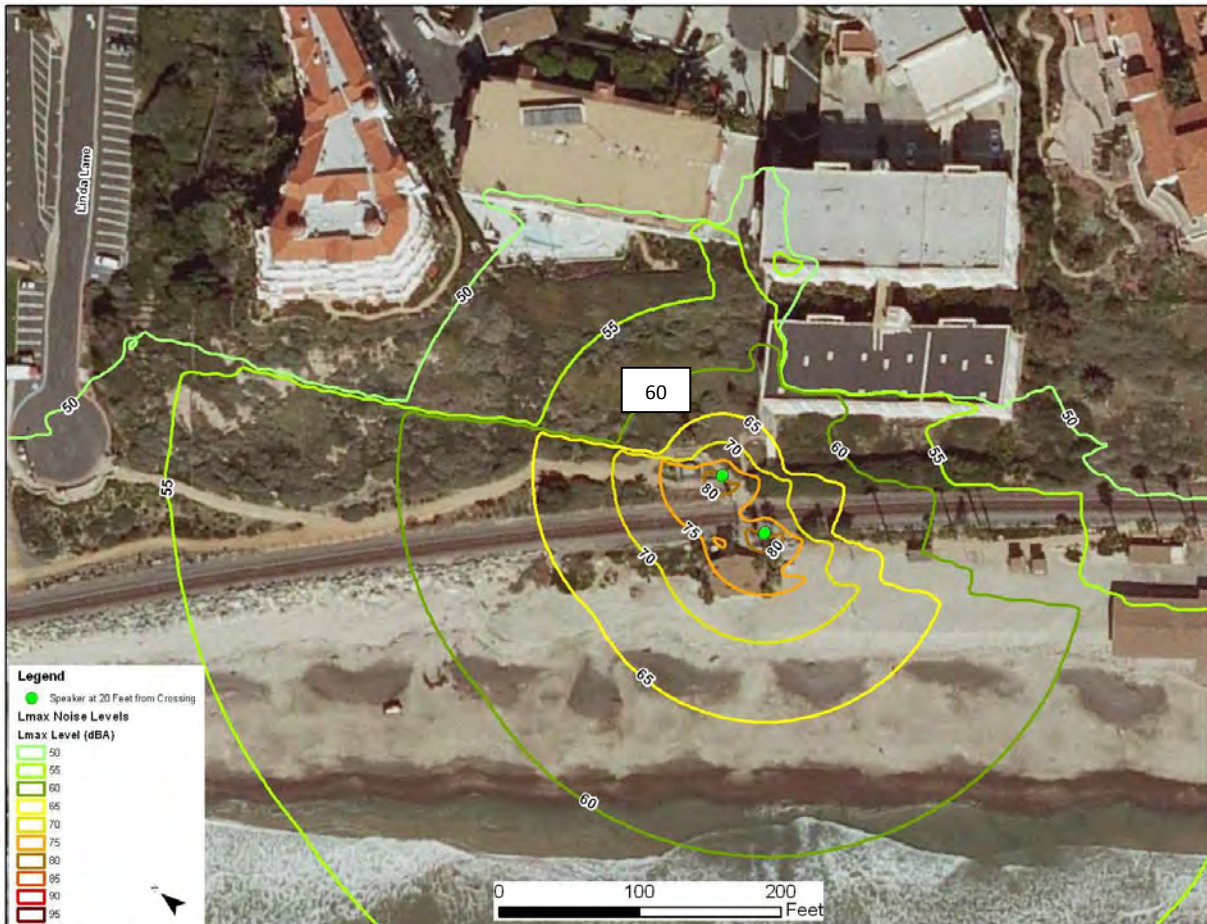
The audible warning from the proposed AWS was modeled using a three dimensional acoustic software program (SoundPLAN® Ver. 7) in order to evaluate the reduced noise compared to a train horn, a WH, and to allow comparison to earlier studies (Greene 2010). The graphic output from the modeling program showing the expected maximum sound levels near the typical pedestrian-bicycle/railroad crossings, including those where residential use is very close to the crossing, is presented in Figure 14-2.

Figure 14—2. Typical Sound Distribution from AWS at a Crossing. Shown is the Corto Lane Crossing.

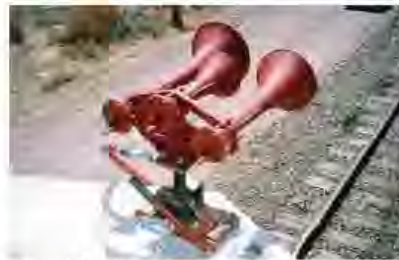
Figure 4. Three-Chime Train Horn Tested in Mundelein

Video cameras were installed at the three UP crossings in Mundelein where the digital five-chime AHS was installed. Motorist behavior was

recorded following activation of both the enhanced wayside AHS and the three-chime in-service train horns—between September and December 2001 and again between April and July 2002.

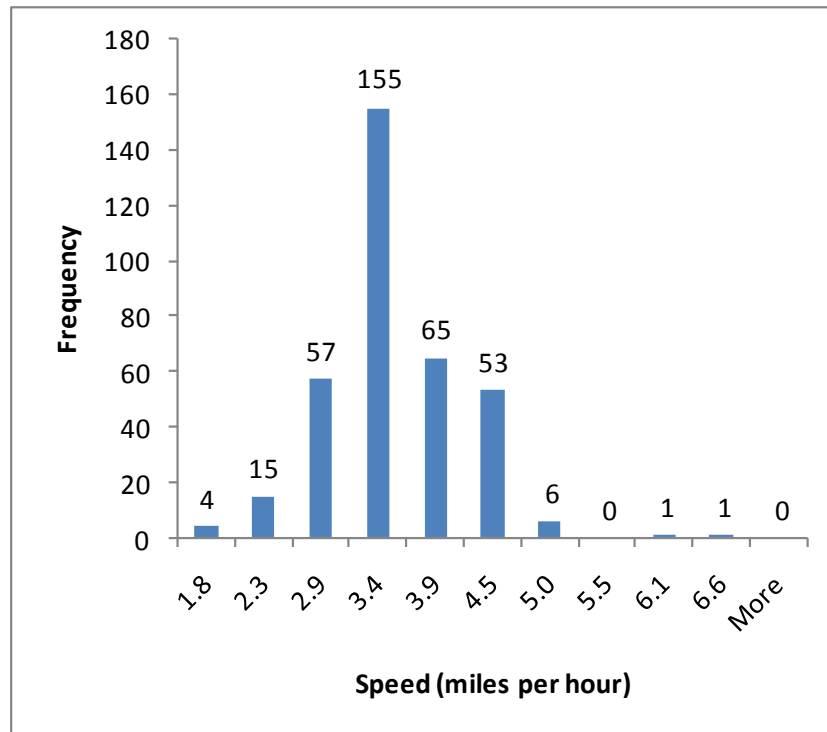
<i>Statistics</i>	<i>All 3 Crossings</i>	<i>T-Street</i>	<i>Corto Lane</i>	<i>Dije Court</i>
Mean	3.3	3.0	3.3	3.4
Standard Error	0.0321	0.1007	0.0428	0.0430
Median	3.3	2.7	3.3	3.4
Mode	3.4	2.7	3.4	3.2
Standard Deviation	0.6056	0.8118	0.5157	0.5216
Sample Variance	0.3668	0.6590	0.2659	0.2720
Range	4.8	4.8	2.4	3.9
Minimum	1.8	1.8	2.1	1.9
Maximum	6.6	6.6	4.5	5.8
Sum	1178.1	192.5	479.7	505.9
Count	357	65	145	147
Confidence Level (95.0%)	0.0630	0.2011	0.0846	0.0850

Figure 21—1. Sample Speed Distribution for Walkers at All Three Extended Locations (Corto Lane, Dije Court, and T-Street Crossings)

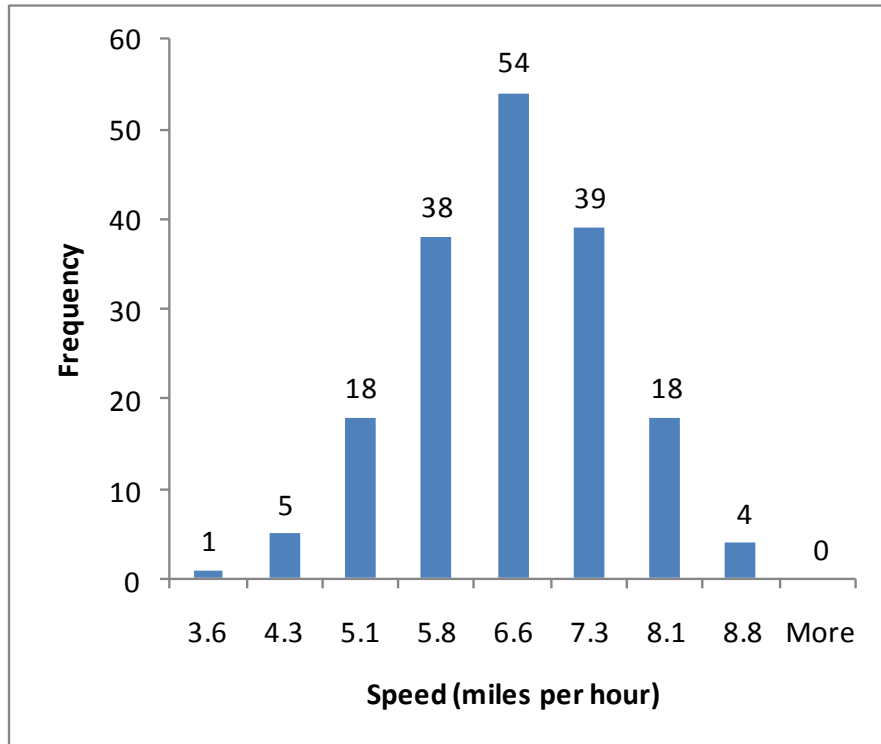
<i>Statistics</i>	<i>All Crossings</i>	<i>T-Street</i>	<i>Corto Lane</i>	<i>Dije Court</i>
Mean	6.2	6.4	6.4	5.9
Standard Error	0.0727	0.1763	0.09740	0.1193
Median	6.3	6.3	6.4	6.0
Mode	6.4	6.3	6.4	6.0
Standard Deviation	0.9675	0.9327	0.8265	1.0470
Sample Variance	0.9360	0.8699	0.6830	1.0963
Range	5.2	3.8	4.4	4.4
Minimum	3.6	4.7	4.4	3.6
Maximum	8.8	8.5	8.8	8.0
Sum	1094.9	179.8	459	456.1
Count	177	28	72	77
Confidence Level (95.0%)	0.1435	0.36166	0.1942	0.2376

Figure 21—2. Sample Speed Distribution for Joggers at All Three Extended Locations (Corto Lane, Dije Court, and T-Street Crossings)

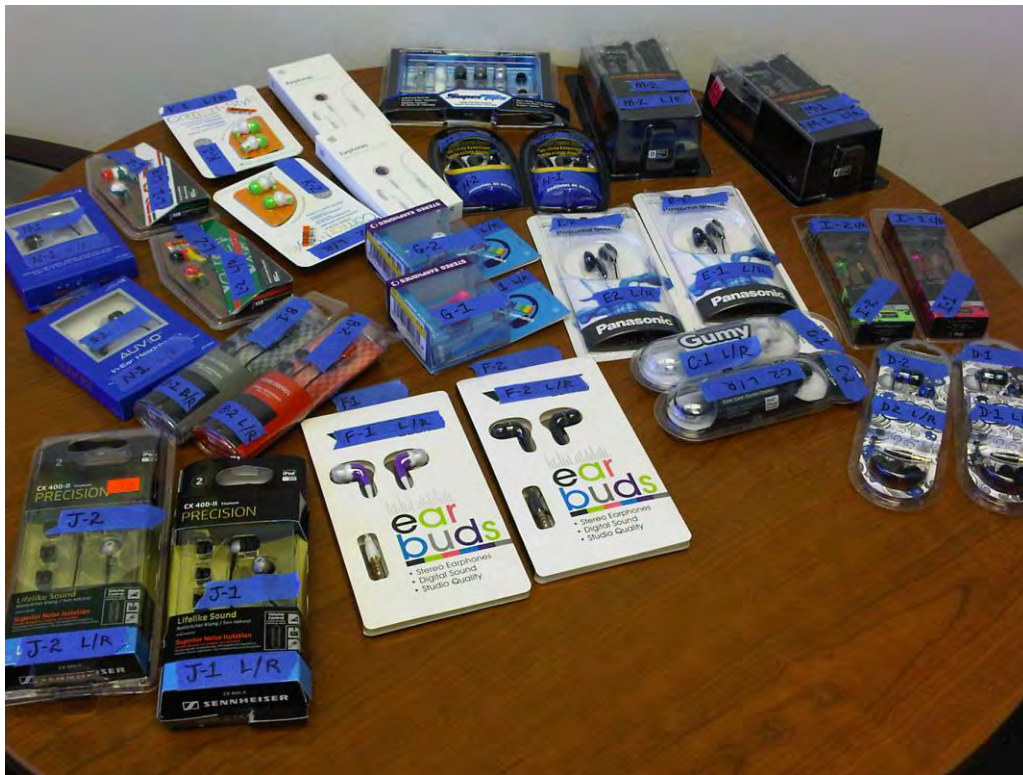
Photo 21—1. Identical Pairs of Earbud Samples Marked and Ready for Delivery

Most of the factory packaged, pre-marked earbud sets are shown in Photo 24-1, below before delivery to testing service.

Thirty unopened packages of earbuds were delivered by Parsons Brinckerhoff (PB) for testing. Fifteen of the thirty packages were labeled A1, B1, etc. through N1 and O1, and fifteen were labeled A2, B2, through N2 and O2. The pairs of earbuds in packages A1 and A2 were identical in terms of manufacturer and model number, as were those in packages B1 and B2, etc. through O1 and O2. Packages labeled A1, B1, through N1, O1 were cut open with a razor blade, carefully opened and the pair of earbuds and, if provided, its associated alternative size silicone rubber

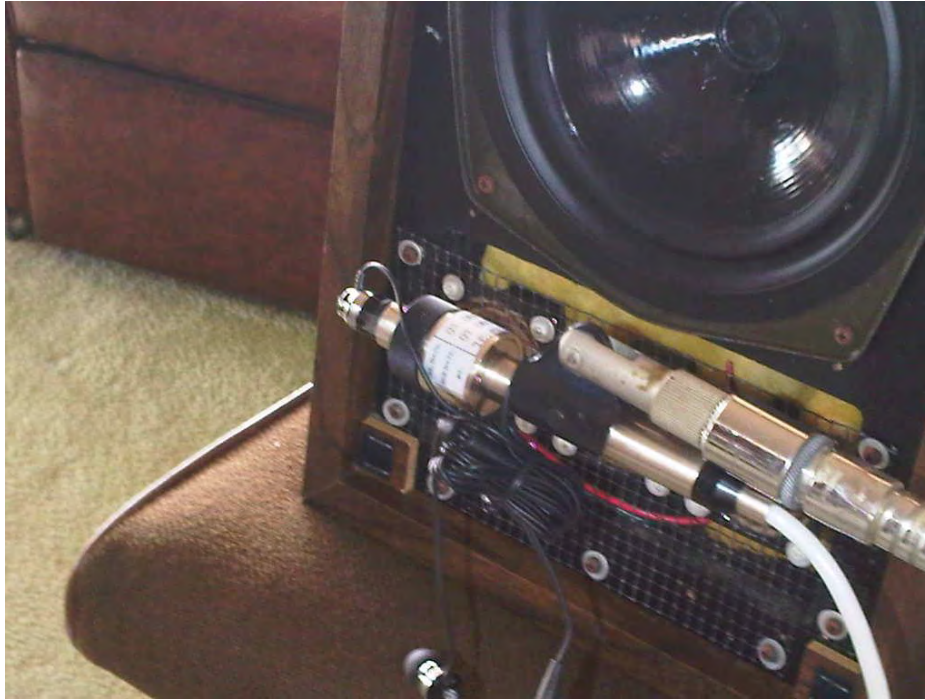
Photo 21—2. Earbud Inserted into Ear Simulator In Front of Excitation Source

The frequency responses of the insert type of earbuds were measured using the bare Brüel & Kjær 4175 ear simulator with an associated DB 2012 ear canal extension in a stand-alone configuration. The insert earbuds were pushed into the open end of the ear canal simulator extension using light finger pressure sufficient to obtain an acoustic seal at the interface between the rubber tip of the earbud under test and the entrance of the simulated ear canal as shown in Photo 21-2, below. The adequacy of the seal was confirmed by the absence of any gross droop of the response below 500Hz in the frequency response measurement. When necessary, light finger pressure was used to prevent the earbud under test from either sliding or creeping out of the entrance of the ear simulator.

Measurements of the attenuation of the *insert* type earbuds were made using the Brüel & Kjær 4175 ear simulator with an associated DB 2012 ear canal extension. The ear simulator was located approximately 39 inches above a carpeted floor at the end of a flexible gooseneck that was attached to a microphone floor stand as shown in Photo 21-2. The orientation of the ear simulator was such that the longitudinal axis of the ear canal simulator was vertical. The insert earbud under test was pushed into the open end of the ear canal simulator using light finger pressure. When necessary, a thin, high-compliance rubber band (that was cut in half and taped to opposite sides the body of the ear simulator) was used to prevent the earbud under test from creeping out of the entrance of the ear simulator with a consequent loss of the acoustic seal. The FMI loudspeaker that provided the acoustic pink-noise excitation was placed on a high chair, elevated such that the center of the 8-inch-diameter cone of the loudspeaker was located approximately 39 inches above the floor at the same height as the ear bud under test. The distance between the loudspeaker and the ear simulator was measured and set to approximately $36 \pm$ inches, thus the test ear bud was in the direct field of the acoustic excitation. The distance between the ear simulator and the nearest reflecting surface of interest (closest wall) was approximately seven feet, and the distance between the ear simulator and the high vaulted ceiling was in excess of ten feet.

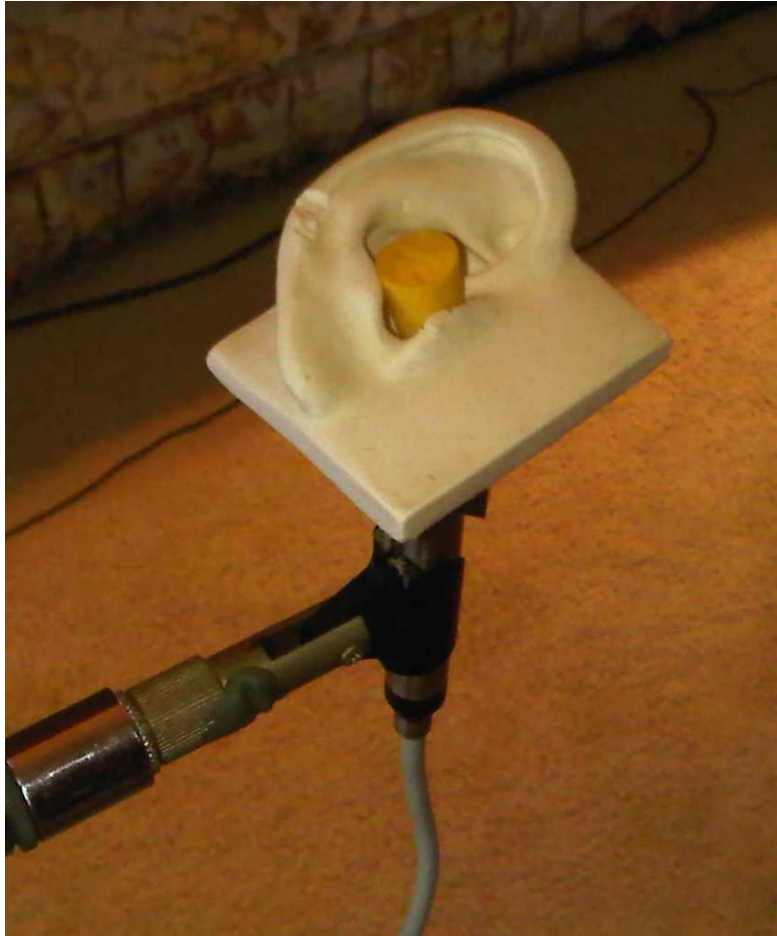
Photo 21—3. Close up of KEMAR Rubber Pinna Used for Testing the Loose Fit, Flat-faced Concha Type Earbuds. Shown with EAR© Insert Hearing Protector (earplug) Tested as a Control

Measurements of the attenuation of *concha* type loose-fit earbuds were made in a manner that was identical to the measurements of the attenuation of insert earbuds, but with the silicone rubber KEMAR right-ear pinna installed on the ear simulator. The orientation of the pinna was such that the wavefront of sound produced by the loudspeaker passed over the pinna as it would if a human subject were looking directly at the loudspeaker. The flat-front loose-fit earbud under test was placed into the concha of the rubber pinna and was held in place by the elasticity of the pinna in a manner that is virtually identical to the way it would be held in place in the concha of a human ear. Photo 21-3 shows the test fixture with a control earplug inserted.

The frequency responses of the flat-front, loose-fit concha earbuds were measured using a silicone rubber KEMAR right-ear pinna that was installed on the Brüel & Kjær ear simulator. The concha loose-fit earbud under test was fitted into the concha of the KEMAR rubber pinna and was held in place by the elasticity of the pinna in a manner that is virtually identical to the way it would be held in place in the concha of a human ear.

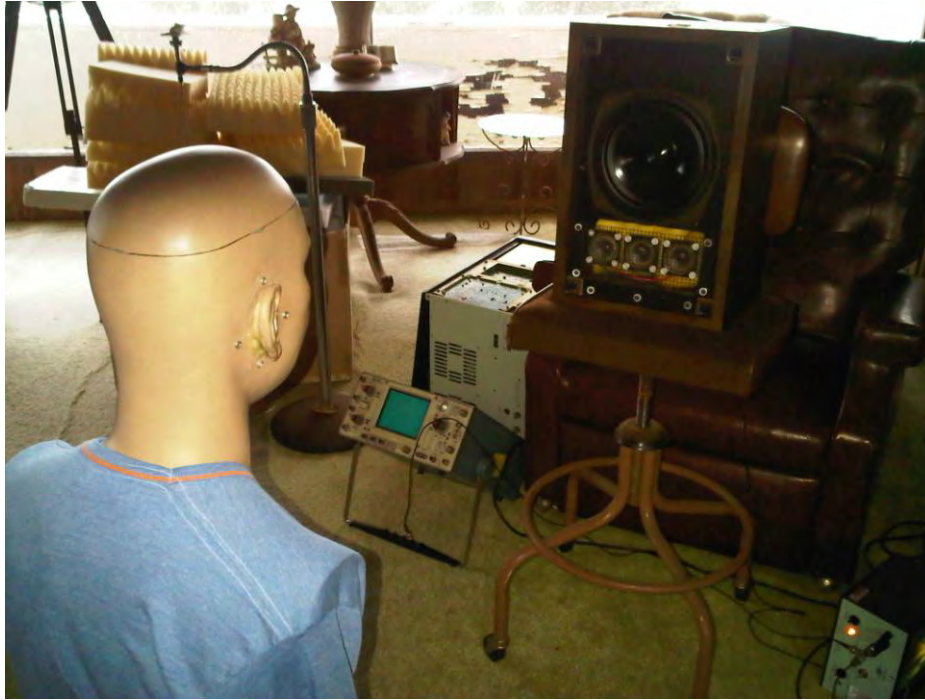
Photo 21—4. Mannequin Facing Excitation Source

In order to evidence the similarity between stand-alone test fixture measurements and earbuds worn by a human, measurements of the attenuation of several insert type earbuds were also made with the ear simulator installed in the right ear of a clothing store mannequin. The mannequin was positioned such that it faced the loudspeaker with the entrance of the ear simulator being approximately 39 inches above the carpeted floor, and the distance between the ear canal and the center of the loudspeaker being again set at approximately $36\pm$ inches. The insert earbud under test was pushed into the mannequin-mounted ear simulator using light finger pressure, and was held in place with a small, $\frac{1}{4}$ inch-diameter wad of sticky, viscous modeling clay that was placed between the plastic housing of the earbud and a nearby ridge on the mannequin's pinna. This test set up is shown in Photo 21-4.

Based on the above described orientation of the acoustic test fixtures, the excitation source, and the dimensions from the test fixture to the nearest surfaces of interest, the overall acoustic test condition specified by Parsons Brinckerhoff of essentially free-field hemi-anechoic (over a reflecting plane), with a frontal source orientation ($\pm 20^\circ$) (i.e., provides approximately grazing incidence of the ear bud with a potential audible warning signal source) was fulfilled.

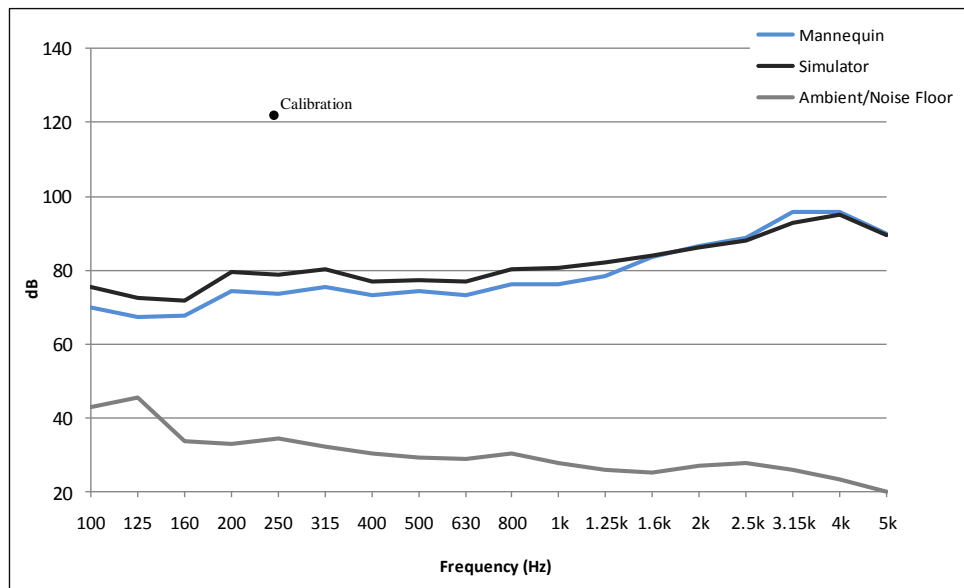
Figure 21—4. Test System Showing Calibration Level, Excitation Level for Mannequin and Simulator with Earbuds Not Inserted, and Noise Floor Level, All with Respect to Frequency

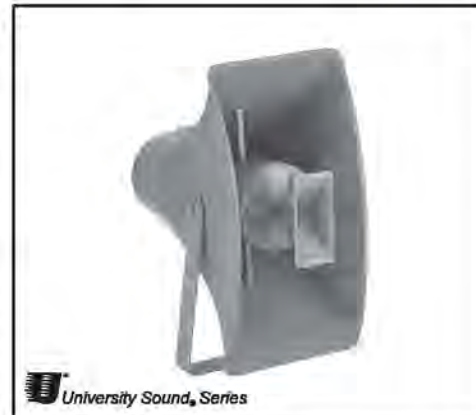
The axial frequency response will extend from 280 to 8,000 Hz and the horn shall exhibit a low frequency cutoff of 180 Hz. Sound pressure level will be 105 dB (1 W/1 M) with a 500 to 5,000 Hz pink noise signal applied, and the horn will produce a horizontal beamwidth of 150° and a vertical beamwidth of 110° at 2 kHz. The horizontal coverage shall be constant over the frequency range of 3 kHz to 10 kHz.

The loudspeaker shall be compression molded fiberglass capable of satisfactory mechanical performance in the temperature range from - 40°C to +40°C and not subject to sunlight embrittlement.

Other major external speaker parts shall be diecast zinc finished in gray polyester paint to match the molded horn parts. All components shall be resistant to damage from weather, moisture and fungus.

A swivel bracket capable of providing either vertical or horizontal installation and a variety of adjustments, is provided.

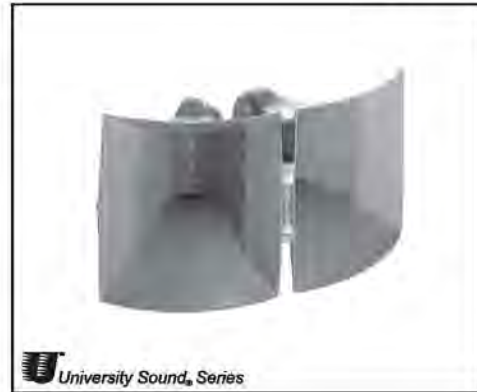
The 100-degree horizontal by 60-degree vertical dispersion pattern is beneficial in many applications requiring a wide coverage pattern. Furthermore, excellent loading is maintained to a low-frequency cutoff of 250 Hz.

The Cobreflex III is constructed from a non-resonant glass fibre reinforced polyester with a self-colored gray finish. A serrated positive-lock "U" mounting bracket is provided for maximum mounting flexibility and ease of installation.

The horn shall be of the folded sectoral type featuring two separate air columns within the single assembly. It shall produce a horizontal beamwidth of 100 degrees and a vertical beamwidth of 60 degrees at 2.0 kHz. In addition, it shall provide useful acoustic loading at all frequencies above 250 Hz.

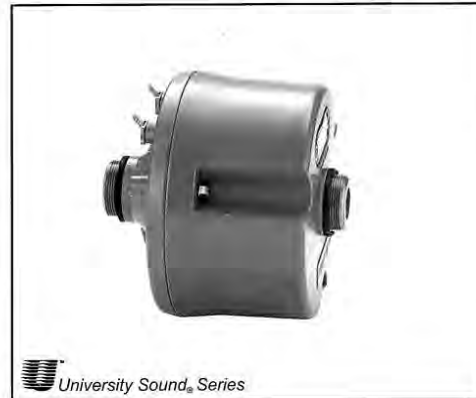
The loudspeakers shall have a diameter of 13.5 cm (5.3 in.), the 1829, a length of 10.3 cm (4.1 in.) and the 1829BT, a length of 16.2 cm (6.4 in.). Both shall have a throat opening of 3.0 cm (1.2 in.) with a 1 3/8"-18 thread for mounting.

The loudspeakers are the ElectroVoice 1829BT which includes a 70V line-matching transformer (see Table III) and weighs no more than 3.2 kg (9.8 lb), and the ElectroVoice 1829B which has a nominal impedance of 16 ohms and weighs no more than 4.5 kg (7.0 lb).

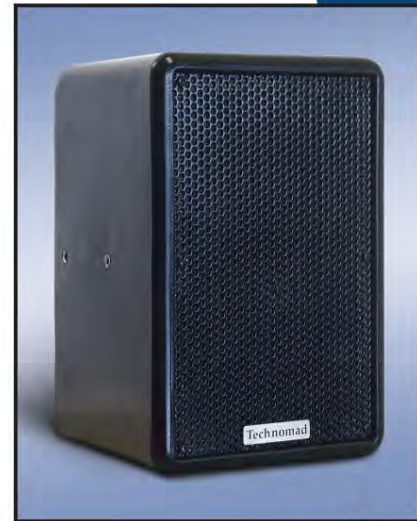
Size	9.1" high X 6.1" wide X 6.1" deep
Weight	8.5 lbs
Cabinet	One-piece 3/8" Thick Molded
Freq Response	100 Hz - 18 KHz (+/- 2 dB)
Sensitivity	91 dB SPL (1W/1M, swept sine)
Continuous Power	60 Watts (based on EIA test 426B)
Max Peak Power	120 Watts (based on EIA test 426B)
Dispersion/Range*	120° V x 120° H / 20 yds
Impedance	8 ohms (nominal)
Connector	1 X Screw Terminal
HF Driver	High-SPL, 1" Horn-loaded Compression Driver
LF Driver	5.25" Custom Polypropylene Driver
Crossover	Passive Internal

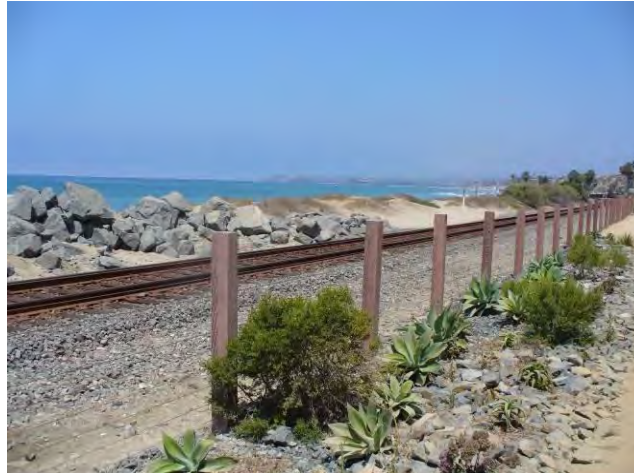
Trail along ROW (MP203.75-204.00) - The trail between the North Beach crossing and the Dije Court crossing appears to be adequately fenced along its entire length. Additional signage warning of possible fines for crossing the ROW at unauthorized locations is recommended.

Fencing between North Beach and Dije Court crossings

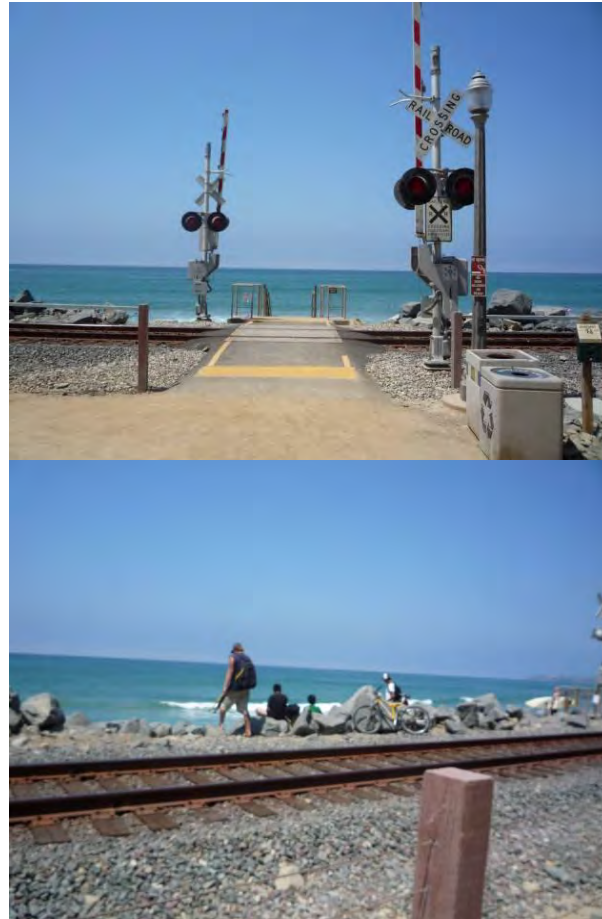
Dije Court At-Grade Pedestrian Crossing (MP 204) - The crossing is pedestrian only, and is equipped with Commission standard 9 warning devices, with an extra set of backlights on each device. The crossing leads pedestrians directly to a stairway to a narrow stretch of beach in this area. Because of the narrow beach, pedestrians are prone to sitting on the boulder rip-rap in the area and occasionally violating the west side of the RR ROW. Warning signage of possible fines for violating the ROW is recommended. The parties discussed proposed improvements including; Swing Gates on east side of track only, due to space considerations on the west side.

Dije Court ped crossing

Pedestrians congregating on the rip-rap south of the Dije Court crossing

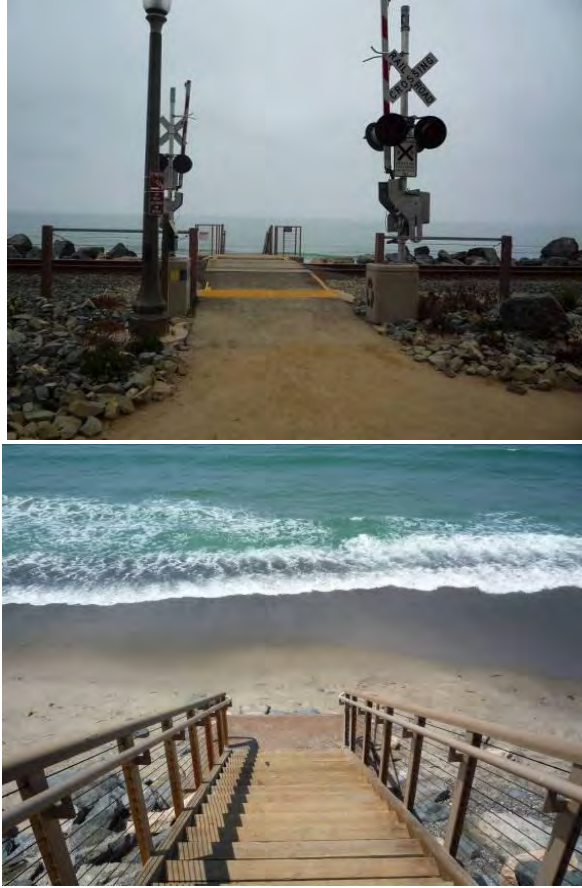
El Portal At-Grade Pedestrian Crossing (MP 204.10) - The crossing is pedestrian only, and is equipped with Commission standard 9 warning devices, with an extra set of backlights on each device. The El Portal crossing is located about 400 feet south of the Dije Court crossing. This crossing also leads pedestrians directly to a stairway down to the narrow portion of beach.

El Portal crossing Beach stairway at El Portal crossing

Parties were in general agreement that the crossing is redundant. Due to concerns such as, poor line-of-sight, proximity to nearby crossings (including the El Portal grade separated underpass) and train horn noise, crossing closure is recommended. At a recent San Clemente community meeting, citizens discussed the closure of the El Portal crossing. Given their responses, the City is considering closure of this crossing. If the crossing is not closed, it should have swing gates installed on the east side, similar to Djie Court crossing.
