**ORANGE COUNTY RAIL-HIGHWAY
GRADE CROSSING SAFETY ENHANCEMENT PROGRAM
SAN CLEMENTE AUDIBLE WARNING SYSTEM STUDY
TECHNICAL MEMORANDUM**

**Parsons Brinckerhoff
505 South Main Street, Suite 900
Orange, CA 92868**

**Orange County Transportation Authority
550 South Main Street
Orange, CA 92868**

June 28, 2011

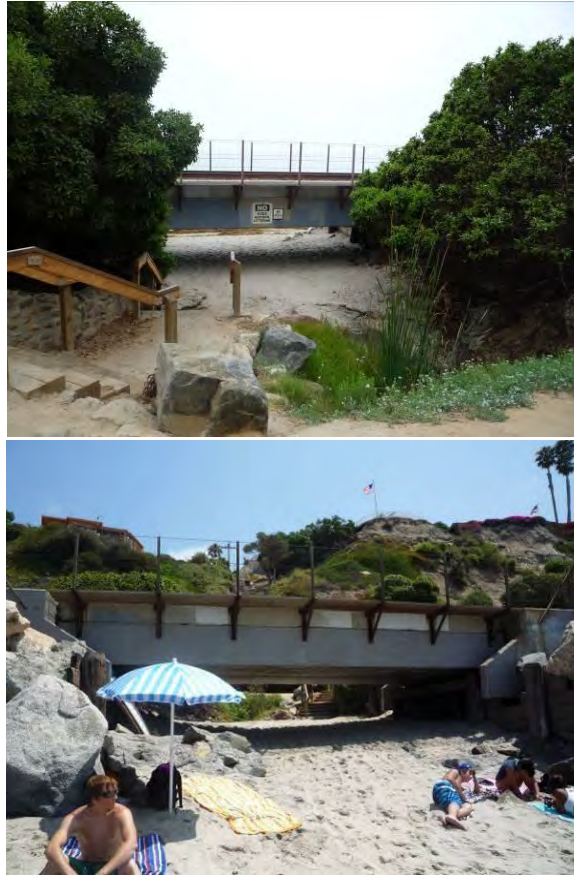
El Portal Grade-Separated Pedestrian Crossing (MP 204.11) Immediately south (approximately 50 feet) of the El Portal at-grade crossing is the El Portal grade-separated pedestrian crossing with a stairway off the trail leading to it. No Recommendations.

El Portal Grade-Separated crossing

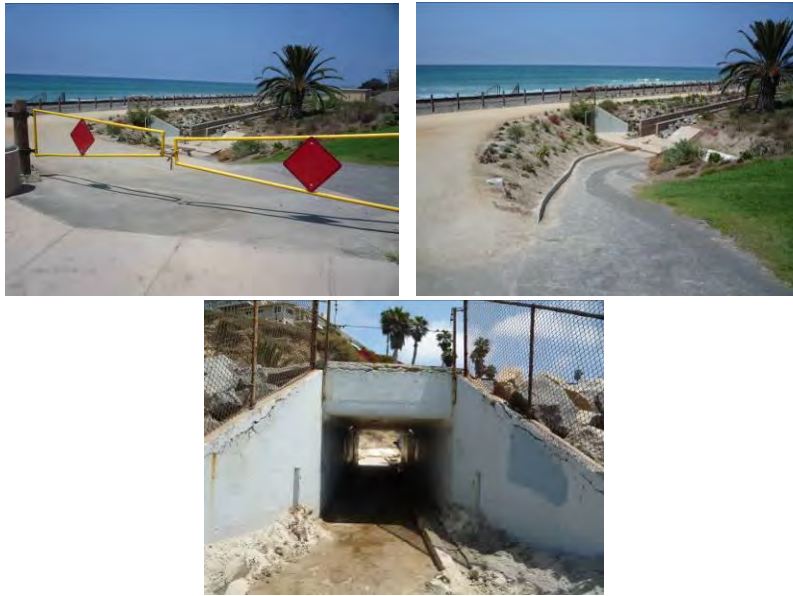
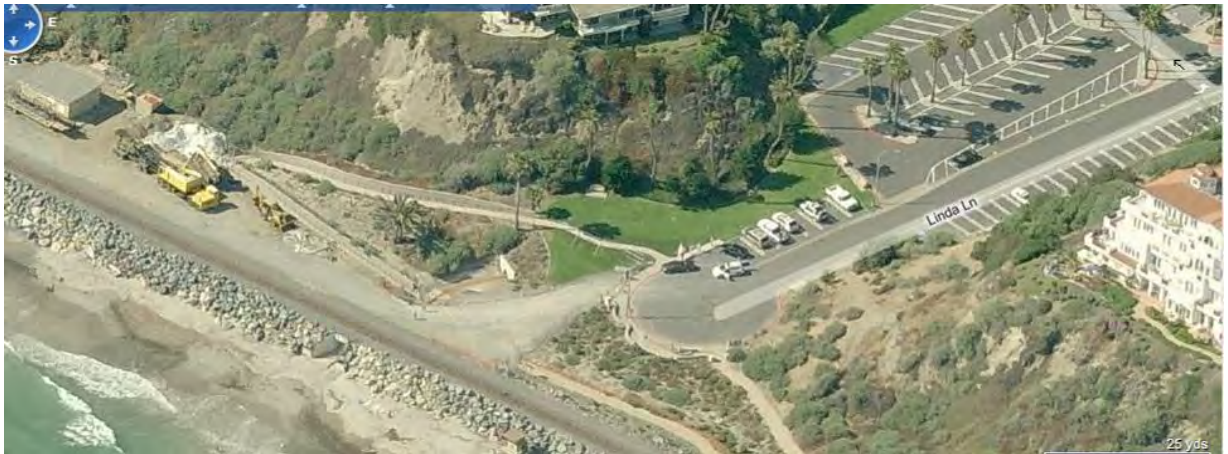
Trail along ROW (MP 204.54 – MP 204.60) - The trail between the Linda Lane grade-separated crossing and Corto Lane at-grade pedestrian crossing appears to be adequately fenced along its entire length. Warning signage of possible fines for violating the ROW is recommended at certain locations.

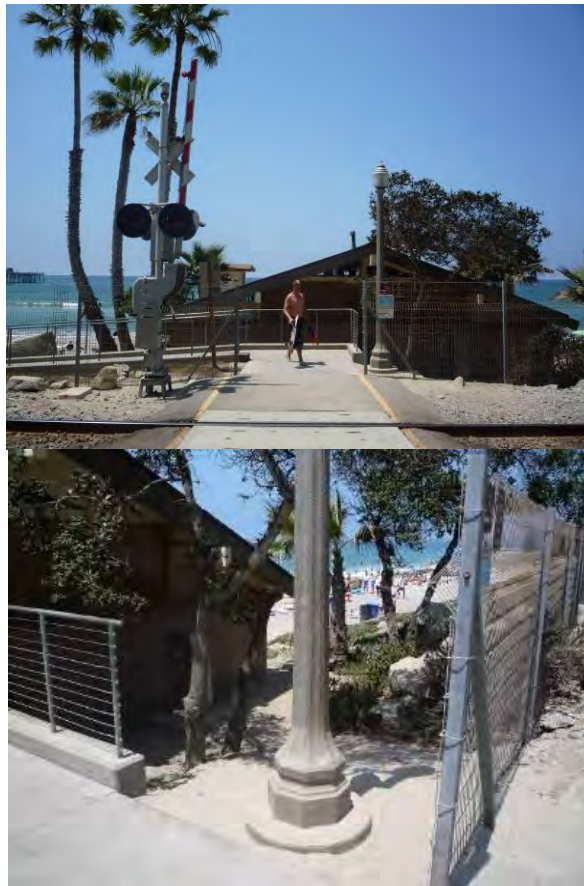
Corto Lane crossing - Well worn path going north on beach side

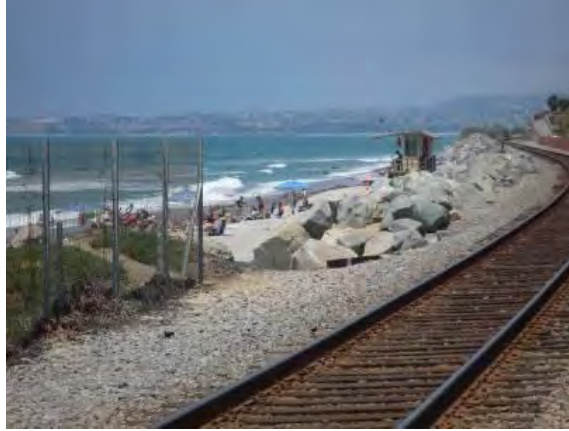
End of fence north of crossing on beach side

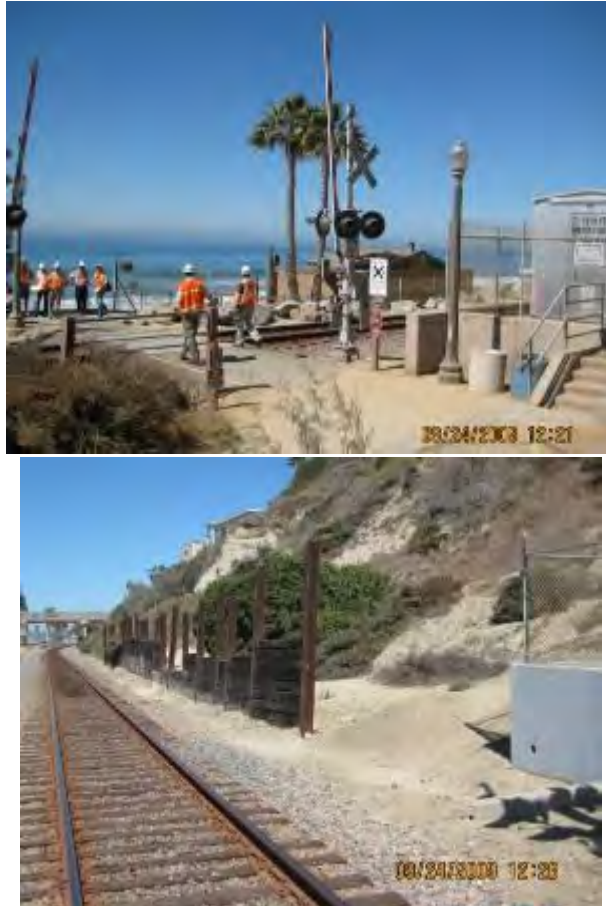
T-Street At-Grade Pedestrian Crossing (MP 205.20) - The crossing is pedestrian only, and is equipped with Commission standard 9 warning devices, with an extra set of backlights. The T-Street crossing is where the San Clemente trail crosses over the tracks, with the trail north of the crossing on the beach side and the trail south of the crossing on the land (east) side. Some additional channelization or fencing is appropriate on the east side of the crossing where the trail turns to cross the tracks. There is evidence of unauthorized paths from around and behind the warning device bungalow in the NE quadrant, leading north where there is no trail. Missing retaining wall section may invite pedestrians down to the RR ROW from the unauthorized trail on that side and should be added; also, missing boards further north should be replaced. South of the crossing, fencing on the east side extends approximately 250 feet. Recommended improvements are addition of swing gates, which may require the crossing be widened.

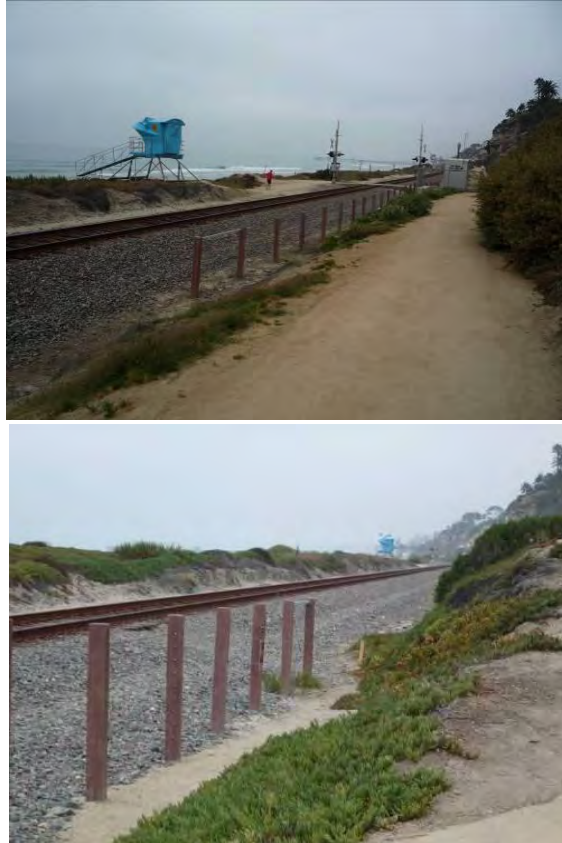
Trail along ROW (MP205.60 -205.80) - The trail between the Lost Winds at-grade crossing and the Riviera grade separated (storm drain) crossing, located on the land (east) side of the tracks, requires additional fencing to complete the fencing along its entire length. Clear evidence of goat trails and unauthorized pathways, as well as witnessing trespassing during our review offer evidence of need. Fencing extends south from the Lost Winds crossing, has a large gap, then begins again for the last 200 feet before the Riviera crossing. Additional fencing is recommended to close the approximate 650 feet gap between the existing fencing

Fencing ends south of Lost Winds

Fencing ends north of Riviera crossing

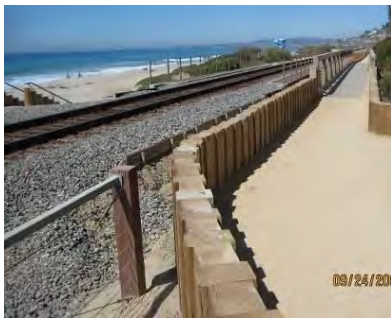
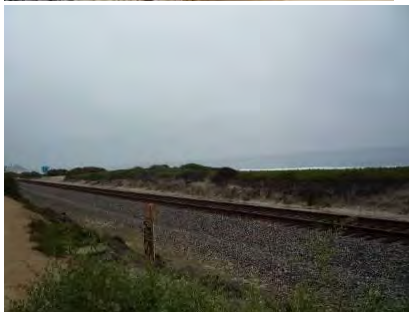
again about 500 feet north of the Calafia Beach crossing. Where the fencing meets the approach channelization for trail overcrossing on the south side of the Montalvo crossing, a relatively narrow 1 – 1.5 foot gap shows evidence of significant pedestrian trespass. It should be closed off or otherwise blocked, which the City of San Clemente stated they would be completing. Further south, the break in fencing of approximately 180 feet offers pedestrians clear access to the RR ROW and significantly promotes trespassing, and should be fenced. Clear evidence of goat trails and unauthorized pathways were evident, and CPUC Staff has witnessed trespassing at this fencing gap. The Calafia Beach parking lot is adjacent to the east side of the trail, and fencing gap offers a more direct route to beach areas north of the fencing.

Gap at trail railing and ROW fence

***Action item** – City of San Clemente to block the gap between the ROW fencing and the south side trail channelization approaching the trail overcrossing of the Montalvo grade separation..

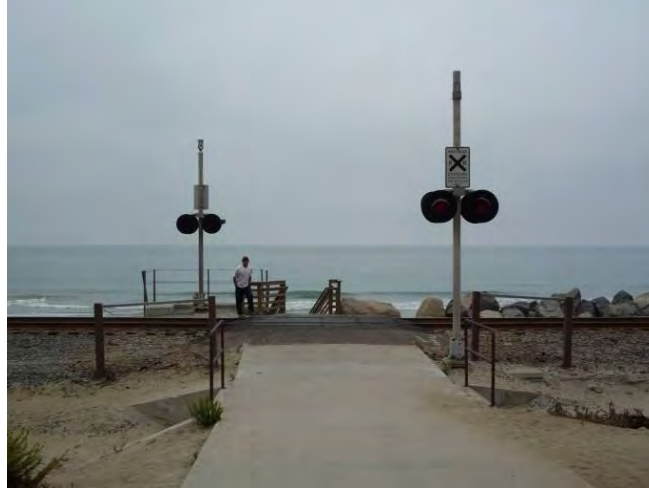
Calafia Pedestrian Crossing (MP 206.00) - The crossing is pedestrian only, and is equipped with Commission standard 8 warning devices (i.e. No Gates)

CPUC representatives believe that as part of a settlement agreement stated in Decision D.04-05-053, all of the at-grade pedestrian crossings must be gated. Railroad and CPUC representatives believe that at a minimum the crossing must be gated to consider any horn silencing. The City does not agree and feels that a grade separation underpass of the tracks is the preferred solution here, but has not been able to acquire funding for such a project. City indicates it has studied adding gates here and that the ocean side landing and stairway presents design issues they cannot resolve. The City recommends interim measures consisting of wayside horns rather than gates. This issue must be resolved in order to move forward.

The parties discussed relocating gates from another Metrolink crossing to significantly reduce cost, if available. The crossing leads to a stairway down to the beach, and the landing/stairway will need to be modified to accommodate gates. The City should consider upgrading the rubber surface to concrete panels. Swing gates are recommended with the ped gates.

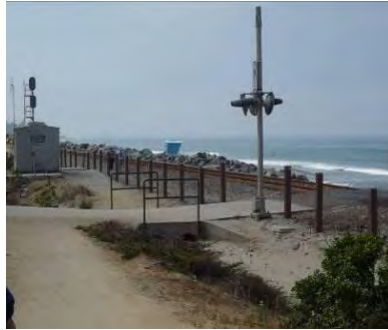
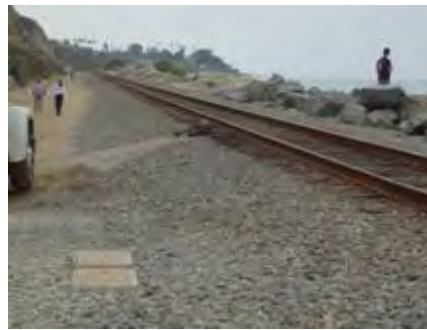
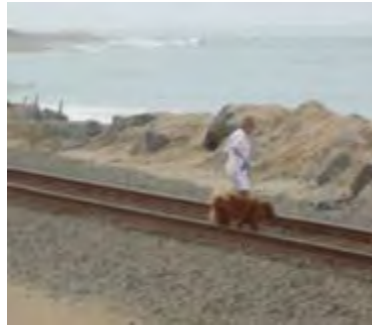
Pedestrians observed not using the trespassing along the RR ROW and crossing the railroad tracks just south of the Calafia pedestrian crossing.
