**TREES AND PARKING LOTS
PRESENTATION TO
ENCINITAS URBAN FOREST ADVISORY COMMITTEE
MAY 23, 2024**

**BY
MARK WISNIEWSKI**

PHOTOS TAKED TAKEN ON MAY 21, 2024
BETWEEN 1:45 AND 3:00 PM EXCEPT AS NOTED

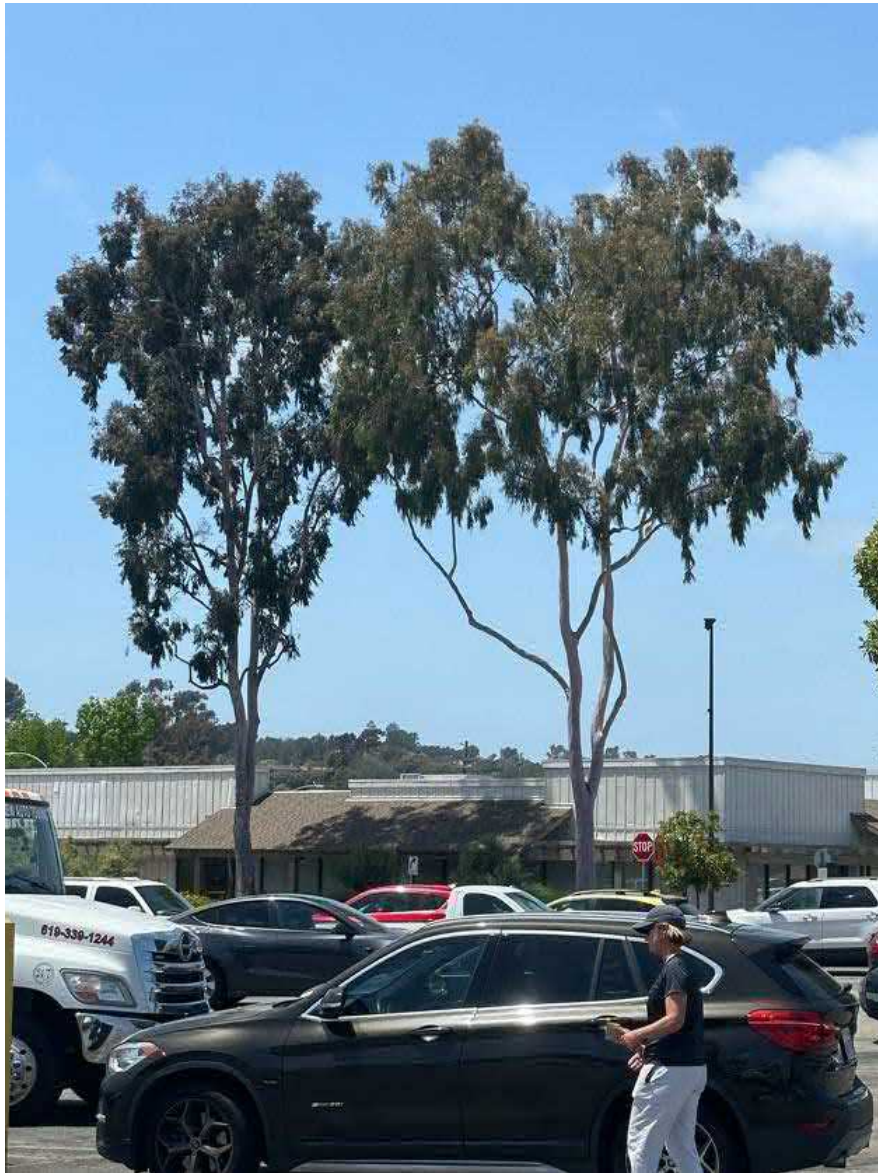
Ralphs/Trader Joes on El Camino Real
Eucalyptus citriodora - Lemon-scented Gum - Original Trees

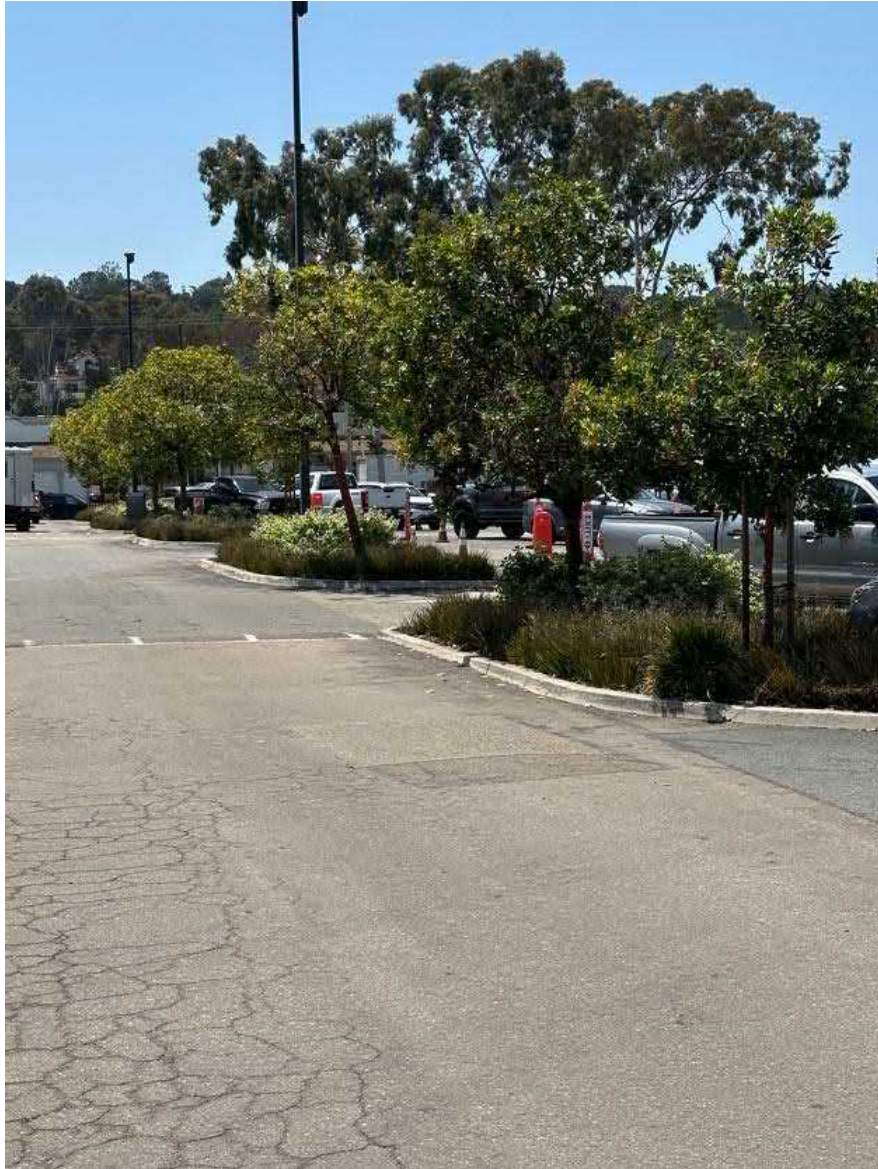
Ralphs/Trader Joes on El Camino Real
Arbutus 'Marina' - Replacement Trees after remodel

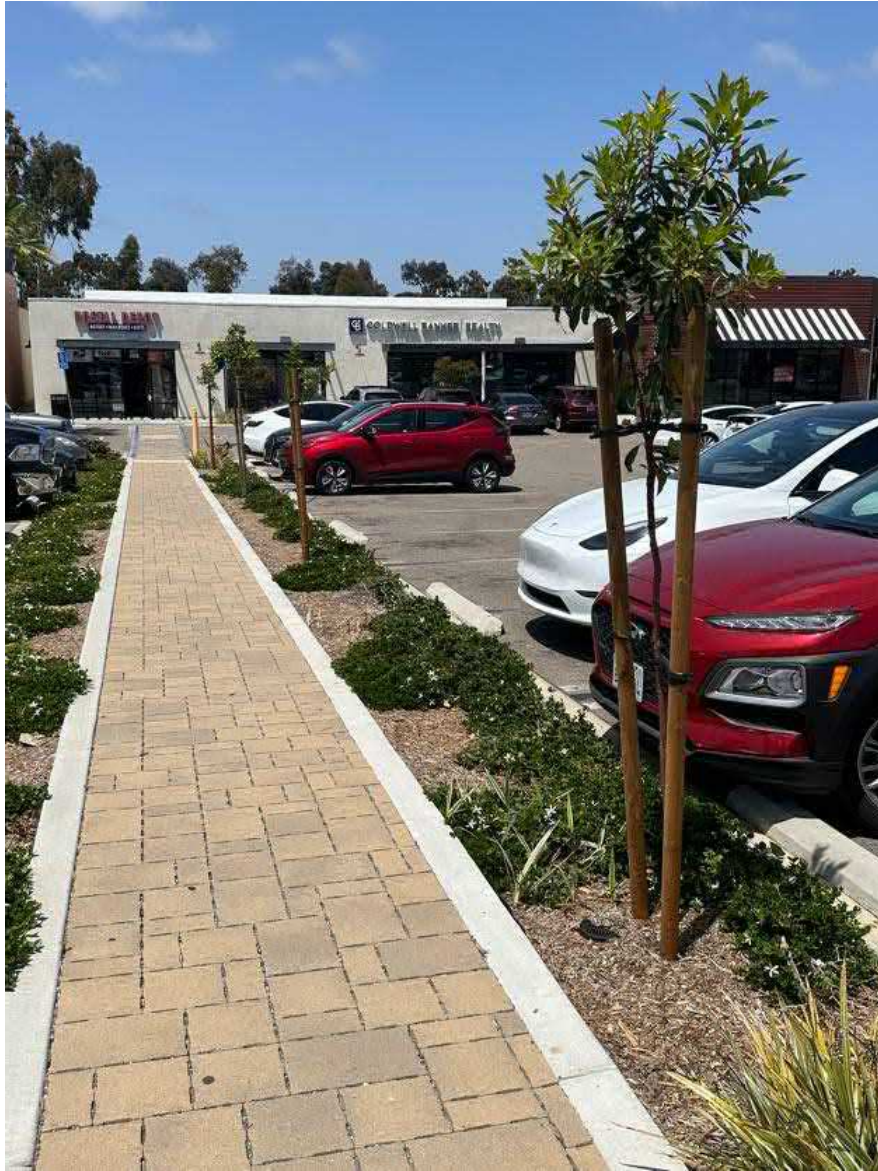
Peets Coffee/Habit Burger on Encinitas Blvd.
Arbutus 'Marina' - Replacement Trees after original trees died

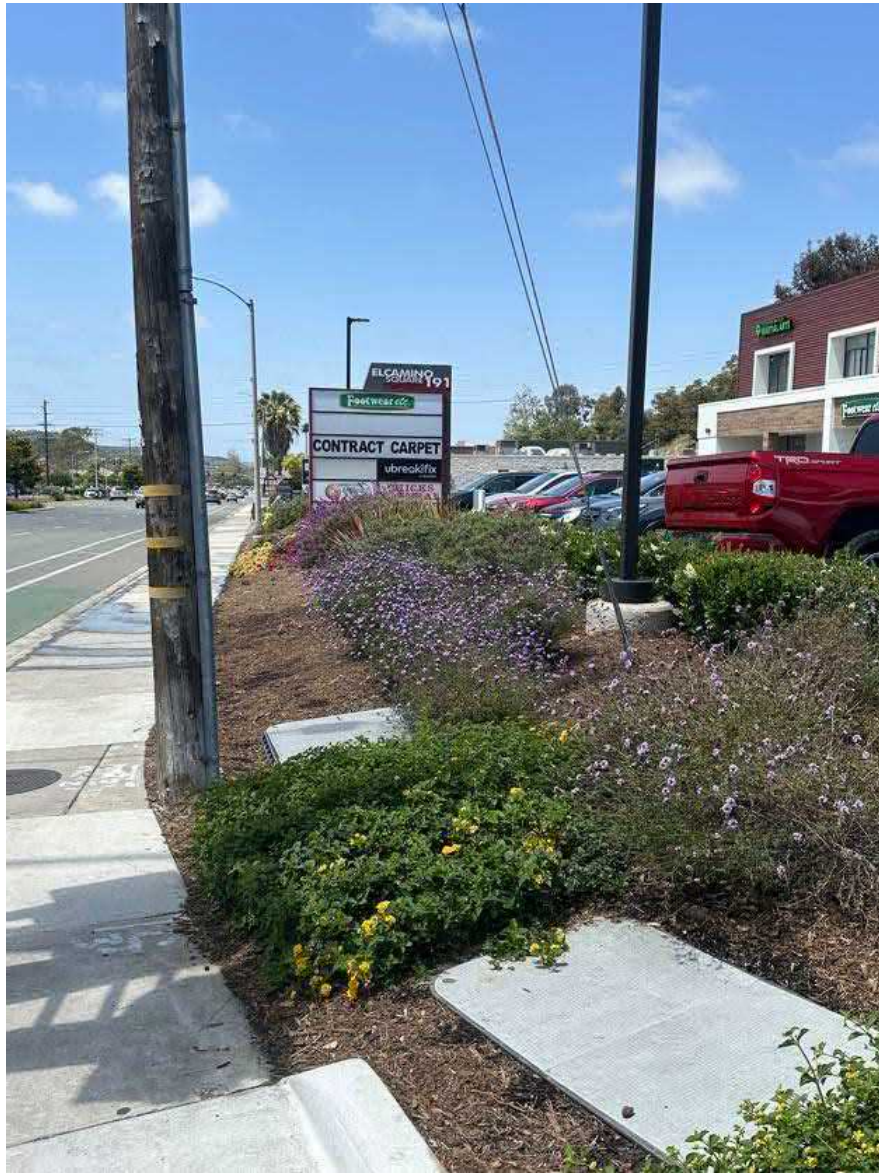
Chicks/Garden State Bagels on El Camino Real
No Parking Lot or Street Trees
Property was relandscaped when building was remodeled

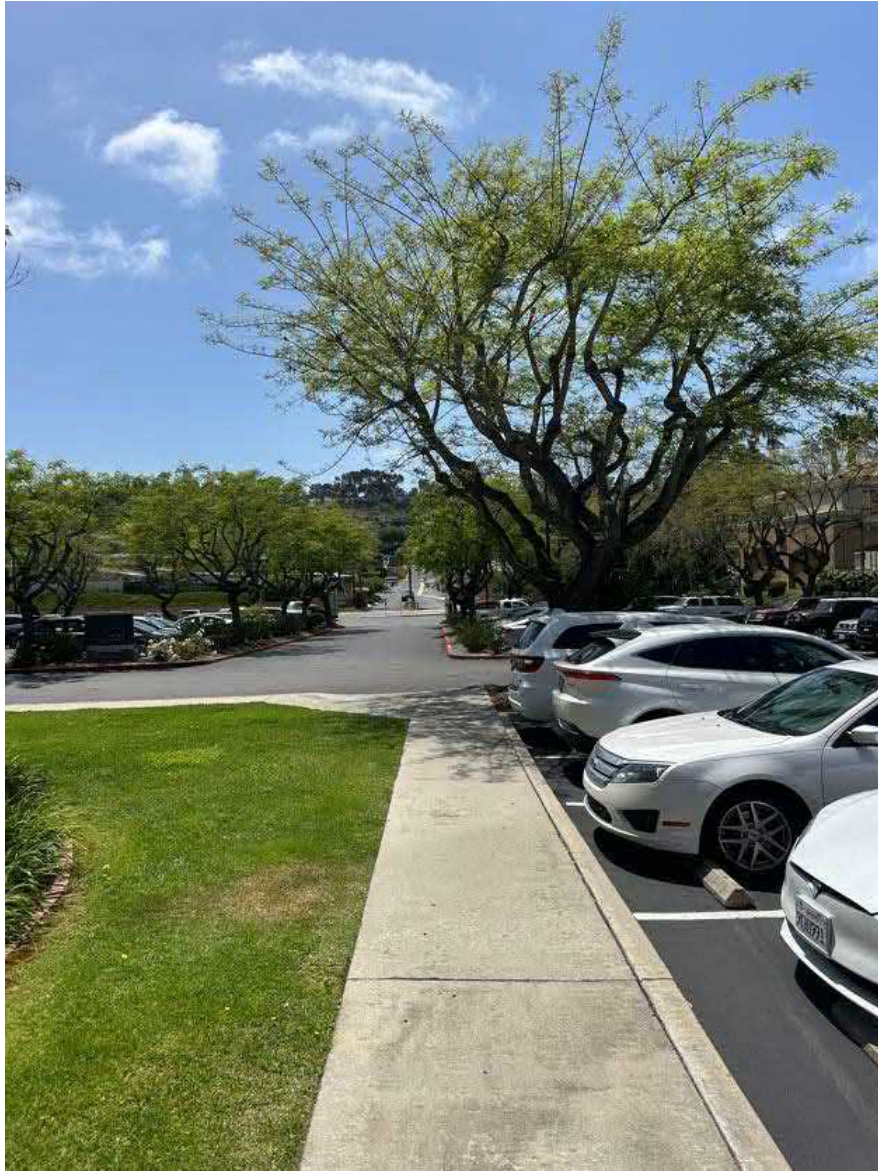
Scripps Coastal Medical Center on El Camino Real
Tipuana tipu - Tipu Tree - Every 3 parking spaces

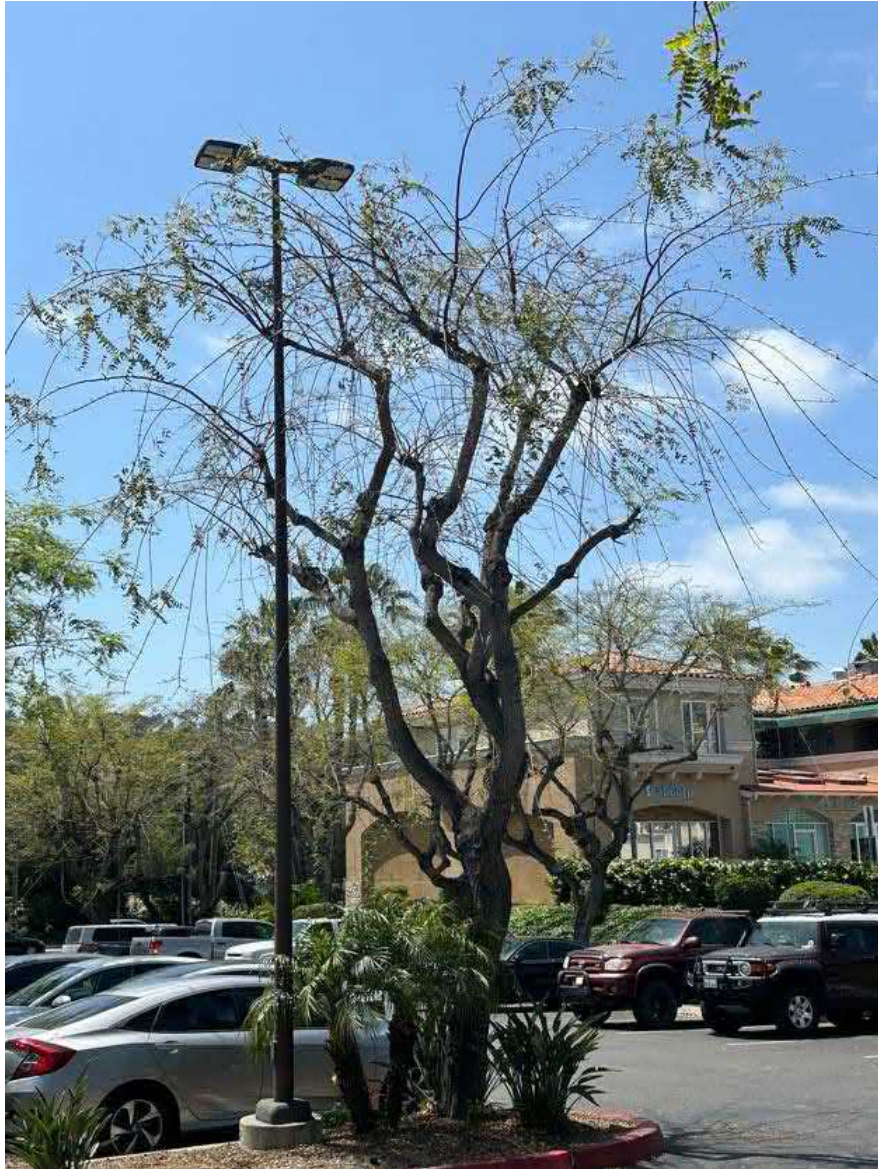
Scripps Coastal Medical Center on El Camino Real
Tipuana tipu - Tipu Tree - Conflict with light pole

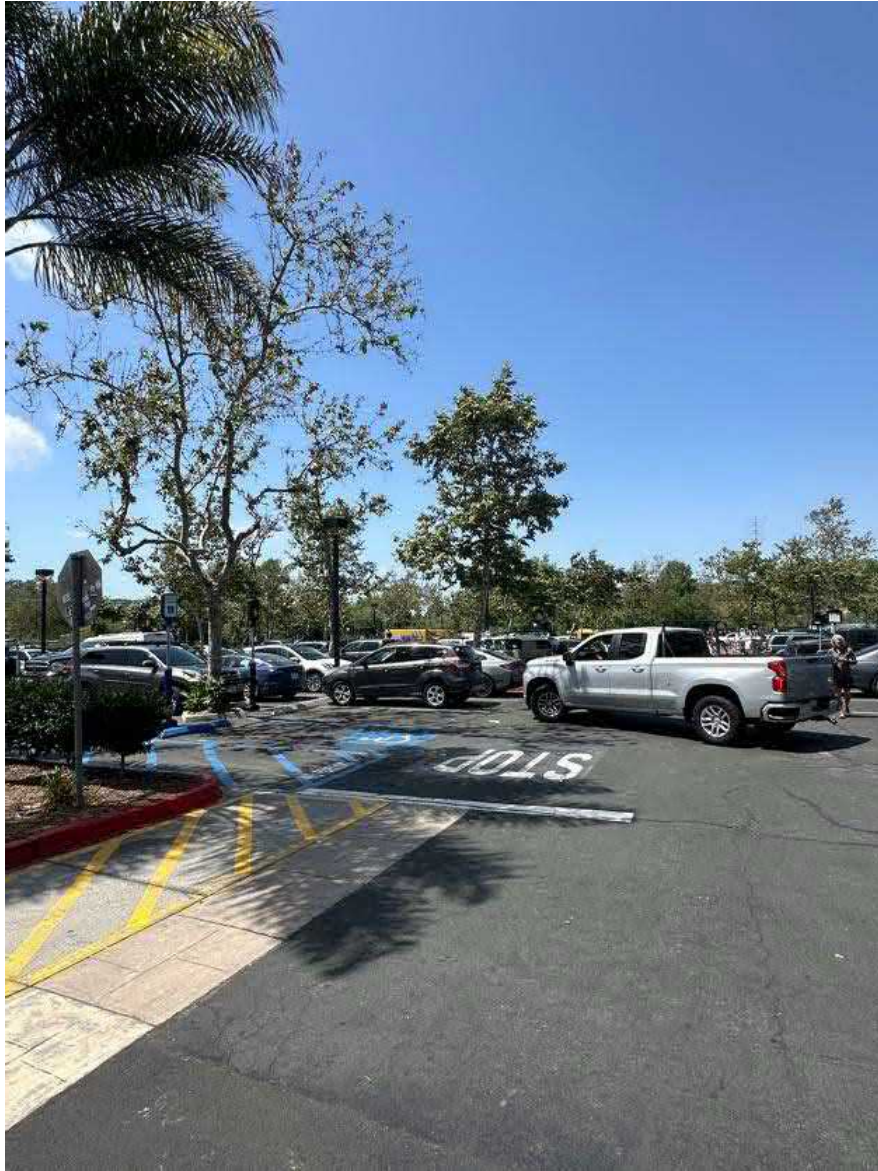
Home Depot on El Camino Real

Platanus racemose – California sycamore

Each tree at maturity (if canopy is not over pruned) could shade 4 spaces

Limited light pole conflicts

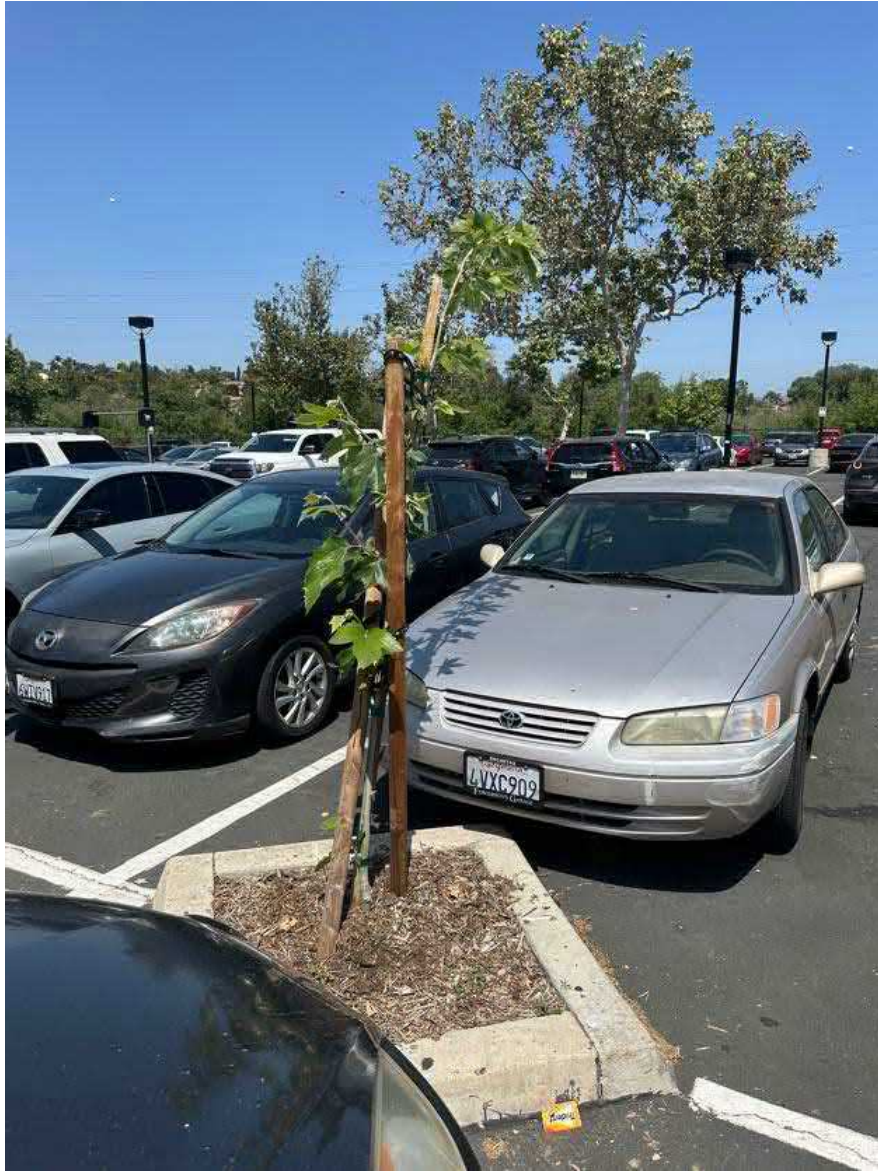
Home Depot on El Camino Real
Platanus racemosa – California sycamore
One of several recent replacement trees

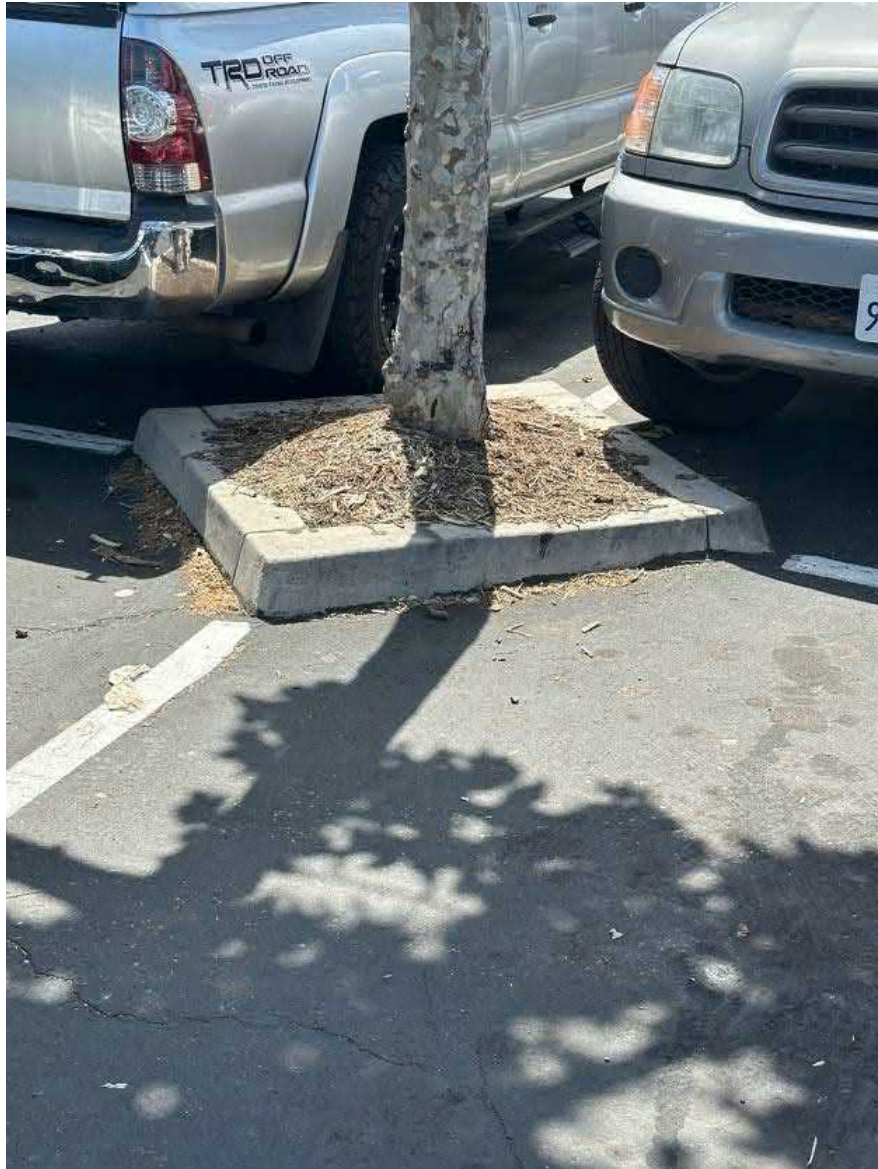
Home Depot on El Camino Real
Platanus racemose – California sycamore
Limited 4'x4' planting space

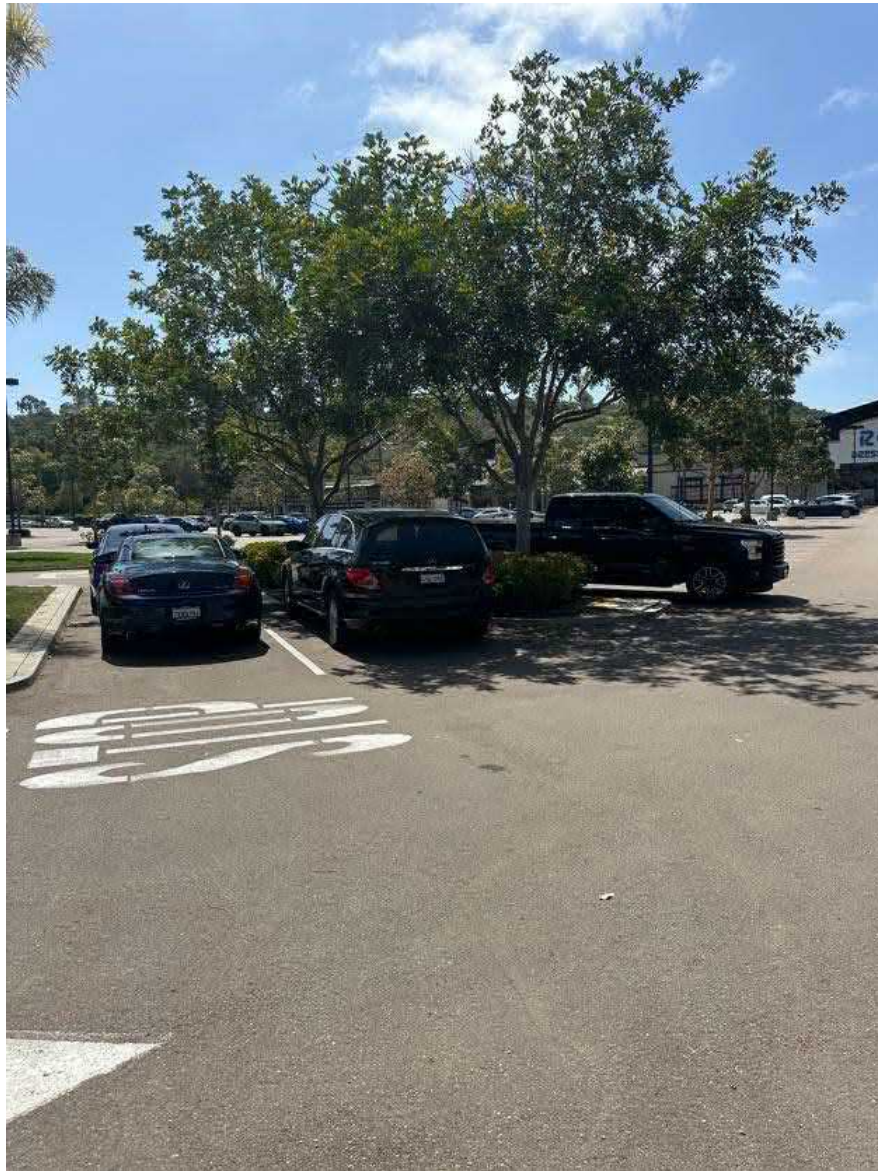
Encinitas Ranch Town Center on El Camino Real
Cupaniopsis anacardioides – Carrotwood tree
Cars parked in shade
Tree size larger related to greater soil volume compared to smaller planting sites

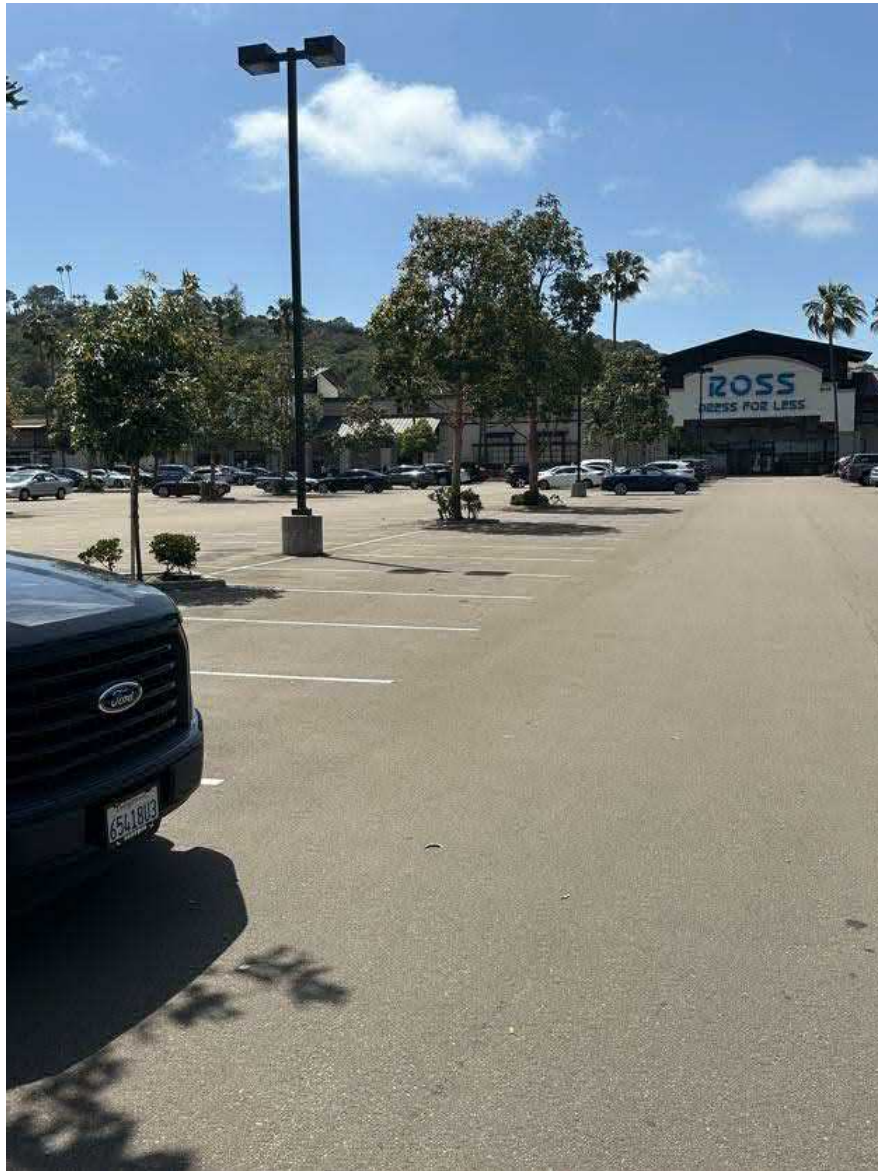
Encinitas Ranch Town Center on El Camino Real
Lophostemon confertus – Brisbane box
One tree for every 10 parking spaces in 4'x4' planting spaces

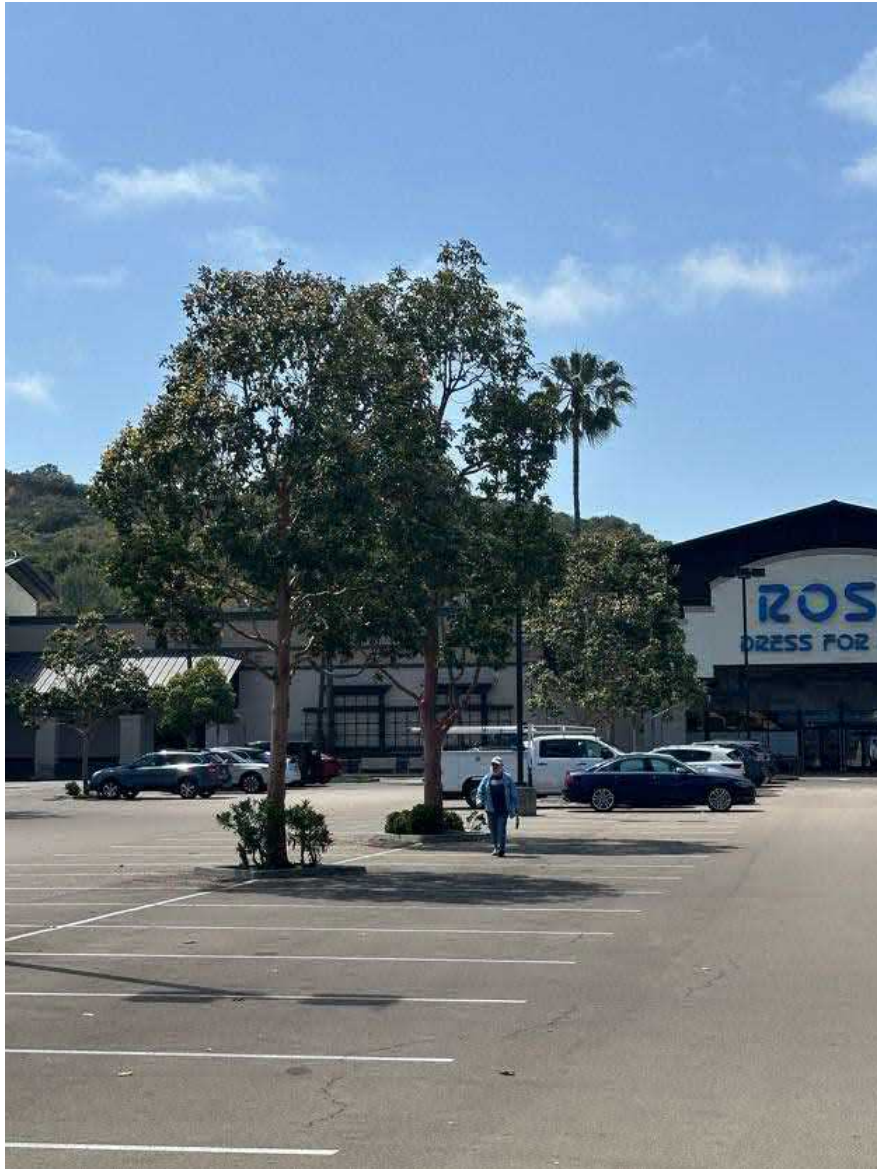
Encinitas Ranch Town Center on El Camino Real

Lophostemon confertus – Brisbane box

Shade cast for 1 parking space at 2:30p.m.

Trees have been pruned by over thinning and by reducing canopy size resulting in smaller and less dense canopy

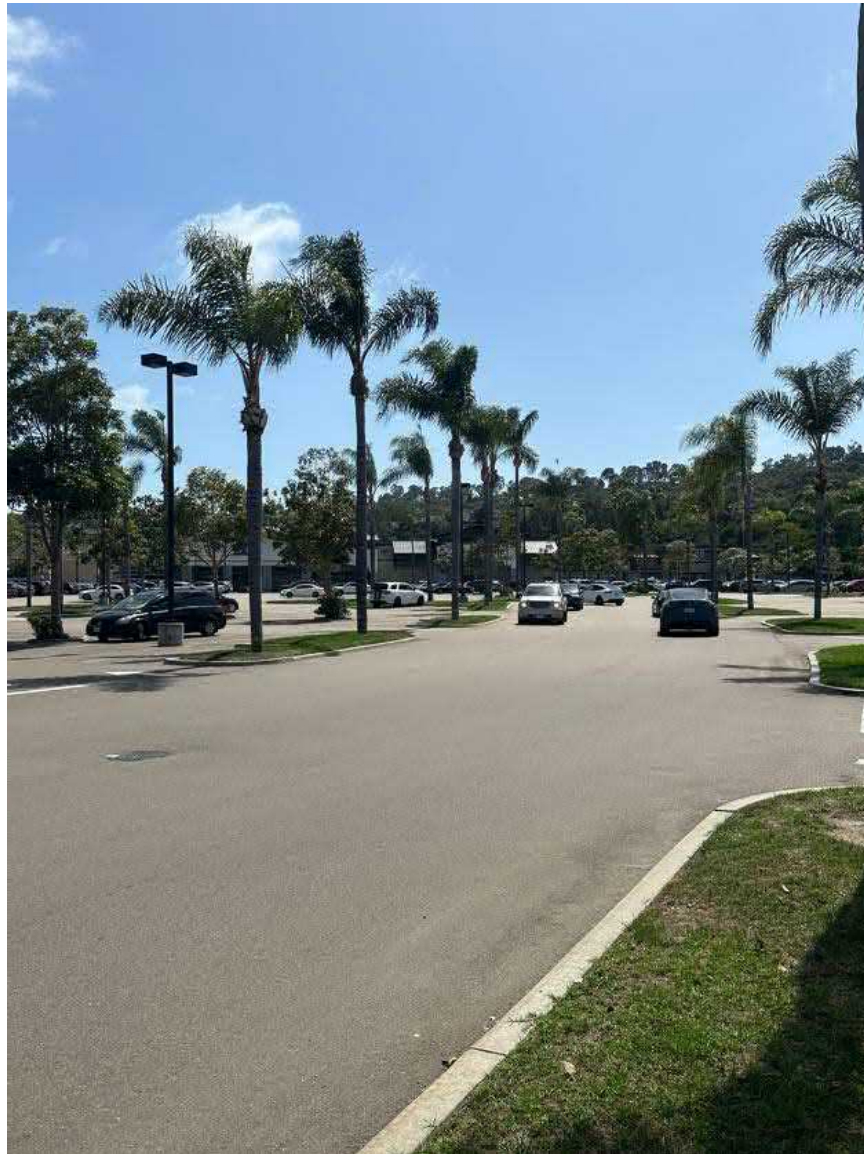
Encinitas Ranch Town Center on El Camino Real
Syagrus romanzoffiana - Queen palms – One of several palm species used in shopping center
Palms provide a minimum amount of shade and require annual pruning

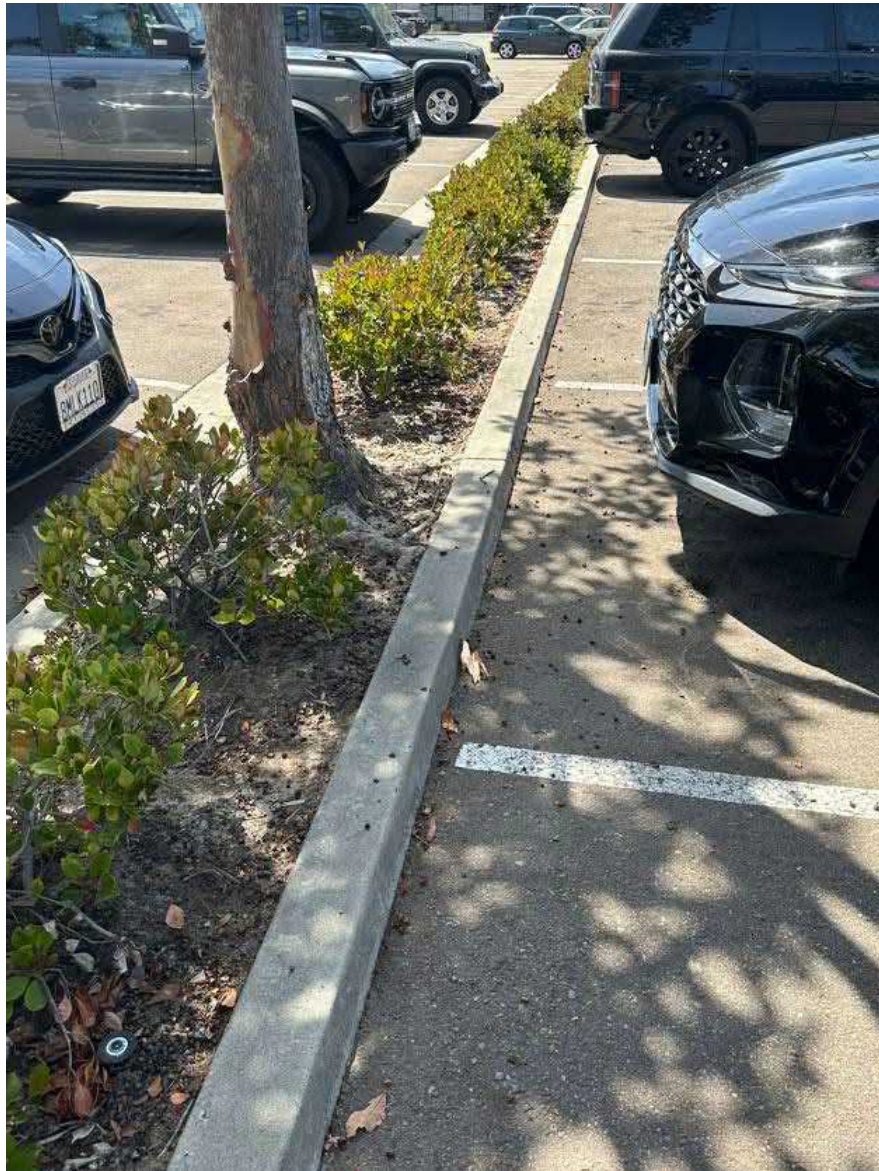
Encinitas Ranch Town Center on El Camino Real
Lophostemon confertus – Brisbane box
Tree in 3' wide planter damaged by car bumpers which typically extend 2' or more past tires

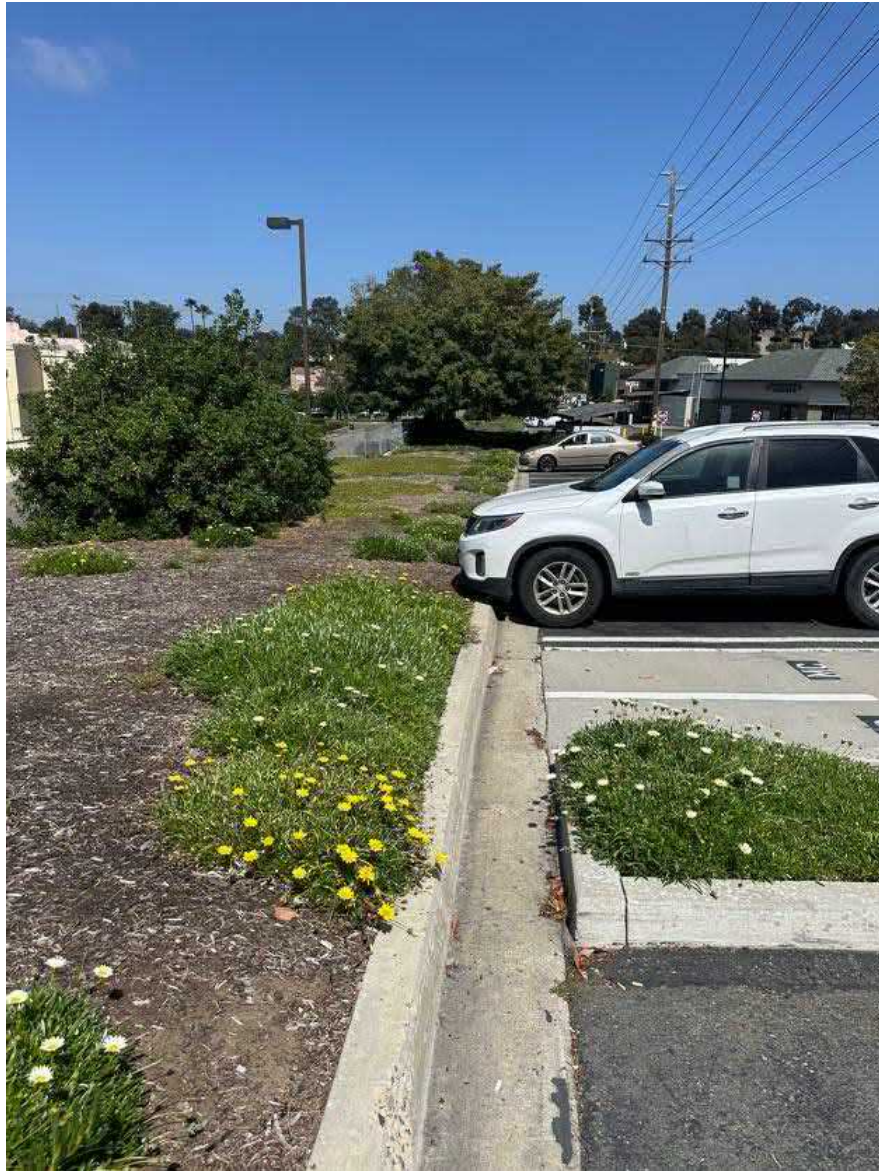
Dollar Store/Rubio's on El Camino Real
Ficus rubiginosa – Rusty leaf fig
1 of 2 trees in 18' wide planting bed

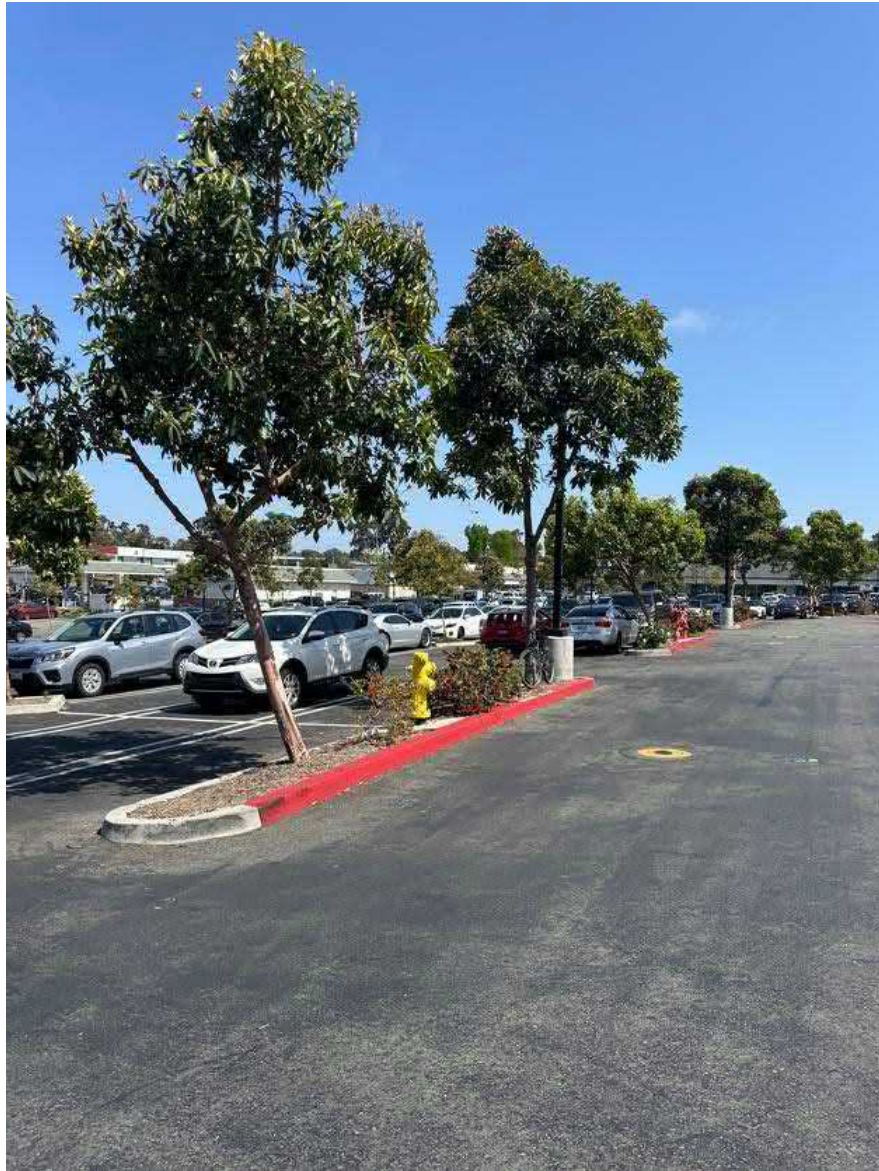
Dollar Store/Rubio's on El Camino Real
Lophostemon confertus – Brisbane box
Numerous utility and light pole conflicts

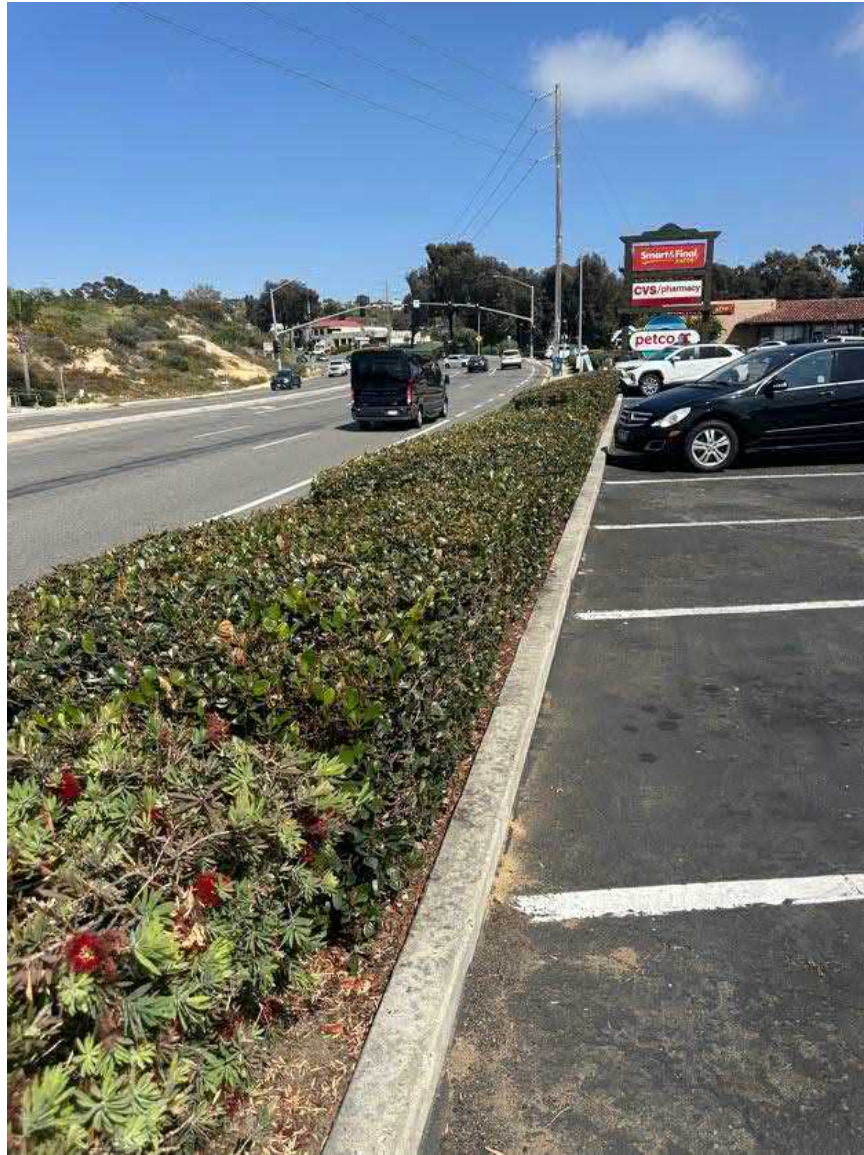
Smart and Final/CVS Pharmacy on Encinitas Blvd.
Europaea olea – Olive
All street trees have been removed with no replacements

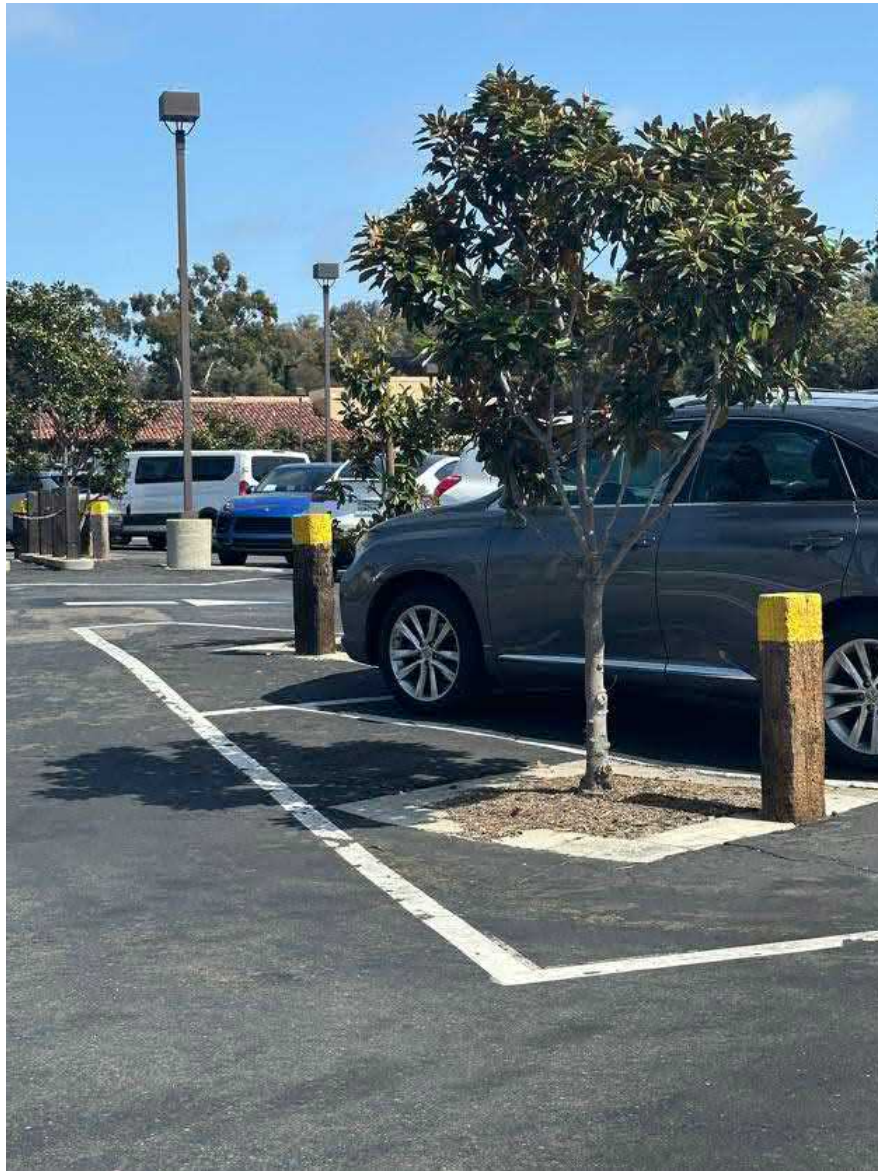
Smart and Final/CVS Pharmacy on Encinitas Blvd.

Magnolia grandiflora – Magnolia ‘Little Gem’

2 trees cast minor amount of shade

These trees were planted to replace mature removed *Platanus racemose* – California sycamore
