INITIAL SITE ASSESSMENT REPORT
for the
ENCINITAS HABITAT STEWARDSHIP PROGRAM
City of Encinitas, California

DUDEK
605 Third Street
Encinitas, California 92024
Contact: Anita Hayworth

AUGUST 2015

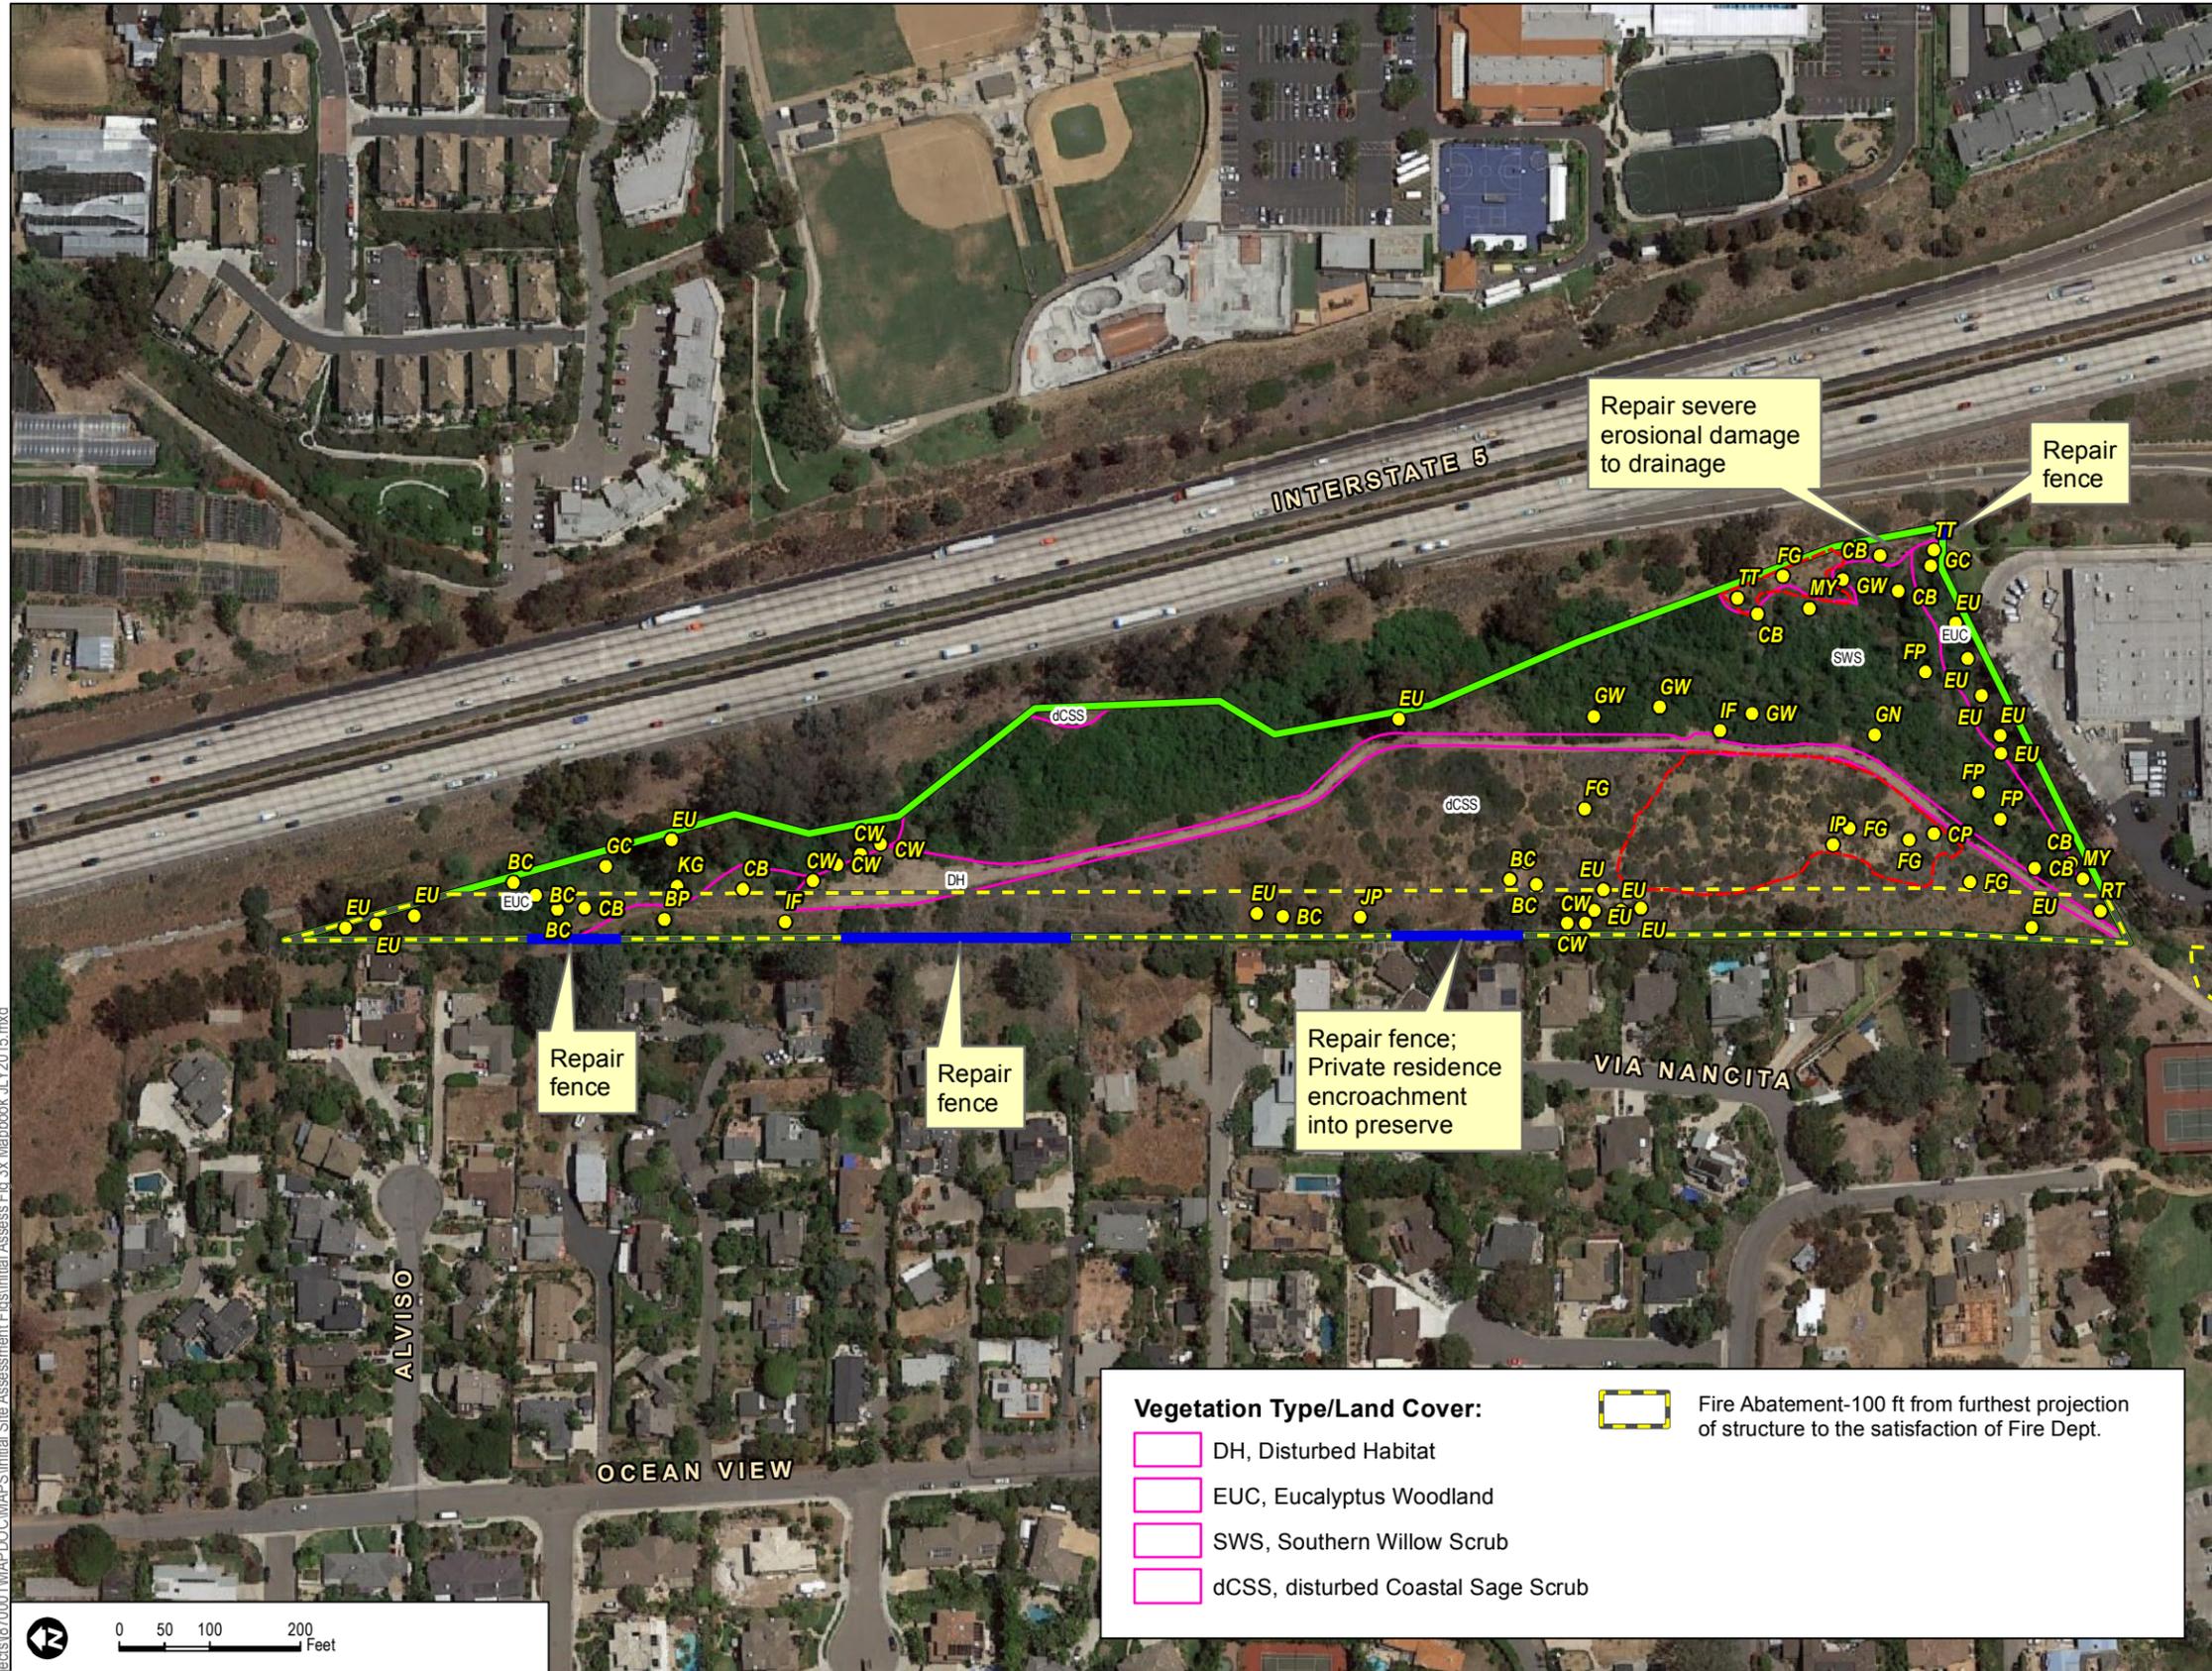
- Minor rilling scattered throughout the slopes on site.
- Two eroded gullies were observed in the southeast corner of the site. One of the eroded drainages formed at an unprotected storm drain outlet pipe. (Figure 3A; Photo 1). The cause of the other eroded gully is unknown, but appears to be from coalescing surface runoff on the slope. The eroded drainages would require substantial grading and heavy equipment work to be repaired; however, this would cause detrimental effects to the native habitat that is established in these areas. Therefore, an attempt should be made to first stabilize the erosion issue to prevent further erosion at these locations.

- Gap in the fencing on the southeast end of the project
- Fencing gaps along the western property line at the top of the slope (Figure 3A)
- Several trail spurs into the habitat on either side of the main trail.
- Approximately 350 feet north from the southwest edge of the open space area, a private residence has encroached into the open space (Photo 2).

5. Repair and stabilize eroded gullies in the southeast corner of the site. Line the eroded slope with a biodegradable coconut fiber blanket. Install biodegradable gravel bags in the eroded gullies and install check dams spaced every 10' along any noticeable flow lines. Place rock on the soil surface below the storm drain outlet to stabilize the land surface and minimize further erosion.

8. Coordinate fence replacement between residences and the open space on the western edge.
9. Repair fence break in the southeast corner of the open space

10. City staff will notify the homeowners adjacent to the open space area regarding encroachment into the open space at the residence located approximately 350 feet north of the southern boundary (Figure 3A) and will work with the owner to remove the encroachment. Dudek recommends providing a map of the conservation area to the adjacent homeowners.
11. Remove trash and landscape debris piles from open space and dispose of off site.
12. Coordinate brush management adjacent to the residential development in the west area of the site and along the southern site boundary near the commercial boundary (within 100 feet). The fire abatement area shall be 100' from the furthest projection of structures to the satisfaction of the Fire Department.

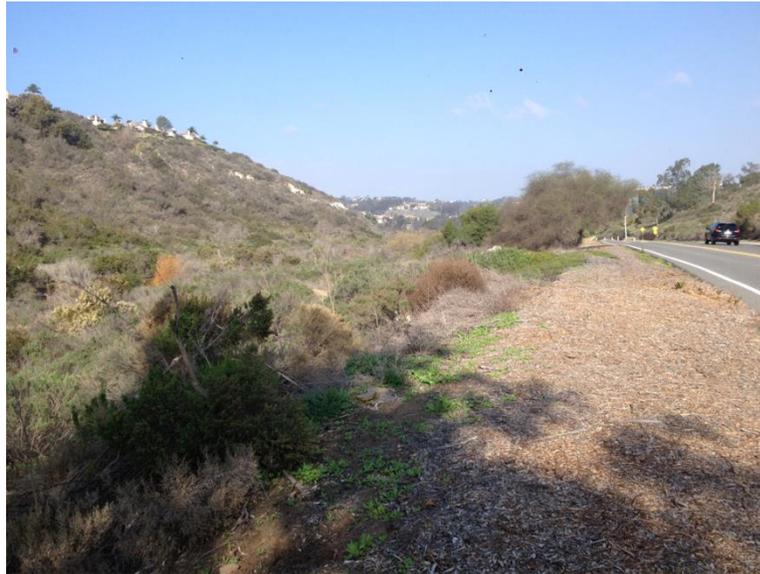
Photo 3: Looking north along Saxony Road from about halfway up the open space

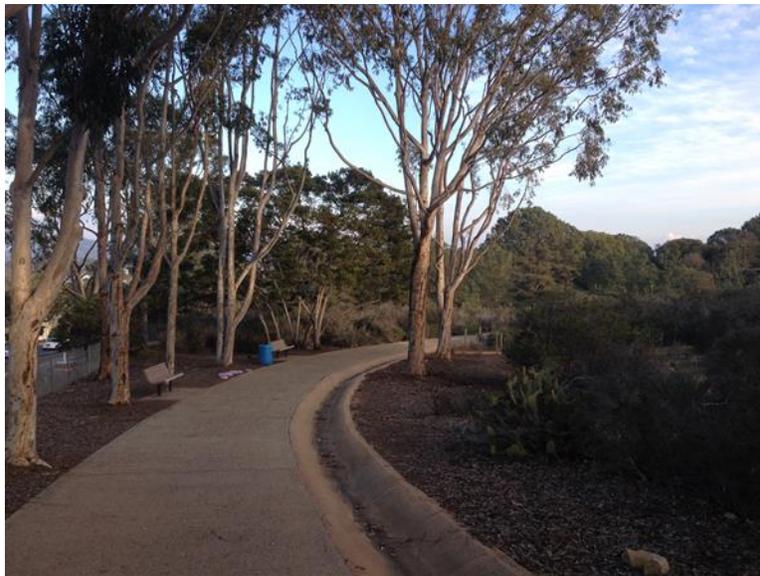
of the open space within an ornamental area (Photo 7). Invasive species were not a major issue on this site.

Photo 7: Looking east from the western border along concrete trail near majority of Eucalyptus trees on site.

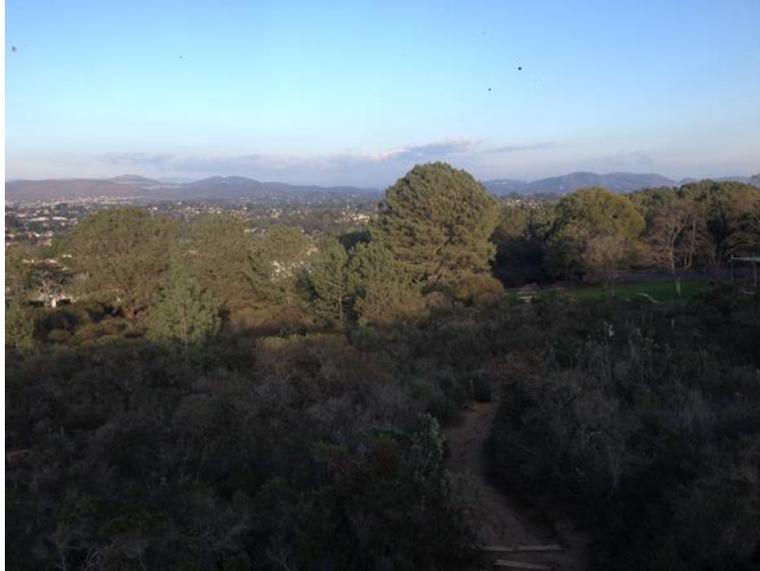
Photo 8: Photo taken from the eastern side of the Encinitas Senior Center looking east towards Oak Crest Park

5. Additional signage should be installed along the City established trail to encourage the public to stay on the trail as to avoid impacts to sensitive native habitat (Photo 8).
