CARDIFF AND ENCINITAS SEWER MASTER PLAN UPDATE

April 2011

The purpose of this Sewer Master Plan Update is to evaluate the City of Encinitas (City) existing and future sewer facility needs, make recommendations and prepare a preliminary opinion of probable cost for each of the proposed improvements. This Master Plan evaluates the condition and capacity of the major elements of the existing wastewater collection systems within both the Cardiff and Encinitas Sanitary Divisions, and makes recommendations for future system improvements.

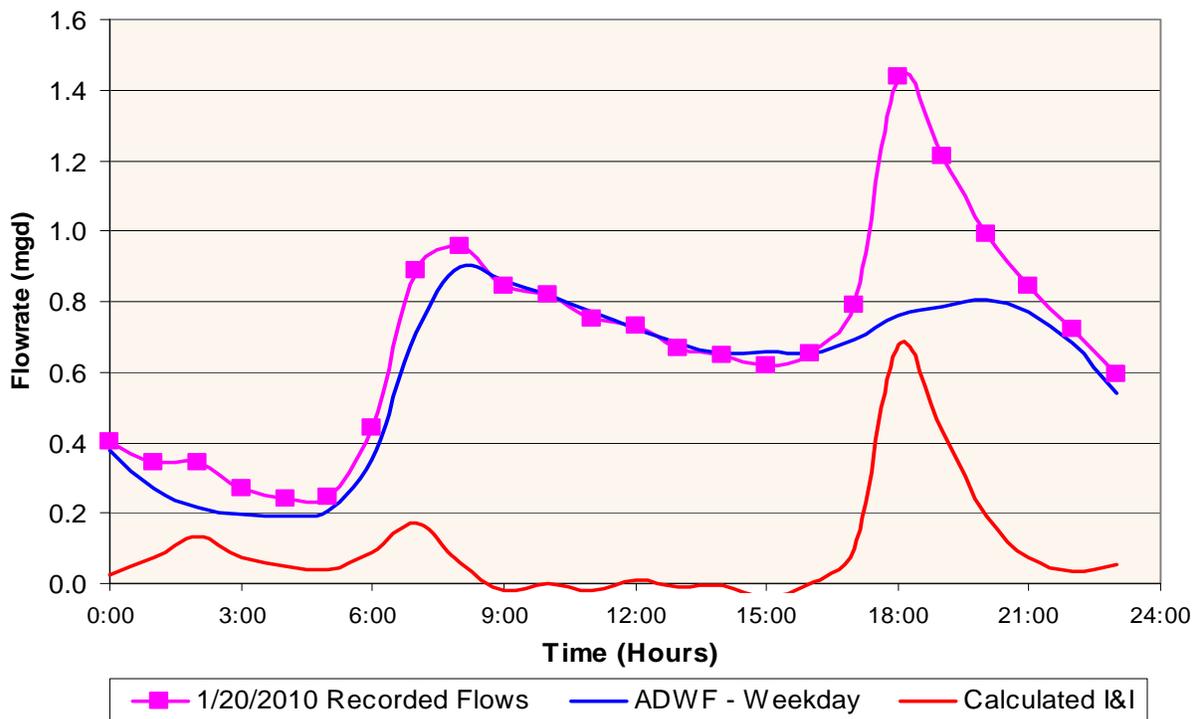
Figure 2-8 CTS I&I Analysis from 1/20/10

The flow meter data for the CTS shown on Figure 2-8 illustrates the method of I&I estimation that is used in this master plan update. On Wednesday, January 20, 2010 a high intensity storm moved over Encinitas and dropped over an inch of rain in the early evening. This storm event came after two previous days of rainfall. The recorded flow from the CTS meter on January 20, 2010 is plotted together with the ADWF weekday curve for the CTS on Figure 2-8, and the I&I rate is calculated from the difference in flows. From the data on this chart, the peak I&I is approximately 0.7 mgd. It is noted that the recorded PWWF would have been higher if the rainfall had coincided with the peak daily flow. Additional plots from selected storm events, which are the basis of the estimated I&I rates to each trunk sewer system, are included in Appendix A.

Results of the I&I analysis indicate that stormwater flows to the CTS, ETS, and the Cardiff Gravity Trunk Sewer are of short duration and primarily due to surface water inflow. The highest intensity storms result in the greatest increase in sewer flows, which return to near normal flows generally within a few hours after the rainfall has subsided. In the OTS, the I&I pattern appears more dependent on total

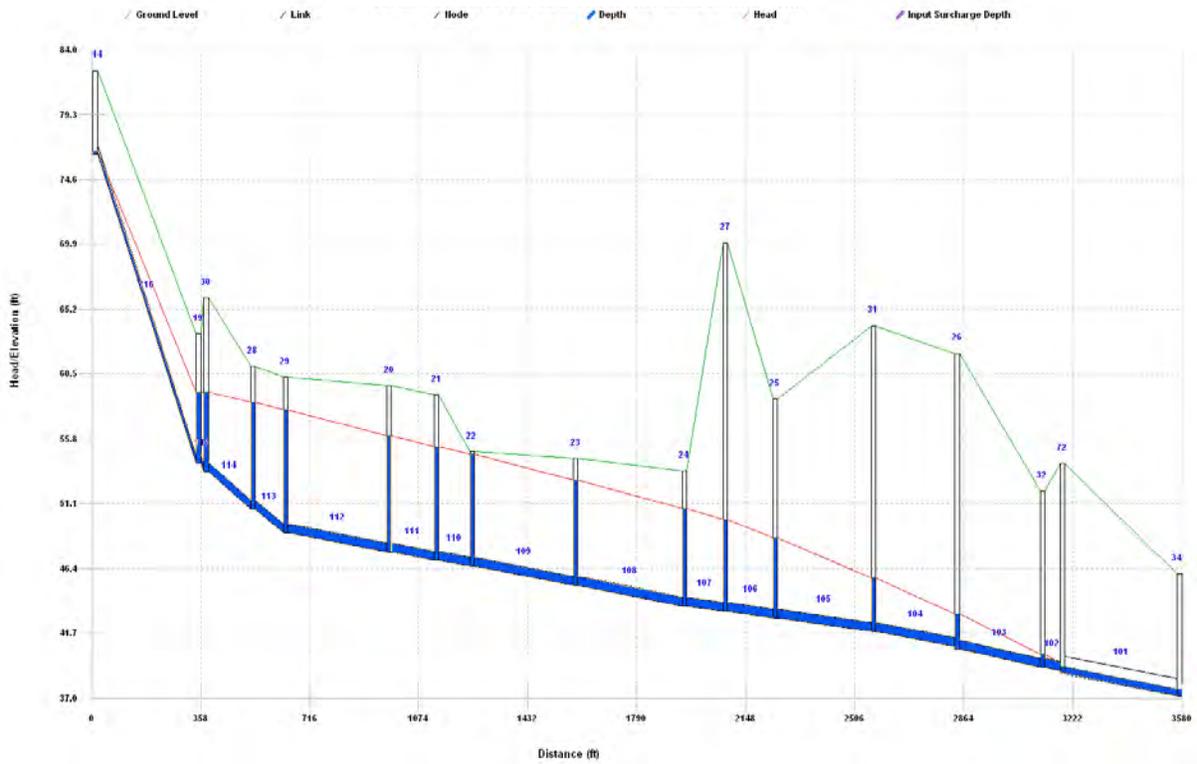
Figure 3-4 OTS Hydraulic Profile – Existing PWWF in 8” Upstream Reach

Under the existing PDWF condition, model results indicate that no trunk sewer reaches are flowing full. Two significant areas of the OTS are surcharging when analyzed under existing PWWF conditions. The first area is an upstream section of 8-inch diameter pipeline between El Camino Del Norte and Little Oaks Park. The hydraulic profile for this section, which is provided on Figure 3-4, indicates that one manhole is predicted to surcharge almost to the ground surface. The second predicted surcharge area is a 15-inch diameter section between 5th Street and the OPS. The hydraulic profile for this section is provided on Figure 3-4. It is noted that in the hydraulic model, flow is “stored” in the surcharged reaches and manholes, and therefore for the modeled wet weather event, the peak wet weather flow reaching the OTS is delayed and is somewhat less than the peak flow input to the hydraulic model.

Both of the surcharged areas in the OTS were identified as Phase 2 capacity upgrade projects in the previous master plan. See Chapter 6 for the recommended phased approach to addressing the current capacity limitations within the OTS.

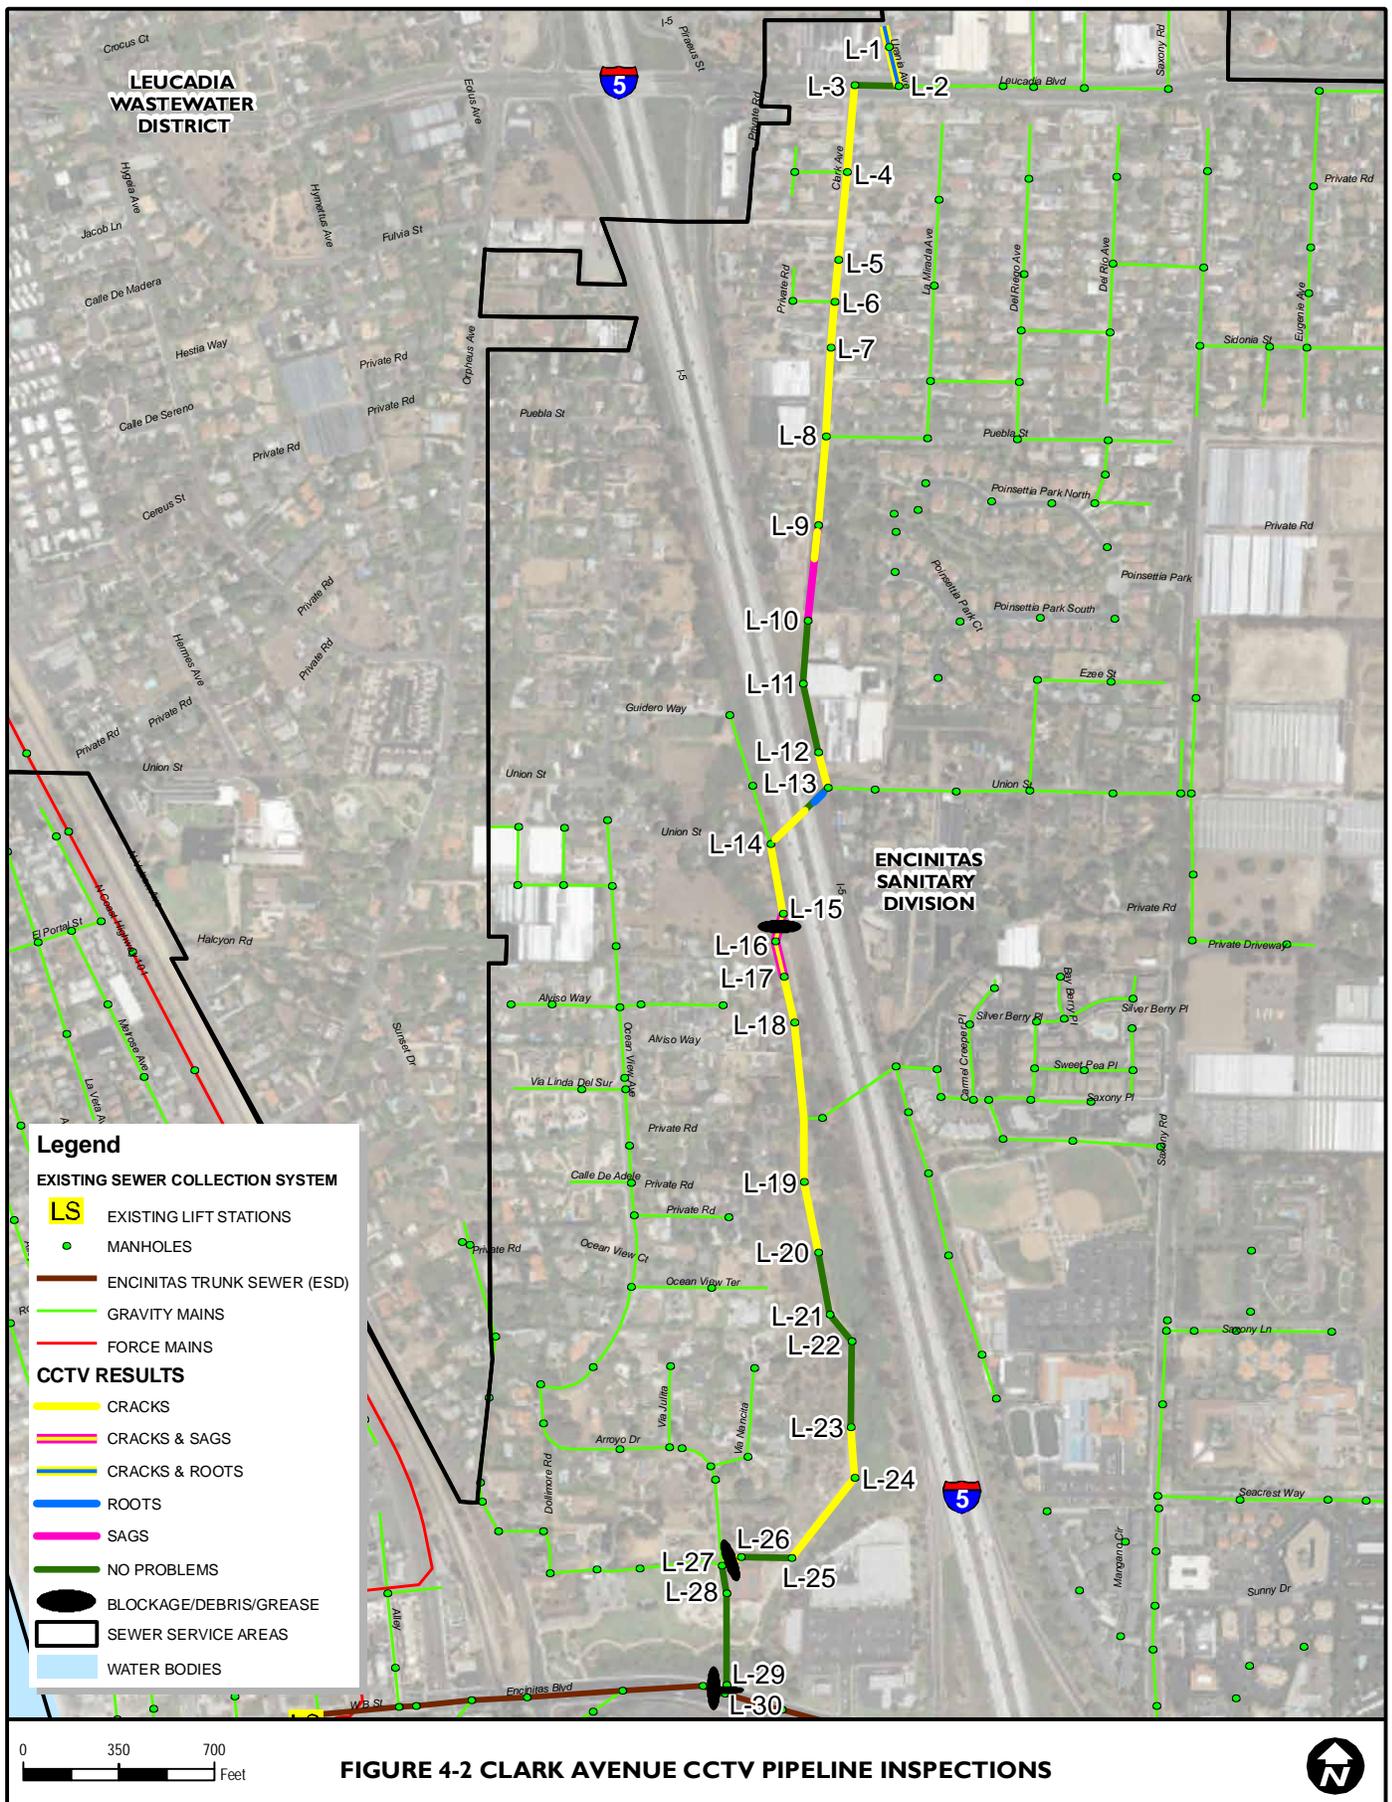
Approximately 7,050 linear feet of 8-inch and 10-inch diameter VCP pipe was inspected in Clark Avenue and the downstream continuation west of Interstate 5, which is aligned in an easement through Cottonwood Creek Park. Figure 4-2 illustrates the pipeline reaches that were inspected and summarizes the general condition of the pipelines. A short section of this pipeline just west of Interstate 5 is above ground and supported on concrete saddles. Most reaches of this pipeline have cracks, and there are a few reaches with sags. Roots are generally not a problem, except in the most upstream reach in Urania Avenue. A section of pipe in Urania Ave was repaired following the inspection due to cracks and soil entering the pipe. The camera was impeded by heavy debris and sediment deposits at four locations. There are short sections of CI and PVC pipe in several reaches, and the camera could not pass through one CI section due to the pipeline surface roughness and a sag (Reach L15-L16).

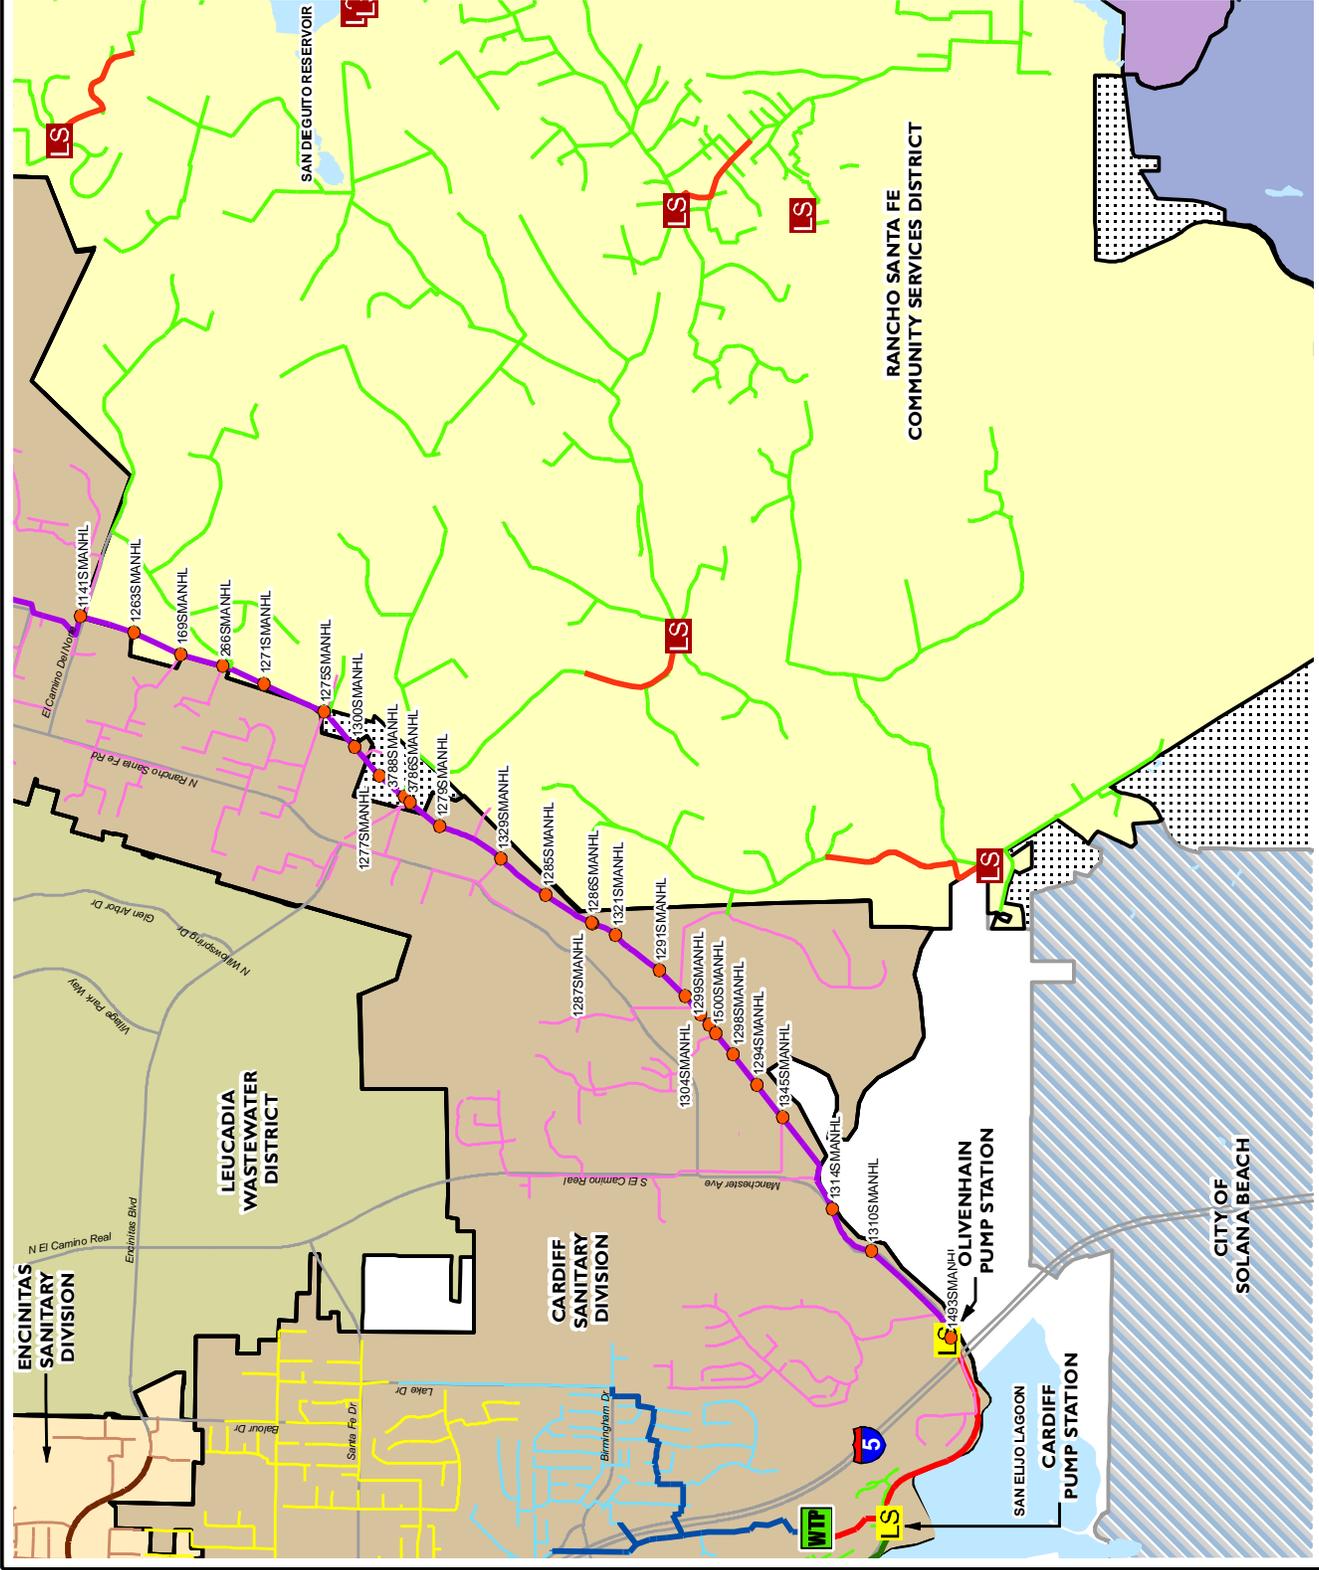
MANHOLE INSPECTIONS

It is noted that the manholes were inspected during the summer, when lagoon and groundwater levels are lowest. Much higher infiltration rates would be expected during the rainy season and periodic flooding of the adjacent lagoon and creek, when some manholes are submerged. Surcharge evidence was also noted at several manholes. Some examples of the surcharge evidence observed included debris located on steps or the bench, and/or water marks on the walls. Five (5) manholes were identified as showing evidence of surcharge.

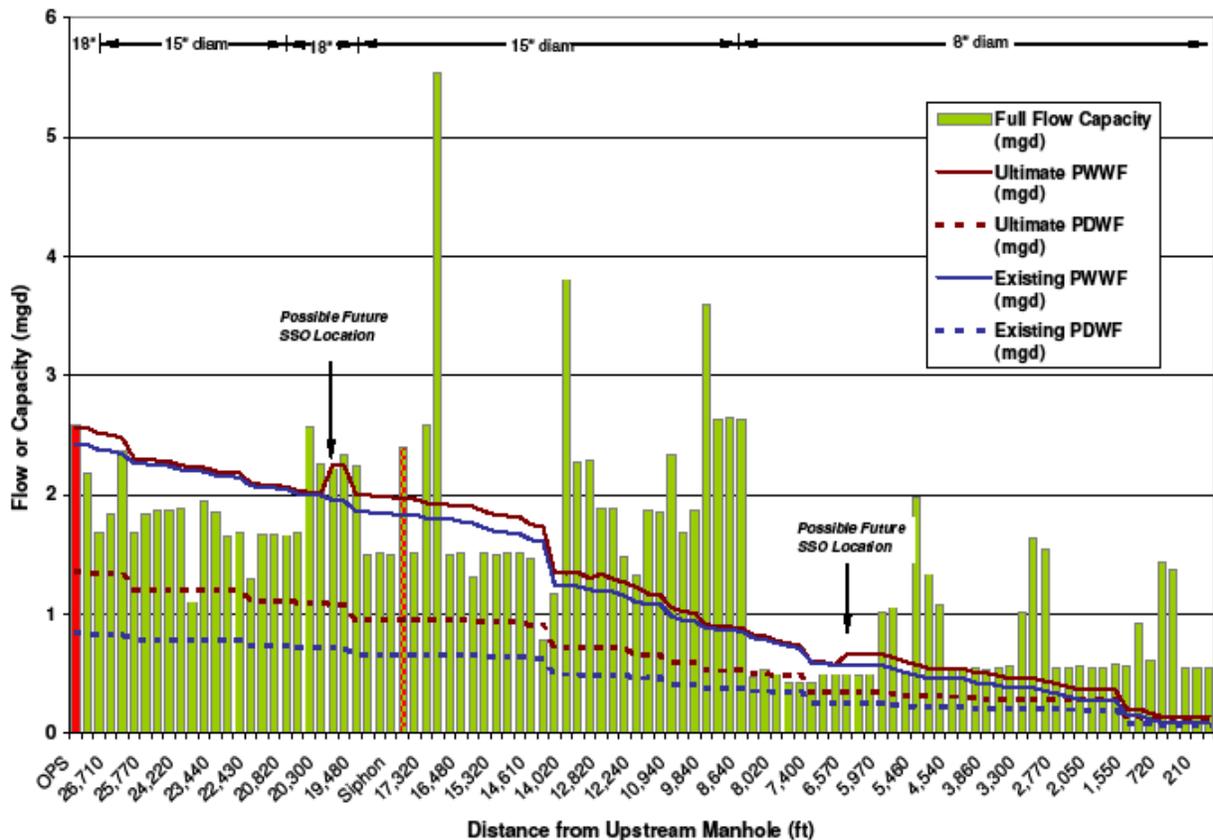
Figure 5-2 OTS Capacity and Modeled Flow Distribution

Figure 5-2 illustrates the calculated full flow capacity of each reach in the OTS (green bars) and the existing and ultimate flows that were modeled (blue and red lines). Areas where flow lines are above the capacity bars are surcharged under that specific flow condition.

In the upstream (Reach 3) 8-inch diameter section, results from the ultimate PDWF analysis indicate that five reaches in the easement south of the bend in Lone Jack Road are flowing above 75 percent full, and two of these reaches are surcharged. Under the ultimate PWWF condition the entire length of the pipeline between El Camino Del Norte and Little Oaks Park is surcharged, as illustrated in Figure 5-3, and the model indicates flow loss (potential sanitary sewer overflow) at one manhole. Furthermore, flow monitoring during wet weather periods should be conducted to confirm the I&I assumptions this far upstream from the SEJPA meter.

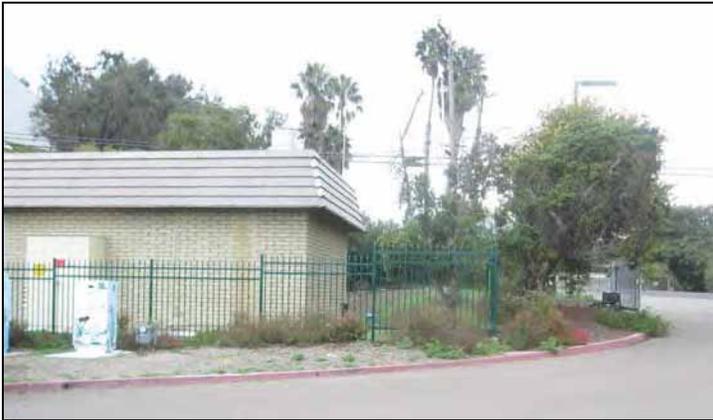
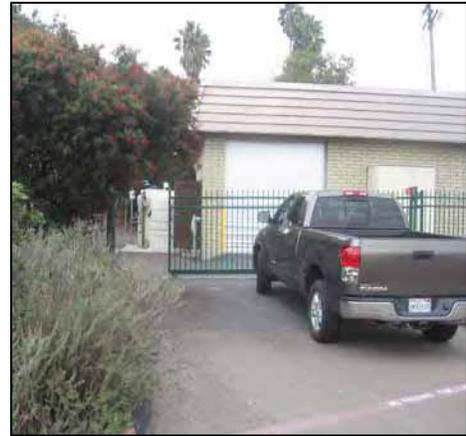
1. General Situation

The Cardiff lift station design is similar to the Solana Beach lift station design. It was constructed in the 1980's, and has seen approximately 30 years of service. There are three vertical non-clog pumps that have extended drive shafts that connect to motors located on the upper floor. As originally constructed, the pumps used 230 volt power. The electrical system has subsequently been converted to 460 volt power. There are two 40 hp pumps and one 20 hp pump:

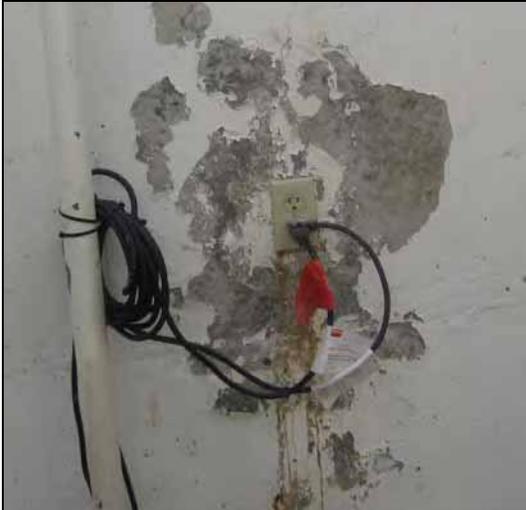
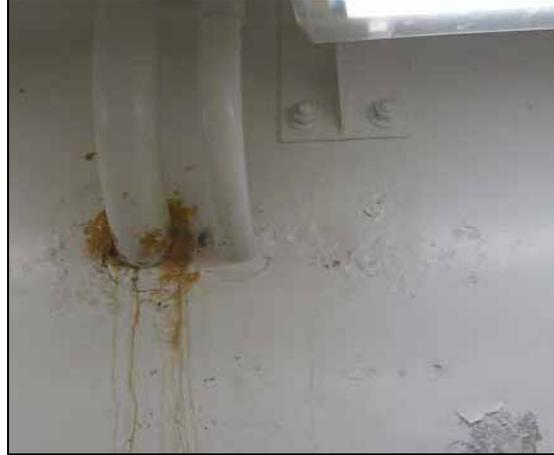
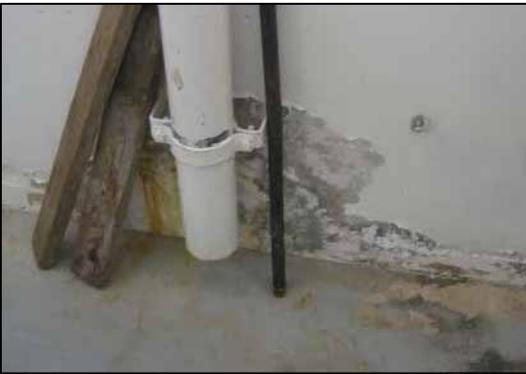
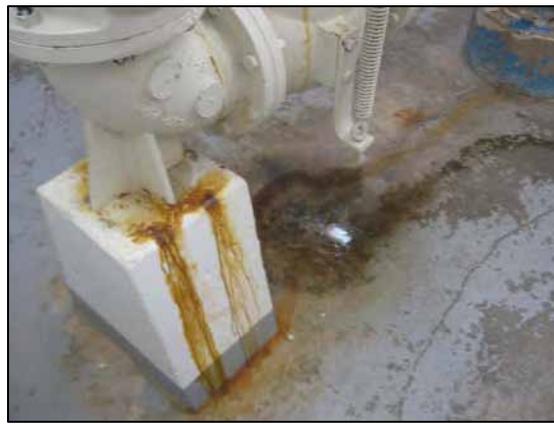
The Pump Room is subject to significant seepage through the concrete walls and by leaks at certain wall penetrations. A wall switch (ON/OFF switch for a fan) is wrapped in plastic to keep it from being damaged by flow that seeps through the walls.

Cracks in the walls should be pressure grouted to seal them against leakage.

Imperfectly sealed wall penetrations should also be pressure grouted to seal those openings against leakage.

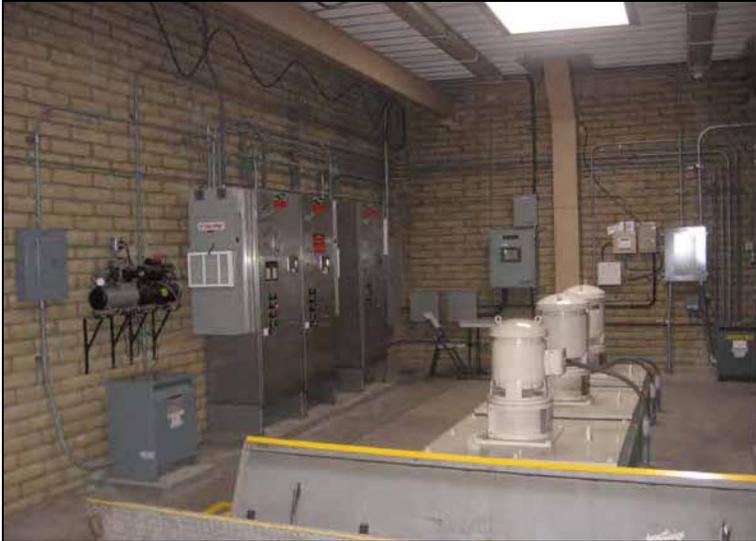
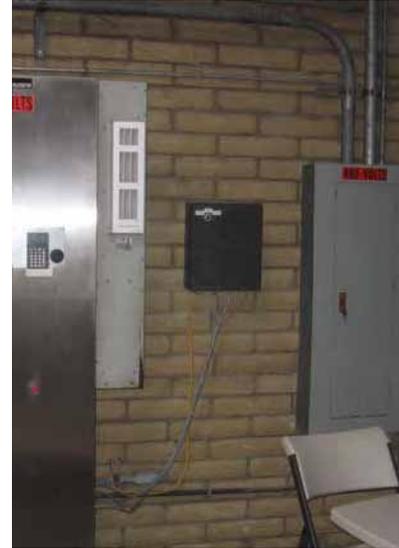
The original electrical gear was manufactured by Autocon (including the variable speed drives). Wet well level sensing is by a bubbler system comprised of dual tank-mounted air compressors, and appurtenant tubing and pressure transmitter. The 4 to 20 mA analog signal from the bubbler system is sent to the VFD's to control pump speed. A wall-mounted control box has been added to automatically change the lead/lag designation among the two main pumps. In April 2009, a new automatic transfer switch (ATS), new Main Switchboard, and new power distribution panel (with breakers) were installed. There are excessive short-circuit (or breaker-tripping) incidents. A short-circuit study may be necessary to evaluate why this is occurring and to recommend a solution.

- D. The electrical system experiences too many unexplained breaker trips. SEJPA Staff have made adjustments to reduce the frequency of such “trips”, but they are still occurring at an undesirable frequency. A short-circuit study is recommended to evaluate electrical system characteristics, with the goal of identifying where new breakers, breaker settings, or other improvements are required to achieve the lowest possible frequency of breaker trips.

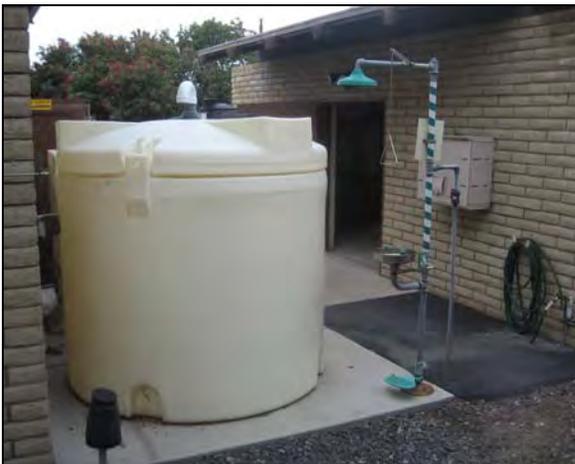
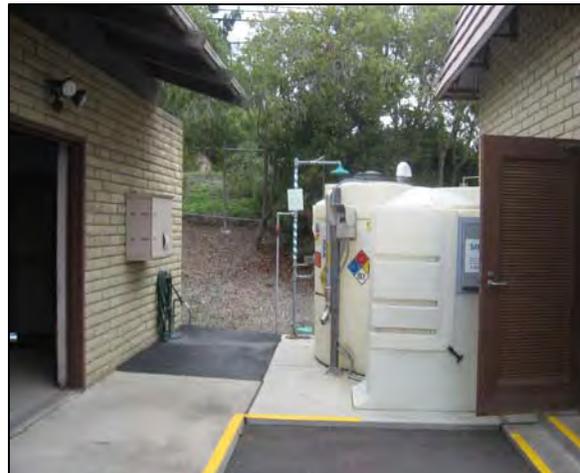
Hydrogen peroxide (H₂O₂) is introduced into the wet well for the purpose of odor control. This system is comprised of storage tank and control panel that are installed at-grade on a concrete slab between the Pump Building and the Standby Power Building. An emergency eye-wash facility is provided near this equipment for worker safety. The presence of this equipment between the two buildings limits equipment access (e.g. vactor trucks or trailer pumps) to the backside (i.e. north side) of the Pump Building.

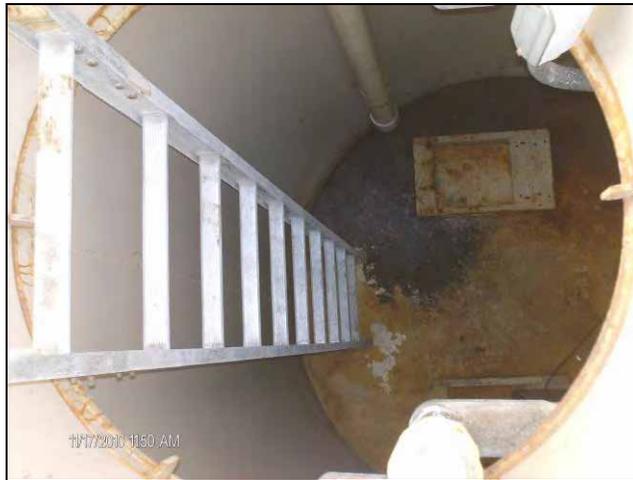
The two suction lift pumps were removed years ago by SEJPA Staff from this facility, because those pumps were unreliable. The cause for such unreliability was not explained to Dudek. It may be that the pumps were losing their prime, or were unable to vent air from the pump volute....either of which can be caused by worn out appurtenances to the pumping system. New suction lift pumps could be installed in the existing steel enclosure, thereby restoring the original lift station concept for this site. The wet well would still need to be rehabilitated, as well as renewing the piping in the valve vault. The electrical gear would not require replacement unless the new suction lift pumps required larger motors than the existing submersible pumps.

This alternative entails restoration of the interior concrete surfaces of the wet well, and replacement of the access hatch and access hatch concrete risers. Corroded ferrous materials will be replaced per determinations made once the wet well can be closely examined. All interior surfaces will be coated with a product appropriate for the wet well environment (e.g. Sancon 100).

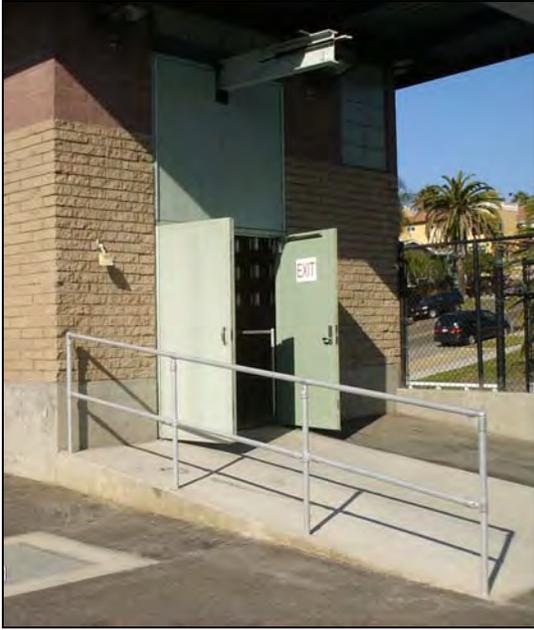
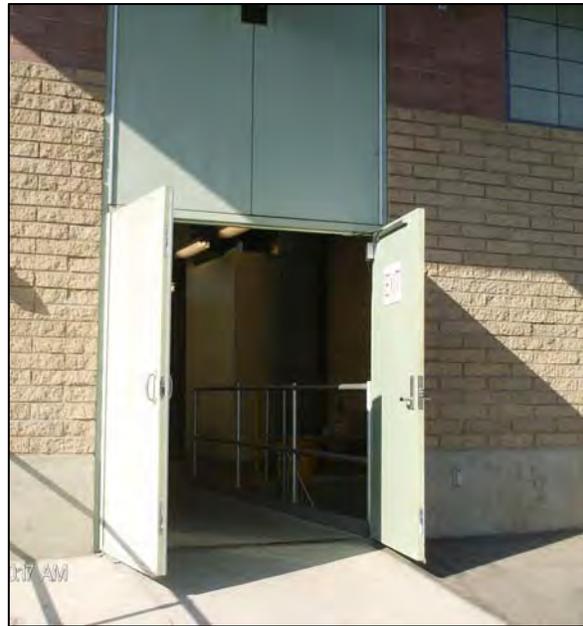
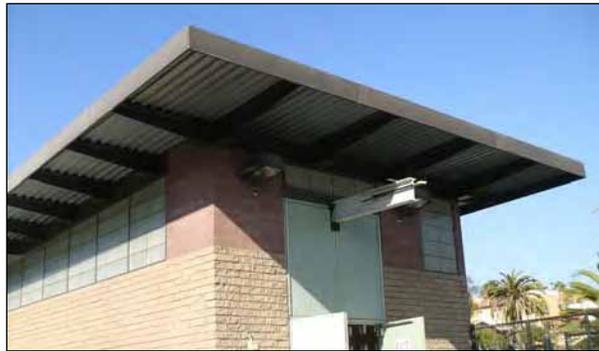
- A. The doors do not open far enough to allow a truck to back up to the load drop point when the trolley is at its furthest point along the monorail beam.
- B. Because the truck cannot back beneath the load drop point, they must drop the load on the sloping concrete ramp/driveway.

- C. Because the ramp is sloped, the dropped load must be stabilized to prevent it from tipping over and rolling down the ramp. The load can be stabilized, but it is not easy to do so.
- D. Once the load is stabilized on the sloping ramp, they must then bring in a truck that has a truck-mounted jib crane, which can lift up that load and place it onto the truck. This is feasible, but it is not easy to maneuver the truck to the required location to do this lifting because the ramp guardrail interferes with positioning of the truck onsite.

- (1) *Option #1: Extend the monorail beam another 5 to 7 feet to allow a truck to back beneath its load drop point.*
- (2) *Option #2: Modify the doors (both sets; the lower pair of doors, and the upper pair of doors) to allow the doors to fold flat against the building wall. This may entail using a different type of door hinge, and/or re-positioning the door frame within the masonry wall opening such that the masonry walls do not preclude the doors from swinging flat against the walls.*

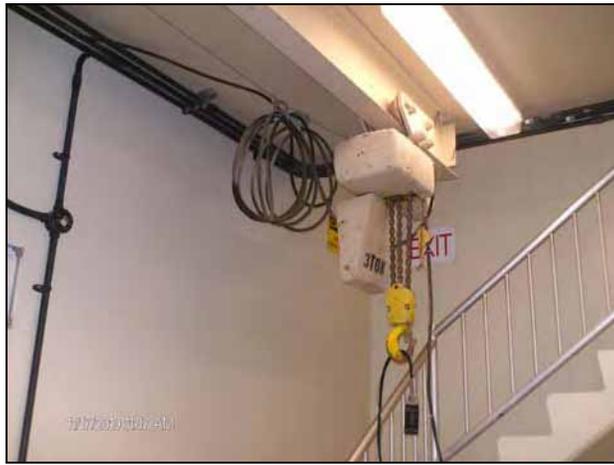
The Pump Room has a monorail that can lift and convey equipment that can be moved to a position directly beneath that beam. All of the mechanical equipment is located south of that monorail. Thus, when a pump, motor, inline grinder, or valve must be removed from the Pump Room, it is necessary for SEJPA Staff to remove that equipment and man-handle it to a location beneath the monorail beam. That is difficult to accomplish.

- (1) *Is it feasible to provide “turnouts” from the monorail that would allow lifting to occur at a point nearer where the equipment is mounted? Dudek’s preliminary analysis suggests that the Pump Room ceiling is not high enough to allow the trolley with hook in highest position to pass over the pumping units. But it may be possible to locate one or more monorail turnouts in areas where the hoist can be effectively used.*
- (2) *Provide a wheeled A-Frame that can be positioned over equipment such as valves, to allow that gear to be lifted and then rolled to a location beneath the monorail.*
- (3) *Provide a low-drag equipment pallet that can be pushed adjacent to heavy equipment. When that equipment is removed (in whole or in part) it can be loaded onto the equipment pallet and pushed to a location beneath the monorail.*
