PACIFIC VIEW ELEMENTARY

Rehabilitation & Re-Use Study

August 10, 2015
90% Review Draft

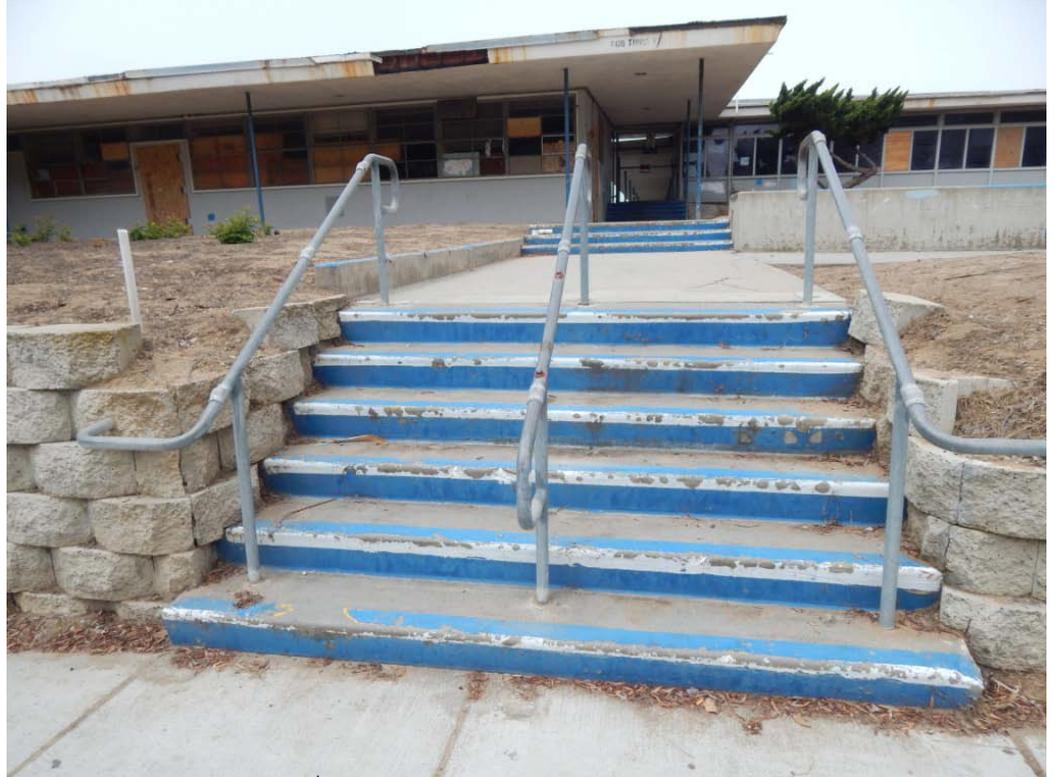
- **Site Accessibility from Public Right of Way**
An ADA compliant accessible path of travel from the public Right of Way (ROW) was not observed during field investigation. The primary access to the site appears to be located southwest of the intersection at 3rd and West E Street. Access consists of a stairway along 3rd Street and a ramp along West E Street. The existing ramp does not appear to meet ADA requirements for an accessible ramp. Slopes along the path of travel leading to the ramp are in excess of 5% and do not provide adequate hand railing. In addition, thresholds at doorways exceed the 1/4" maximum for accessibility.

Existing Main Entrance (3rd Street)

- **Site Accessibility from Public Right of Way**
Remove existing main entrance access point south of the intersection of 3rd Street and E Street. Reconstruct ADA path from E Street access point to ADA path of travel to the North and East Buildings in compliance with local, state, and federal codes and requirements. An ADA assessment should be performed to

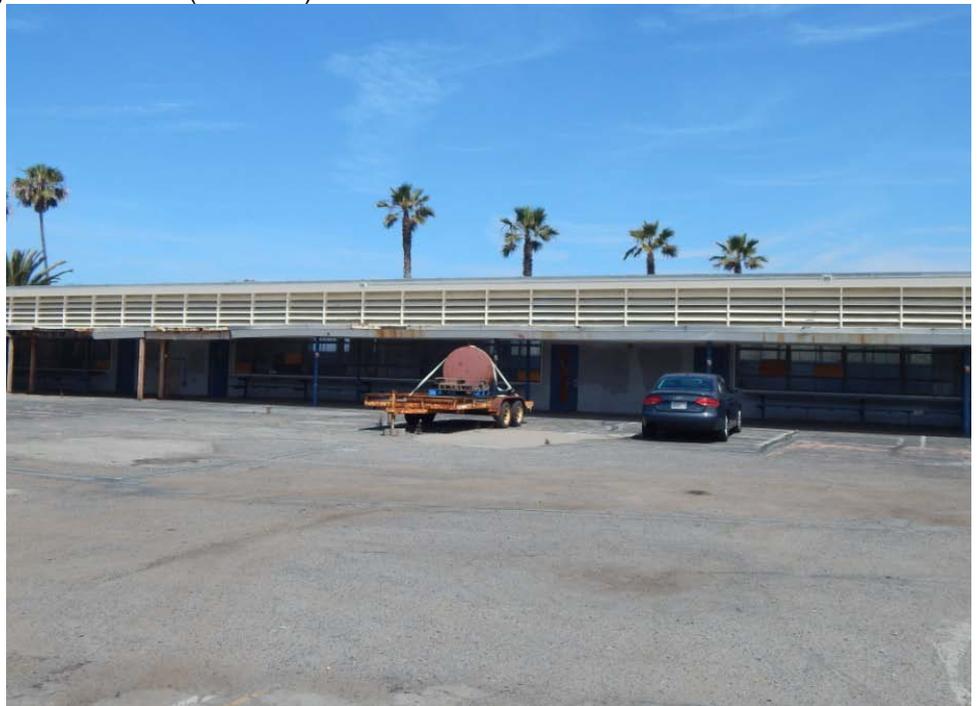
- **Accessible Parking**
No designated ADA parking was observed during our field investigation.
- **Interior Accessible Route**
Areas along the common path of travel around the existing buildings appeared to be non-compliant with ADA accessibility requirements. Concrete and asphalt pavements appear to be uneven, damaged, or contain non-compliant fore and cross slopes. Additionally there does not appear to be a compliant accessible path to the lower level of existing East Building.

Existing Parking (Looking North)

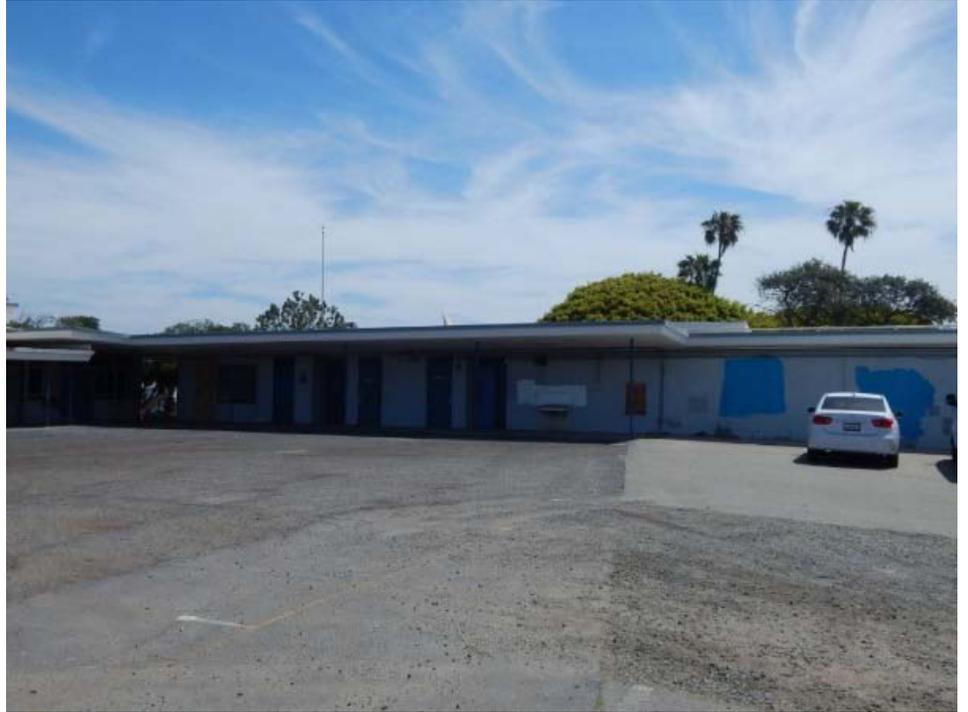
Existing Parking (Looking East)

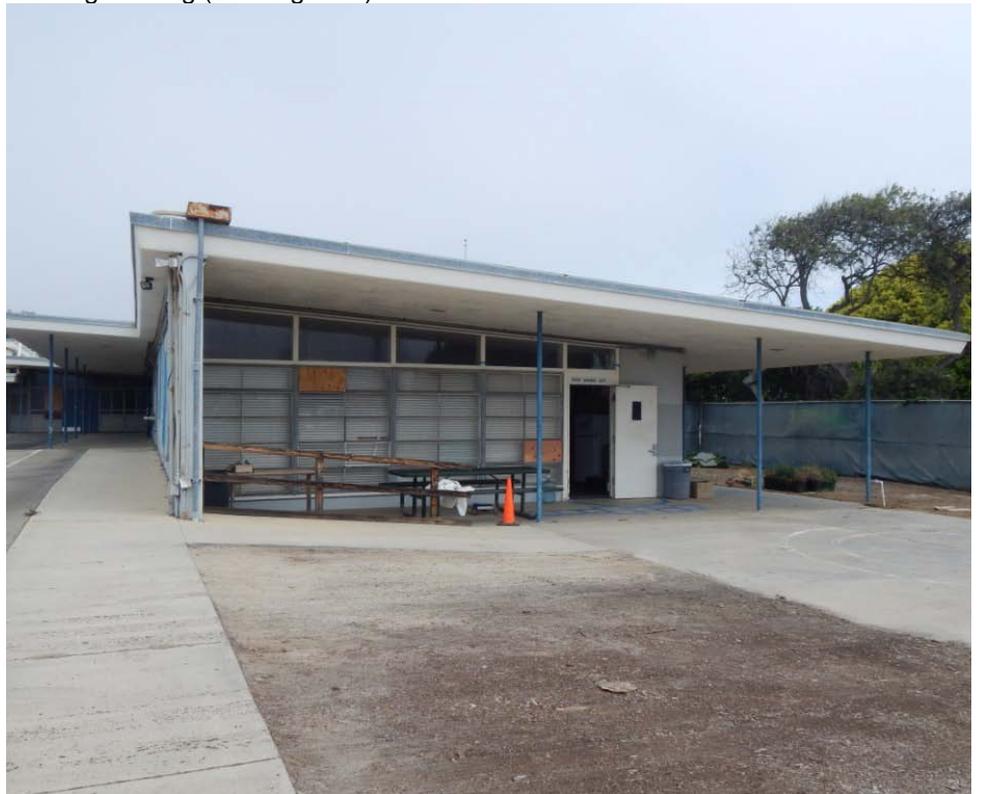
Existing East Building Access (Looking North)

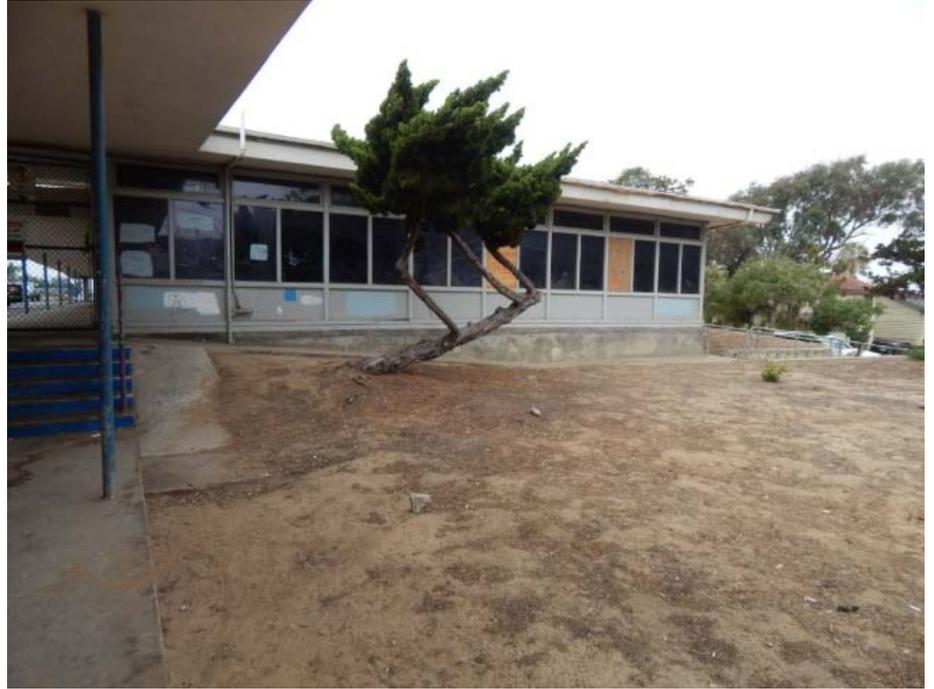
Existing East Building Access (Looking West)

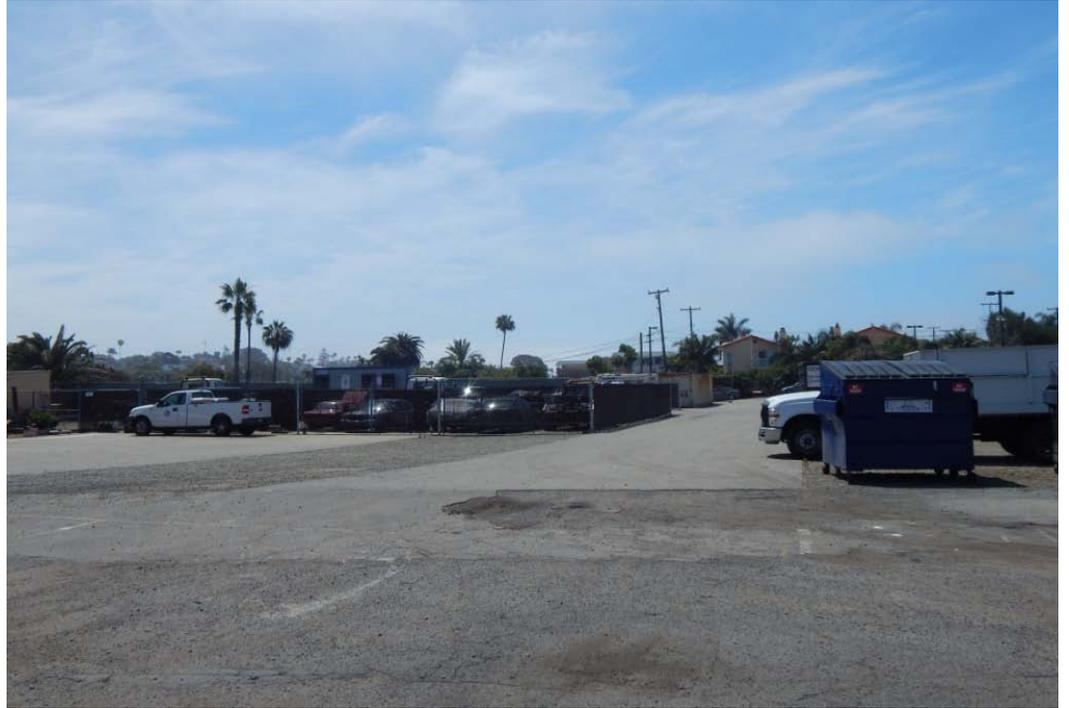
- **Travel ways**
The existing parking lot travel way appears to be to be unmaintained and in generally poor condition. Parking and travel way are poorly defined by the lack of adequate pavement striping or signage. Structural damage was observed in some areas of the site consisting of rutting, cracking, raveling, stripping, and potholes. Damage caused by neighboring tree roots was also observed on the south and west portions of the site.

Existing Travel Way (Looking South)

- **Travel ways**
Provide at least 24-feet of improved unobstructed pavement width for all travel areas with an inside turning radius of 28-feet for fire access, including providing any structural sections within unpaved areas that require fire access per the City of Encinitas requirements. It may be necessary to consult with a qualified arborist regarding impact to neighboring trees if trees are to remain (Refer to Recommended Pacific View – Option IIIA Site Plan).

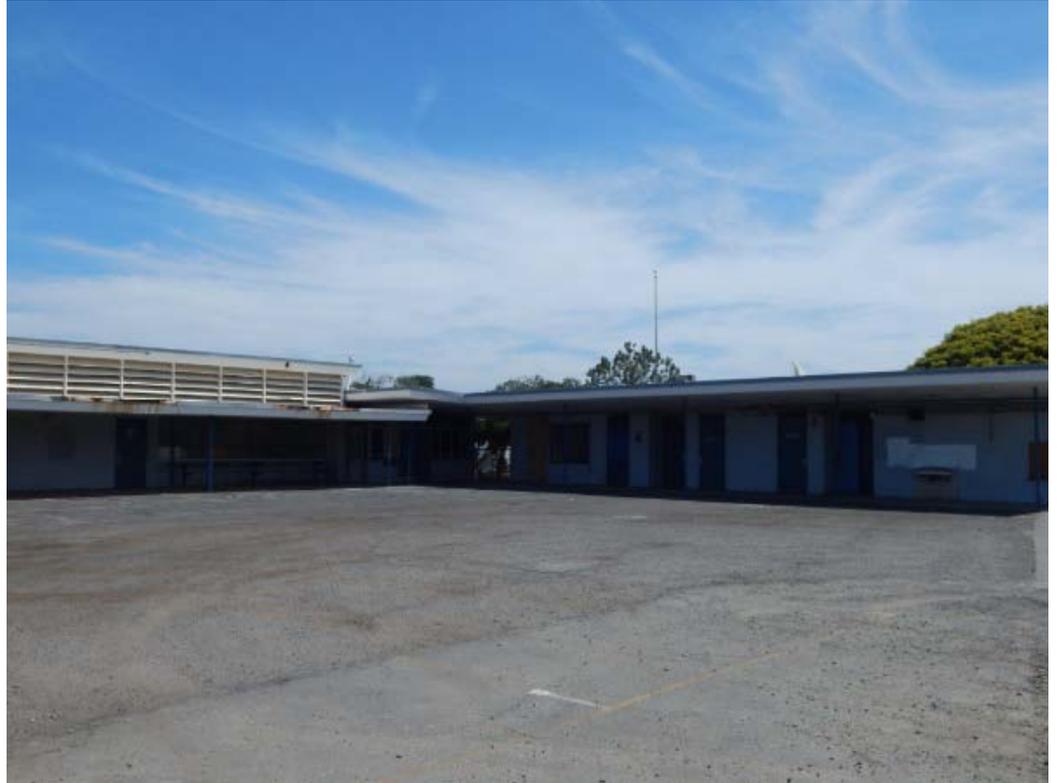
- **Parking Areas**
During our site investigation, vehicles were observed parking in marked asphalt stalls and in unmarked dirt parking areas between travel ways. Asphalt parking areas are in similar physical condition compared to the travel ways. Dirt areas have a light to patchy gravel covering with some areas completely exposed to dirt. Limited erosion and rutting was observed in the dirt parking areas. Pavement stall marking appeared to be unmaintained and well worn.

Existing Parking Striping (Looking North)

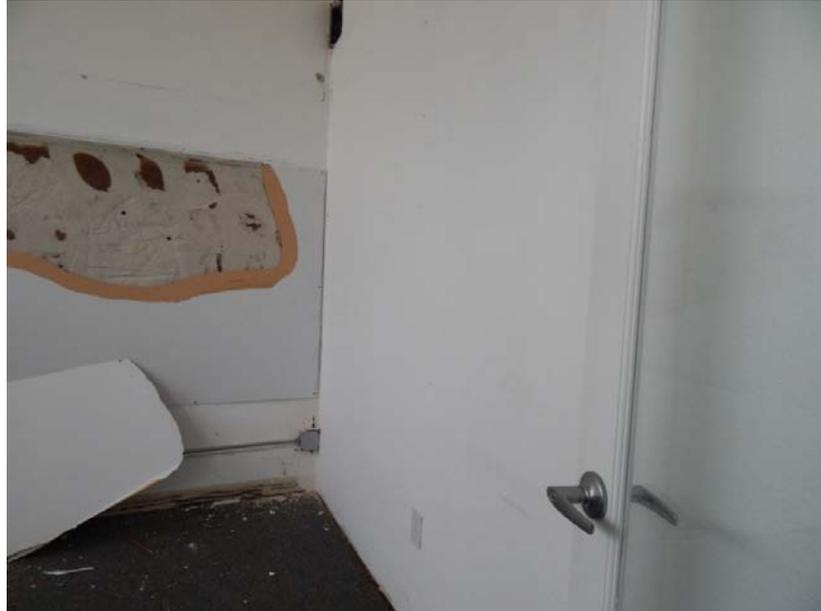
Non ADA compliant return on lever

Remove and replace doors and frames with Hollow Metal (HM) doors and frames at exterior locations and Solid Core Wood (SC) doors with HM frames at interior locations. All doors to receive new accessible hardware sets. See appendix G for hazardous materials report for lead paint locations.

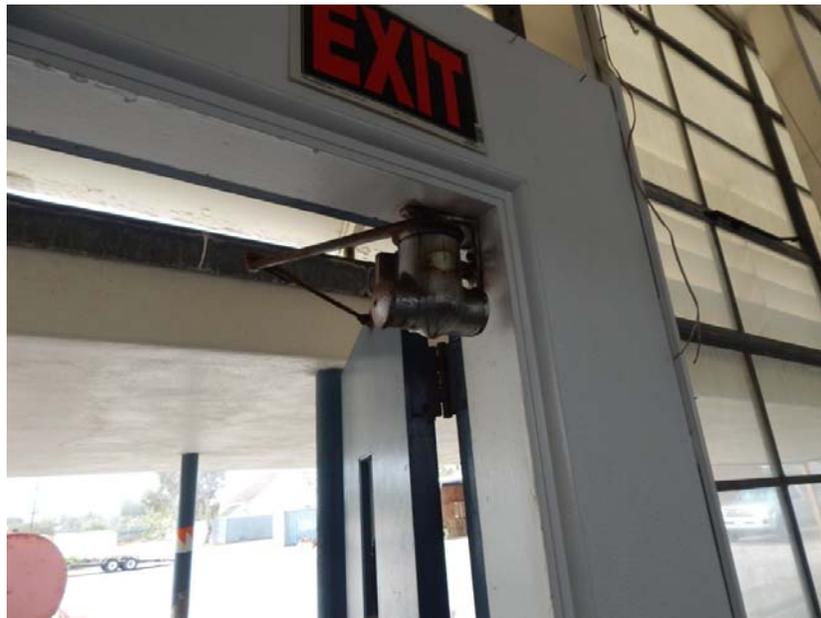
Aging door hardware components and lack of required ADA clearance under closer

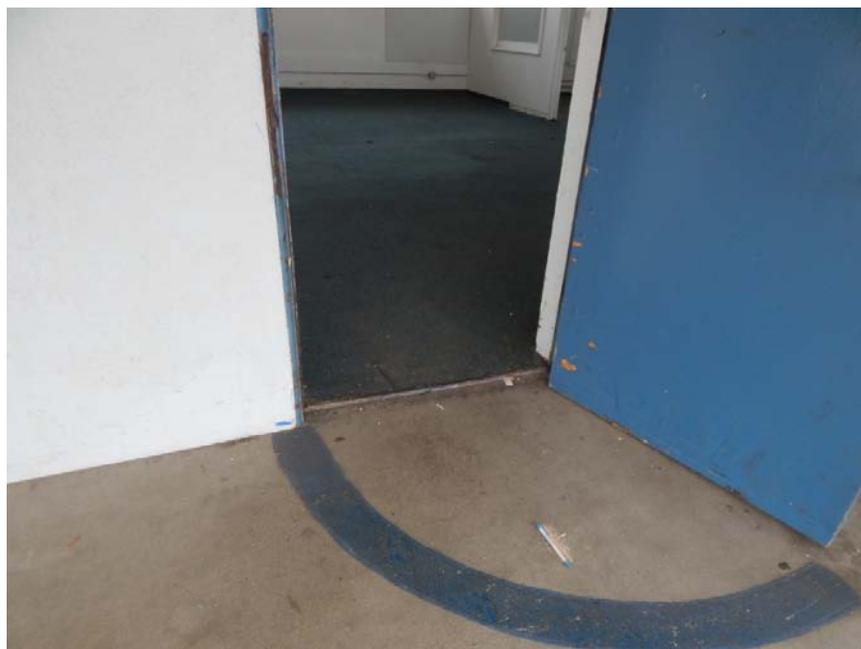
Non ADA compliant threshold. Exceeds 1/4" height in barrier free POT

Demolish and replace exterior concrete walk to provide compliant thresholds and accessible Path of Travel (POT) to all spaces.

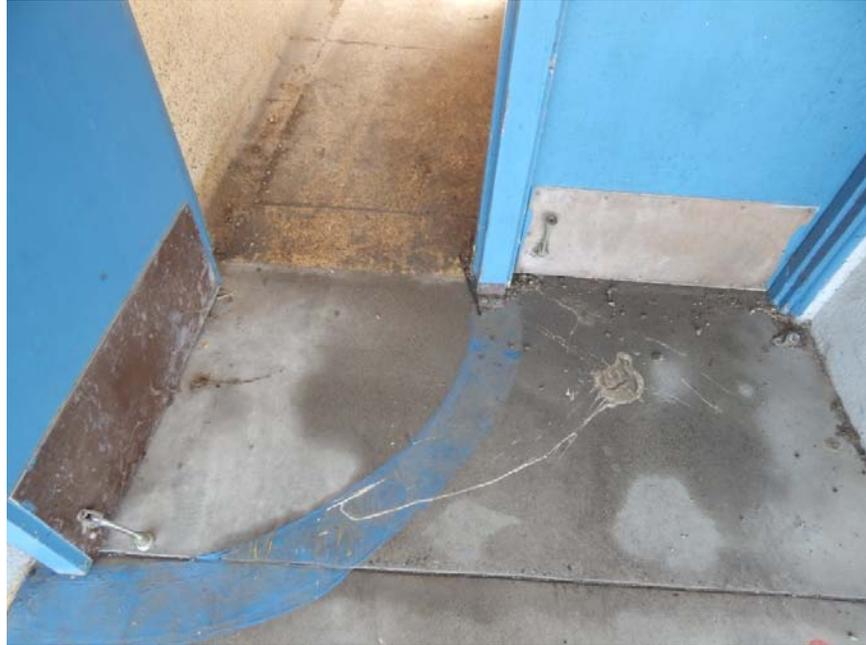
Non ADA compliant door maneuvering clearances and widths

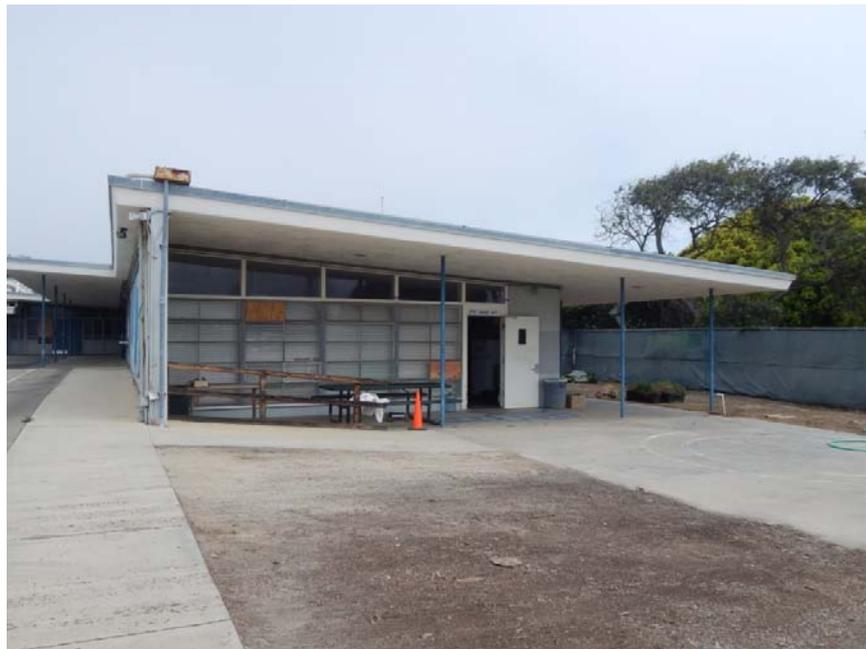
Non ADA compliant ramp in necessary POT

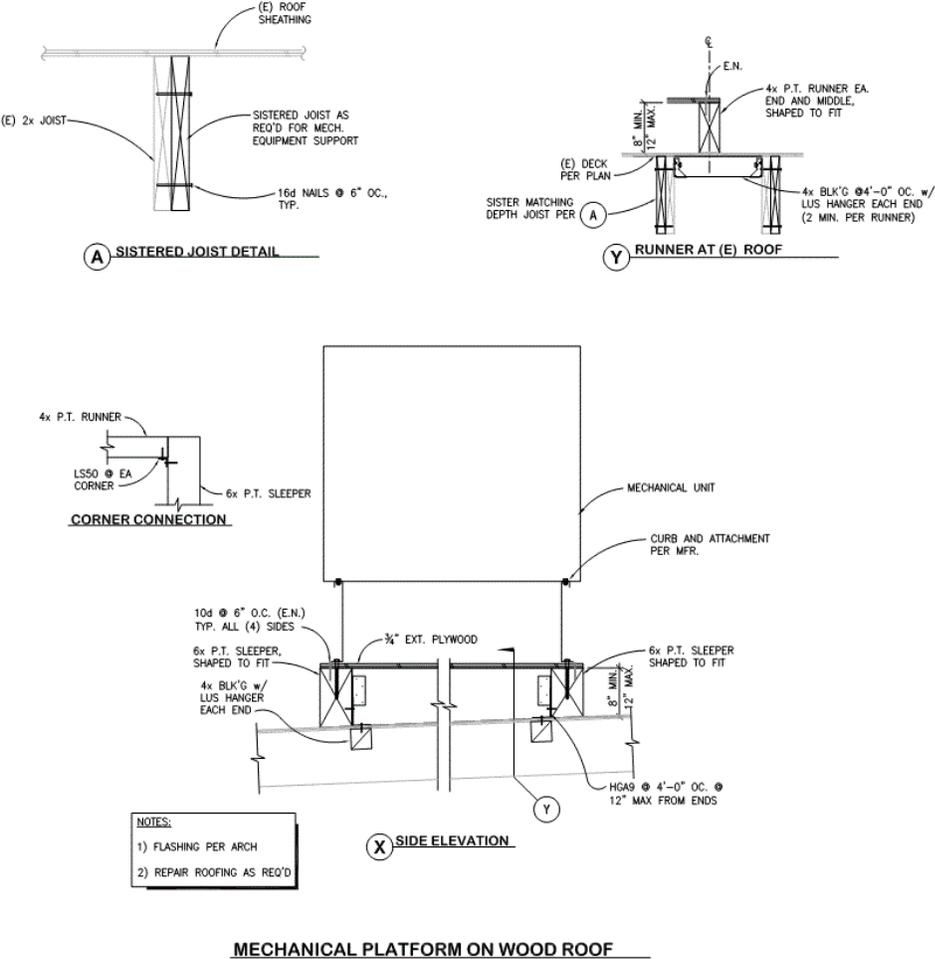
Figure 2. Typical roof joist strengthening and support of new mechanical equipment.

MEP Equipment Considerations – Multiple new roof-mounted heat pumps and exhaust fans are proposed to accommodate the reconfigured spaces in Option 2. Depending on the final weights and locations of the proposed pieces of equipment, new equipment may require strengthening of existing roof joists and new equipment support framing

similar to what is shown in **Figure 2**. Any new roof openings for mechanical equipment should be provided per **Figure 3**.

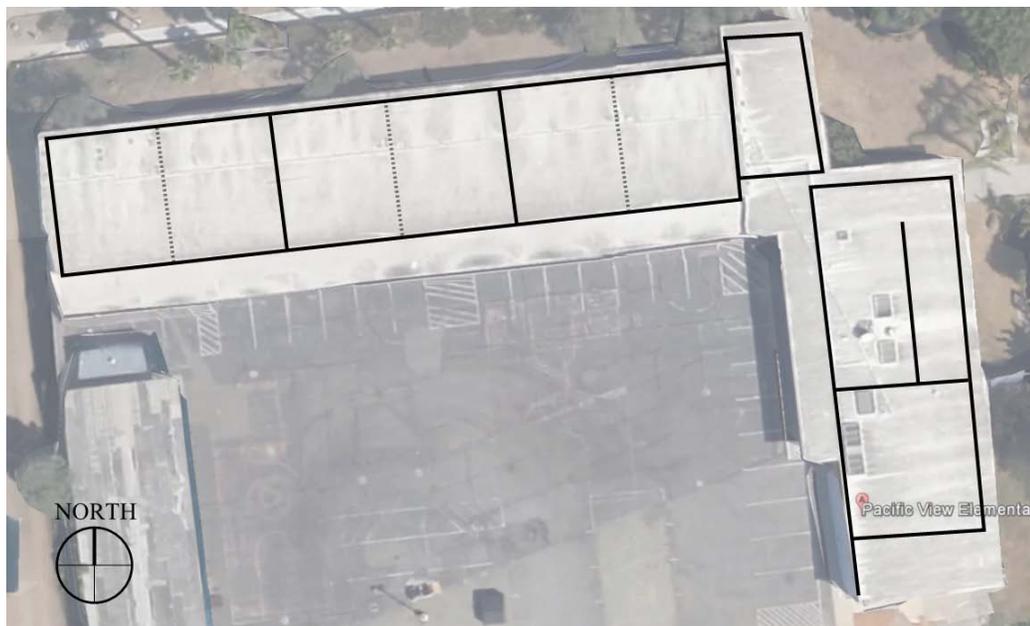
**Figure 4. Field-identified bearing and/or shear walls shown in solid black lines.
(Image courtesy of Google Earth)**

Based on the findings presented in KPFF's January 19, 2015 report prepared for the City of Encinitas, the interior walls identified in **Figure 4** were determined to be non-bearing partition walls and not part of the existing lateral force resisting system. Therefore, similarly to the scope identified in Option 1, these walls may be removed without triggering any of the requirements stated in chapter 34 of the CBC. Option 2 was developed as an extension to Option 1 in an effort to maximize usable space while still avoiding modifications to the existing building that would require additional seismic analysis and potential retrofit of the existing structure. Refer to **Option 2 Structural Demo and Proposed Plans** for scope of work associated with this option.

- All Option 1 scope to be included in Option 2.
- Alternating interior walls in the building short direction are not part of the structure's lateral or gravity system and may be removed without additional seismic retrofit. Bearing and/or shear walls that should remain are shown in **Figure 4**.
- Recommended voluntary seismic upgrade: provide three new 10' long full-height shear walls along the north side of the North building as shown in **Option 2 Structural Floor Plan**. Shear walls should be constructed with single-sided ½" plywood sheathing and Simpson holdowns at each end. If inadequate concrete footings are present, new footing should be constructed under these shear wall segments.

- All Option 1 scope to be included in Option 2.
- Shear walls to remain are shown in **Figure 4** and the **Option 2 Structural Floor Plan**. All other interior walls may be removed and reconfigured without requiring additional seismic retrofit.

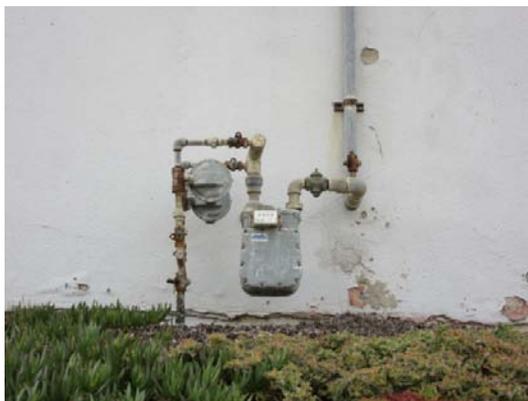
Natural Gas - The buildings are served by natural gas entering the east west oriented building at its west end. The service is 1" high pressure regulated and metered to 2" galvanized piping. The piping proceeds to the roof top and is distributed to use points from roof top piping. See Existing Observations Floor Plan for Plumbing, Heating, and Ventilation for location of fixture (Keynote - Bubble 24).

Natural Gas Service Regulator and Meter

The piping system looks to be from the original construction of 1953. Because of the marine environment the exterior piping system should be pressure tested to determine its integrity.

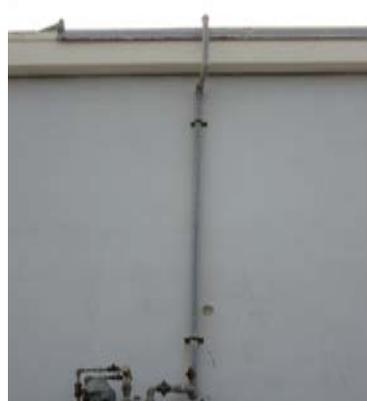
Piping to Rooftop

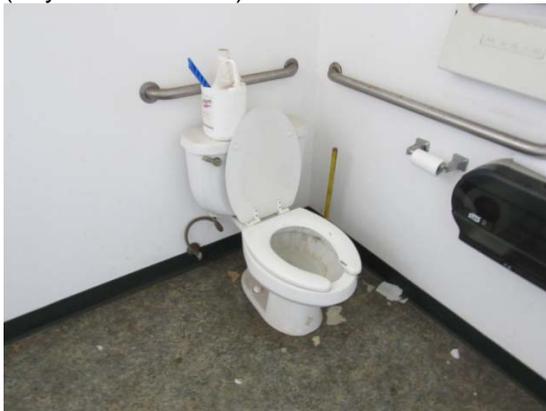
Women's Restroom - Another room in the space contains a Women's restroom. The restroom contains a flush tank water closet and counter mounted lavatory sink, hot and cold water piping, and drain, waste and vent piping. The sink and water closet look to be in poor condition (age estimated at 25 years or more). It is assumed the piping is from the original construction. The sink faucet was cycled with water coming from the hot and cold side. The water drained correctly from the sink bowl. The water closet was flushed with water draining correctly from the water closet bowl. See Existing Observations Floor Plan for Plumbing, Heating, and Ventilation for location of fixture (Keynote - Bubble 8).

Water Closet

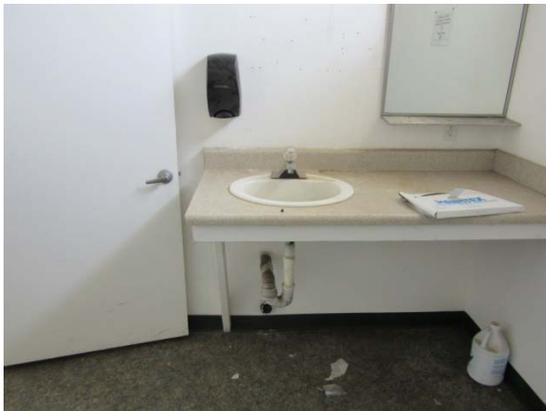
Lavatory Sink

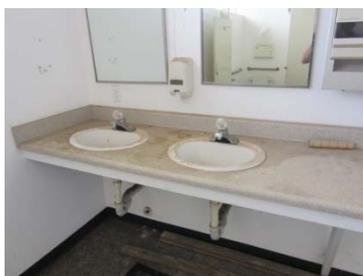
Men's Restroom - Another room in the space contains a Men's restroom. The restroom contains one flush tank water closet, two counter mounted lavatory sinks, one flush valve urinal, hot and cold water piping, and drain, waste and vent piping. The sinks, water closet, and urinal look to be in poor condition (age estimated at 25 years or more). It is assumed the piping is from the original construction. The sink faucets were cycled with water coming from the hot and cold side. The water drained correctly from the sink bowl. The water closet was flushed with water draining correctly from the water closet bowl. The flush valve on the urinal was flushed with water draining from the fixture correctly. See Existing Observations Floor Plan for Plumbing, Heating, and Ventilation for location of fixture (Keynote - Bubble 9).

Lavatory Sinks

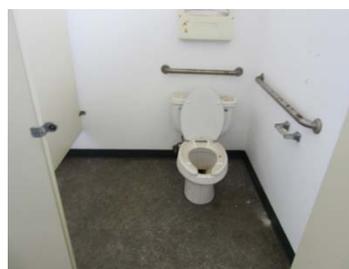
Water Closet

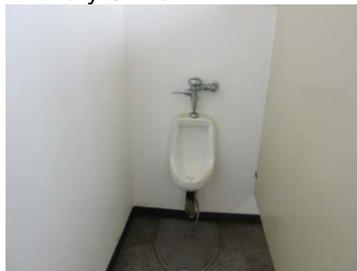
Urinal

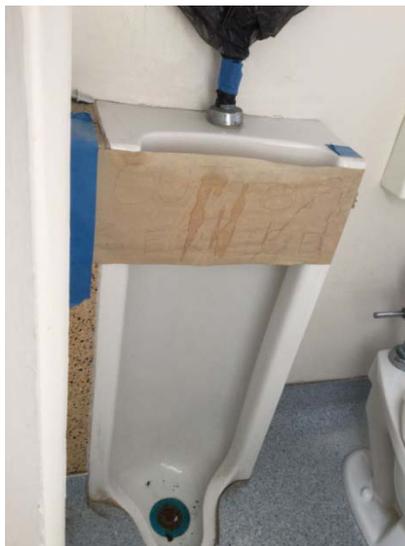
Men's Restroom Classroom 7 - This room contains a floor mounted urinal and a water closet. The urinal was not operational. The fixtures look to be in fair condition (age at least 25 years old). It is assumed the piping is from the original construction. The water closet was flushed with water draining correctly from the water closet bowl. The flush valve on the urinal was not flushed therefore the ability to drain properly was not determined. See Existing Observations Floor Plan for Plumbing, Heating, and Ventilation for location of fixture (Keynote - Bubble 13).

Floor Mounted Urinal

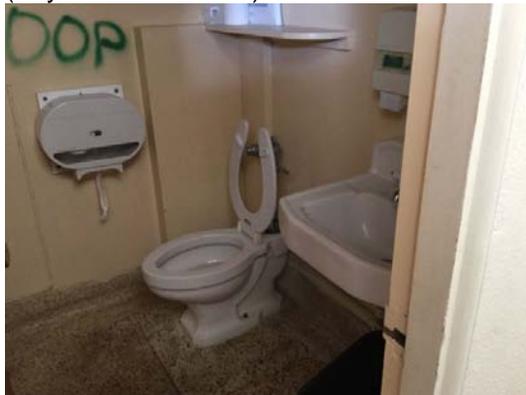
Private Restroom (South of Previous Office) - The restroom contains a flush valve water closet and wall mounted lavatory sink, hot and cold water piping, and drain, waste and vent piping. The sink and water closet look to be in poor condition (age estimated at 35 years or more). It is assumed the piping is from the original construction. The sink faucet was cycled with water coming from the hot and cold side. The water drained correctly from the sink bowl. The water closet was flushed with water draining correctly from the water closet bowl. See Existing Observations Floor Plan for Plumbing, Heating, and Ventilation for location of fixture (Keynote - Bubble 19).

Water Closet and Lavatory

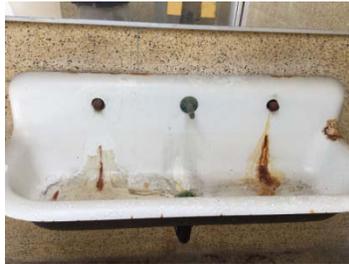
Boy's Restroom - The restroom contains two flush valve water closet, two wall mounted urinals, one trough sink, cold water piping, and drain, waste and vent piping. The trough sink was in very poor condition (visually it looked to be from the original construction). The faucets have been removed. The water closets also look to be in very poor condition (original construction). It is assumed the piping is from the original construction. The sink faucets

Boy's Trough Sink

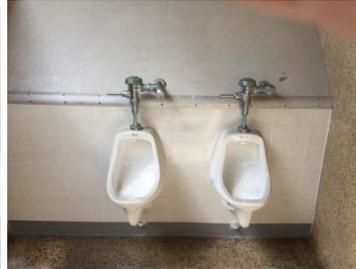
could not be cycled. The water closets were flushed with water draining correctly from the water closet bowl. The urinals looked to be in fair condition (age estimated at less than 20 years). The urinals were flushed with water draining correctly from the fixture. See Existing Observations Floor Plan for Plumbing, Heating, and Ventilation for location of fixture (Keynote - Bubble 21).

Urinals

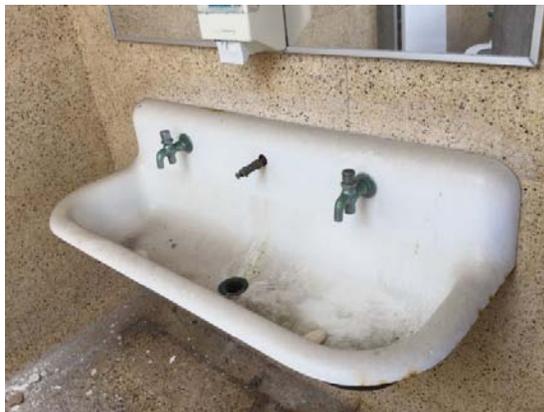
Girl's Trough Sink

Girl's Restroom - The restroom contains three flush valve water closet and one trough sink, cold water piping, and drain, waste and vent piping. The trough sink was in very poor condition (visually it looked to be from the original construction). The water closets also look to be in very poor condition (original construction). It is assumed the piping is from the original construction. The sink faucets were cycled with water flowing from each one. The water closets were flushed with water draining correctly from the water closet bowl. The urinals were flushed with water draining correctly from the fixture. See Existing Observations Floor Plan for Plumbing, Heating, and Ventilation for location of fixture (Keynote - Bubble 22).

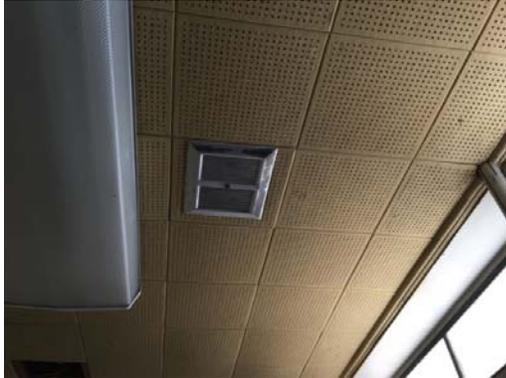
Ceiling Mounted Electric Heater

Office Classroom 7 Area - This area has a ceiling mounted electric heater. Age (looks more than 20 years old) and capacity unknown. See Existing Observations Floor Plan for Plumbing, Heating, and Ventilation for location of heating unit (Keynote - Square 11).

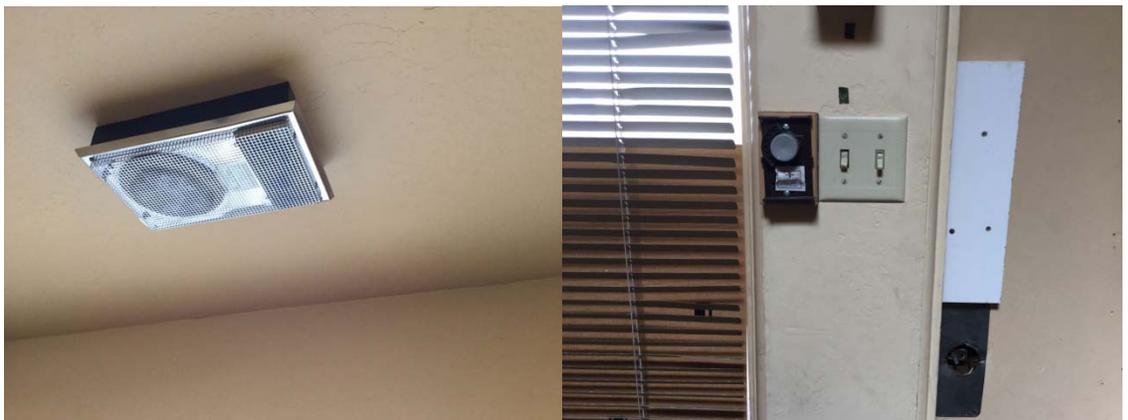
Electric Heater

Office Northwest Corner of Building - This area has a ceiling mounted electric heater with wall mounted control switch. Age (looks more than 20 years old) and capacity unknown. See Existing Observations Floor Plan for Plumbing, Heating, and Ventilation for location of heating unit (Keynote - Square 12).

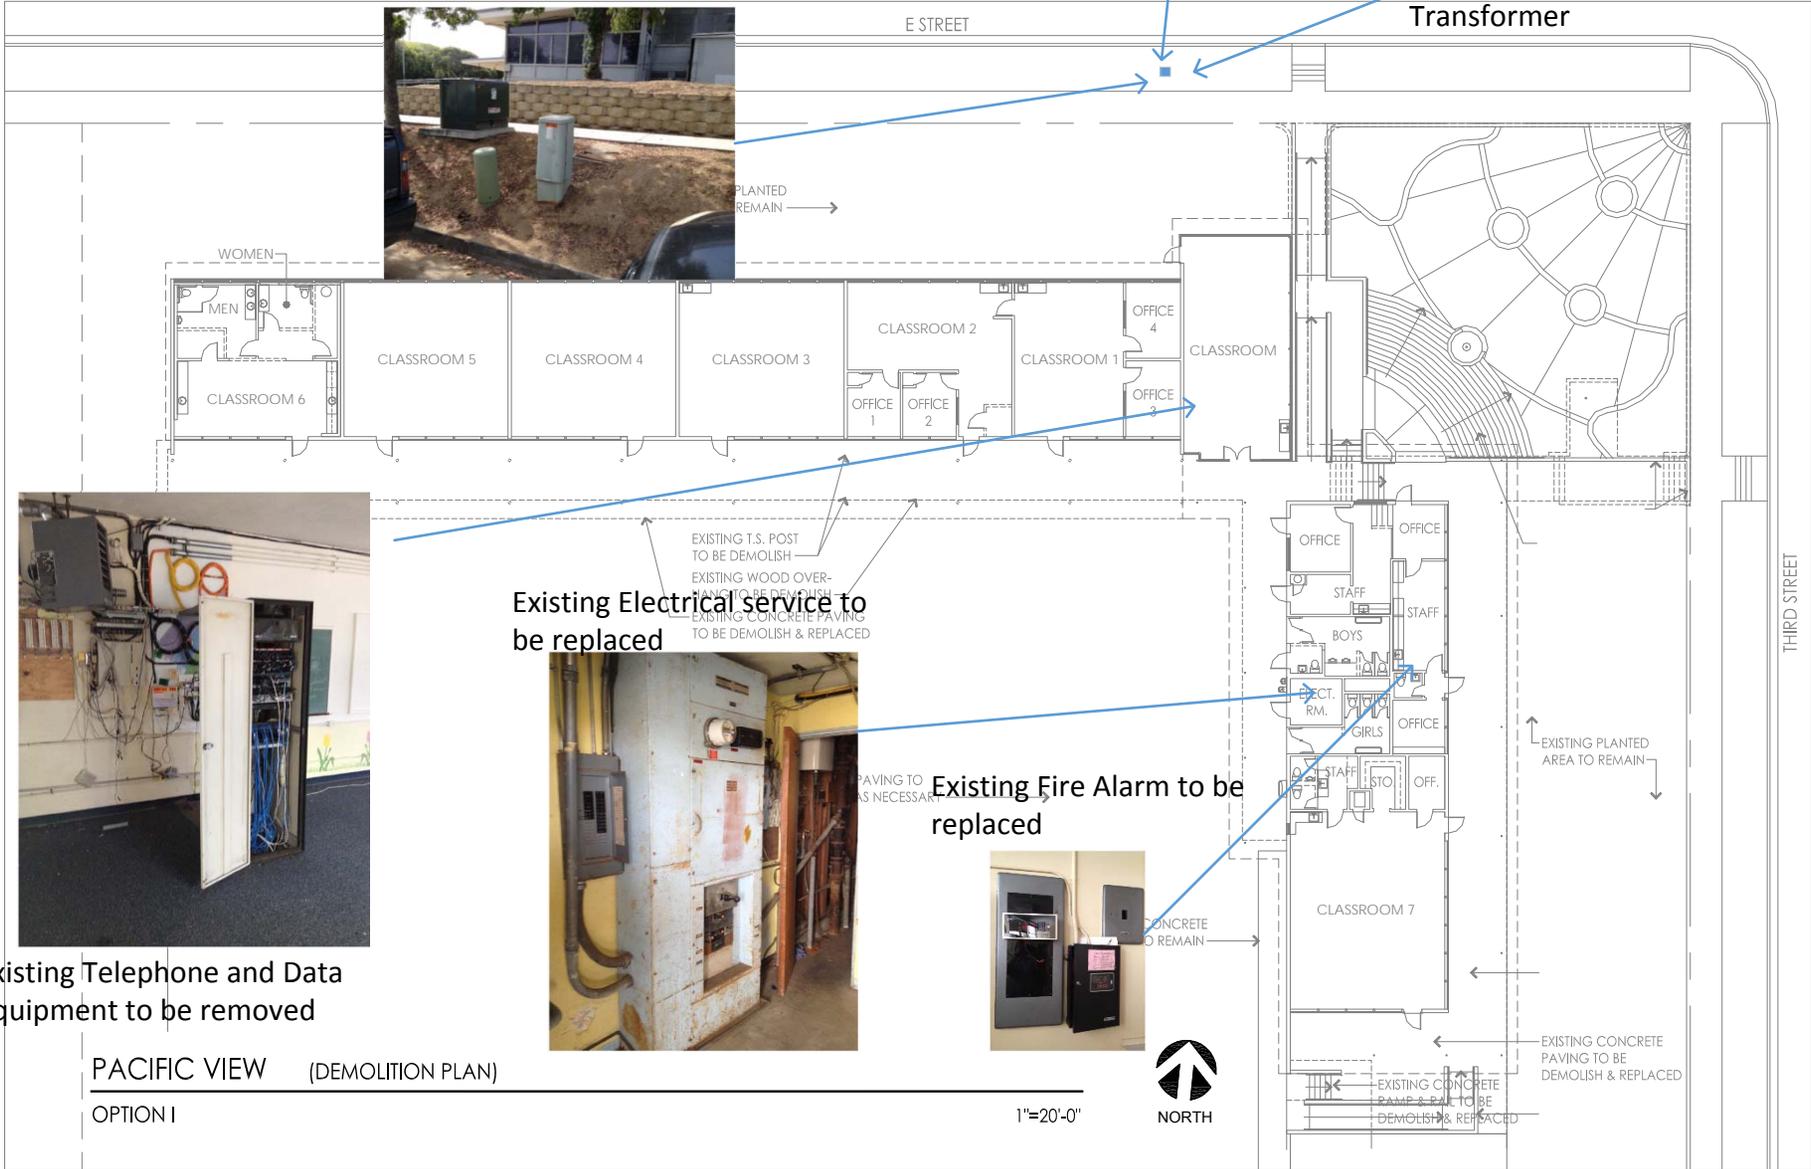
Existing Telephone Co.
Service pedestal
Existing SDG&E pad Mounted
Transformer

Existing Telephone and Data equipment to be removed

Existing Electrical service to be replaced

Existing Fire Alarm to be replaced
