Street Tree Removal

Monterey Cypress – 465 Neptune

Street Tree Removal Evaluation

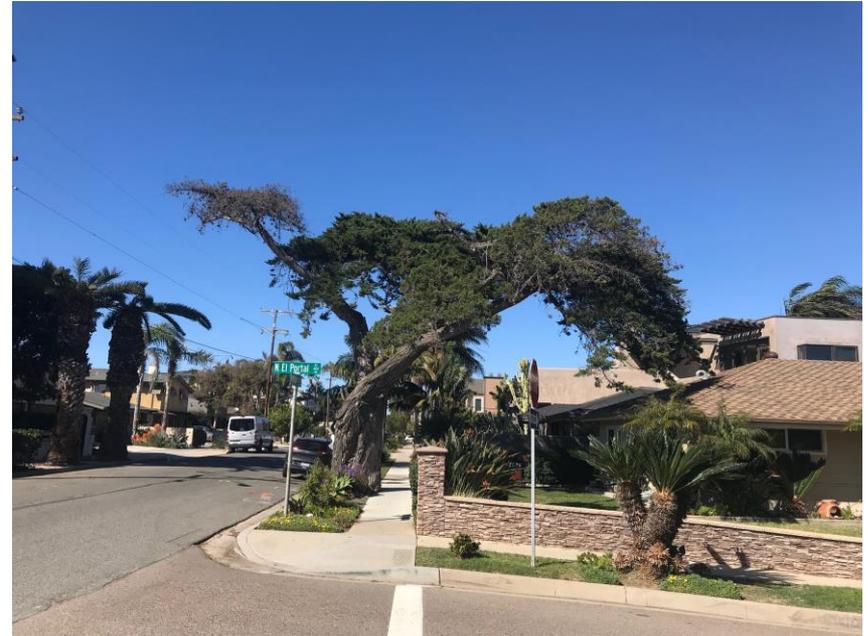
1. City received a request to evaluate the health and structure of the tree.
2. Public works notified the City Arborist and requested a review of the tree.
3. City arborist performed a LV 1 evaluation of the tree.
4. Based on observations the City Arborist recommended the tree for removal, and requested that West Coast Arborist, Inc. perform a LV 3 risk evaluation of the tree.
5. WCA determined that the tree presented a high risk and recommended either removal or substantial pruning to mitigate the risk.

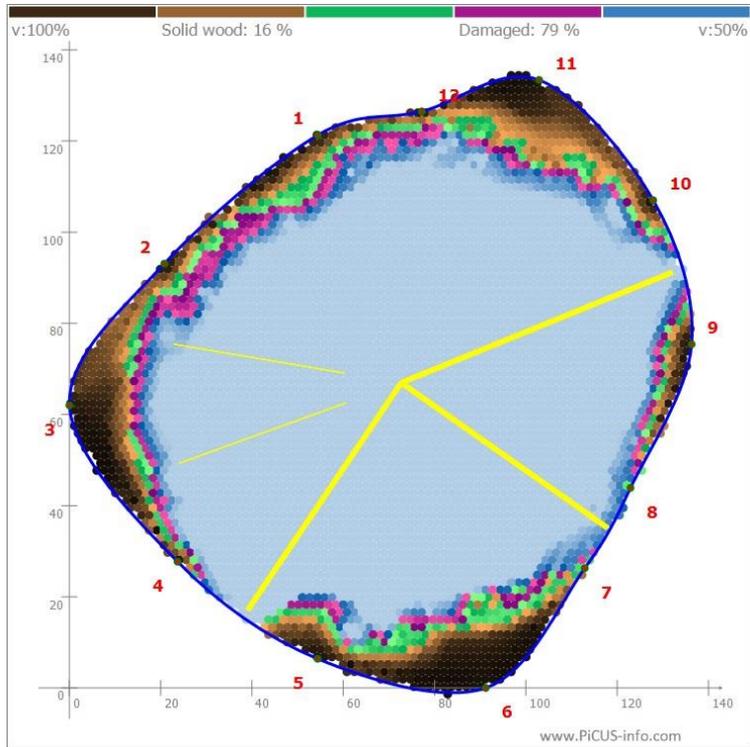
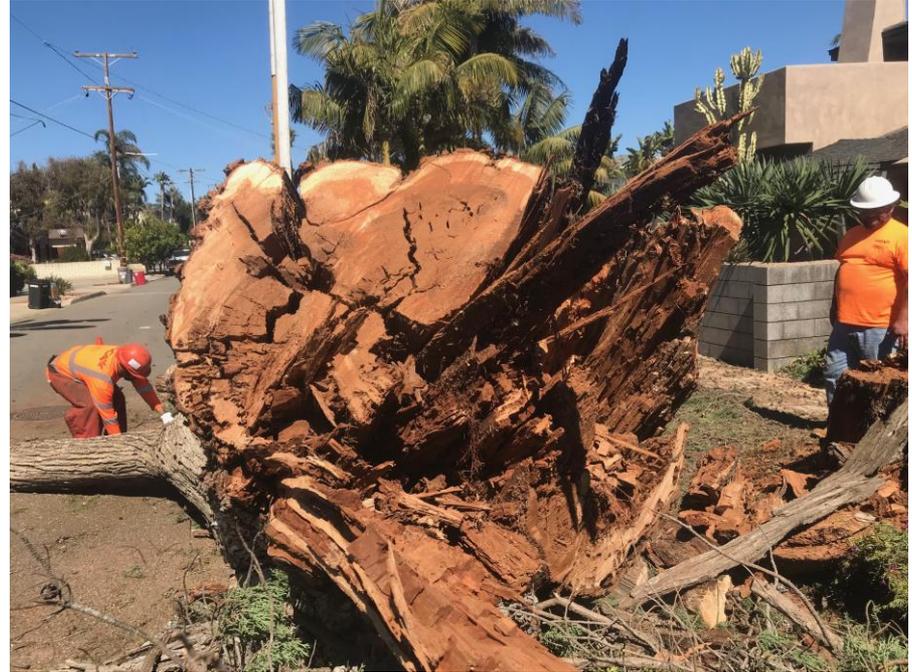
LV3 – City Evaluation

1. The tree had approximately 16% solid wood, 79% damaged wood, and 5% transitional wood (area between healthy and damaged wood).
2. The average depth of the residual wall thickness (**brown**) ranged from virtually non-existent to a maximum thickness of approximately 6.6 inches.
3. Due to the level of detected damaged wood, the size, and location of the tree, tree was considered to pose a significant threat to the community and was recommended for removal.
