City of Encinitas

Level 3 Assessment of Blue Gum Tree

Near 1009 2nd Street
Asset I.D. # 5919TREE

OCTOBER 10, 2018

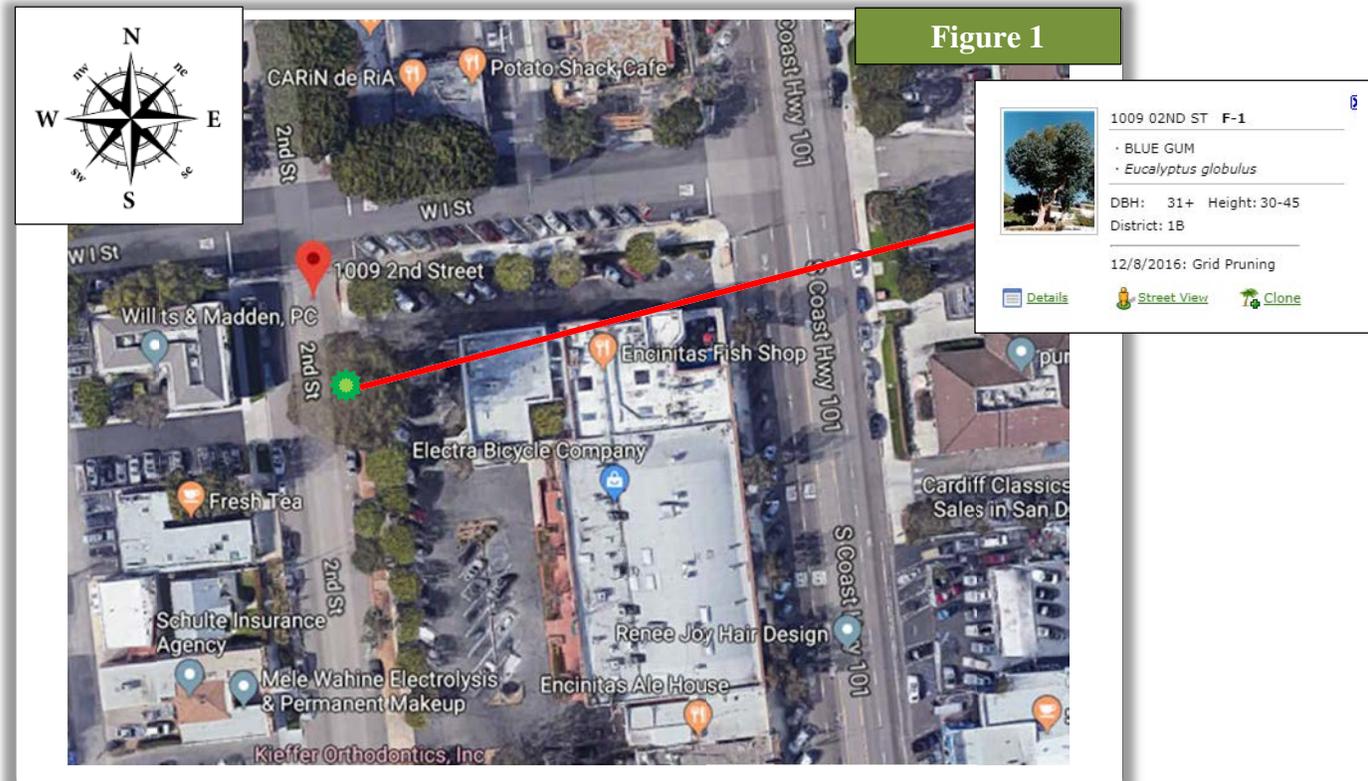
In September of 2018, West Coast Arborists, Inc., (WCA) was contacted by the City of Encinitas in regard to the assessment of a Blue Gum (*Eucalyptus globulus*) tree located in front of 1009 2nd Street. In ArborAccess (WCA’s tree inventory database), the tree is inventoried as 1009 02ND ST F-1 (see Figure 1 below).
