# City of Encinitas

## Level 3 Assessment of Blue Gum Tree

Near 751 2<sup>nd</sup> Street  
Asset I.D. # 5357TREE

SEPTEMBER 26, 2018

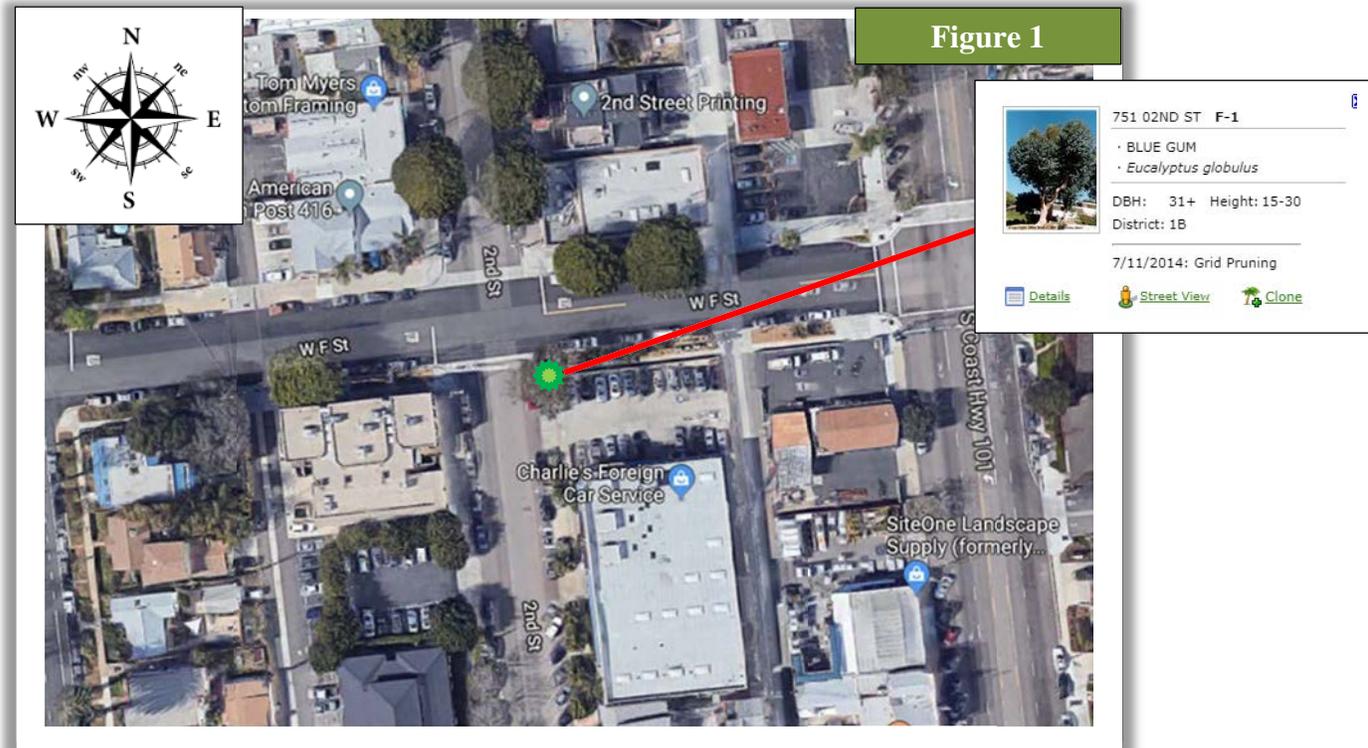
In September of 2018, West Coast Arborists, Inc., (WCA) was contacted by the City of Encinitas in regard to the assessment of a Blue Gum (*Eucalyptus globulus*) tree located in front of 751 2<sup>nd</sup> Street. In ArborAccess (WCA’s tree inventory database), the tree is inventoried as 751 2<sup>ND</sup> ST F-1 (see Figure 1 below).

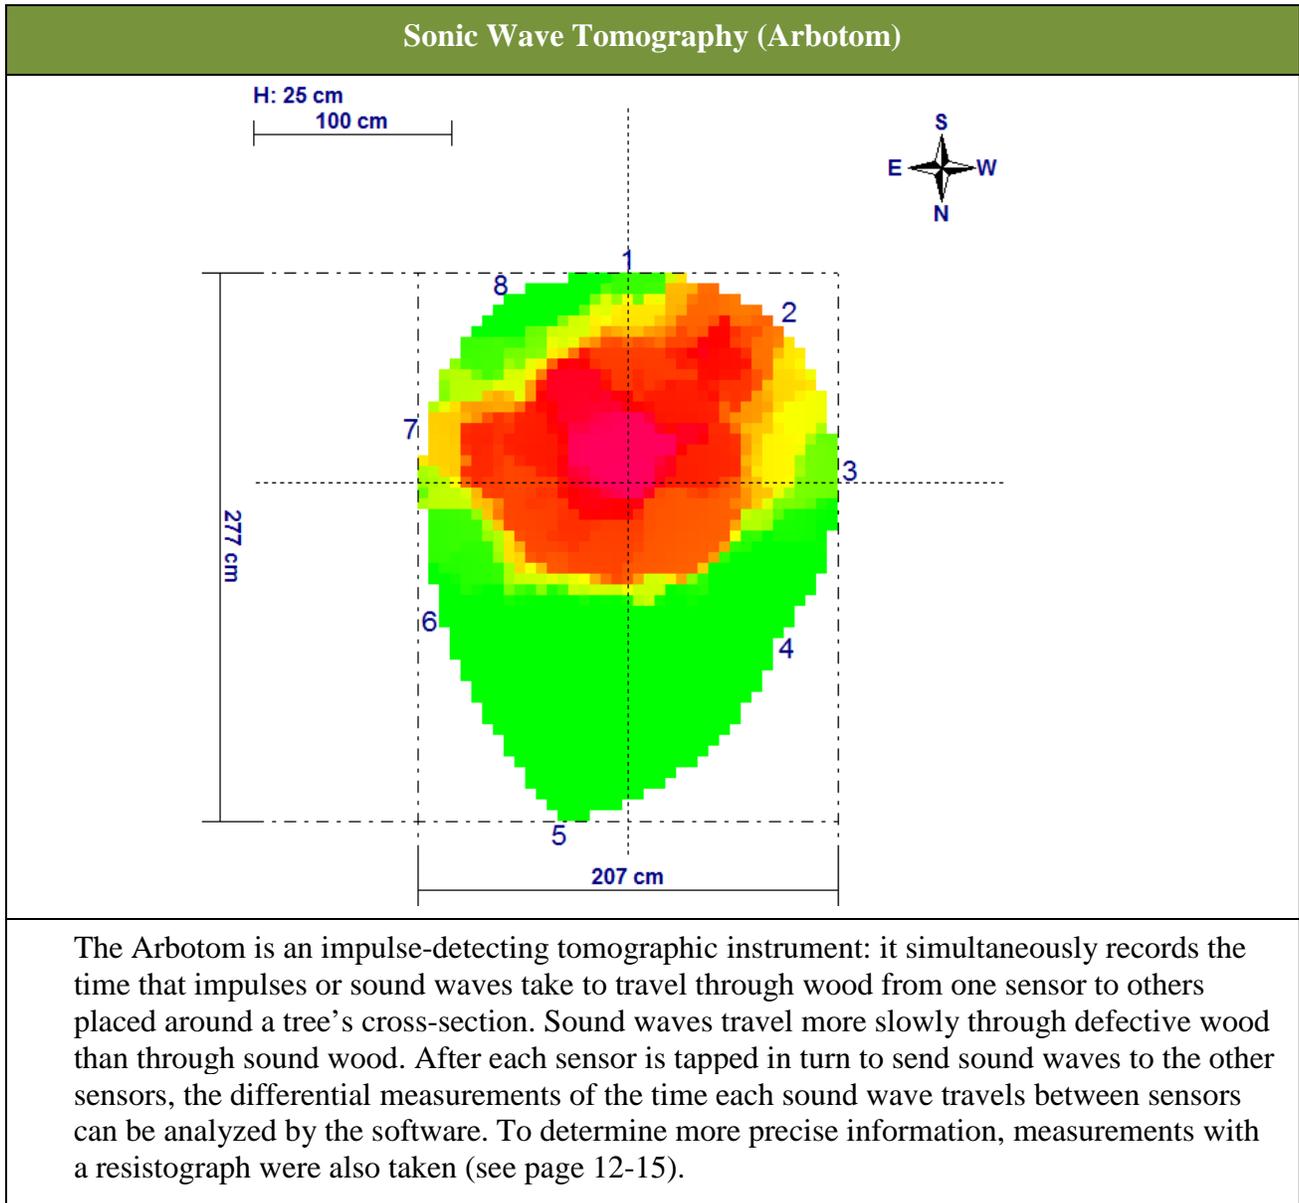
## APPENDIX B – ADVANCED TRUNK ANALYSIS

After completing the advanced trunk assessment, the defect of greatest concern was basal/ root decay. This is due to the large clusters of fungal fruiting bodies (likely *Laetiporus gilbertsonii*), evidence of asymmetrical basal/ root decay, a slight lean, and unknown root pruning history. *Laetiporus gilbertsonii* is a fairly aggressive parasitic brown rot fungi commonly found in mature Eucalyptus trees and it is known provoke unpredictable failures (e.g. tree falling over). In addition, this asymmetrical/ off-center decay is more prone to failures than a central decay with an intact shell of intact wood. The *likelihood of failure* because of basal/ root decay was assessed as **possible** within the next 2 years. This failure would most likely occur towards the north- east during a seasonal wind or storm event.
