INITIAL SITE ASSESSMENT REPORT
for the
ENCINITAS HABITAT STEWARDSHIP PROGRAM
City of Encinitas, California

DUDEK
605 Third Street
Encinitas, California 92024
Contact: Anita Hayworth

APRIL 2019

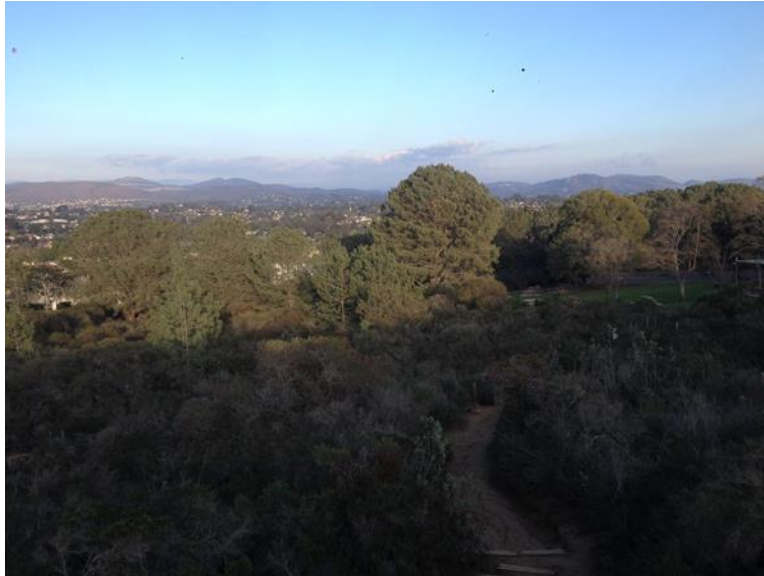
5. Additional signage should be installed along the City established trail to encourage the public to stay on the trail as to avoid impacts to sensitive native habitat (Photo 8).

Photo 8: Photo taken from the eastern side of the Encinitas Senior Center looking east towards Oak Crest Park
